Minnesota Airport System Pavement Evaluation 2013 Update

Longville Municipal Airport (XVG)

Longville, Minnesota

Final Report

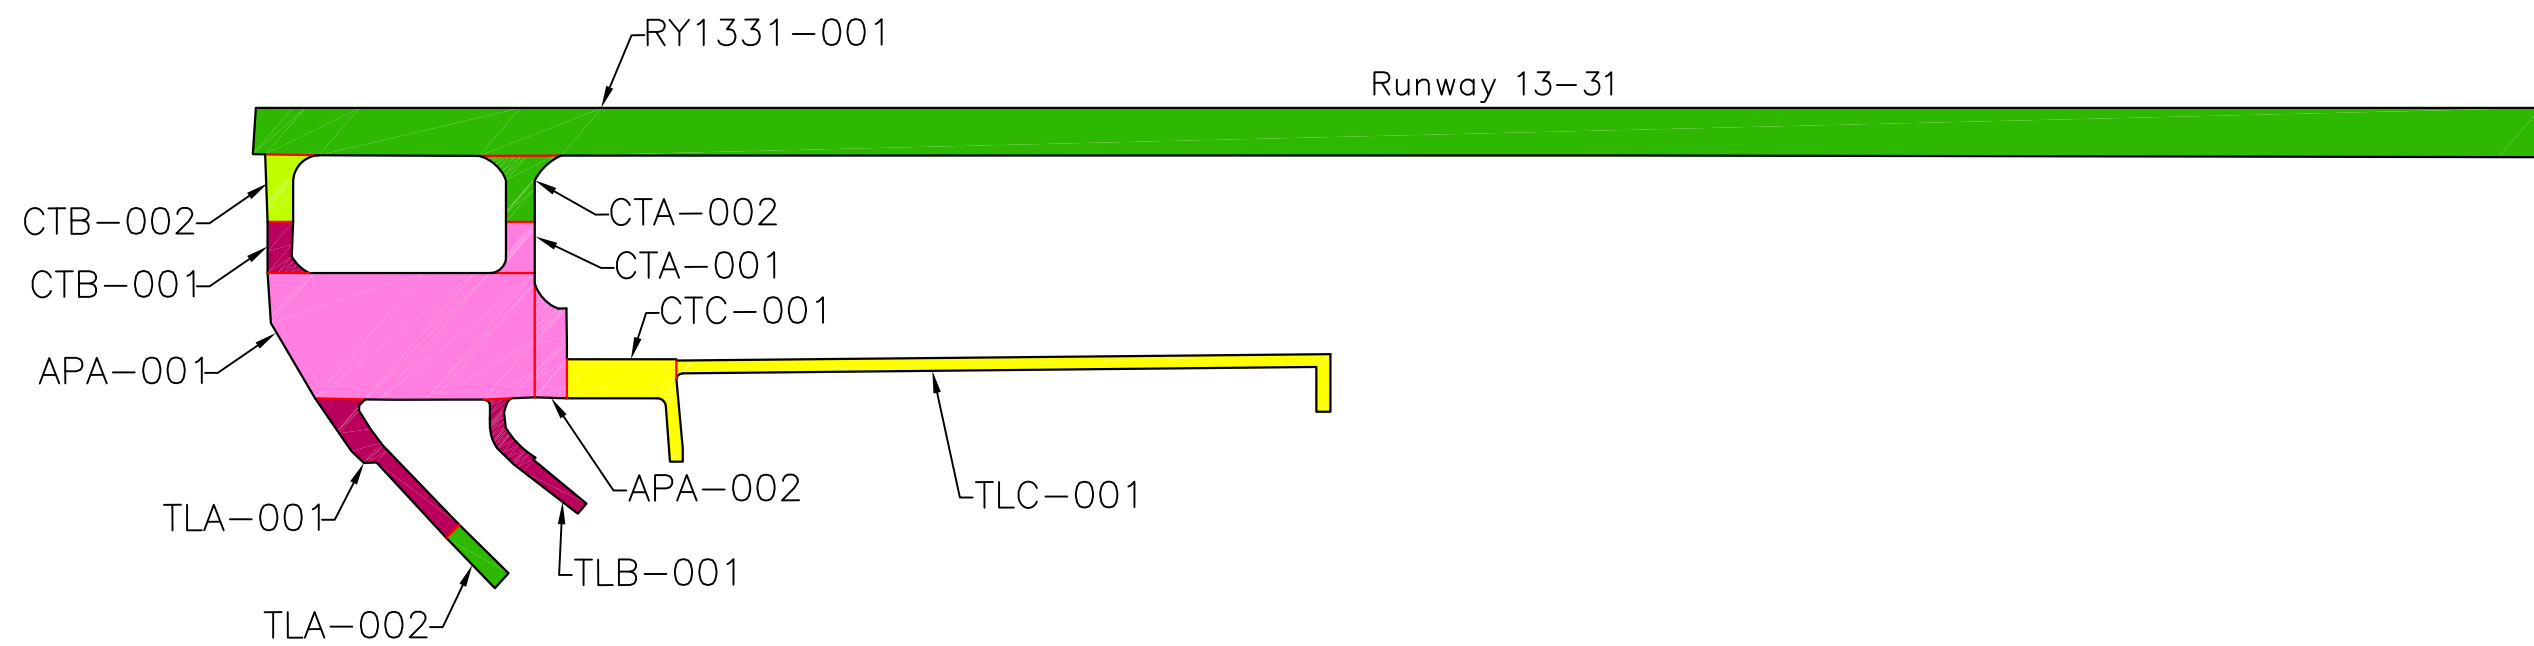
Figure 4. 2013 Pavement Condition Index Rating at Longville Municipal Airport (XVG).

Figures 5 and 6 present the overall PCI for XVG by area distribution and pavement use, respectively. Table 3 presents the PCI summary for each section at XVG, including the drop in PCI per year. Generally, pavement sections will deteriorate between 1 and 3 PCI points per year. Sections deteriorating at higher rates may need maintenance above the normal application rates and should be closely monitored in case major repairs become necessary.

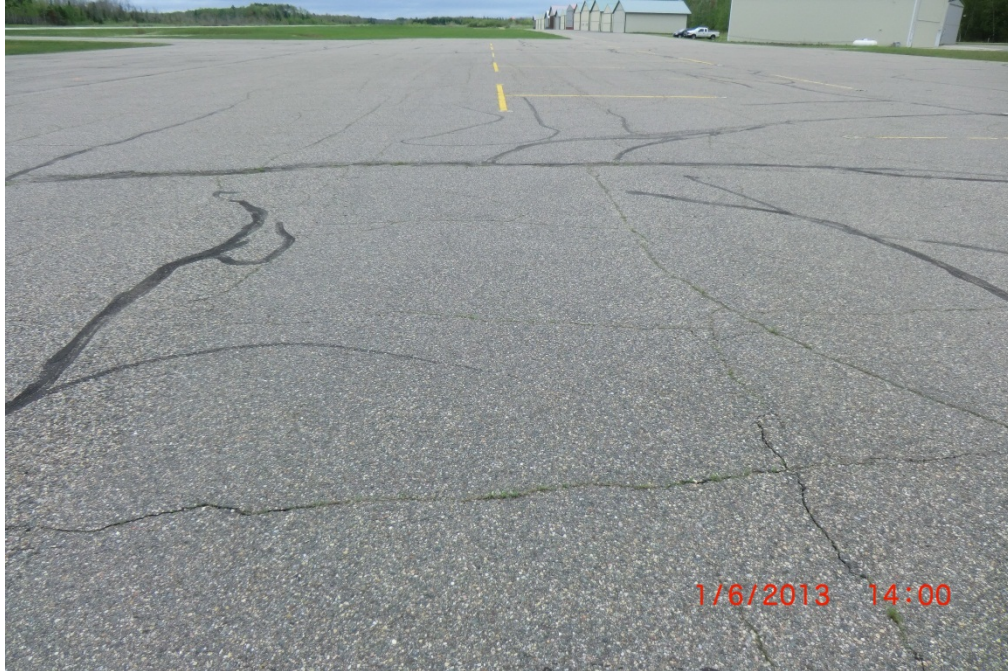
XVG APA 001 (PCI = 44)

Conditions: PCI: 44

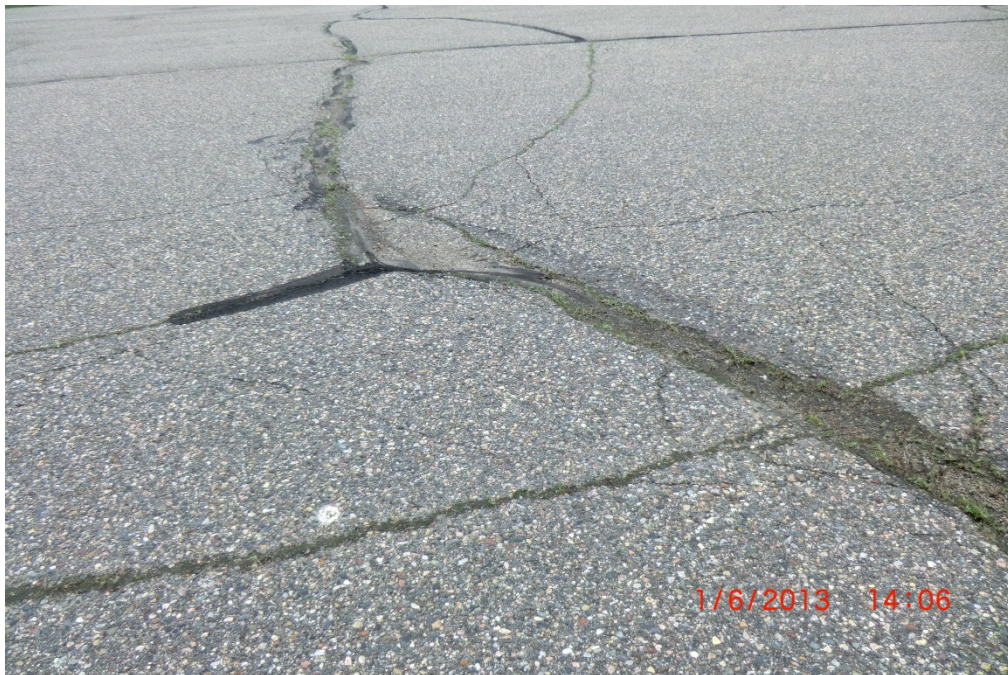
XVG APA 001 (High-Severity L&T Crack)

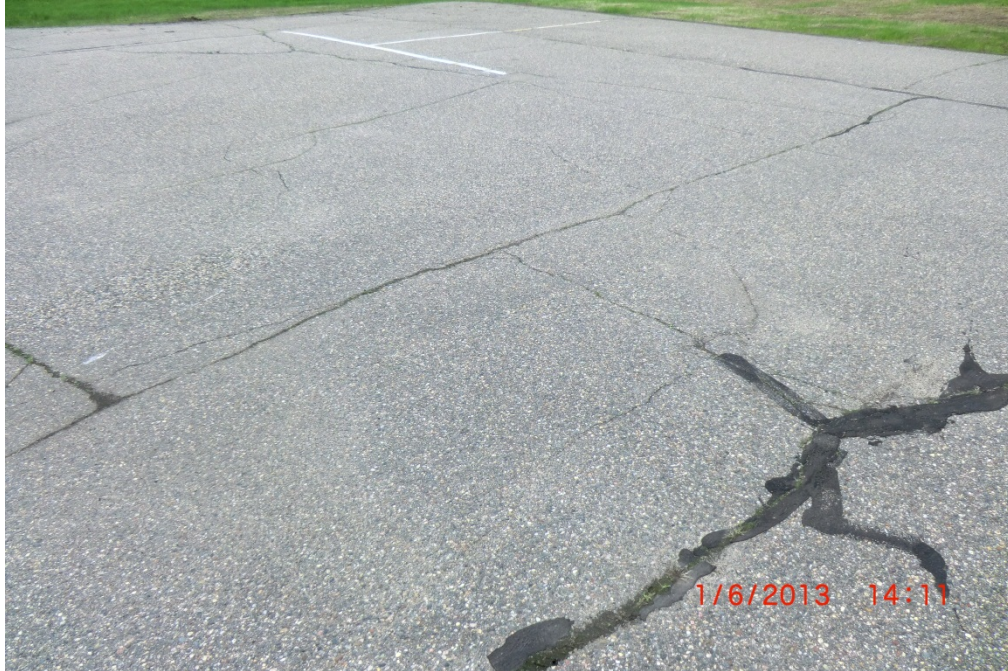
XVG APA 002 (PCI = 51)

Conditions: PCI: 51

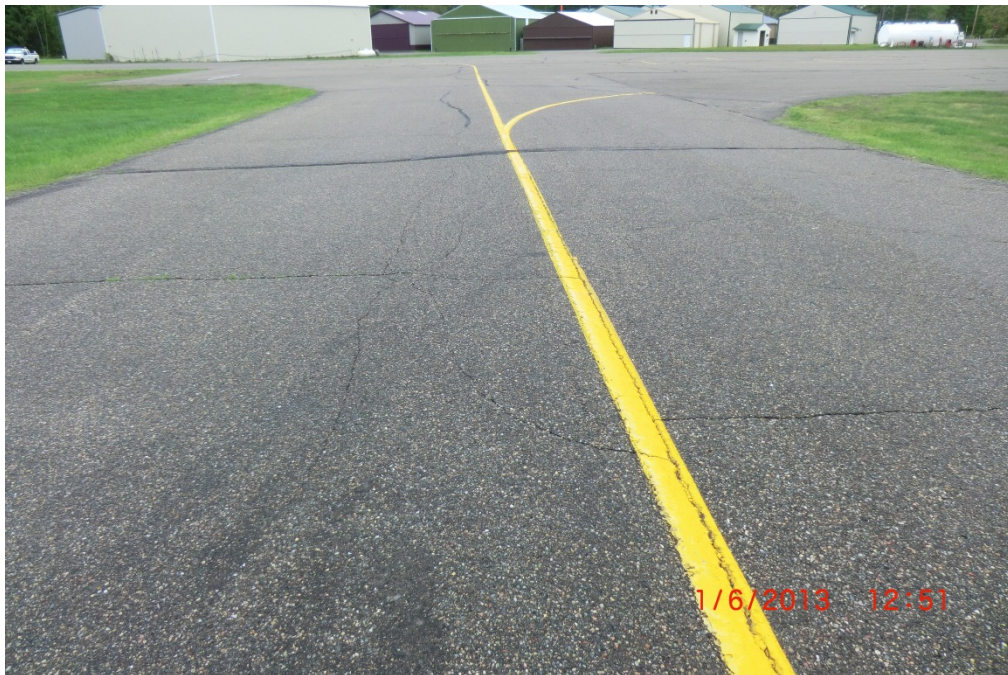
XVG CTA 001 (PCI = 52)

Conditions: PCI: 52

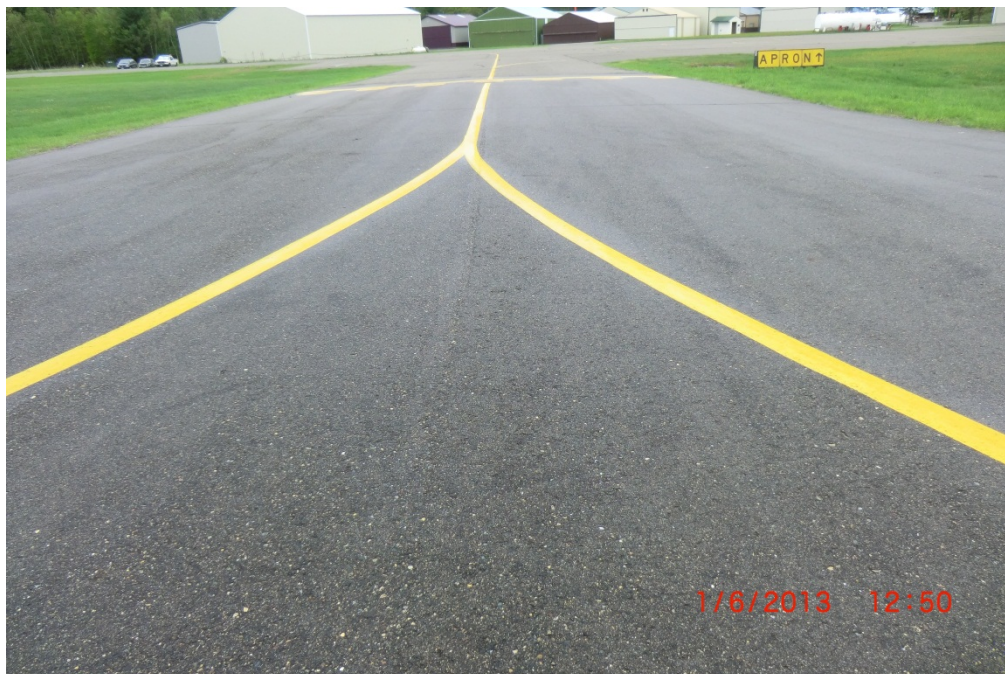
XVG CTA 002 (PCI = 97)

Conditions: PCI : 97

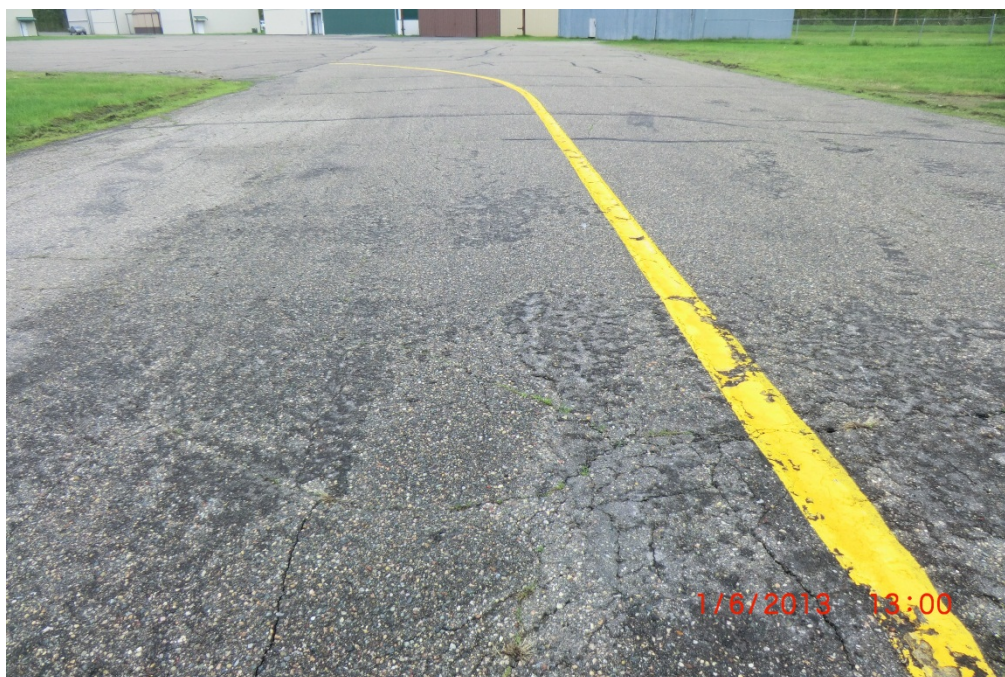
XVG CTB 001 (PCI = 16)

Conditions: PCI: 16

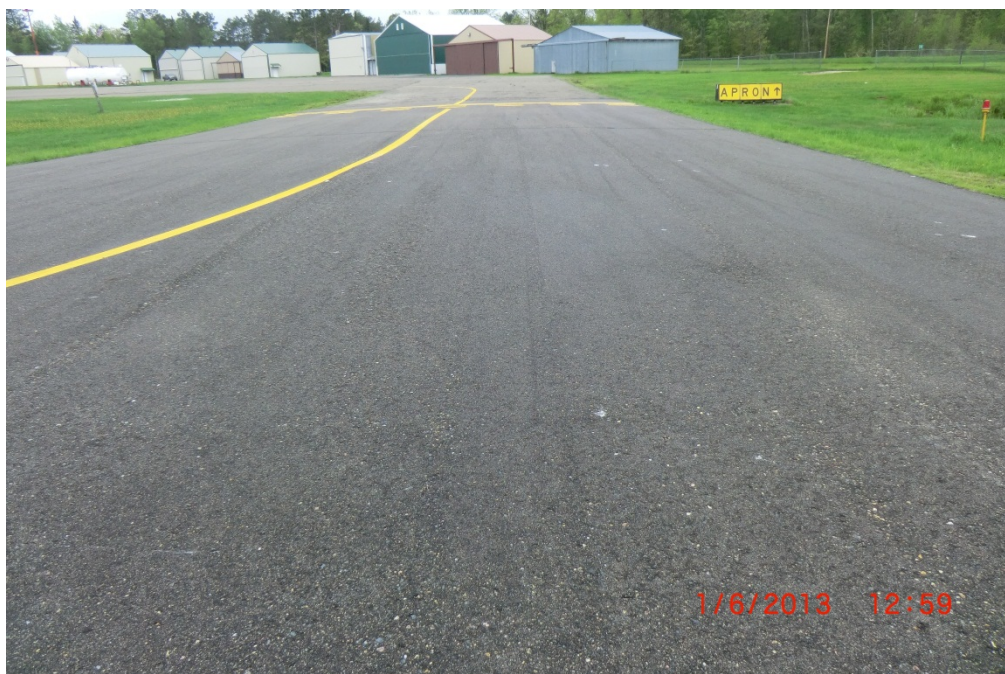
XVG CTB 002 (PCI = 82)

Conditions: PCI : 82

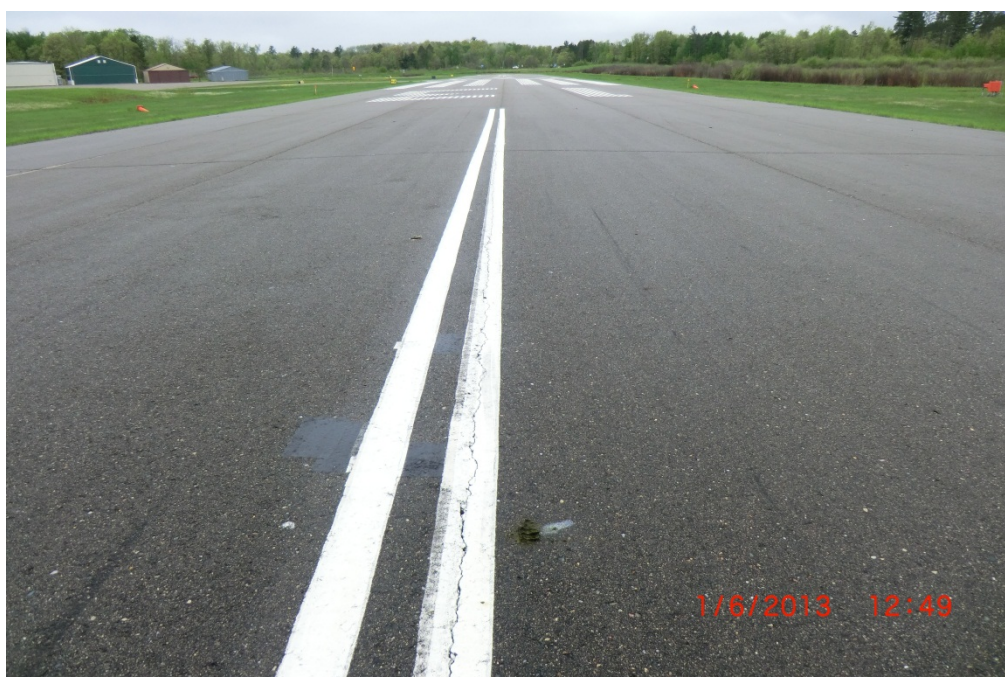
XVG RY1331 001 (PCI = 92)

Conditions: PCI: 92

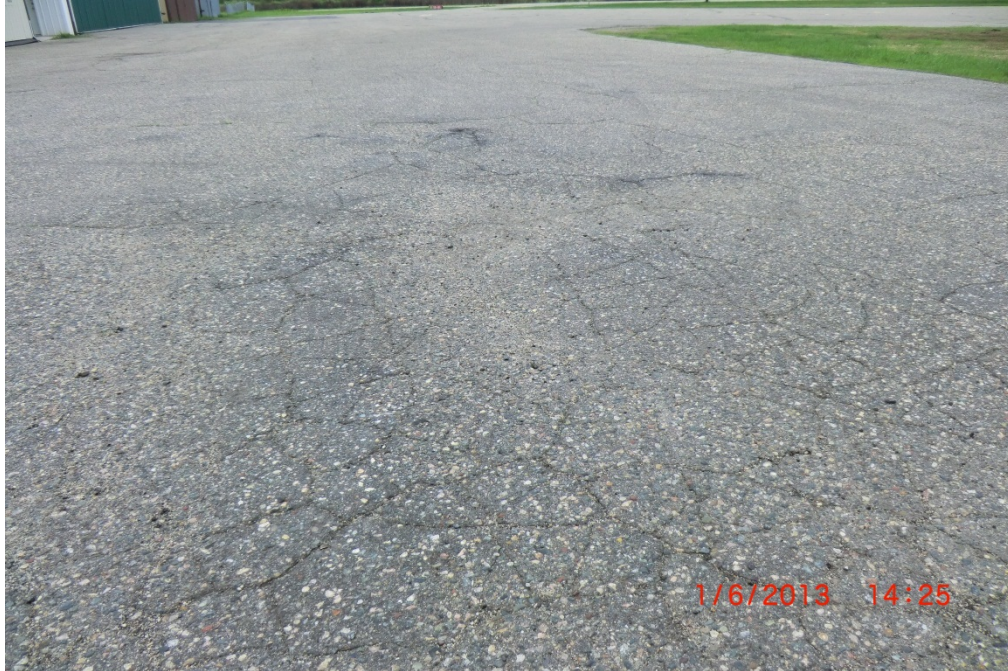
XVG TLA 001 (PCI = 20)

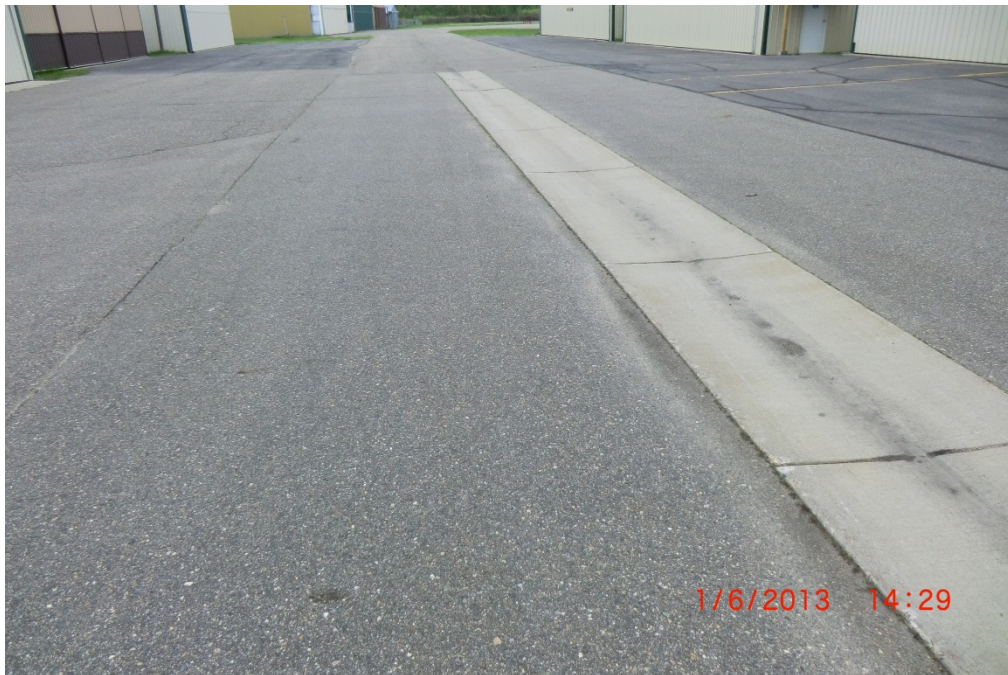
TLA	2	AC	2,600	2007	96	94	1.0	0	100	L&T cracking
TLB	1	AAC	7,250	1995	25	22	4.3	28	65	Alligator cracking, Block cracking, Depression, Rutting, Swelling, Weathering
TLC	1	AC	22,540	2005	79	70	3.8	41	59	L&T cracking, Rutting

XVG TLA 002 (PCI = 94)

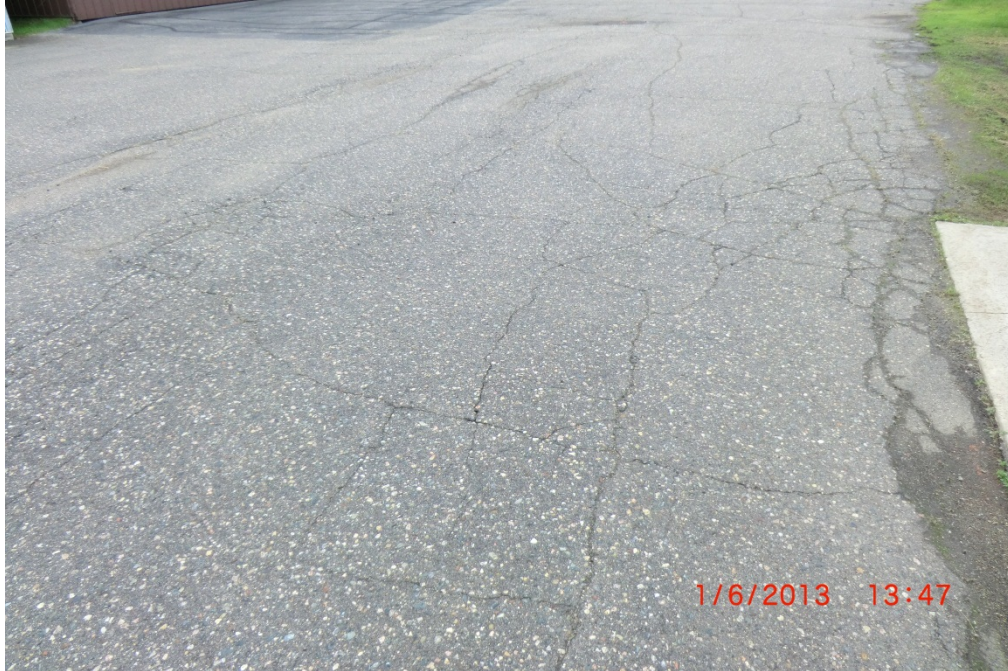
XVG TLB 001 (PCI = 22)

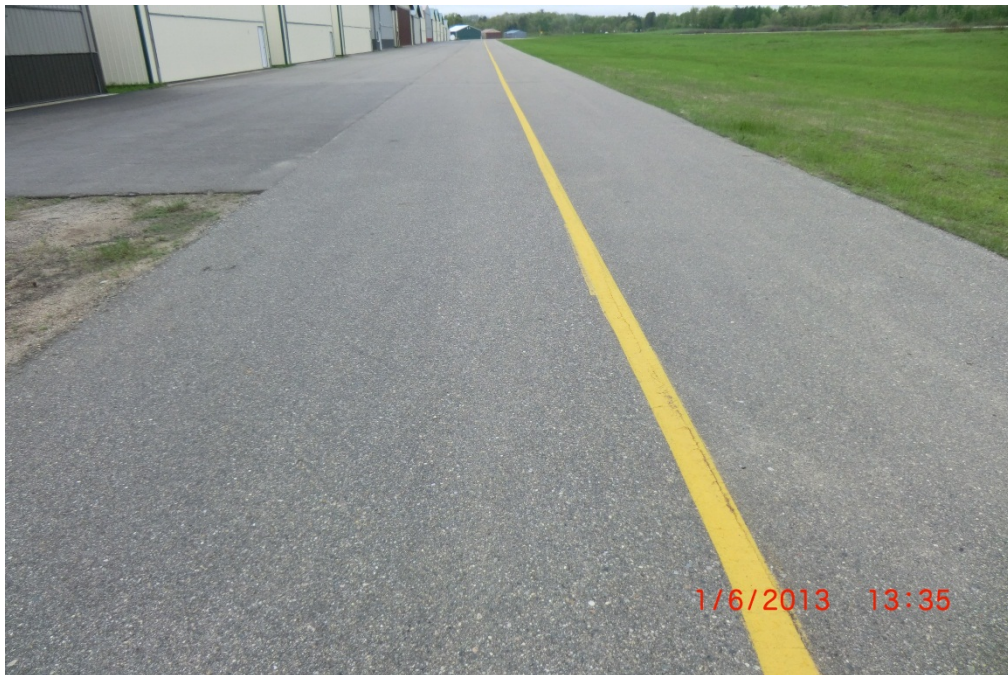
XVG TLC 001 (PCI = 70)

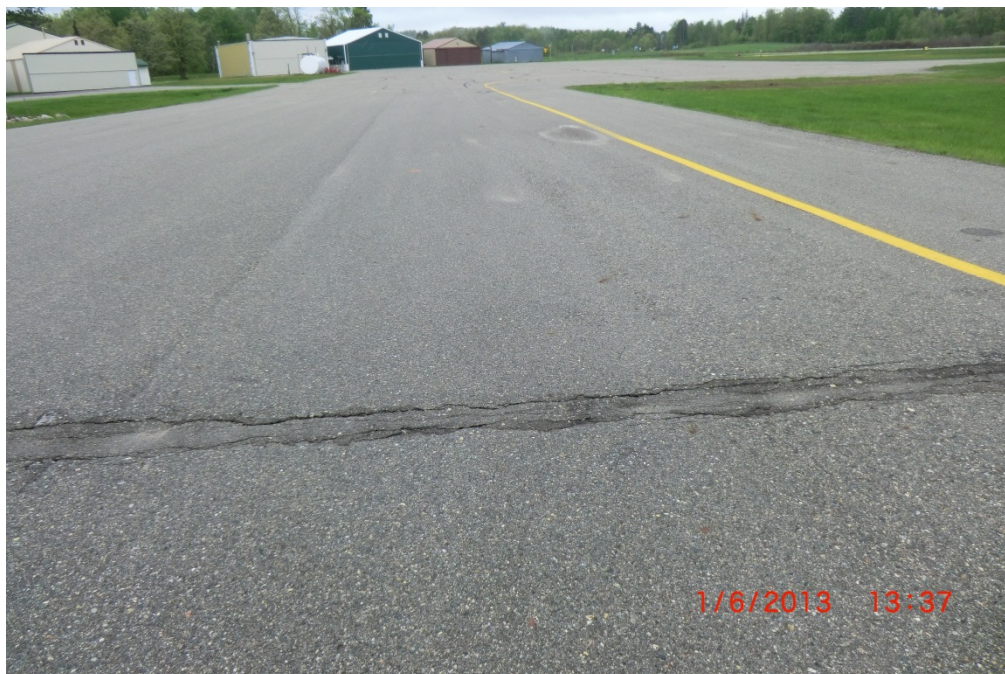
XVG TLC 001 (High-Severity L&T Crack)
