Minnesota Airport System Pavement Evaluation 2013 Update

Walker Municipal Airport (Y49)

Walker, Minnesota

Final Report

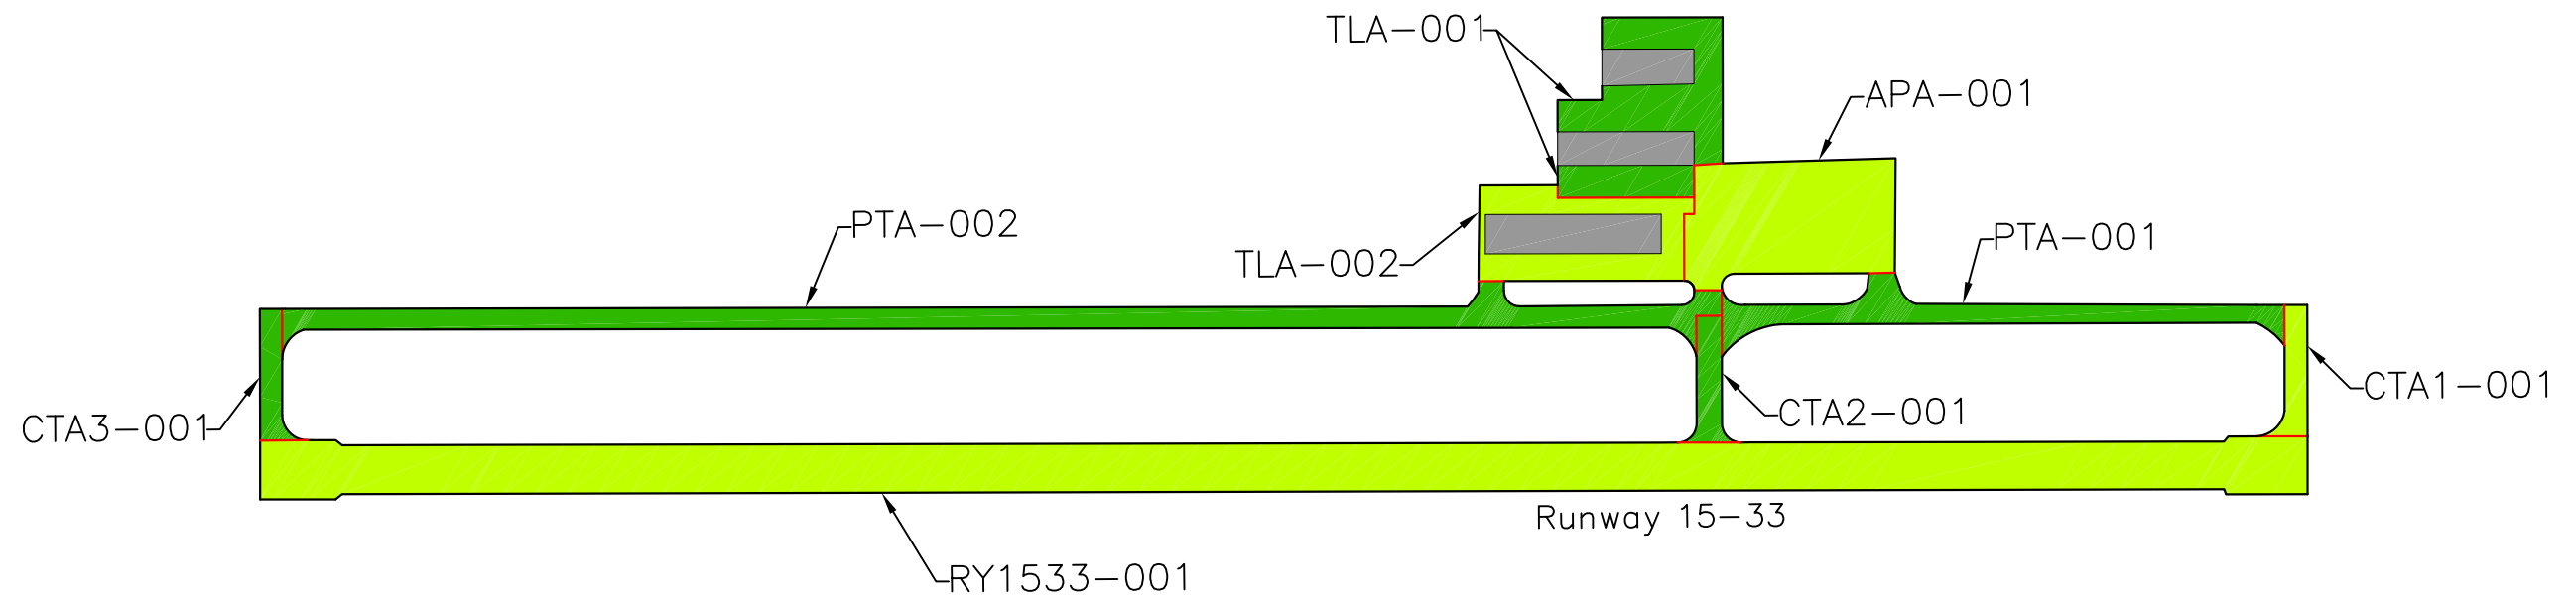
Figure 4. 2013 Pavement Condition Index Rating at Walker Municipal Airport (Y49).

Branch ID	Section ID	Surface type ¹	Section area (SF)	LCD ²	2010 PCI	2013 PCI	Drop in PCI/Yr ³	% Deduct due to		Distress types
								Load ⁴	Climate ⁵	
APA	1	AC	55,900	2007	95	83	2.8	24	76	Longitudinal & transverse (L&T) cracking, Raveling, Rutting
CTA1	1	AC	7,860	2010	100	82	6.0	100	0	Rutting
CTA2	1	AC	8,400	2007	100	88	2.0	0	100	L&T cracking
CTA3	1	AC	7,860	2010	100	92	2.7	100	0	Rutting
PTA	1	AC	32,975	2010	100	100	0.0	0	0	-
PTA	2	AC	82,525	2010	100	98	0.7	0	100	Raveling, Weathering
RY1533	1	AC	246,500	2008	89	76	4.8	45	54	Alligator cracking, Depression, L&T cracking, Patching, Rutting, Weathering
TLA	1	AC	42,725	2007	92	86	2.3	47	53	L&T cracking, Rutting
TLA	2	AC	31,620	2003	85	73	2.7	34	66	Alligator cracking, L&T cracking, Patching

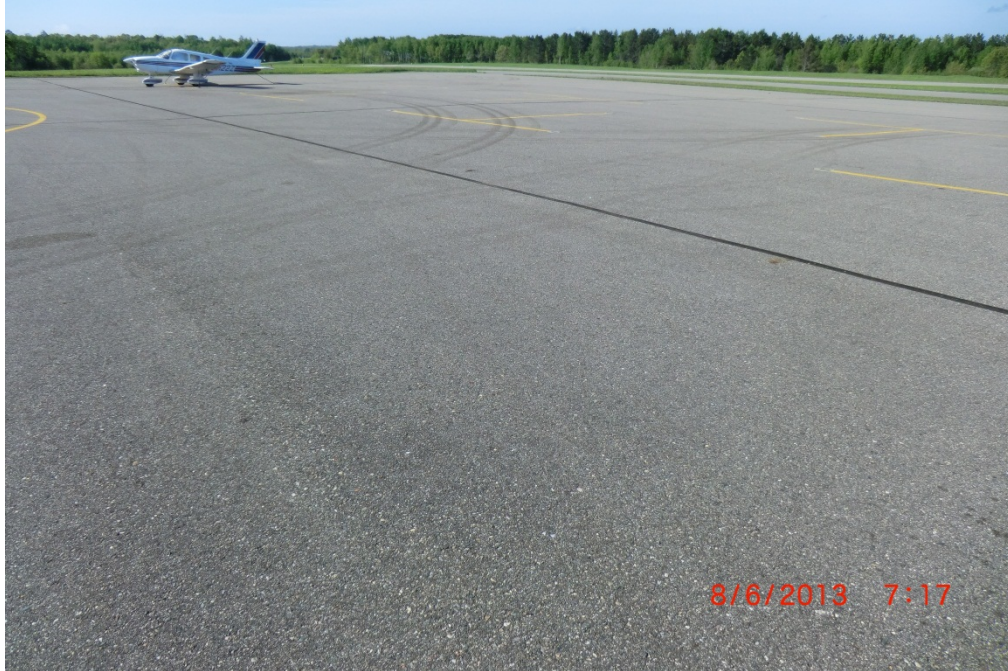
Y49 APA 001 (PCI = 83)

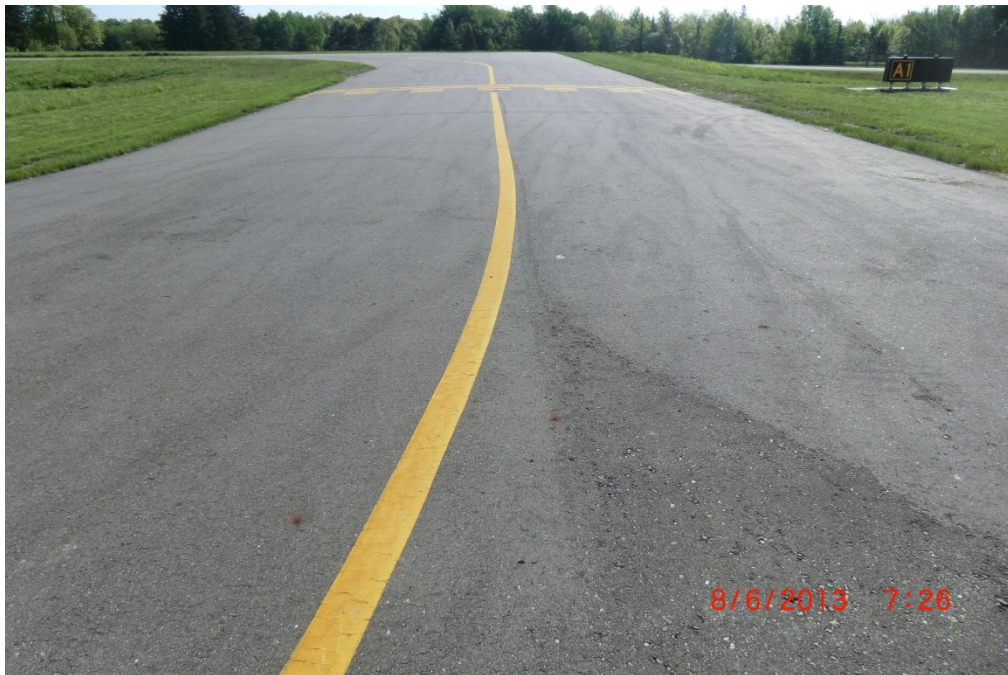
Y49 CTA1 001 (PCI = 82)

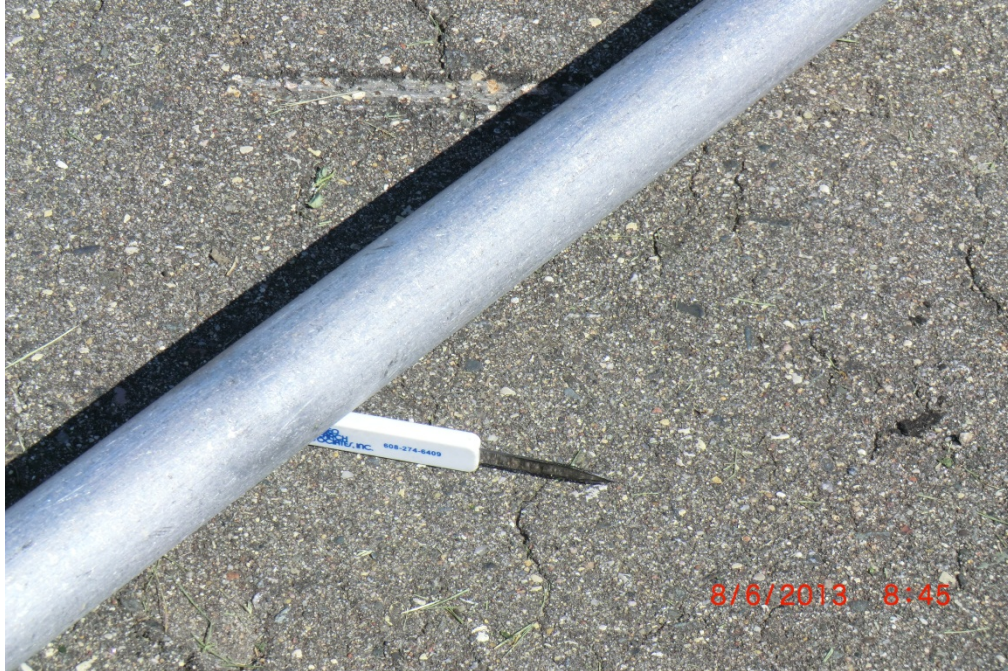
Y49 CTA1 001 (Medium-Severity Rutting)

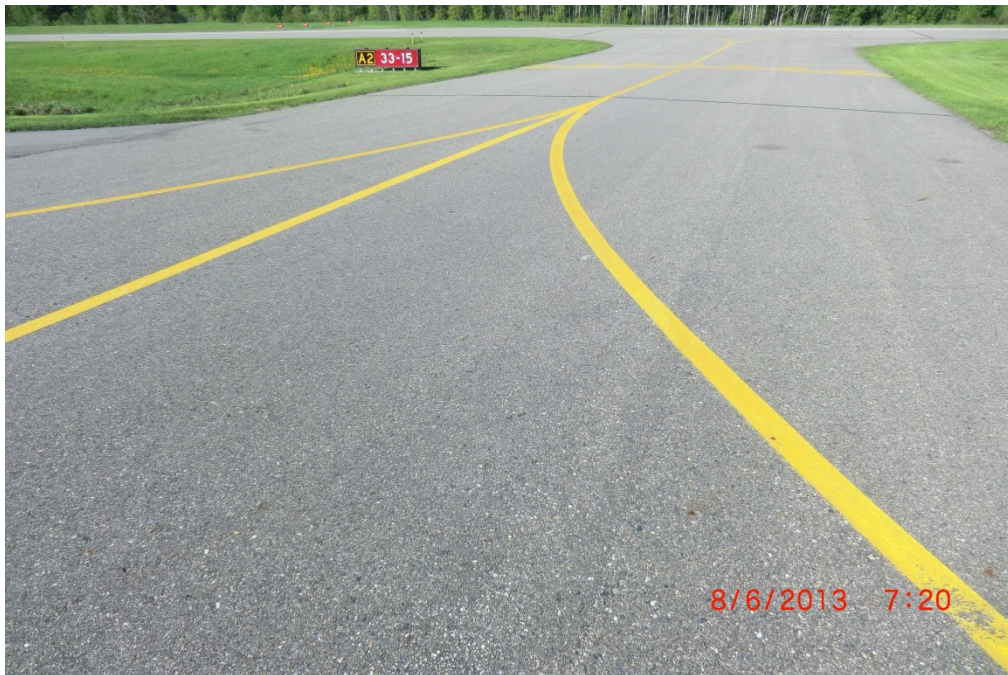
Y49 CTA2 001 (PCI = 88)

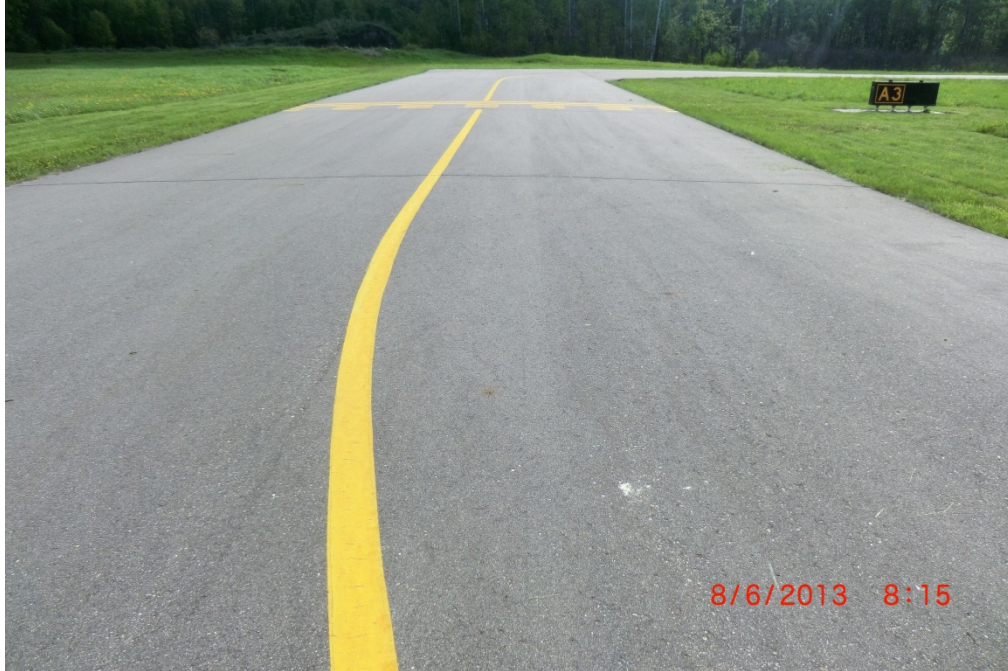
Y49 CTA3 001 (PCI = 92)

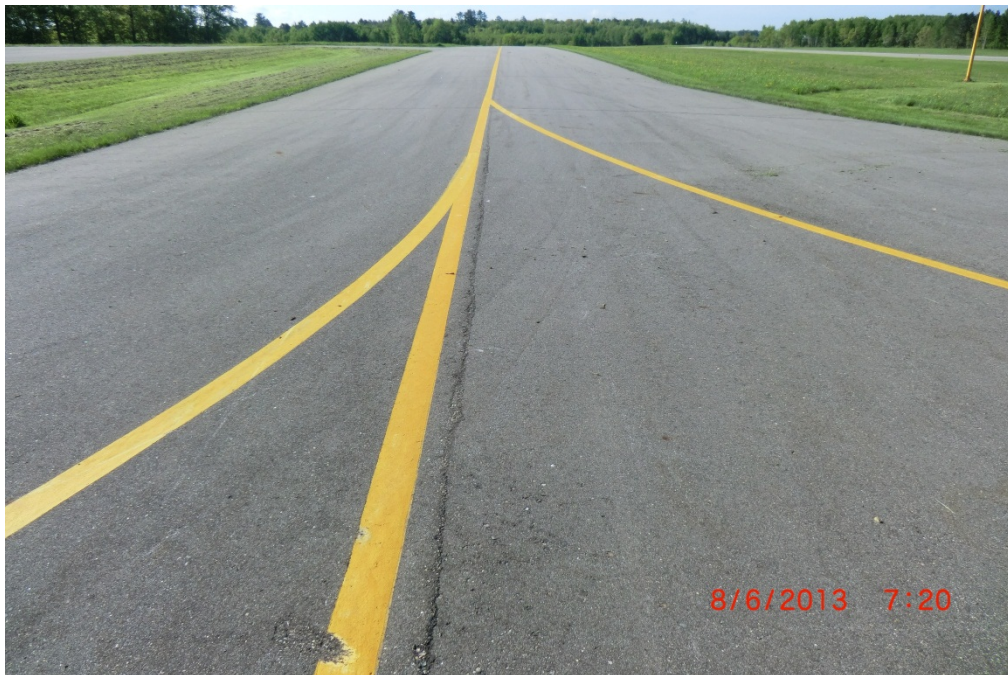
Y49 PTA 001 (PCI = 100)

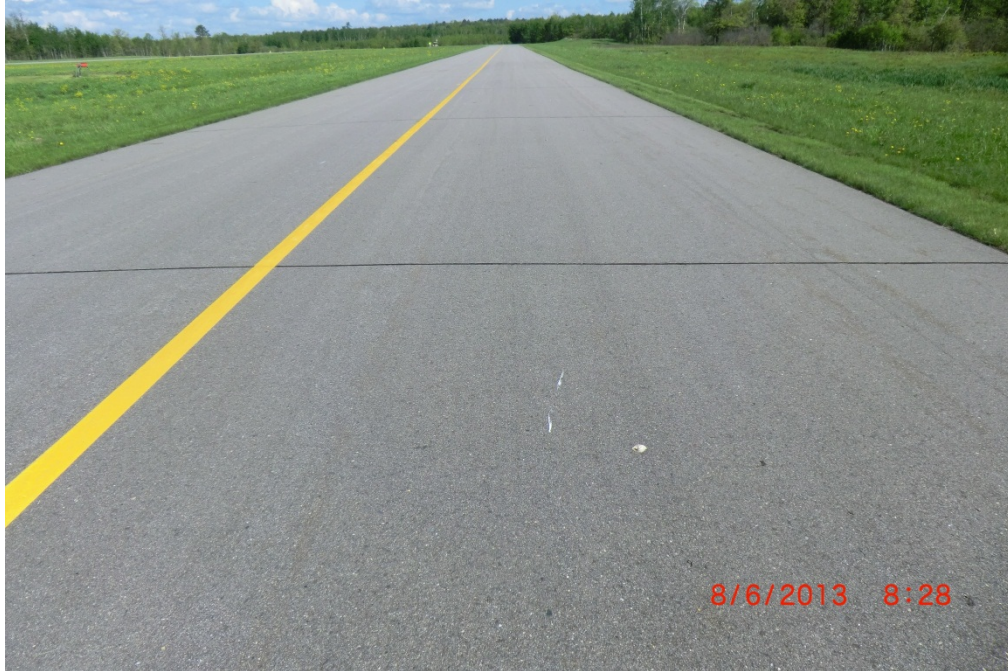
Y49 PTA 002 (PCI = 98)

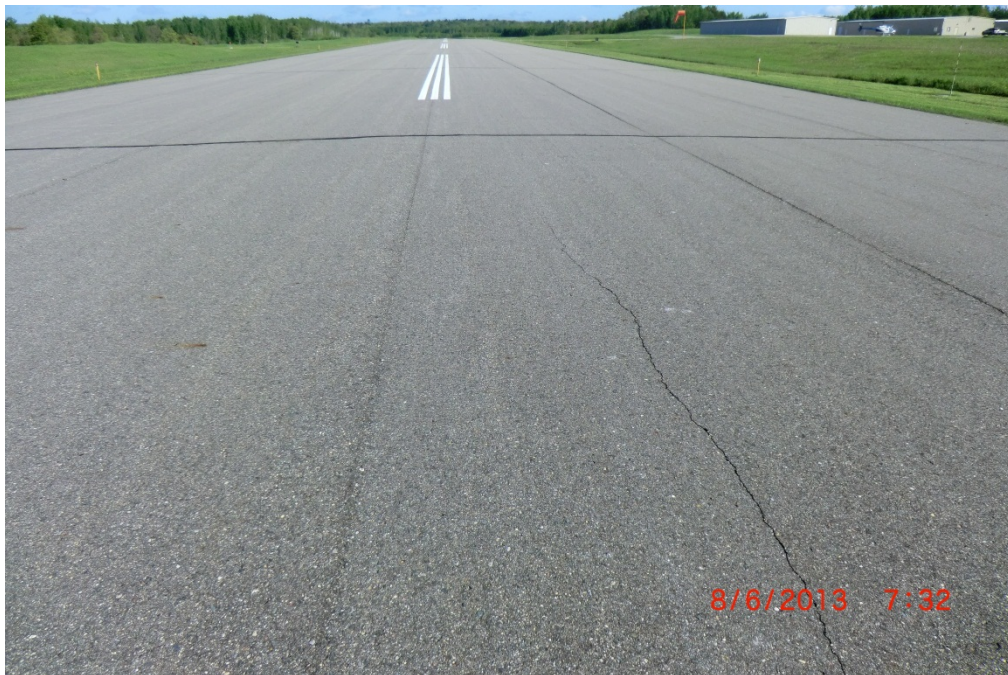
Y49 RY1533 001 (PCI = 76)

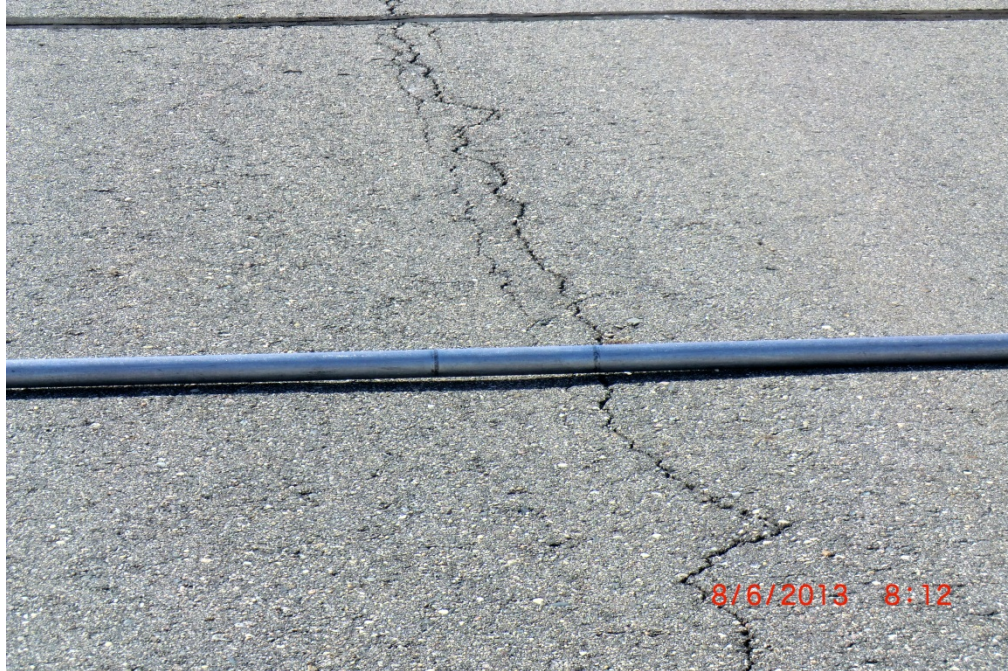
Y49 RY1533 001 (Low-Severity L&T Cracking and Rutting)

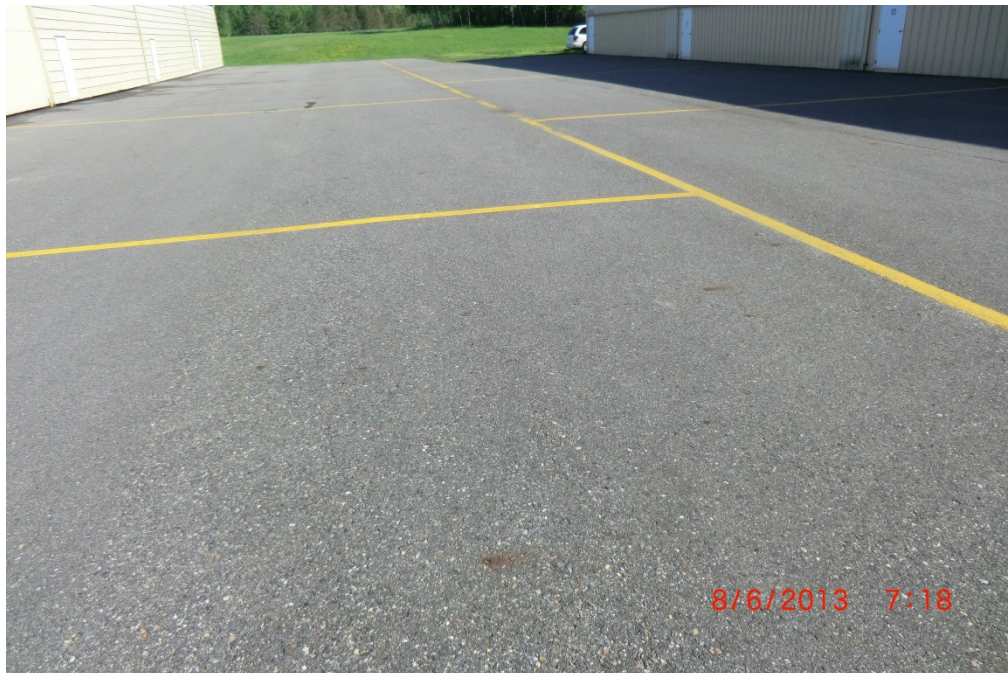
Y49 TLA 001 (PCI = 86)

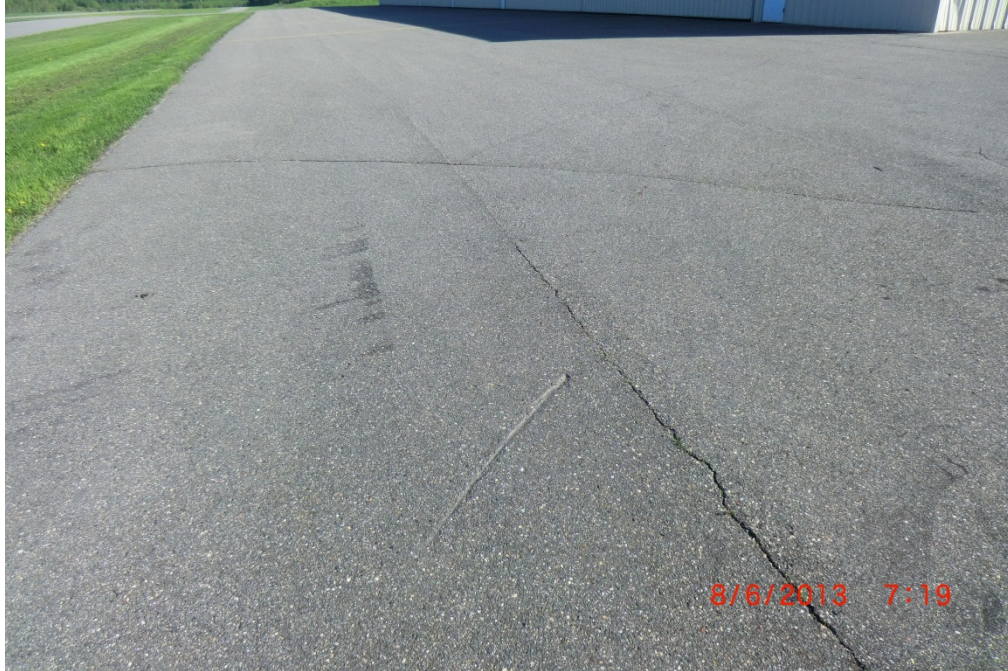
Y49 TLA 002 (PCI = 73)
