Final Report

Pavement Condition Report

Le Sueur Municipal Airport (12Y)

December 2014

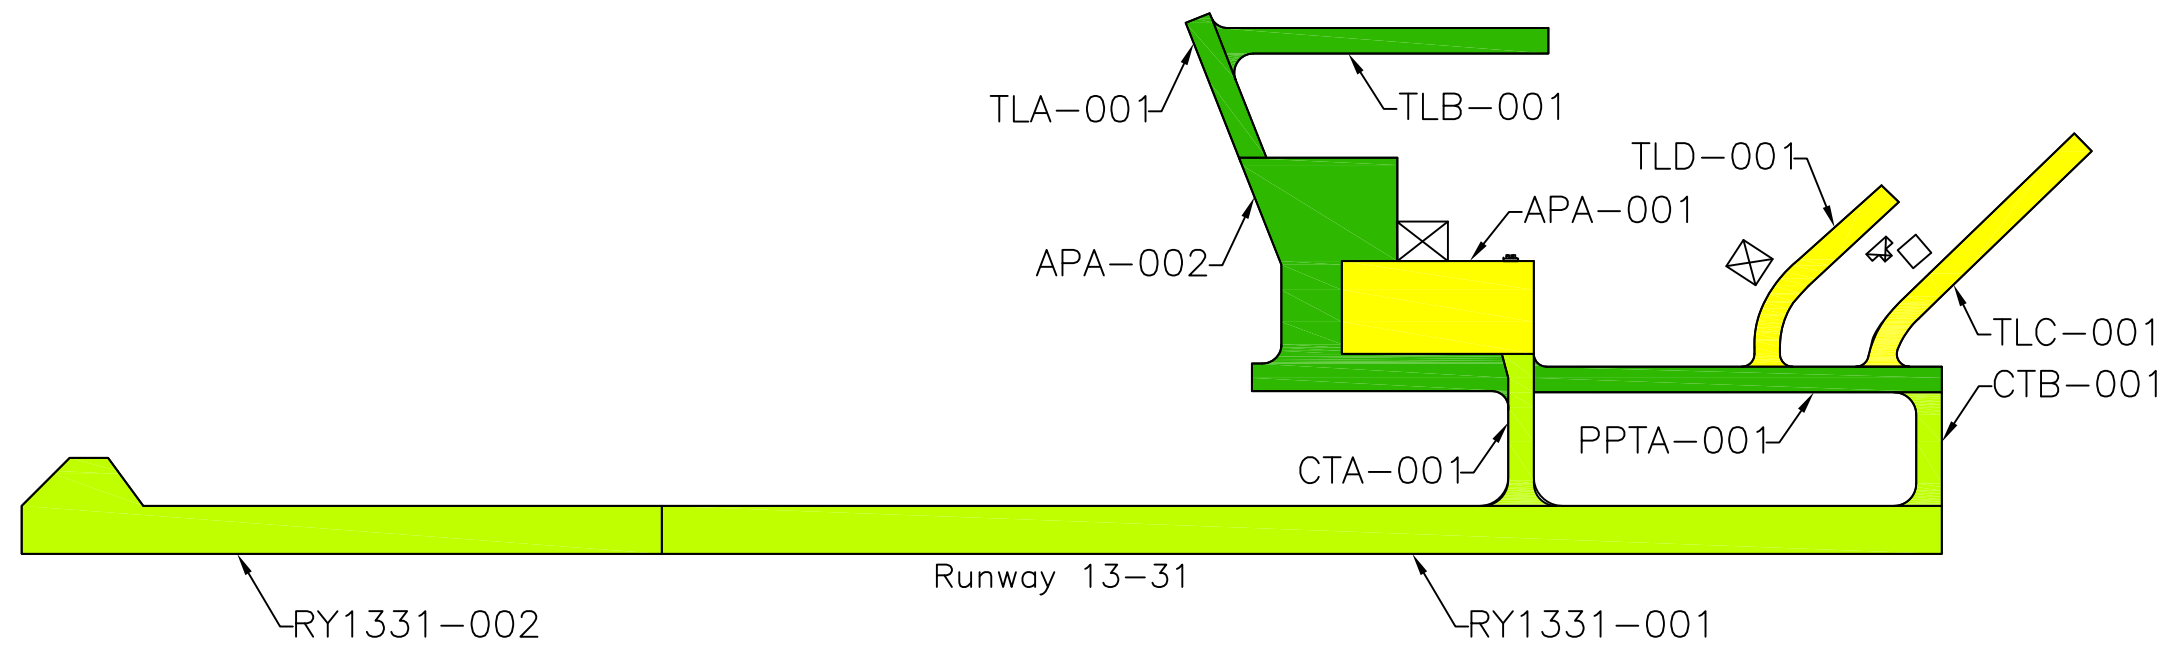
Figure 4. 2014 Pavement Condition Index Rating at Le Sueur Municipal Airport (12Y).

Figures 5 and 6 present the overall PCI for 12Y by area distribution and pavement use, respectively. Table 3 presents the PCI summary for each section at 12Y, including the drop in PCI per year. Generally, pavement sections will deteriorate between 1 and 3 PCI points per year. Sections deteriorating at higher rates may need maintenance above the normal application rates and should be closely monitored in case major repairs become necessary earlier than expected.

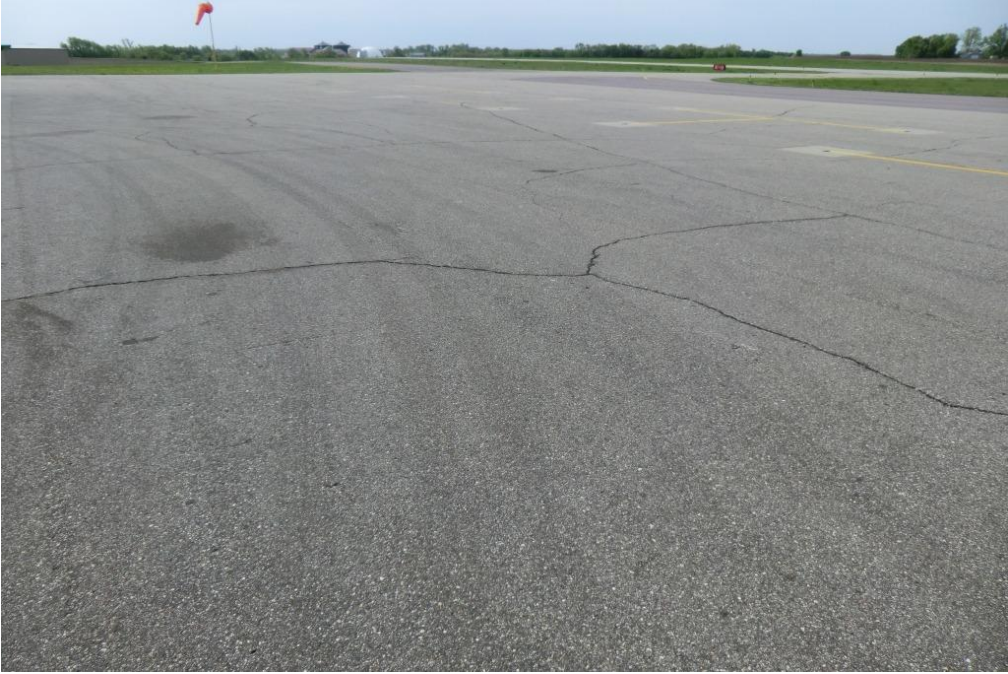
12Y APA 001 (PCI = 68)

Conditions: PCI : 68

48 LONGITUDINAL/TRANSVERSE CRACKING L 190.00 Ft Comments:

48 LONGITUDINAL/TRANSVERSE CRACKING M 262.00 Ft Comments:

48 LONGITUDINAL/TRANSVERSE CRACKING L 216.00 Ft Comments:

48 LONGITUDINAL/TRANSVERSE CRACKING M 334.00 Ft Comments:

48 LONGITUDINAL/TRANSVERSE CRACKING L 202.00 Ft Comments:

48 LONGITUDINAL/TRANSVERSE CRACKING M 222.00 Ft Comments:

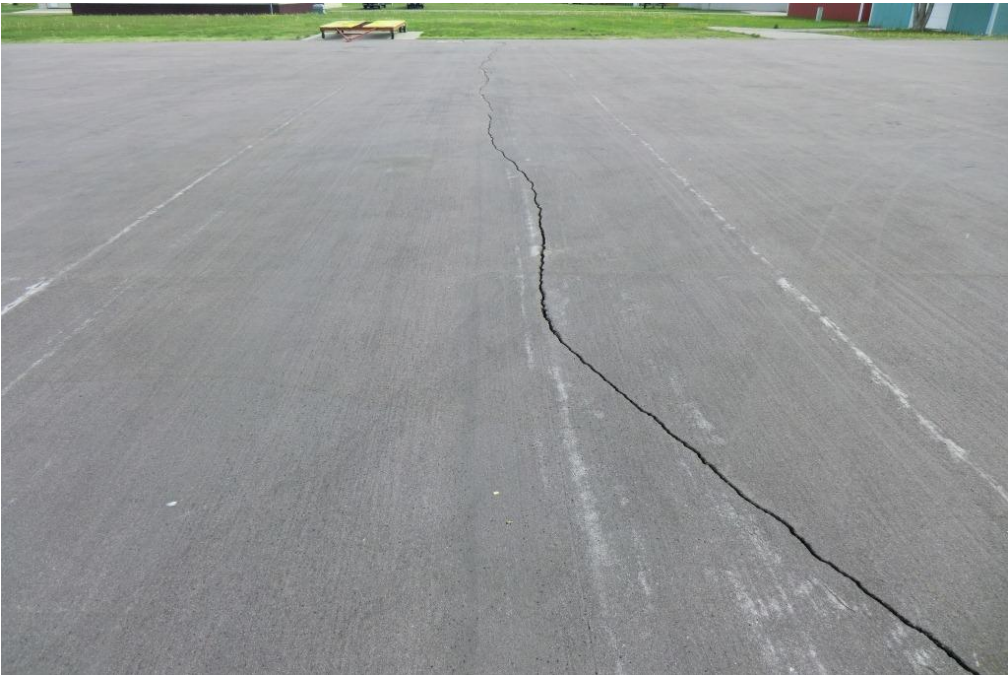
12Y APA 002 (PCI = 91)

Conditions: PCI : 91

48 LONGITUDINAL/TRANSVERSE CRACKING L 33.00 Ft Comments:

48 LONGITUDINAL/TRANSVERSE CRACKING M 46.00 Ft Comments:

48 LONGITUDINAL/TRANSVERSE CRACKING L 62.00 Ft Comments:

48 LONGITUDINAL/TRANSVERSE CRACKING L 157.00 Ft Comments:

48 LONGITUDINAL/TRANSVERSE CRACKING M 43.00 Ft Comments:

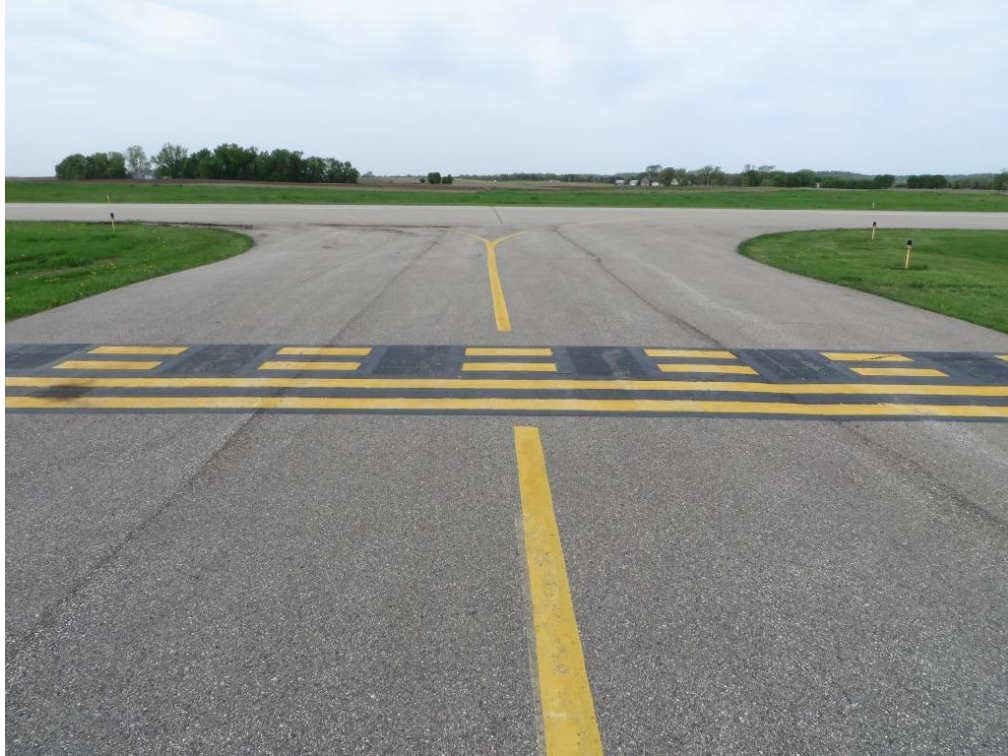
12Y CTA 001 (PCI = 83)

Conditions: PCI : 83

48 LONGITUDINAL/TRANSVERSE CRACKING L 81.00 Ft Comments:

48 LONGITUDINAL/TRANSVERSE CRACKING M 12.00 Ft Comments:

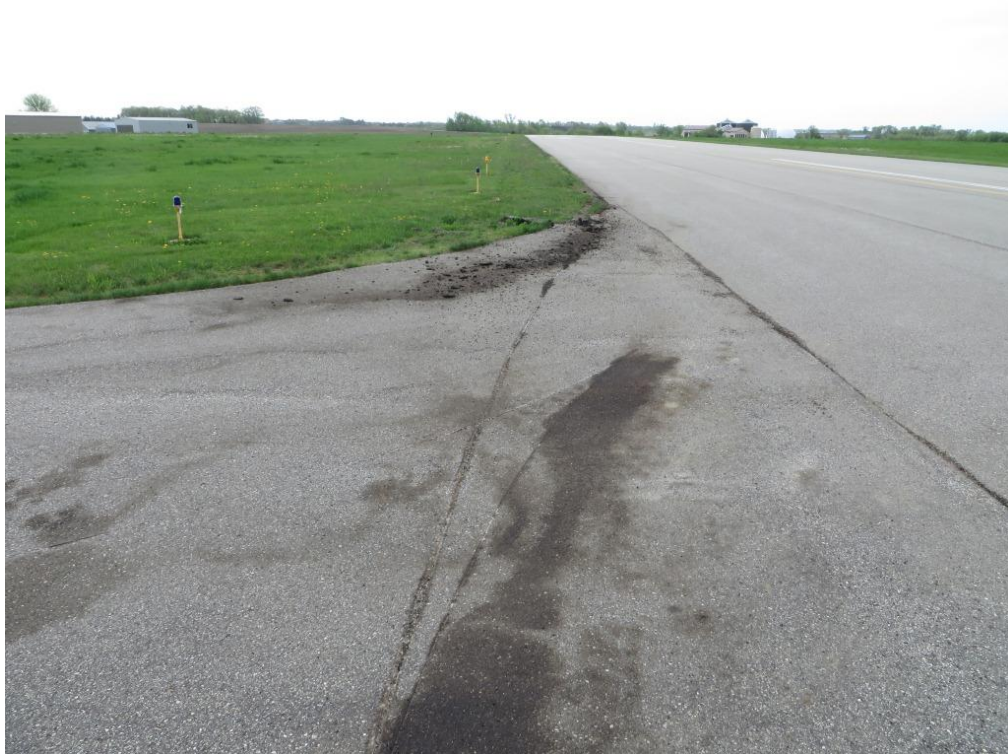
12Y CTA 001 (Oil Spill)

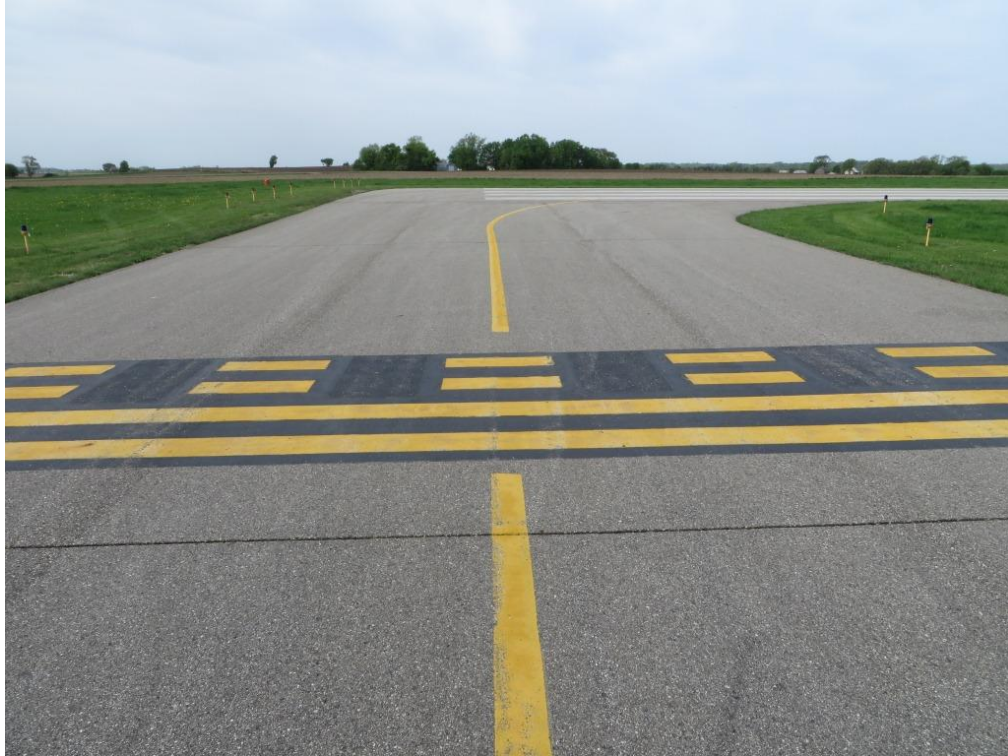
12Y CTB 001 (PCI = 81)

Conditions: PCI : 81

48 LONGITUDINAL/TRANSVERSE CRACKING L 30.00 Ft Comments:

48 LONGITUDINAL/TRANSVERSE CRACKING M 48.00 Ft Comments:

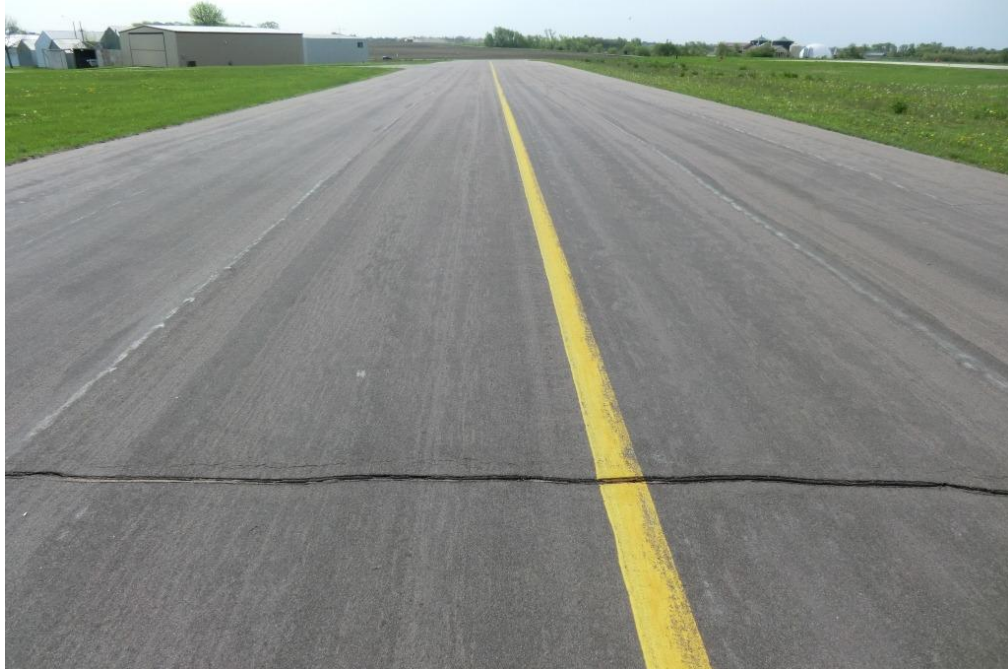
12Y PPTA 001 (PCI = 91)

Conditions: PCI : 91

48 LONGITUDINAL/TRANSVERSE CRACKING M 3.00 Ft Comments:

48 LONGITUDINAL/TRANSVERSE CRACKING L 36.00 Ft Comments:

48 LONGITUDINAL/TRANSVERSE CRACKING M 23.00 Ft Comments:

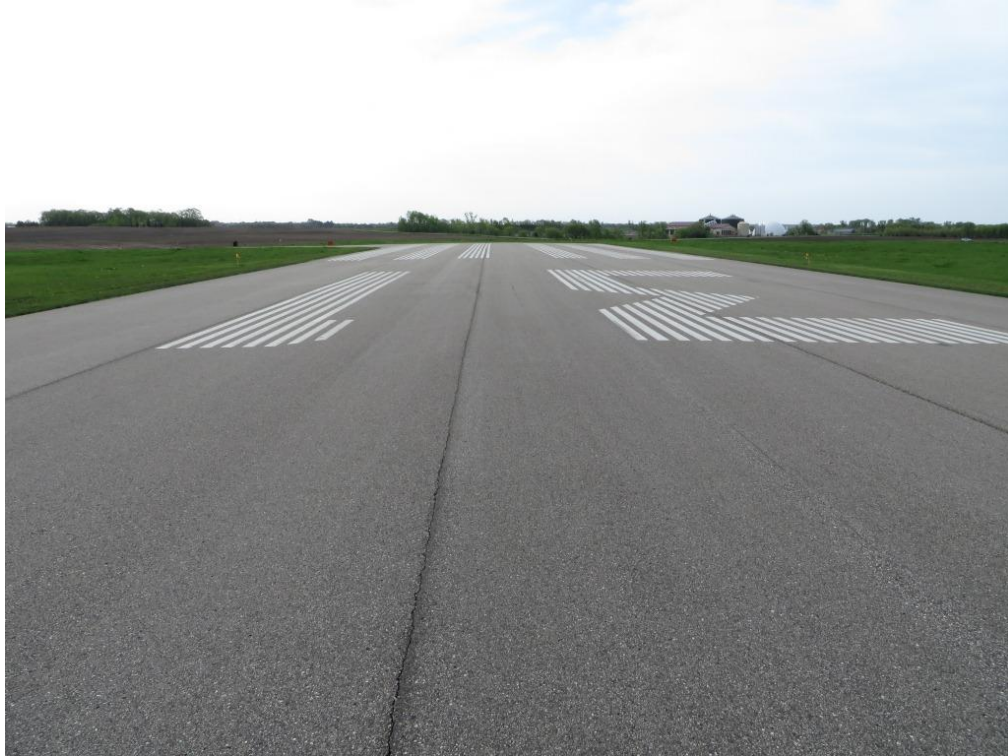
12Y PPTA 001 (PCI = 82)

Conditions: PCI : 82

48 LONGITUDINAL/TRANSVERSE CRACKING L 81.00 Ft Comments:

48 LONGITUDINAL/TRANSVERSE CRACKING M 73.00 Ft Comments:

48 LONGITUDINAL/TRANSVERSE CRACKING L 65.00 Ft Comments:

48 LONGITUDINAL/TRANSVERSE CRACKING M 71.00 Ft Comments:

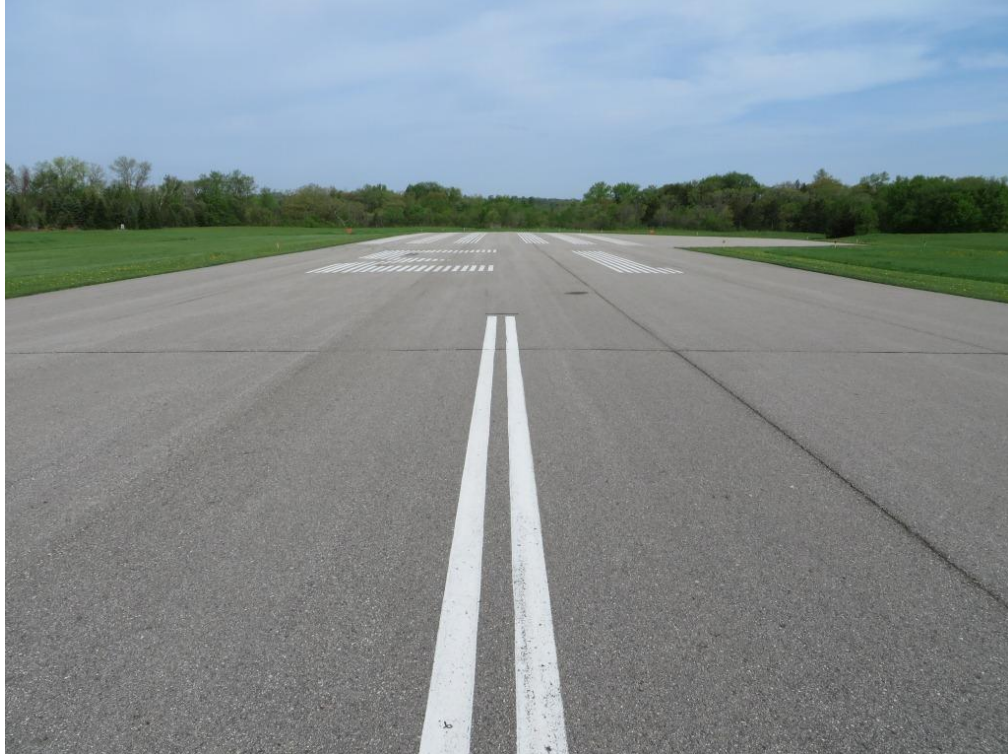
12Y RY1331 002 (PCI = 85)

Conditions: PCI : 85

48 LONGITUDINAL/TRANSVERSE CRACKING L 14.00 Ft Comments:

48 LONGITUDINAL/TRANSVERSE CRACKING M 75.00 Ft Comments:

48 LONGITUDINAL/TRANSVERSE CRACKING L 15.00 Ft Comments:

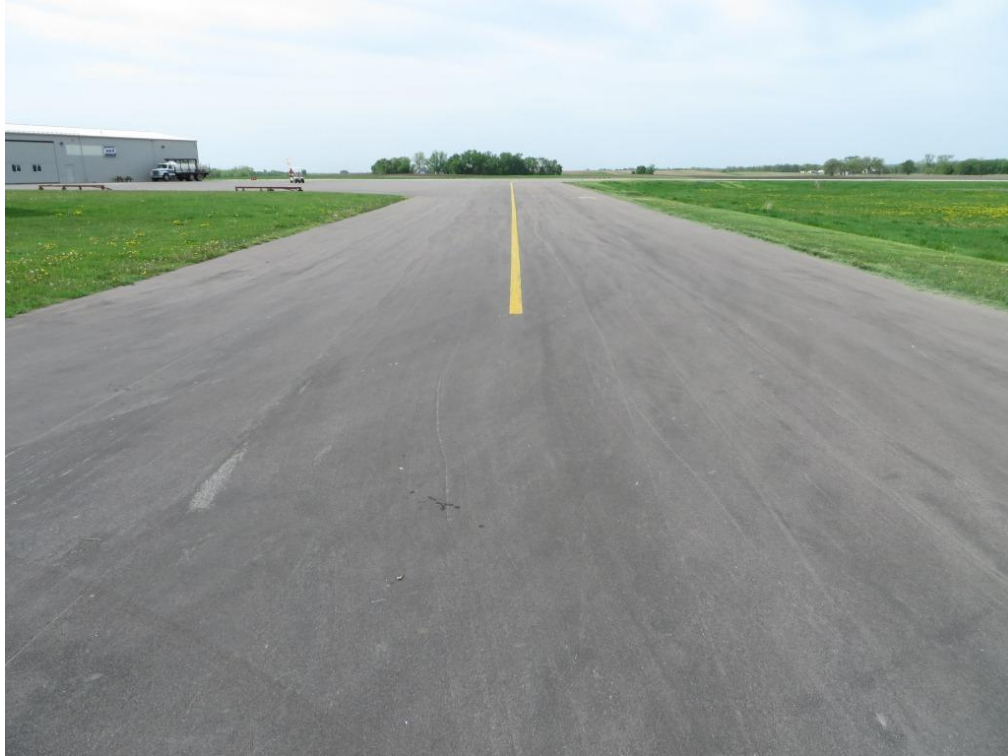
12Y TLA 001 (PCI = 100)

Conditions: PCI: 100

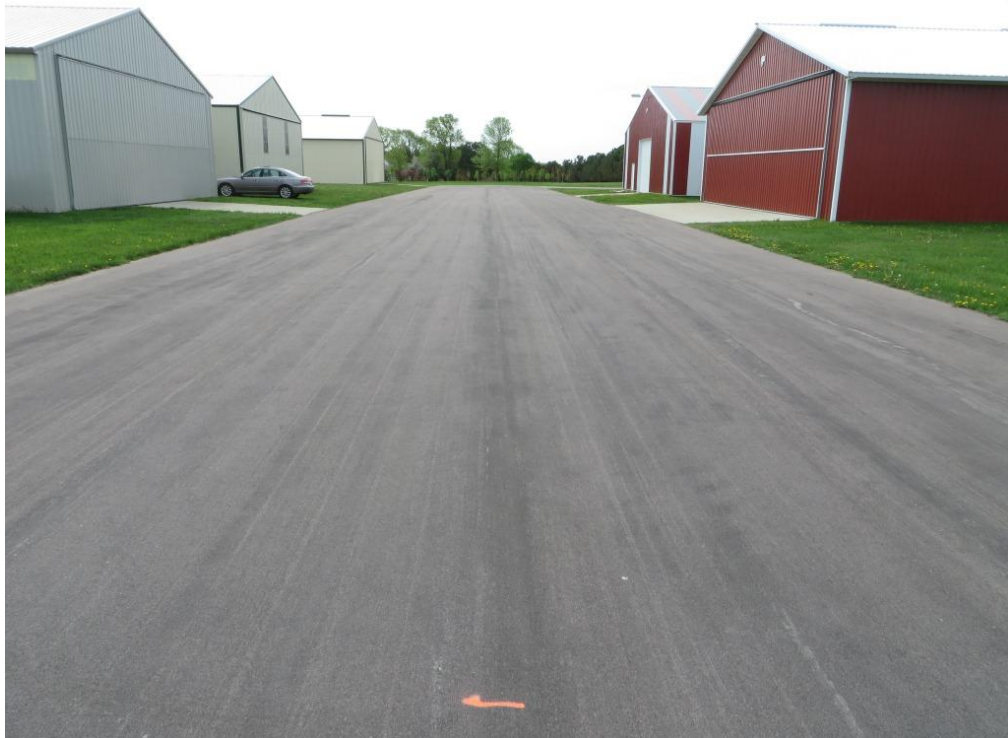
12Y TLB 001 (PCI = 95)

Conditions: PCI: 95

48 LONGITUDINAL/TRANSVERSE CRACKING L 40.00 Ft Comments:

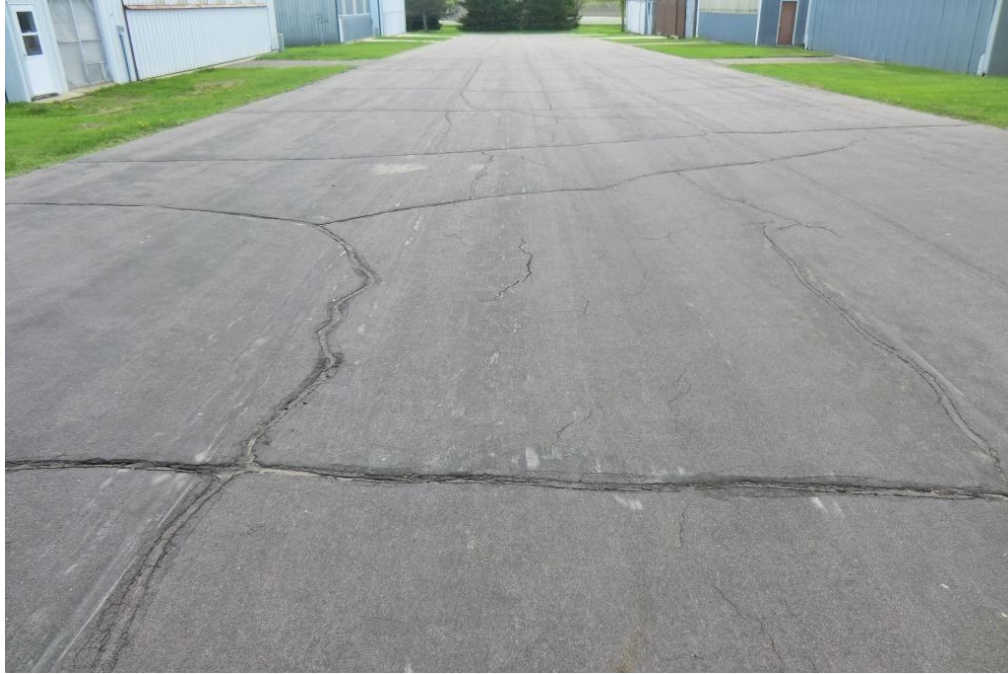
12Y TLC 001 (PCI = 63)

Conditions: PCI: 63

48 LONGITUDINAL/TRANSVERSE CRACKING L 795.00 Ft Comments:

48 LONGITUDINAL/TRANSVERSE CRACKING M 8.00 Ft Comments:

48 LONGITUDINAL/TRANSVERSE CRACKING L 675.00 Ft Comments:

48 LONGITUDINAL/TRANSVERSE CRACKING M 14.00 Ft Comments:

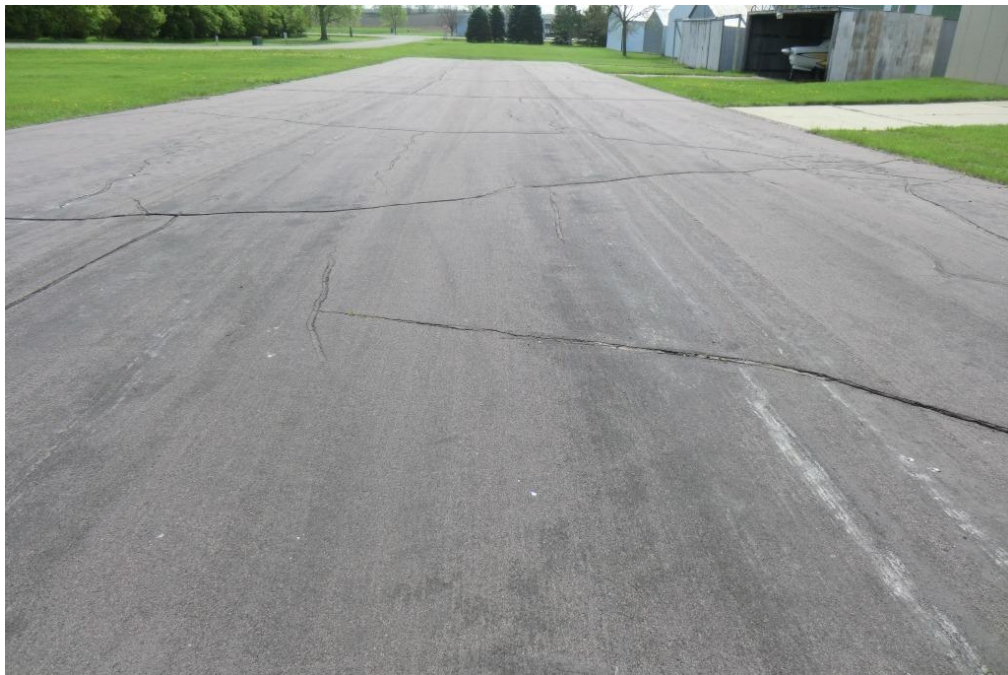
12Y TLD 001 (PCI = 65)

Conditions: PCI: 65

48 LONGITUDINAL/TRANSVERSE CRACKING L 660.00 Ft Comments:

48 LONGITUDINAL/TRANSVERSE CRACKING M 21.00 Ft Comments:
