Final Report

Pavement Condition Report

Austin Municipal Airport (AUM)

December 2014

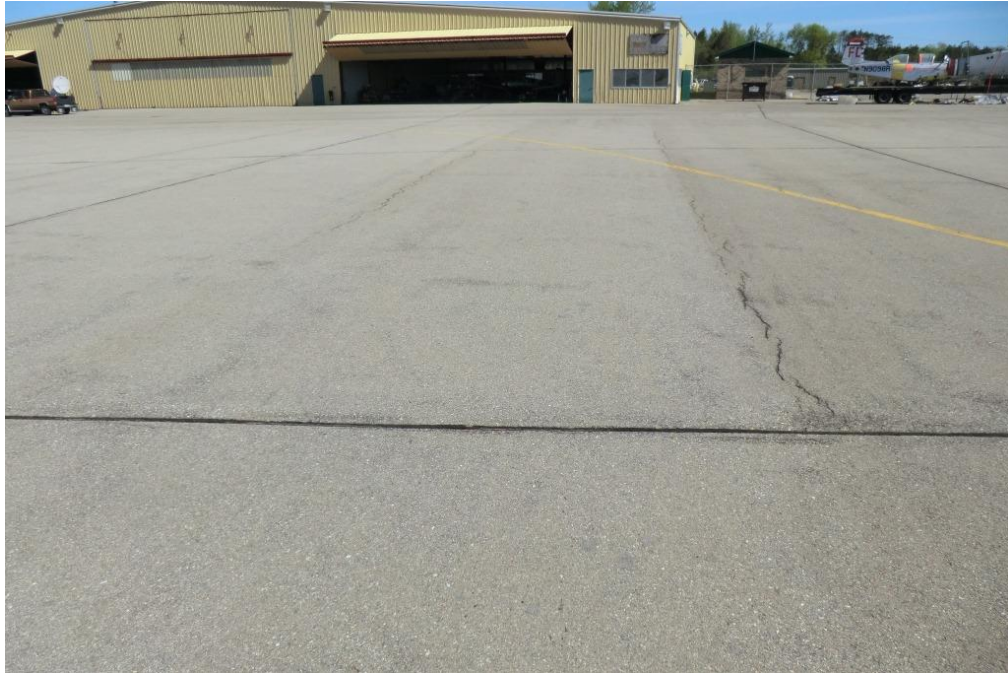
AUM APA 001 (PCI = 71)

Conditions: PCI: 71

Sample Number: 100 Type: R Area: 5,000.00SqFt PCI = 73
Sample Comments: included 50 ft SC
45 DEPRESSION L 25.00 SqFt Comments:
48 LONGITUDINAL/TRANSVERSE CRACKING L 142.00 Ft Comments:
48 LONGITUDINAL/TRANSVERSE CRACKING M 110.00 Ft Comments:
56 SWELLING L 30.00 SqFt Comments:

Sample Number: 200 Type: R Area: 5,000.00SqFt PCI = 70
Sample Comments: included 150 ft SC
45 DEPRESSION L 50.00 SqFt Comments:
48 LONGITUDINAL/TRANSVERSE CRACKING L 104.00 Ft Comments:
48 LONGITUDINAL/TRANSVERSE CRACKING M 123.00 Ft Comments:
56 SWELLING L 35.00 SqFt Comments:

Sample Number: 301 Type: R Area: 5,000.00SqFt PCI = 78
Sample Comments: included 200 ft SC
48 LONGITUDINAL/TRANSVERSE CRACKING L 266.00 Ft Comments:
48 LONGITUDINAL/TRANSVERSE CRACKING M 115.00 Ft Comments:

Sample Number: 401 Type: R Area: 5,000.00SqFt PCI = 74
Sample Comments: included 250 ft SC
48 LONGITUDINAL/TRANSVERSE CRACKING L 189.00 Ft Comments:
48 LONGITUDINAL/TRANSVERSE CRACKING M 172.00 Ft Comments:

Sample Number: 701 Type: R Area: 5,000.00SqFt PCI = 72
Sample Comments: included 200 ft SC
48 LONGITUDINAL/TRANSVERSE CRACKING L 159.00 Ft Comments:
48 LONGITUDINAL/TRANSVERSE CRACKING M 200.00 Ft Comments:

Sample Number: 801 Type: R Area: 5,000.00SqFt PCI = 59
Sample Comments: included 200 ft SC
41 ALLIGATOR CRACKING L 13.00 SqFt Comments:
45 DEPRESSION L 2.00 SqFt Comments:
48 LONGITUDINAL/TRANSVERSE CRACKING L 154.00 Ft Comments:
48 LONGITUDINAL/TRANSVERSE CRACKING M 163.00 Ft Comments:
48 LONGITUDINAL/TRANSVERSE CRACKING H 5.00 Ft Comments:
56 SWELLING L 90.00 SqFt Comments:

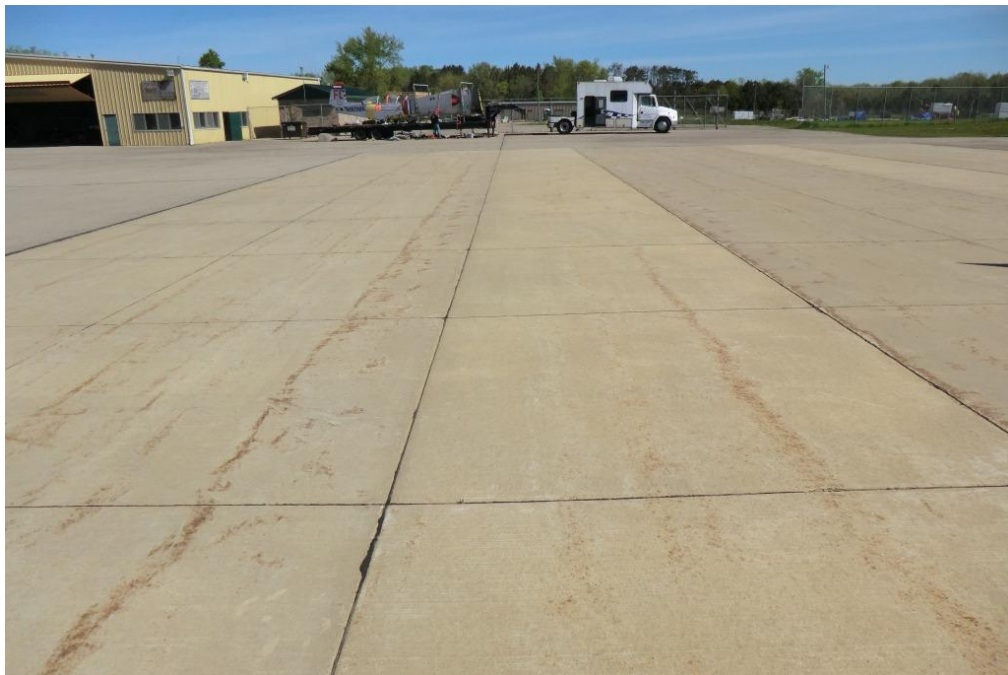
AUM APA 002 (PCI = 95)

Conditions: PCI : 95

65 JOINT SEAL DAMAGE L 24.00 Slabs Comments:

65 JOINT SEAL DAMAGE M 24.00 Slabs Comments:

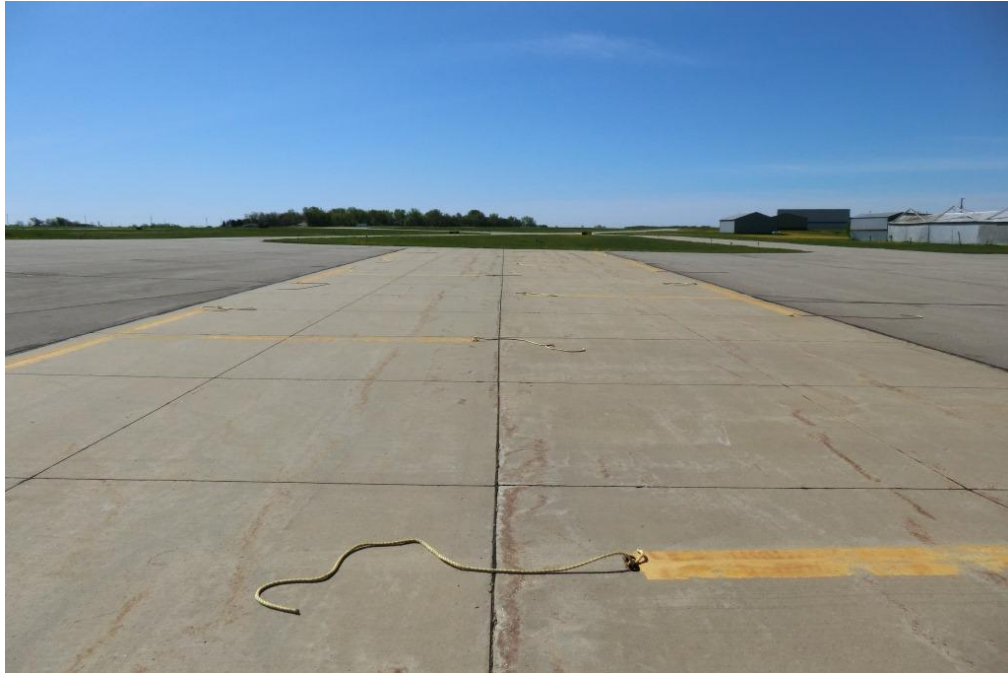
AUM APA 003 (PCI = 100)

Conditions: PCI : 100

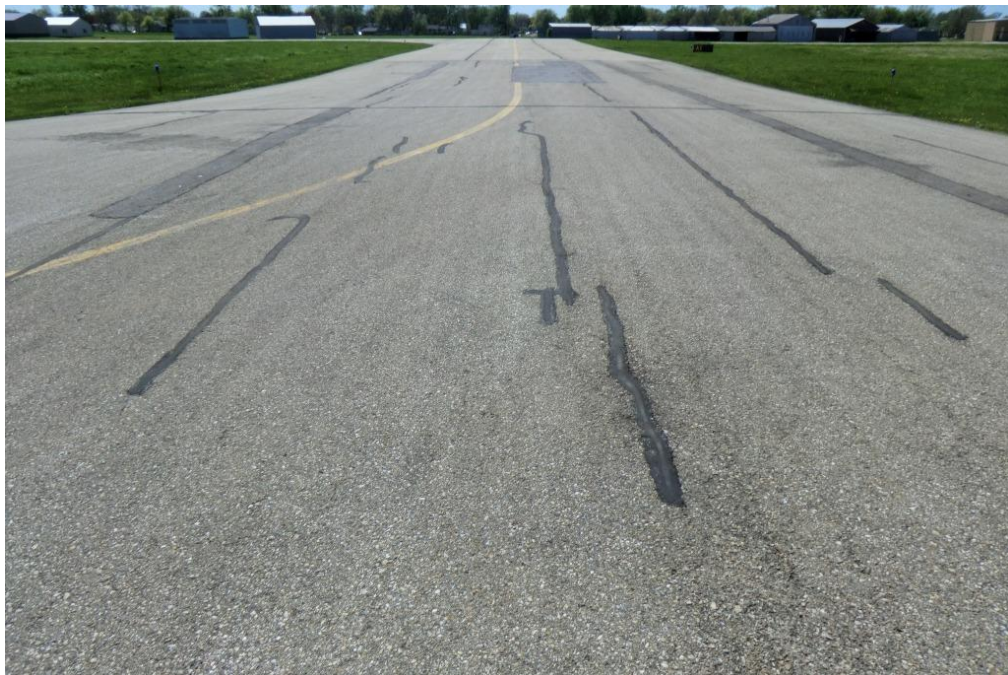
AUM CTA1 001 (PCI = 71)

Conditions: PCI: 71

48	LONGITUDINAL/TRANSVERSE CRACKING	L	424.00 Ft	Comments:
50	PATCHING	L	708.00 SqFt	Comments:
52	RAVELING	L	75.00 SqFt	Comments:
57	WEATHERING	M	500.00 SqFt	Comments:

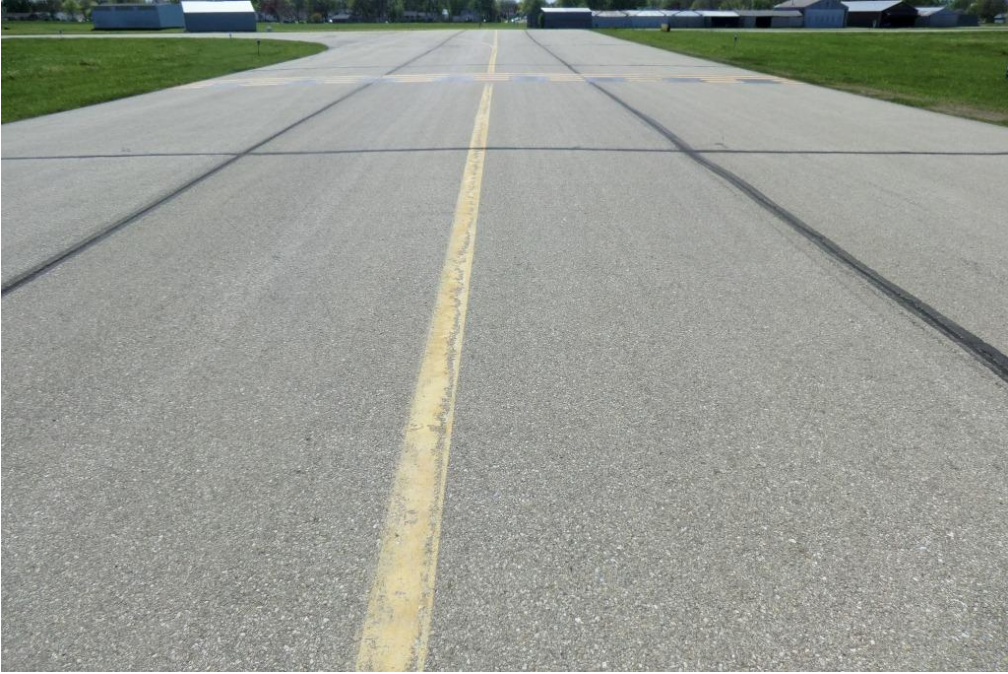
AUM CTA1 002 (PCI = 83)

Conditions: PCI: 83

Sample Comments: all cracks are SC

48 LONGITUDINAL/TRANSVERSE CRACKING M 49.00 Ft Comments:

48 LONGITUDINAL/TRANSVERSE CRACKING L 67.00 Ft Comments:

48 LONGITUDINAL/TRANSVERSE CRACKING M 68.00 Ft Comments:

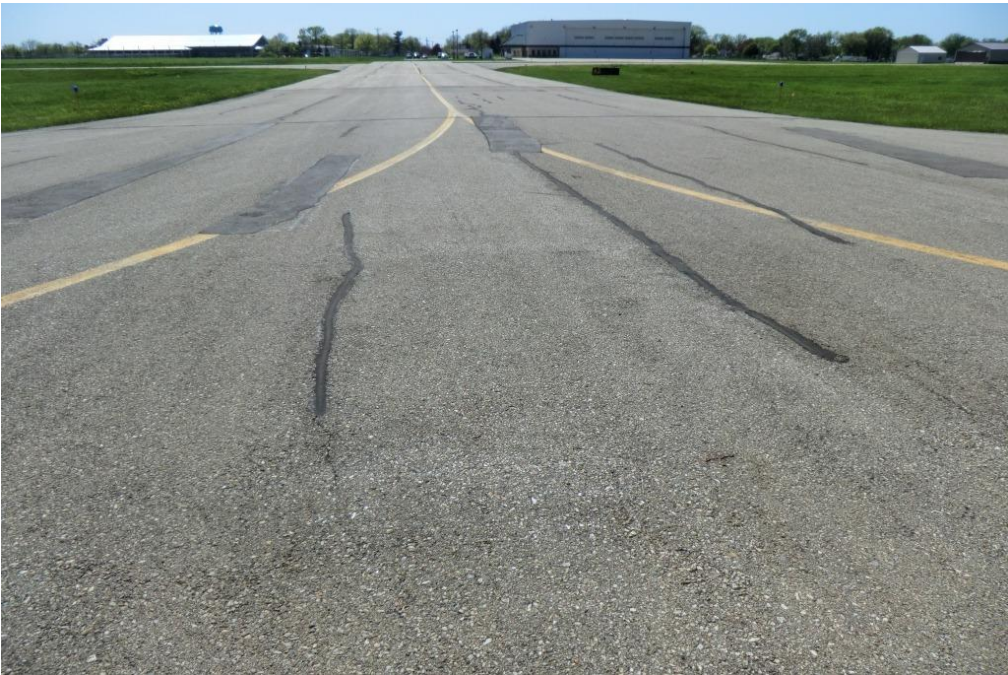
AUM CTA2 001 (PCI = 71)

Conditions: PCI: 71

48 LONGITUDINAL/TRANSVERSE CRACKING L 504.00 Ft Comments:

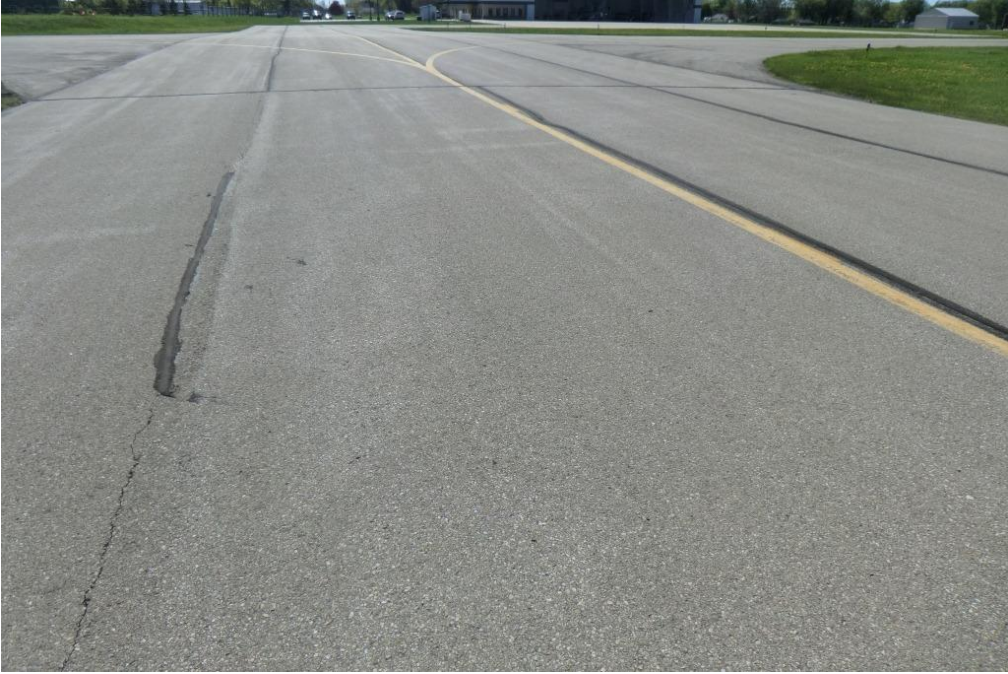
AUM CTA2 002 (PCI = 76)

Conditions: PCI: 76

48 LONGITUDINAL/TRANSVERSE CRACKING L 344.00 Ft Comments:

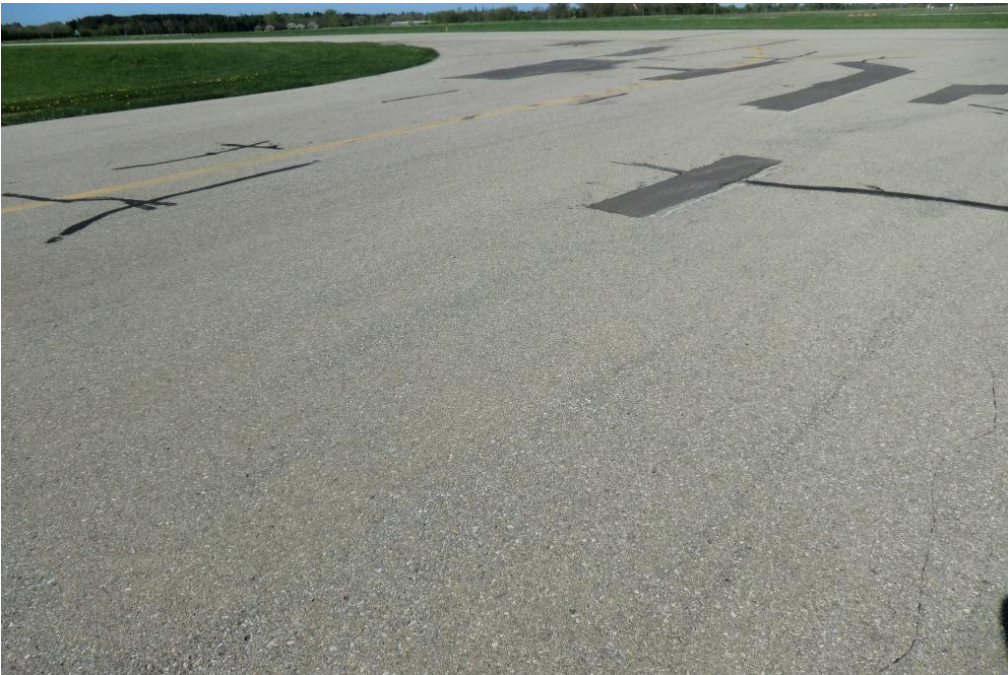
AUM CTA2X 001 (PCI = 79)

Conditions: PCI: 79

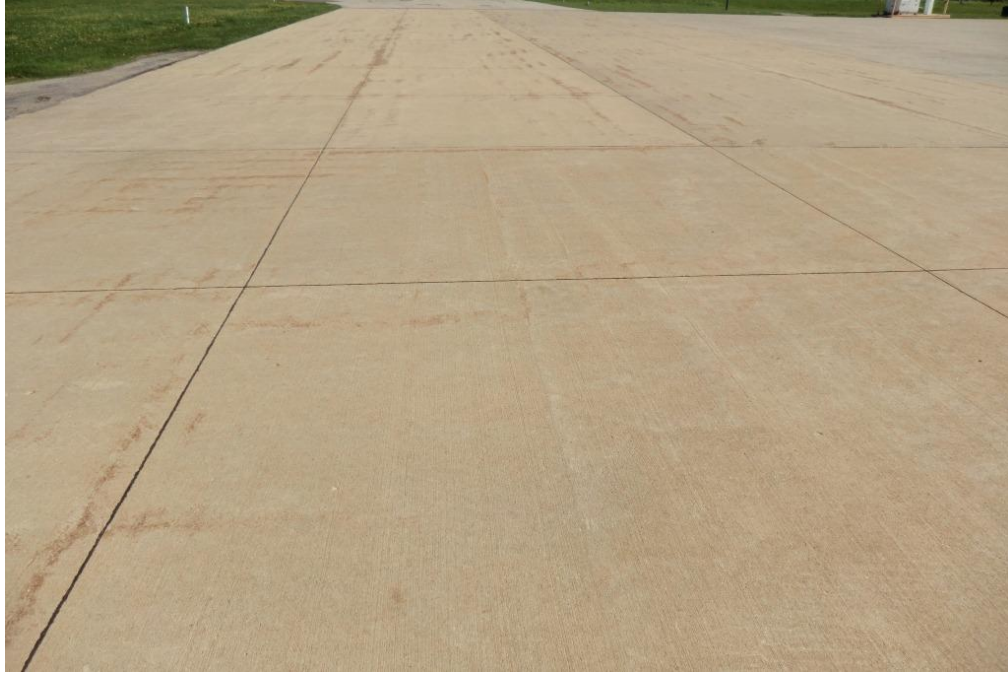
AUM CTA2X 002 (PCI = 96)

Conditions: PCI : 96

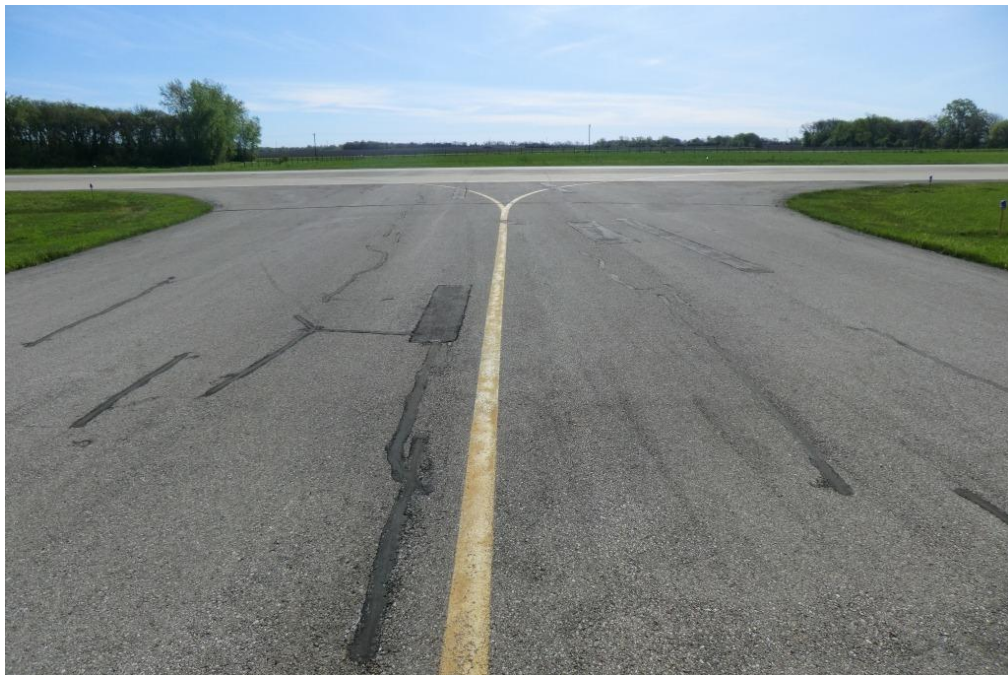
AUM CTA3 001 (PCI = 73)

Conditions: PCI: 73

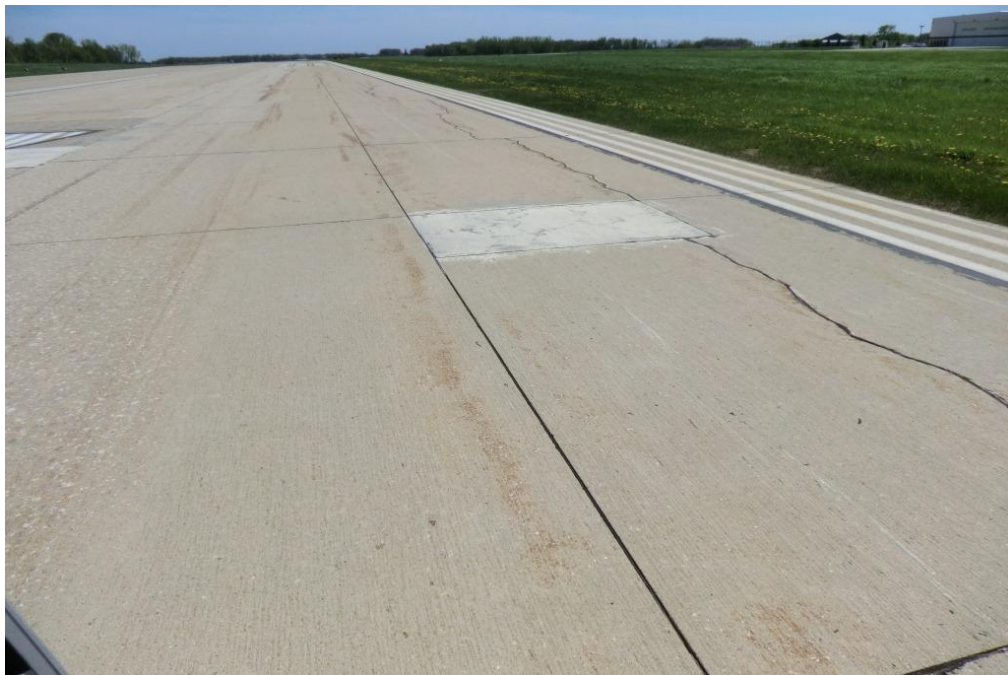
AUM RY1735 001 (LTD Cracking)
