*Final Report*

# Pavement Condition Report

Baudette International Airport (BDE)

**December 2014**

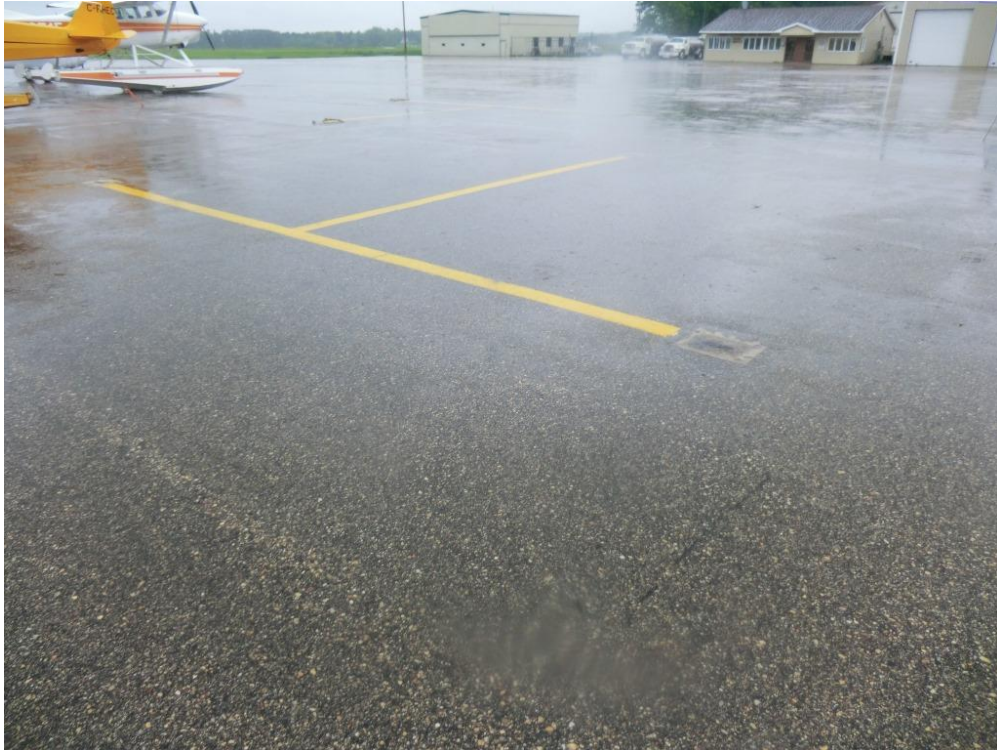
BDE APA 001 (PCI = 87)

| Branch ID | Section ID | Surface type <sup>1</sup> | Section area (SF) | LCD <sup>2</sup> | 2011 PCI | 2014 PCI | Drop in PCI/Yr <sup>3</sup> | % Deduct due to | | Distress types |
|---|---|---|---|---|---|---|---|---|---|---|
| APA | 1 | AAC | 183,837 | 2005 | 92 | 87 | 1.4 | 51 | 39 | L&T cracking, oil spill, ruts, weathering |

Conditions: PCI : 87

Sample Number: 105 Type: R Area: 5,000.00SqFt PCI = 75  
Sample Comments:  
48 LONGITUDINAL/TRANSVERSE CRACKING L 21.00 Ft Comments:  
49 OIL SPILLAGE N 3.00 SqFt Comments:  
53 RUTTING L 40.00 SqFt Comments:  
57 WEATHERING M 825.00 SqFt Comments:

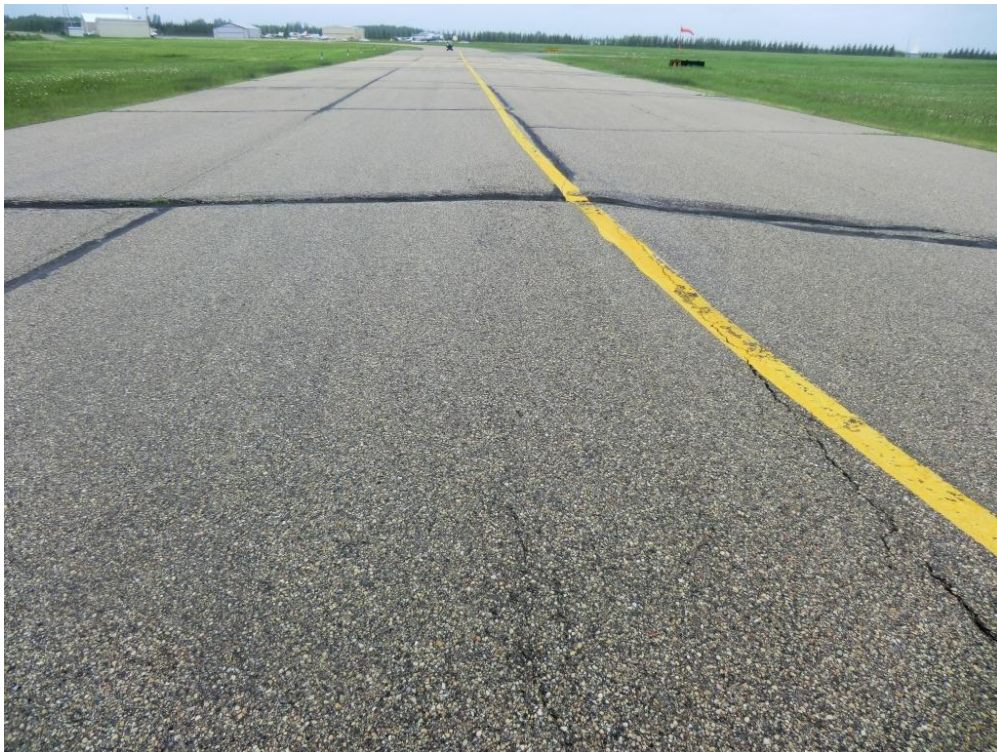
BDE CTA 001 (PCI = 67)

| Branch ID | Section ID | Surface type <sup>1</sup> | Section area (SF) | LCD <sup>2</sup> | 2011 PCI | 2014 PCI | Drop in PCI/Yr <sup>3</sup> | % Deduct due to | | Distress types |
|---|---|---|---|---|---|---|---|---|---|---|
| CTA | 1 | AAC | 14,540 | 1987 | 68 | 67 | 1.2 | 0 | 99 | depression, L&T cracking |

Conditions: PCI : 67

48 LONGITUDINAL/TRANSVERSE CRACKING L 408.00 Ft Comments:

48 LONGITUDINAL/TRANSVERSE CRACKING M 88.00 Ft Comments:

48 LONGITUDINAL/TRANSVERSE CRACKING H 50.00 Ft Comments:

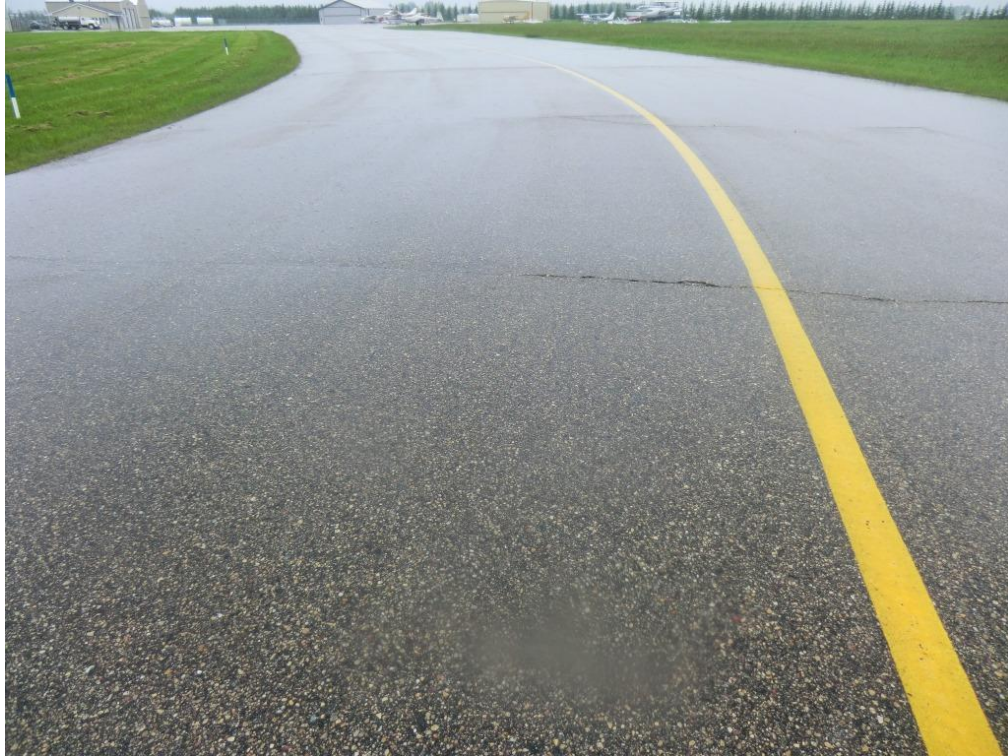
BDE CTAX 001 (PCI = 76)

| Branch ID | Section ID | Surface type <sup>1</sup> | Section area (SF) | LCD <sup>2</sup> | 2011 PCI | 2014 PCI | Drop in PCI/Yr <sup>3</sup> | % Deduct due to | | Distress types |
|---|---|---|---|---|---|---|---|---|---|---|
| CTAX | 1 | AAC | 40,760 | 2005 | 84 | 76 | 2.7 | 0 | 100 | L&T cracking |

Conditions: PCI : 76

48 LONGITUDINAL/TRANSVERSE CRACKING L 121.00 Ft Comments:  
48 LONGITUDINAL/TRANSVERSE CRACKING M 148.00 Ft Comments:

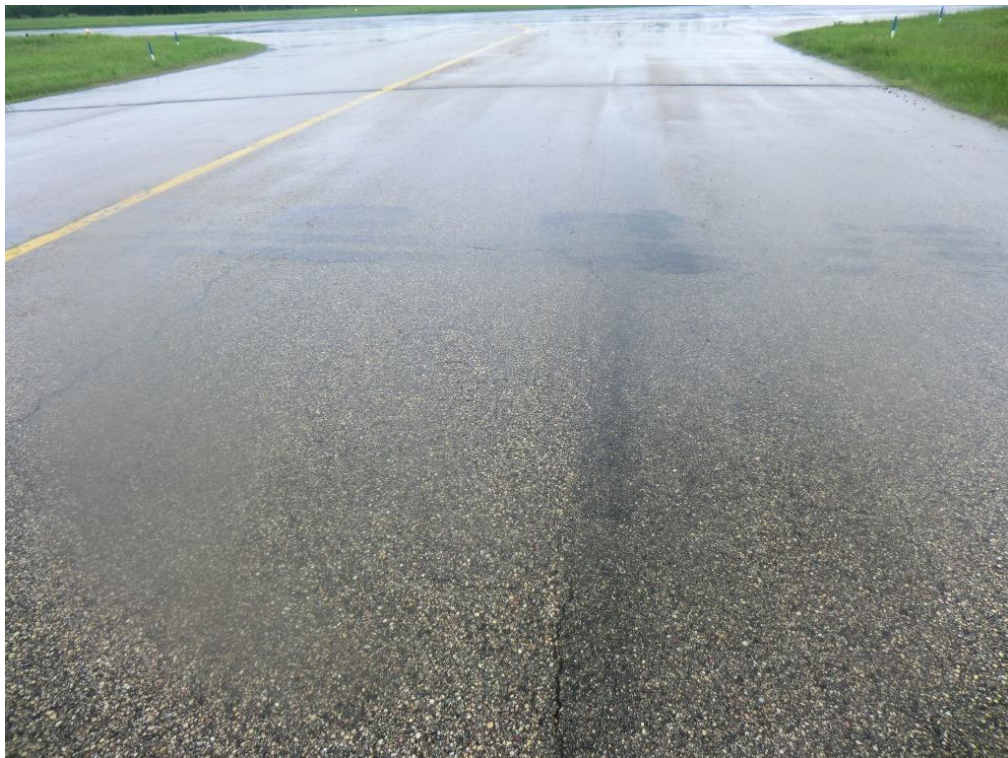
BDE CTB 001 (PCI = 67)

| Branch ID | Section ID | Surface type <sup>1</sup> | Section area (SF) | LCD <sup>2</sup> | 2011 PCI | 2014 PCI | Drop in PCI/Yr <sup>3</sup> | % Deduct due to | | Distress types |
|---|---|---|---|---|---|---|---|---|---|---|
| CTB | 1 | AAC | 12,300 | 1987 | 70 | 67 | 1.2 | 19 | 81 | L&T cracking, rutting |

Conditions: PCI : 67

| 48 | LONGITUDINAL/TRANSVERSE CRACKING | L | 327.00 Ft | Comments: |
| 48 | LONGITUDINAL/TRANSVERSE CRACKING | M | 87.00 Ft | Comments: |
| 48 | LONGITUDINAL/TRANSVERSE CRACKING | H | 8.00 Ft | Comments: |

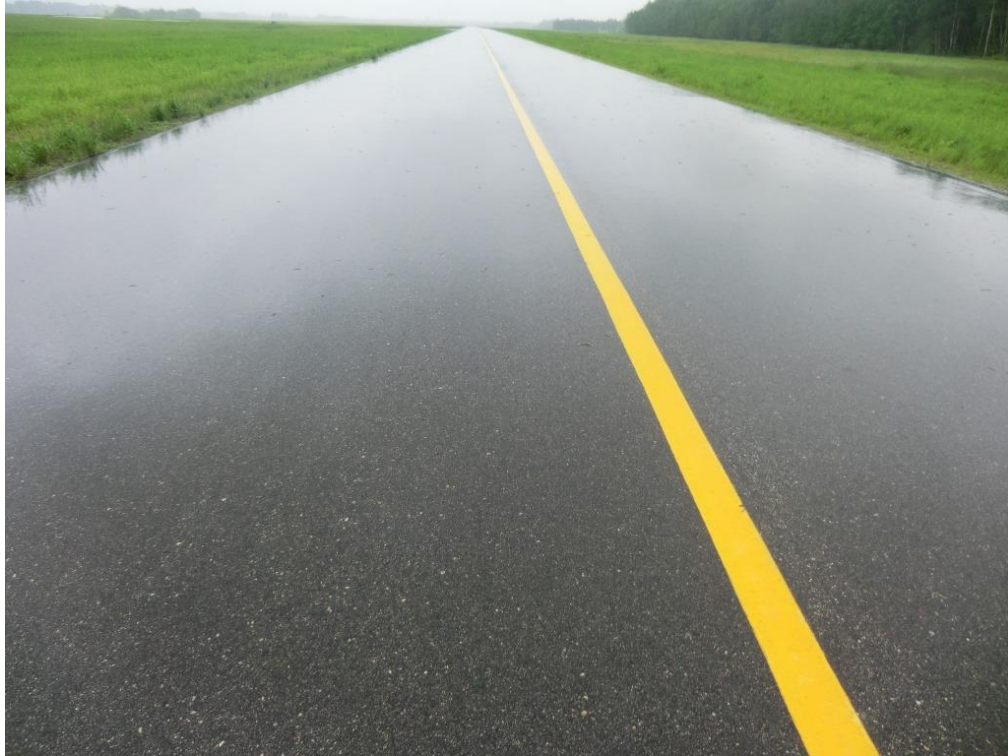
BDE PTA 001 (PCI = 100)

Conditions: PCI : 100

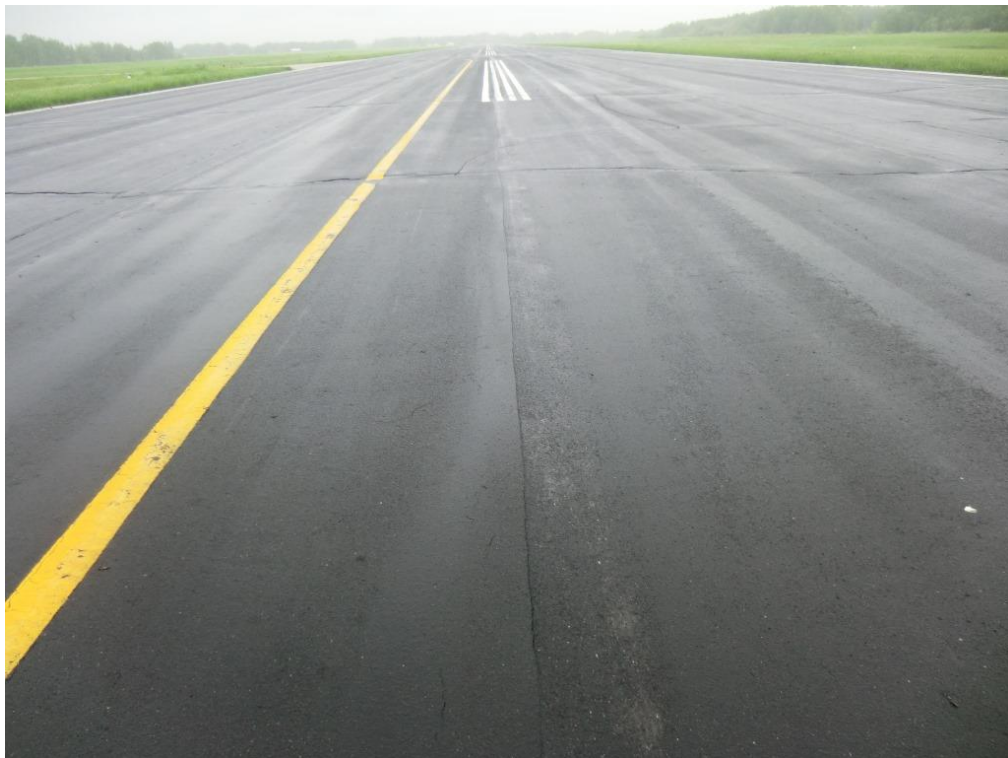
BDE RY1230 001 (PCI = 66)

| Branch ID | Section ID | Surface type <sup>1</sup> | Section area (SF) | LCD <sup>2</sup> | 2011 PCI | 2014 PCI | Drop in PCI/Yr <sup>3</sup> | % Deduct due to | | Distress types |
|---|---|---|---|---|---|---|---|---|---|---|
| RY1230 | 1 | AAC | 556,243 | 1987 | 71 | 66 | 1.3 | 0 | 100 | L&T cracking |

Conditions: PCI : 66

| 48 | LONGITUDINAL/TRANSVERSE CRACKING | L | 539.00 Ft | Comments: |
| 48 | LONGITUDINAL/TRANSVERSE CRACKING | M | 29.00 Ft | Comments: |
| 48 | LONGITUDINAL/TRANSVERSE CRACKING | H | 68.00 Ft | Comments: |
