Final Report

Pavement Condition Report

Willmar Municipal Airport (BDH)

December 2014

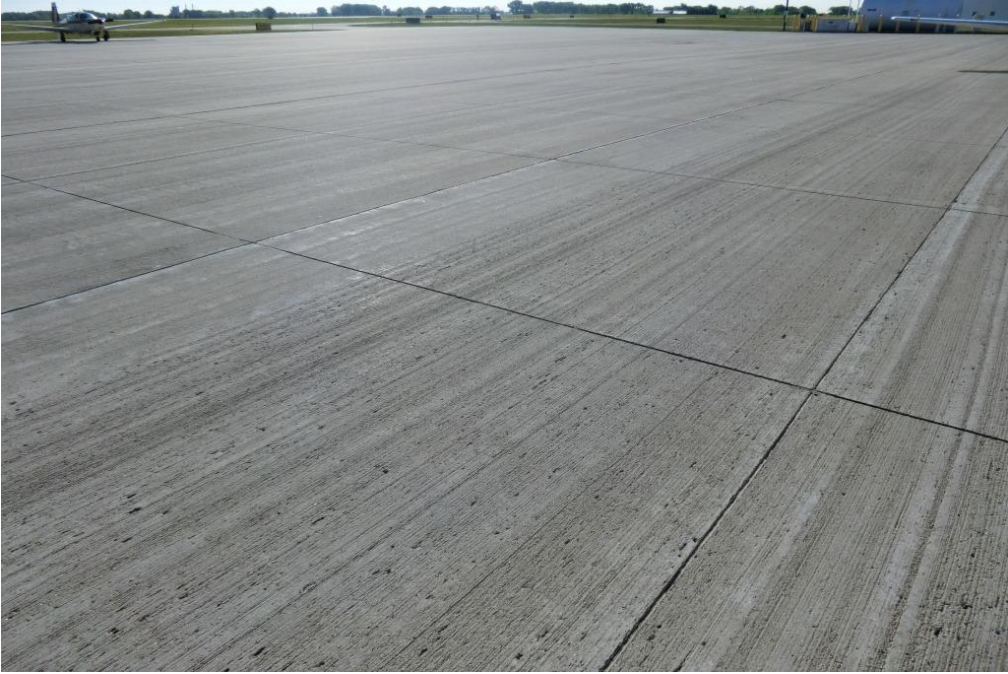
BDH APA 001 (PCI = 96)

Conditions: PCI : 96

Sample Number: 104 Type: R Area: 20.00Slabs PCI = 98
Sample Comments:
74 JOINT SPALLING L 1.00 Slabs Comments:

Sample Number: 107 Type: R Area: 20.00Slabs PCI = 95
Sample Comments:
63 LINEAR CRACKING L 1.00 Slabs Comments:

Sample Number: 201 Type: R Area: 20.00Slabs PCI = 94
Sample Comments:
74 JOINT SPALLING L 1.00 Slabs Comments:
74 JOINT SPALLING M 1.00 Slabs Comments:

Sample Number: 302 Type: R Area: 20.00Slabs PCI = 96
Sample Comments:
74 JOINT SPALLING L 1.00 Slabs Comments:
75 CORNER SPALLING L 1.00 Slabs Comments:

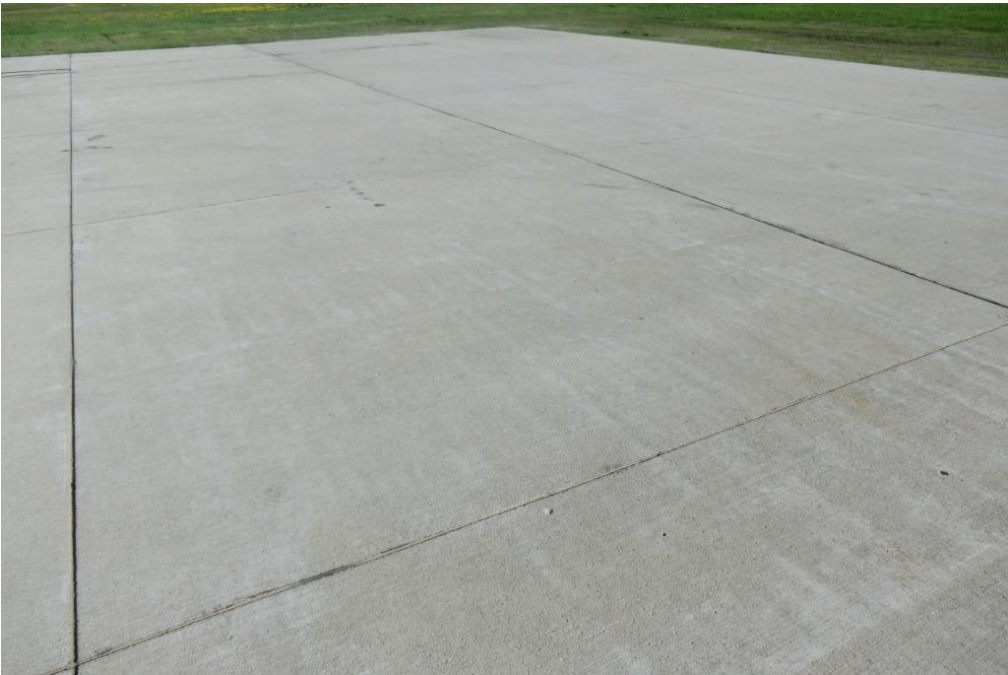
BDH APA 002 (PCI = 100)

Conditions: PCI : 100

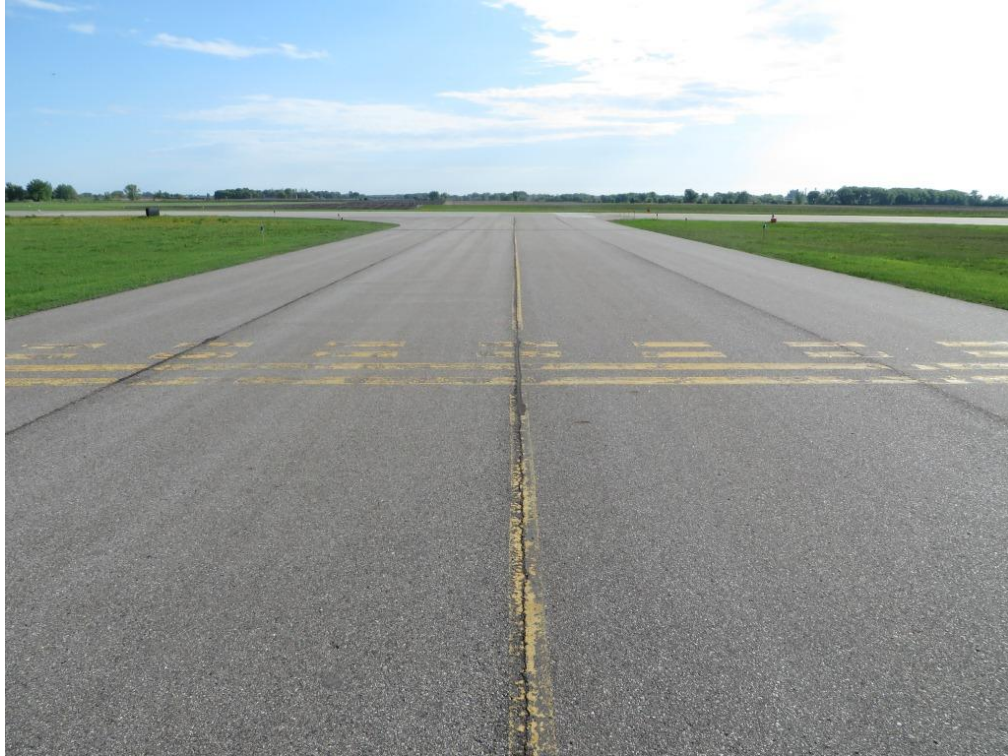
BDH CTA1 001 (PCI = 88)

Conditions: PCI : 88

48 LONGITUDINAL/TRANSVERSE CRACKING L 255.00 Ft Comments:

48 LONGITUDINAL/TRANSVERSE CRACKING L 141.00 Ft Comments:

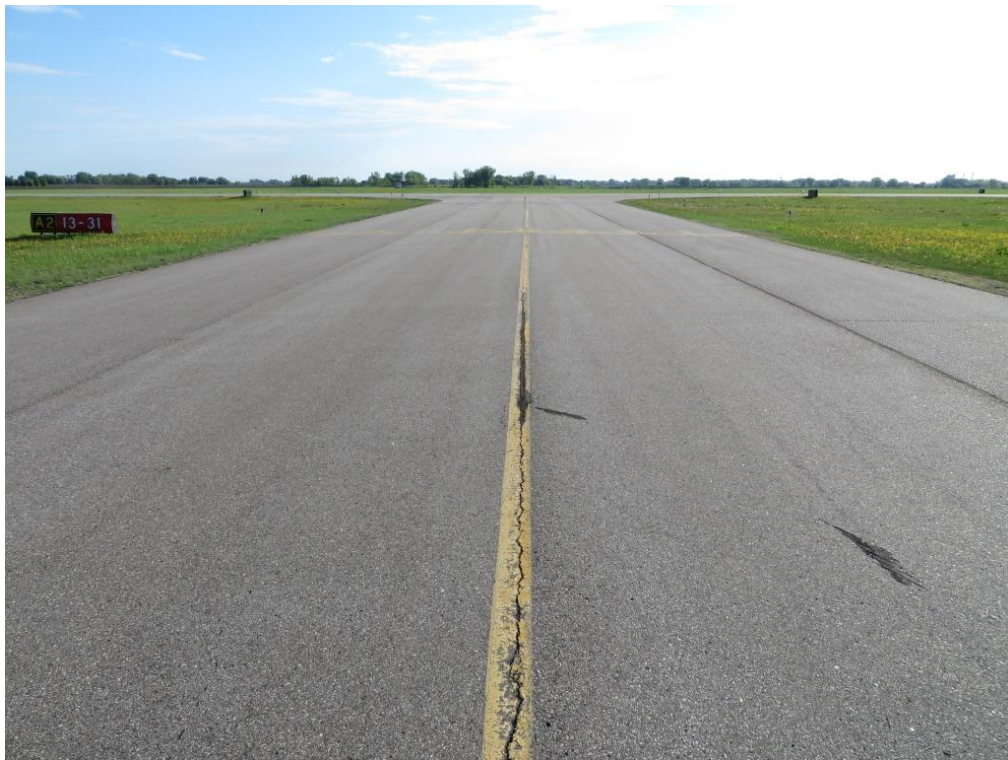
BDH CTA2 001 (PCI = 86)

Conditions: PCI: 86

48 LONGITUDINAL/TRANSVERSE CRACKING L 181.00 Ft Comments:

48 LONGITUDINAL/TRANSVERSE CRACKING L 217.00 Ft Comments:

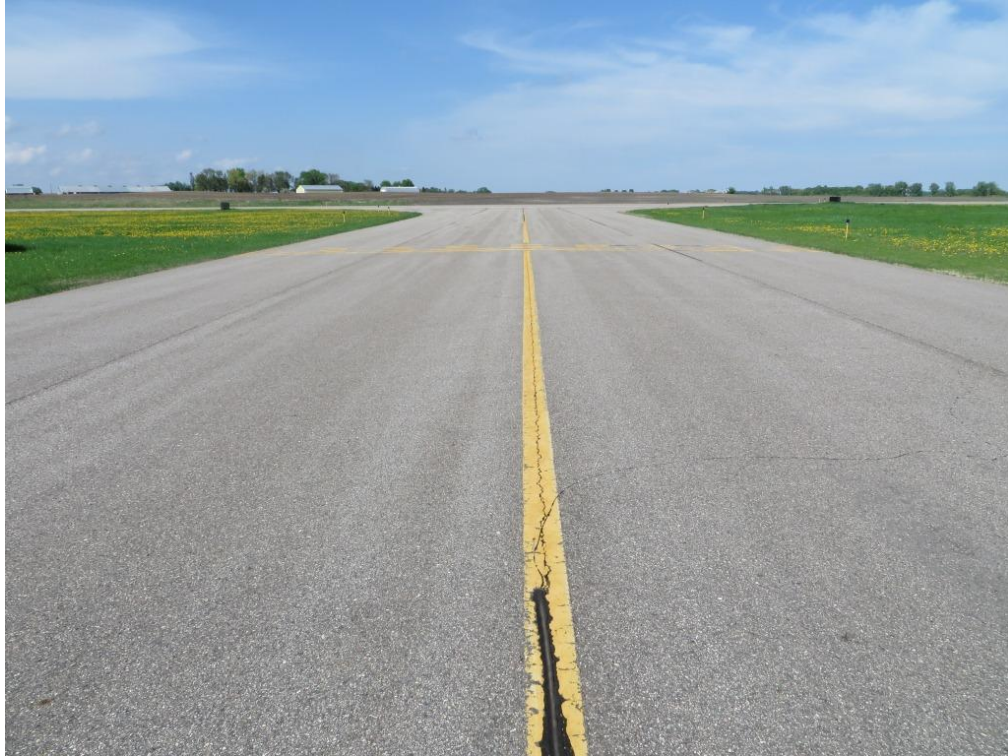
BDH CTA3 001 (PCI = 79)

Conditions: PCI: 79

48 LONGITUDINAL/TRANSVERSE CRACKING L 258.00 Ft Comments:

48 LONGITUDINAL/TRANSVERSE CRACKING M 16.00 Ft Comments:

48 LONGITUDINAL/TRANSVERSE CRACKING L 284.00 Ft Comments:

48 LONGITUDINAL/TRANSVERSE CRACKING M 25.00 Ft Comments:

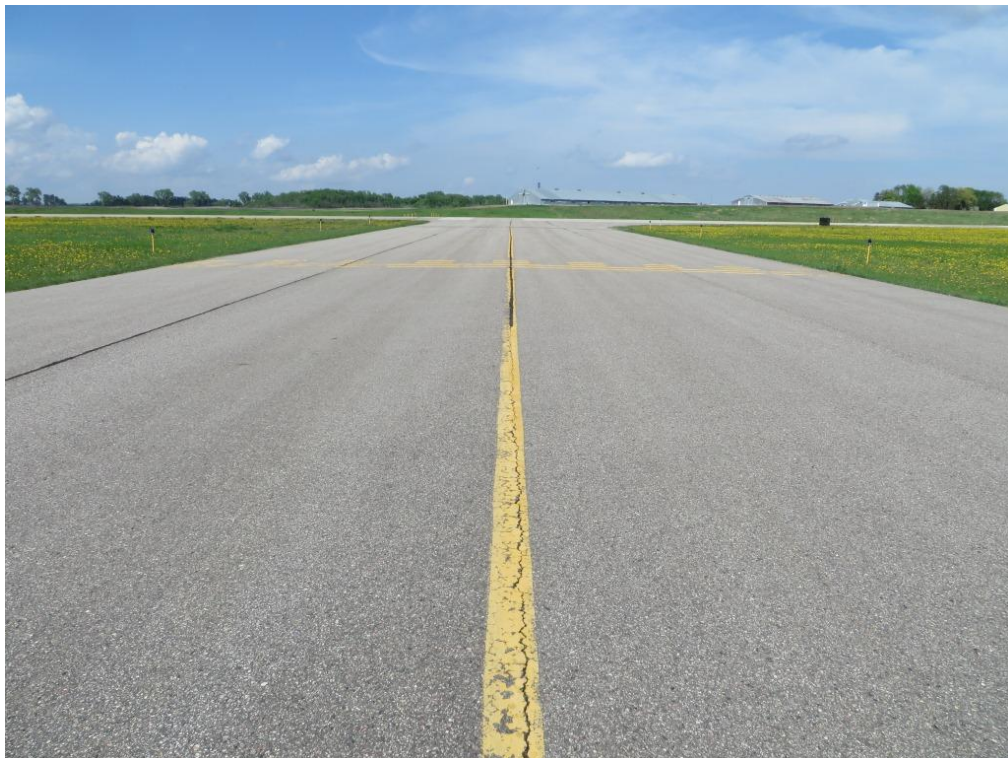
BDH CTA4 001 (PCI = 82)

Conditions: PCI: 82

48 LONGITUDINAL/TRANSVERSE CRACKING L 209.00 Ft Comments:

48 LONGITUDINAL/TRANSVERSE CRACKING L 237.00 Ft Comments:

48 LONGITUDINAL/TRANSVERSE CRACKING M 18.00 Ft Comments:

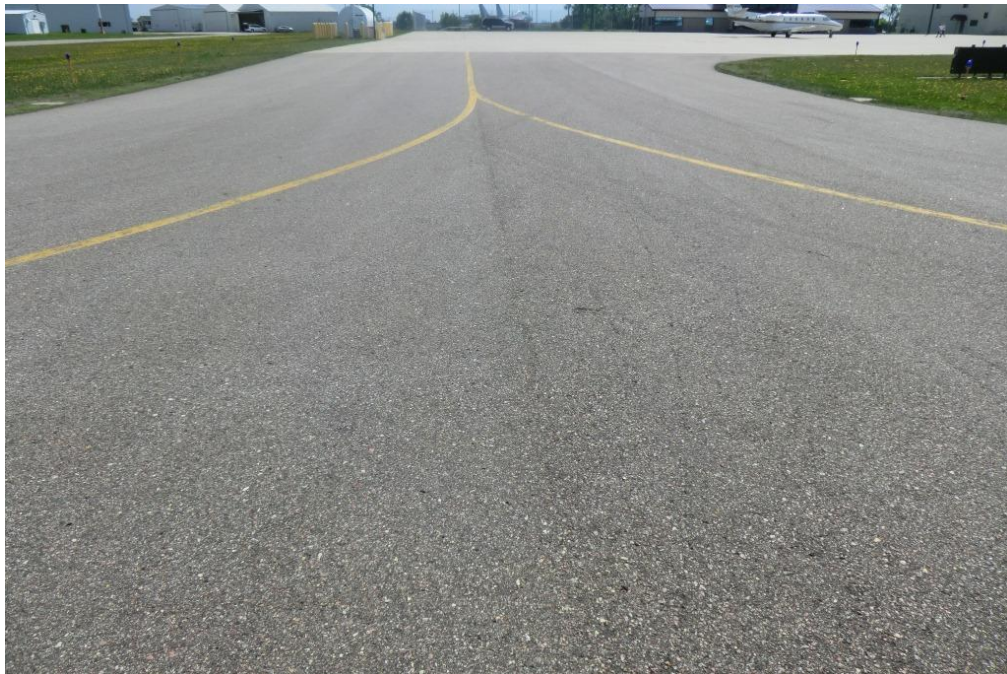
BDH CTC1 001 (PCI = 85)

Conditions: PCI : 85

48 LONGITUDINAL/TRANSVERSE CRACKING L 61.00 Ft Comments:

48 LONGITUDINAL/TRANSVERSE CRACKING M 24.00 Ft Comments:

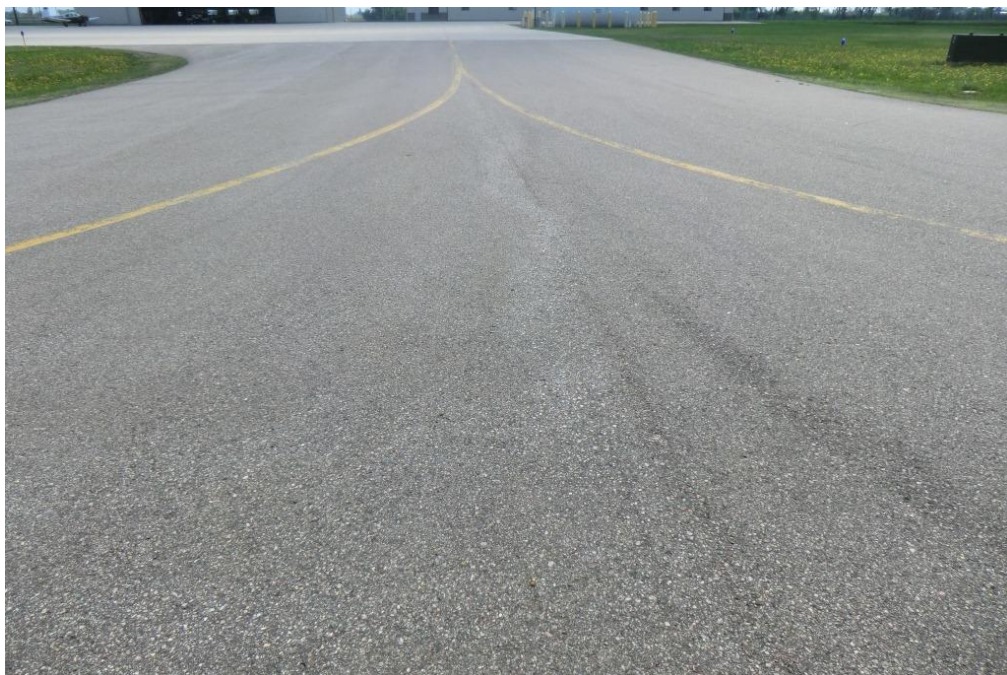
BDH CTC2 001 (PCI = 93)

Conditions: PCI: 93

48 LONGITUDINAL/TRANSVERSE CRACKING L 106.00 Ft Comments:

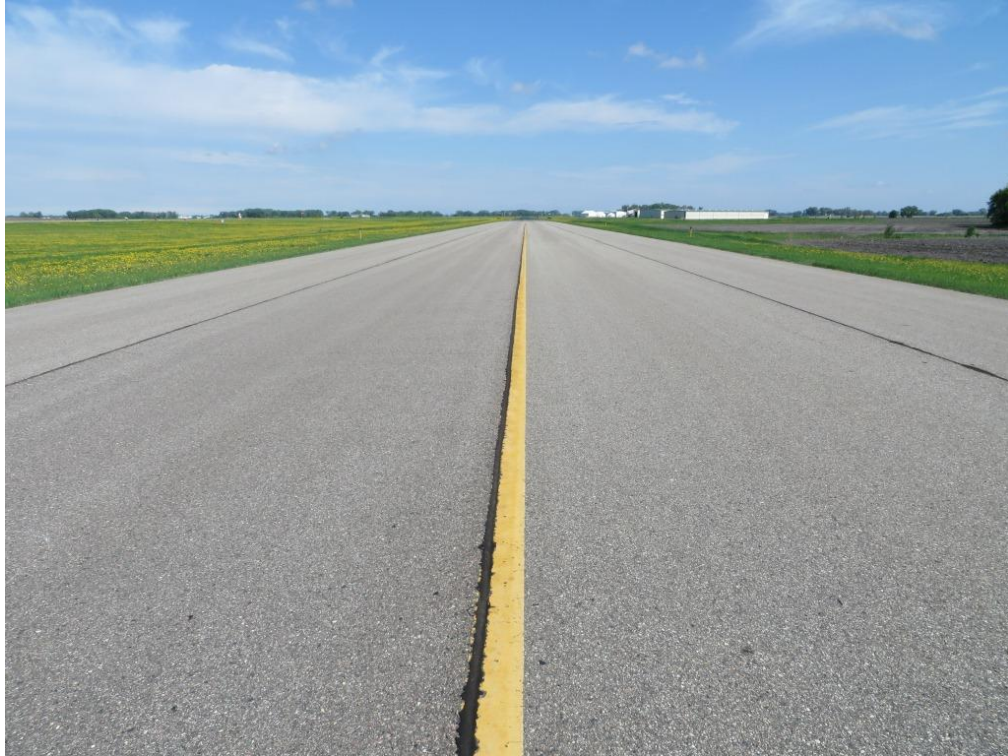
BDH PTA 001 (PCI = 84)

Conditions: PCI : 84

Sample Number: 102 Type: R Area: 5,000.00SqFt PCI = 85
Sample Comments:
48 LONGITUDINAL/TRANSVERSE CRACKING L 245.00 Ft Comments:

Sample Number: 109 Type: R Area: 5,000.00SqFt PCI = 86
Sample Comments:
48 LONGITUDINAL/TRANSVERSE CRACKING L 233.00 Ft Comments:

Sample Number: 123 Type: R Area: 5,000.00SqFt PCI = 86
Sample Comments:
48 LONGITUDINAL/TRANSVERSE CRACKING L 230.00 Ft Comments:

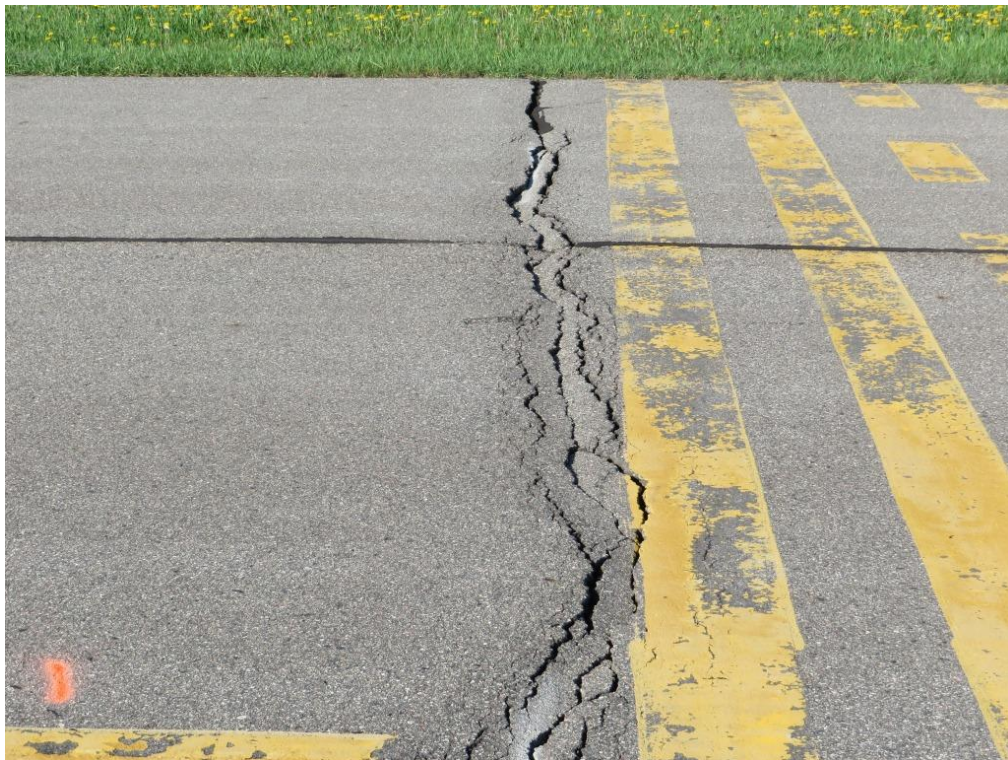
BDH PTA 001 (High-Severity L&T Crack – Sample Unit 151)

Low severity longitudinal and transverse cracks are less than $\frac{1}{4}$ inch wide, or if sealed with suitable filler material in satisfactory condition can be any width, less than 3 inches, if they are not spalled. Maintenance usually is not indicated for low-severity cracking. Moderately spalled cracks and cracks wider than $\frac{1}{4}$ inch which are not satisfactorily sealed are at medium severity. Medium-severity cracks should be sealed with a high-quality crack filling material. Severely spalled cracks and cracks wider than 3 inches are at high severity. High-severity L&T cracks normally require patching.

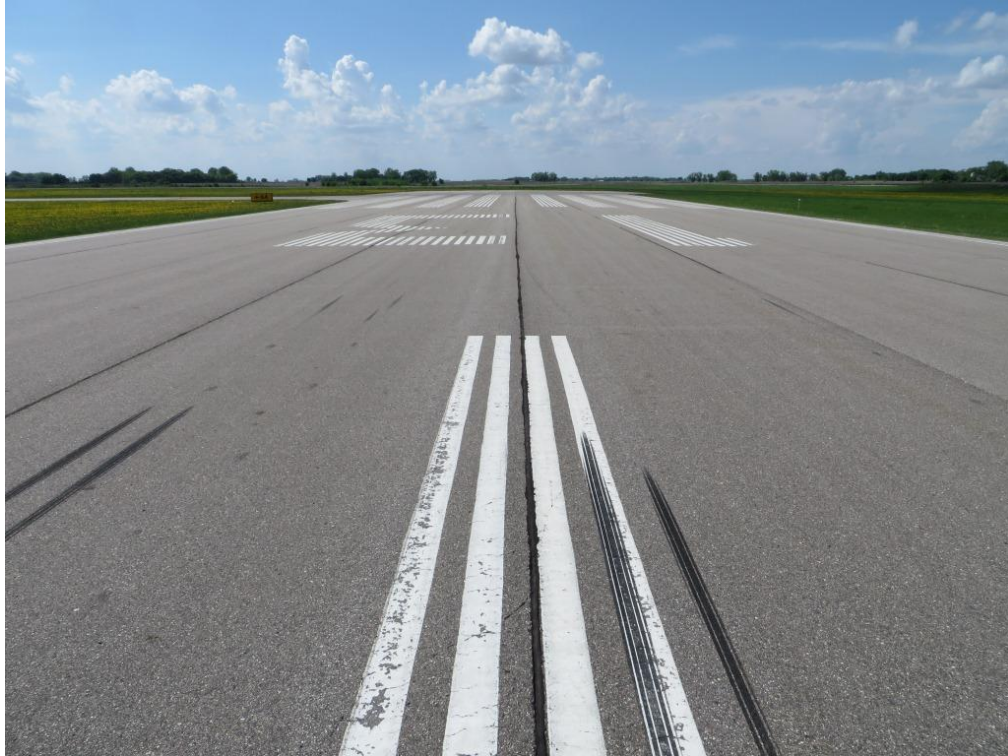
BDH RY1331 001 (PCI = 80)

Conditions: PCI: 80

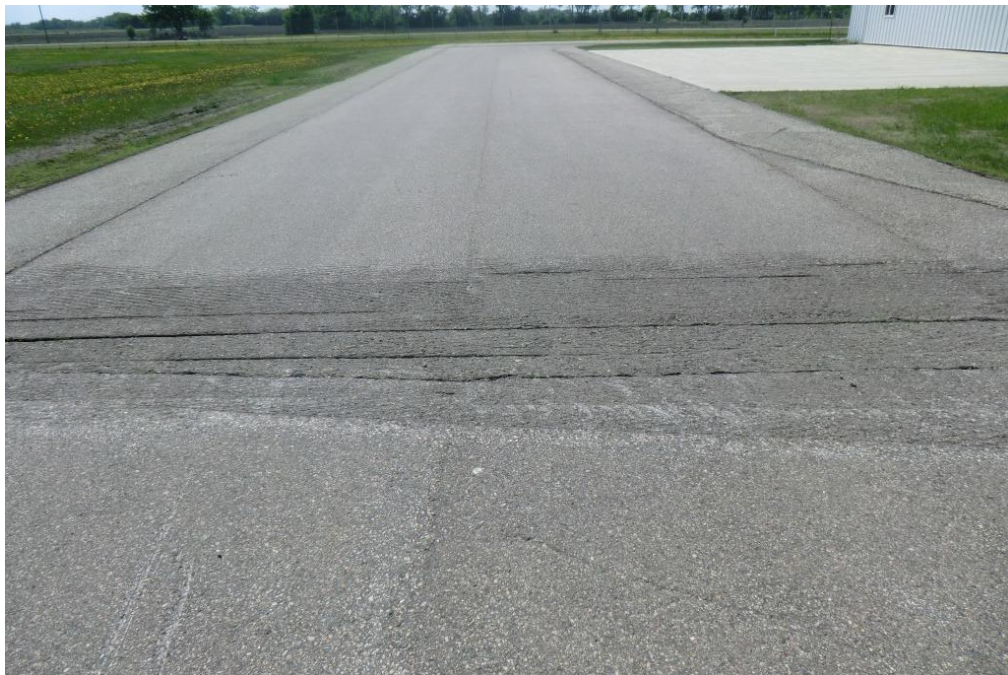
BDH TLF 001 (PCI = 76)

TLF	1	AAC	13,200	2005	79	76	2.7	0	100	L&T Cracking
TLH	1	AC	17,280	2005	100	95	0.6	0	100	L&T Cracking
TLJ	1	AC	16,280	2005	96	95	0.6	0	100	L&T Cracking
TLK	1	AC	16,280	2005	93	87	1.4	0	100	L&T Cracking
TLL	1	AC	16,280	2005	96	92	0.9	0	100	L&T Cracking
