Final Report

Pavement Condition Report

Brainerd Lakes Regional Airport (BRD)

December 2014

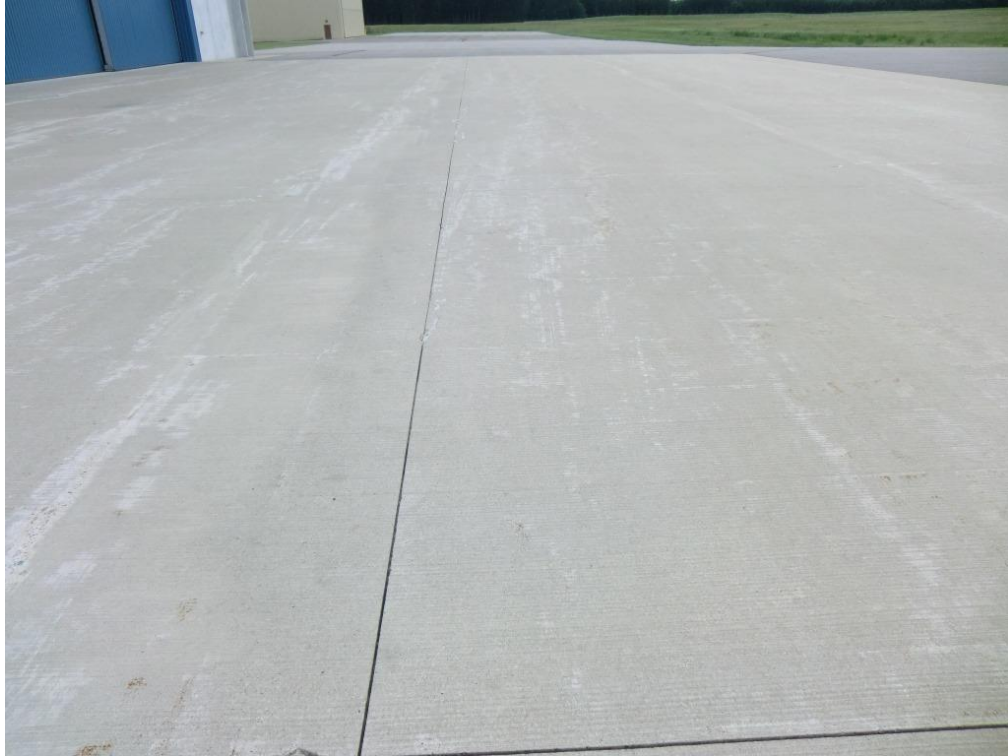
BRD APA 002 (PCI = 56)

63 LINEAR CRACKING	L	8.00 Slabs	Comments:
63 LINEAR CRACKING	M	3.00 Slabs	Comments:
72 SHATTERED SLAB	L	3.00 Slabs	Comments:
73 SHRINKAGE CRACKING	N	2.00 Slabs	Comments:
74 JOINT SPALLING	L	3.00 Slabs	Comments:

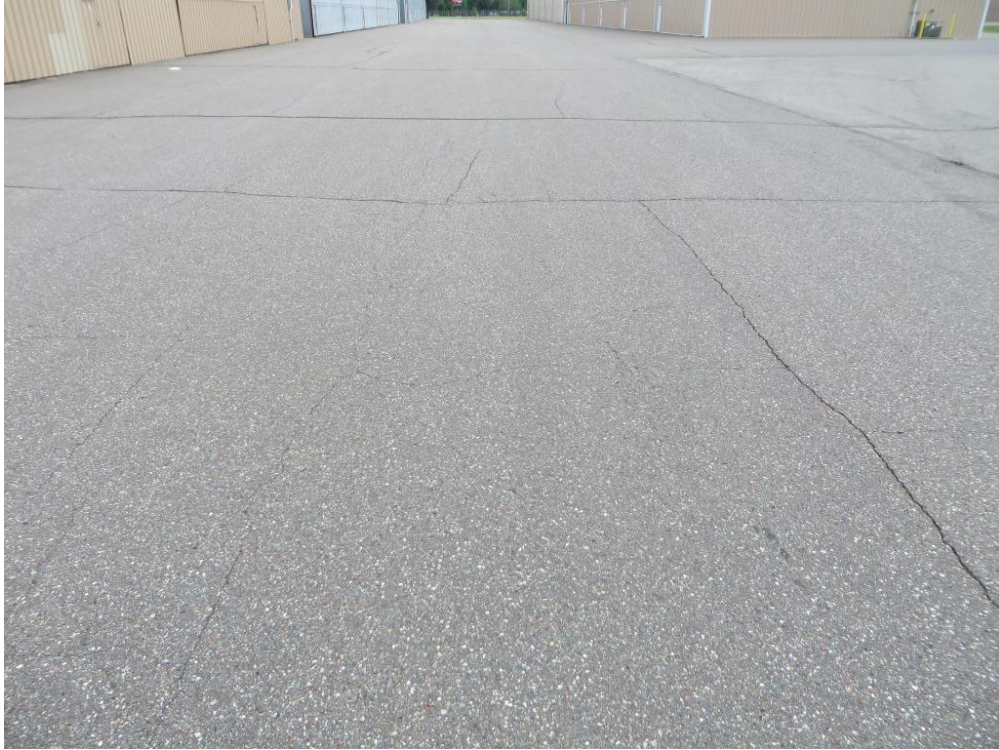
BRD TLC 001 (PCI = 53)

Branch ID	Section ID	Surface type ¹	Section area (SF)	LCD ²	2011 PCI	2014 PCI	Drop in PCI/Yr ³	% Deduct due to		Distress types
								Load ⁴	Climate ⁵	
TLC	1	AC	14,000	2000	68	53	3.4	38	62	alligator crack. Block and L&T cracking
TLD	1	AC	24,000	2007	94	88	1.7	0	100	L&T cracking

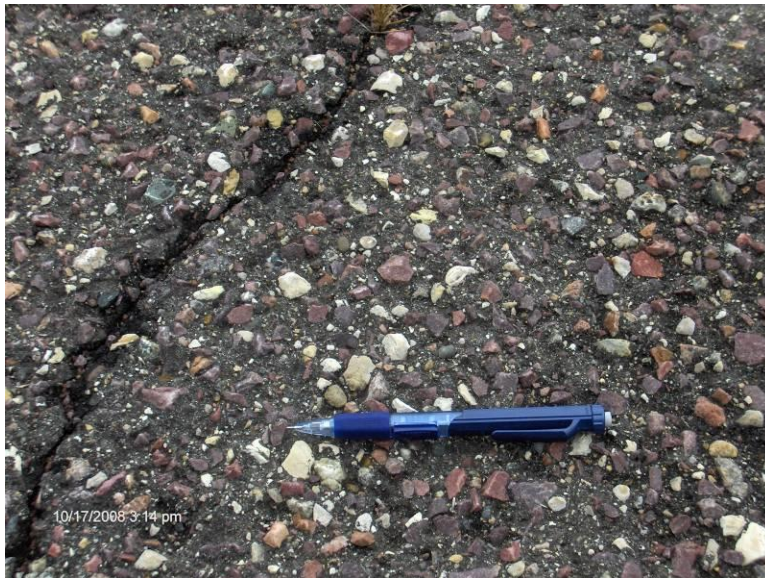
Example of Raveling/Weathering

Raveling and weathering are the wearing away of the pavement surface. Raveling is the condition where the mid- to large size aggregates are becoming dislodged; weathering is when the fine aggregate wears away exposing the edges of the larger aggregate. These distresses are usually evident over large areas and may occur together (pictured above) or separately. Raveling and weathering may indicate that the asphalt binder has hardened significantly.

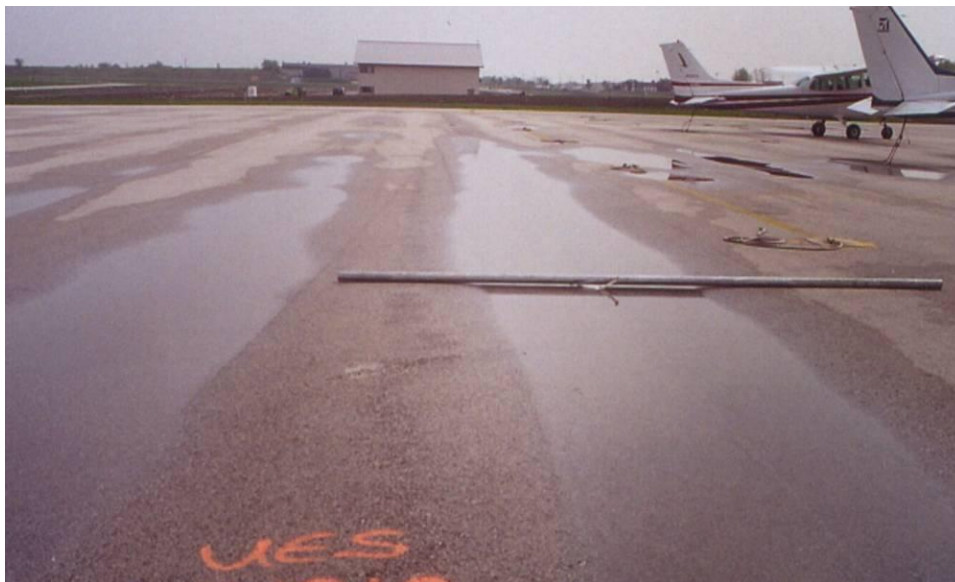
Example of Rutting

Ruts are localized, load related, areas of pavement having elevations lower than the surrounding sections. Rutting is due to base and subgrade consolidation, caused by excessive wheel loads or poor compaction. Ruts indicate structural failure, and can cause hydroplaning. At low severity, ruts have an

average depth of ¼ to ½ inches. At medium severity, ruts have an average depth of ½ to 1 inch. High severity, ruts have an average depth greater than 1 inch. Full-depth patching is the appropriate repair for ruts.

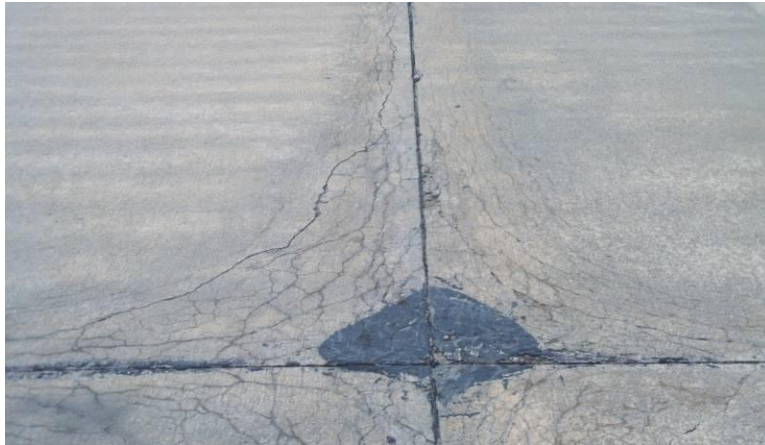
Example of Durability Cracking

Durability cracking (D-cracking) is caused by environmental factors, the most common of which is freezing/thawing. It usually appears as a pattern of hairline cracks running parallel to a joint or crack, or in a corner, where water tends to collect. This type of cracking eventually leads to disintegration of the pavement, creating FOD potential. At low severity, D-cracking is evident, but no disintegration has occurred. As the distress advances to medium severity, the distress pattern is evident over a significant area of the slab, and some disintegration and FOD potential exists. High severity durability cracking is evidenced by extensive cracking with loose and missing pieces and significant FOD potential.

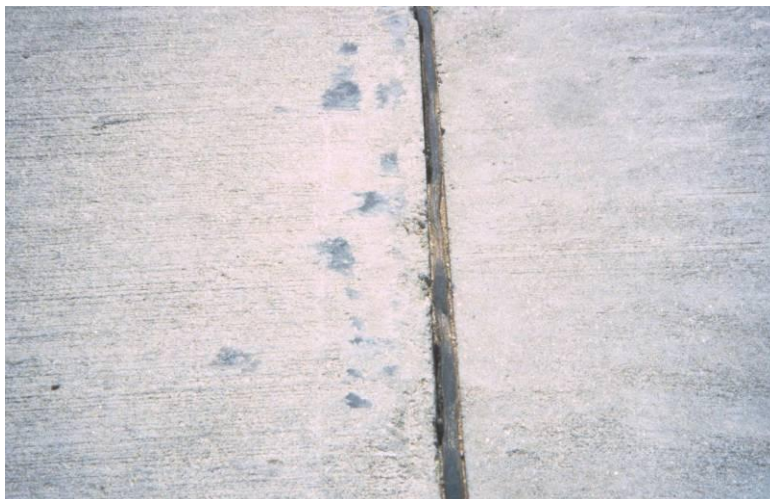
Example of Joint Seal Damage

Joint seal damage is recorded at three severities: low, medium, and high. When joint sealant is in perfect condition (no damage), it is not a distress. At low severity, at least 10 percent of the sealant is debonded but still in contact with the joint edges (i.e., joint sealant is in serviceable condition but should

be monitored for evidence of more serious failure). Medium-severity joint seal damage is recorded when at least 10 percent of the sealant has visible gaps smaller than 1/8th inch and is an indicator that replacement should be programmed as soon as is practicable. In the meantime, aggressive inspection and sustaining maintenance is recommended to minimize subsurface damage from moisture penetration. At high severity, visible gaps exceed 1/8th inch and the amount and degree of joint seal damage is such that repair is no longer feasible. The only appropriate corrective action is sealant replacement.
