Final Report

Pavement Condition Report

Cambridge Municipal Airport (CBG)

December 2014

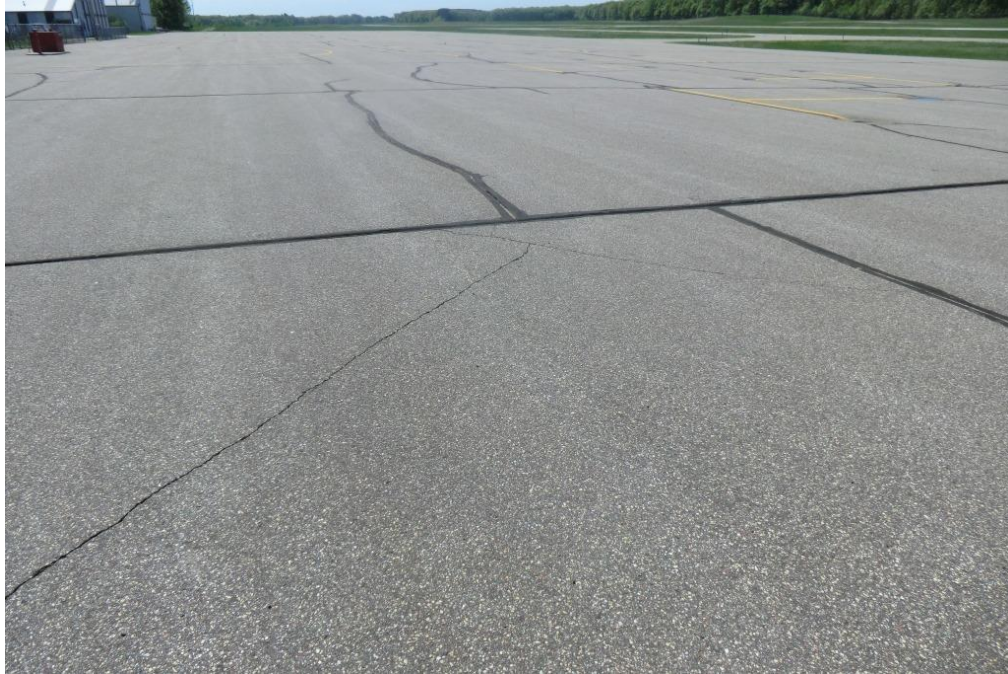
CBG APA 001 (PCI = 76)

Conditions: PCI: 76

48 LONGITUDINAL/TRANSVERSE CRACKING L 577.00 Ft Comments:
48 LONGITUDINAL/TRANSVERSE CRACKING M 16.00 Ft Comments:

48 LONGITUDINAL/TRANSVERSE CRACKING L 424.00 Ft Comments:
48 LONGITUDINAL/TRANSVERSE CRACKING M 36.00 Ft Comments:

48 LONGITUDINAL/TRANSVERSE CRACKING L 258.00 Ft Comments:
48 LONGITUDINAL/TRANSVERSE CRACKING M 31.00 Ft Comments:

48 LONGITUDINAL/TRANSVERSE CRACKING L 337.00 Ft Comments:
48 LONGITUDINAL/TRANSVERSE CRACKING M 26.00 Ft Comments:

48 LONGITUDINAL/TRANSVERSE CRACKING L 215.00 Ft Comments:
48 LONGITUDINAL/TRANSVERSE CRACKING M 13.00 Ft Comments:

48 LONGITUDINAL/TRANSVERSE CRACKING L 416.00 Ft Comments:
48 LONGITUDINAL/TRANSVERSE CRACKING M 67.00 Ft Comments:

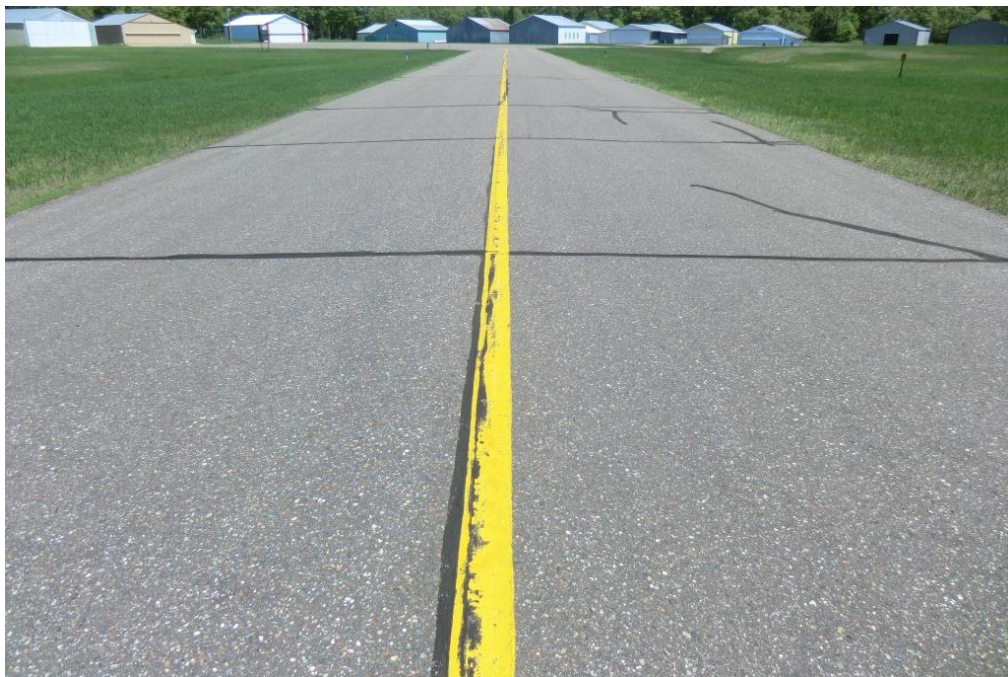
CBG CTA 001 (PCI = 73)

Conditions: PCI: 73

48 LONGITUDINAL/TRANSVERSE CRACKING L 258.00 Ft Comments:
48 LONGITUDINAL/TRANSVERSE CRACKING M 8.00 Ft Comments:

48 LONGITUDINAL/TRANSVERSE CRACKING L 307.00 Ft Comments:
48 LONGITUDINAL/TRANSVERSE CRACKING M 3.00 Ft Comments:

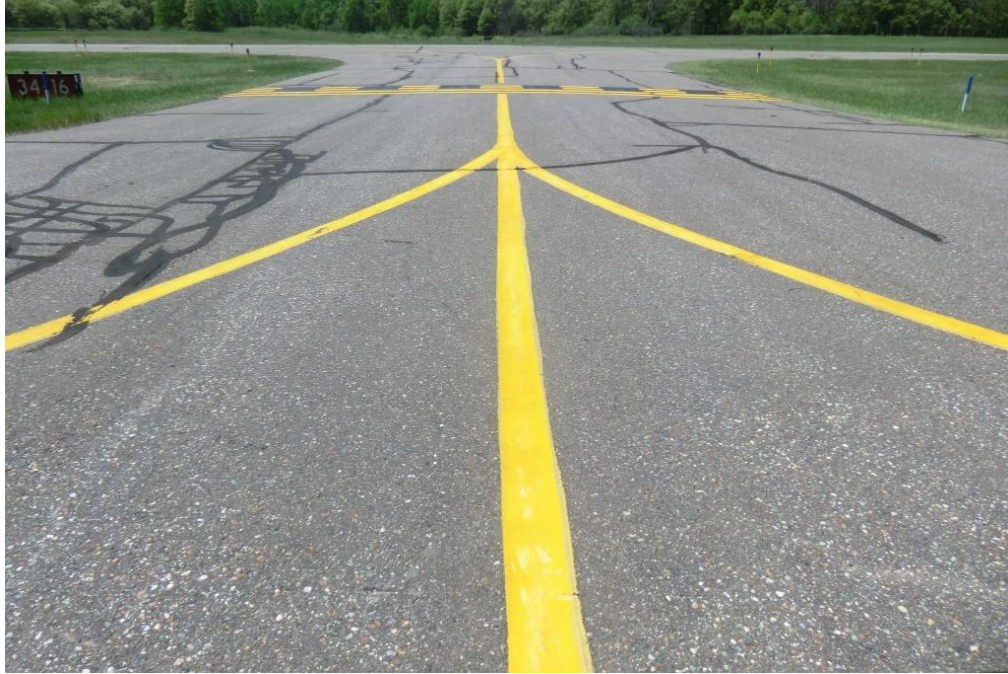
CBG CTB 001 (PCI = 63)

Conditions: PCI: 63

48 LONGITUDINAL/TRANSVERSE CRACKING L 743.00 Ft Comments:

48 LONGITUDINAL/TRANSVERSE CRACKING M 25.00 Ft Comments:

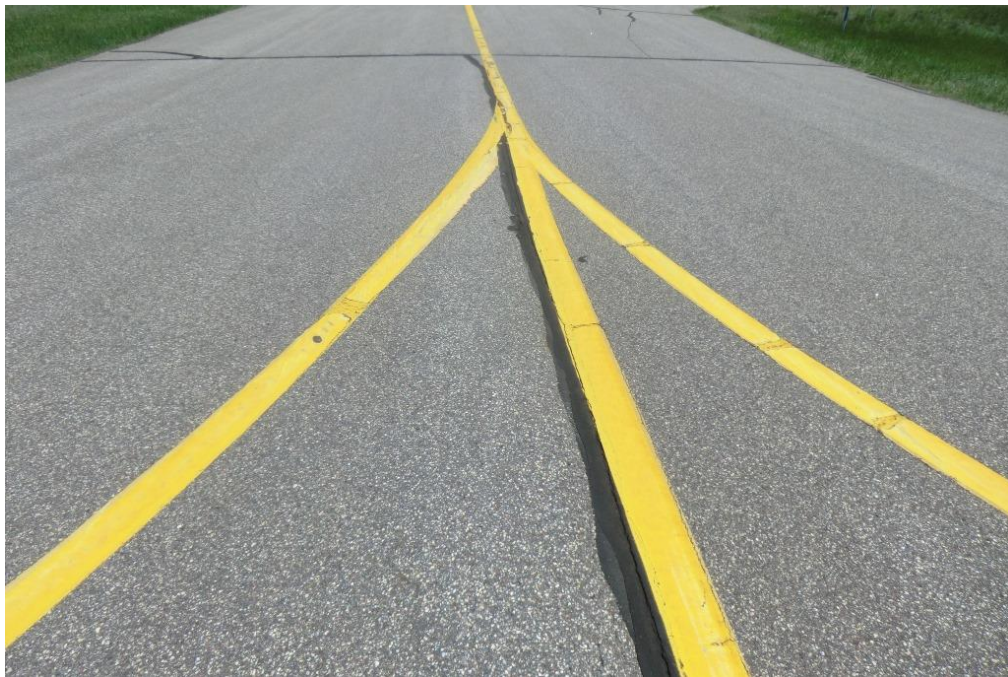
CBG CTBX 001 (PCI = 82)

Conditions: PCI : 82

48 LONGITUDINAL/TRANSVERSE CRACKING L 203.00 Ft Comments:

48 LONGITUDINAL/TRANSVERSE CRACKING M 33.00 Ft Comments:

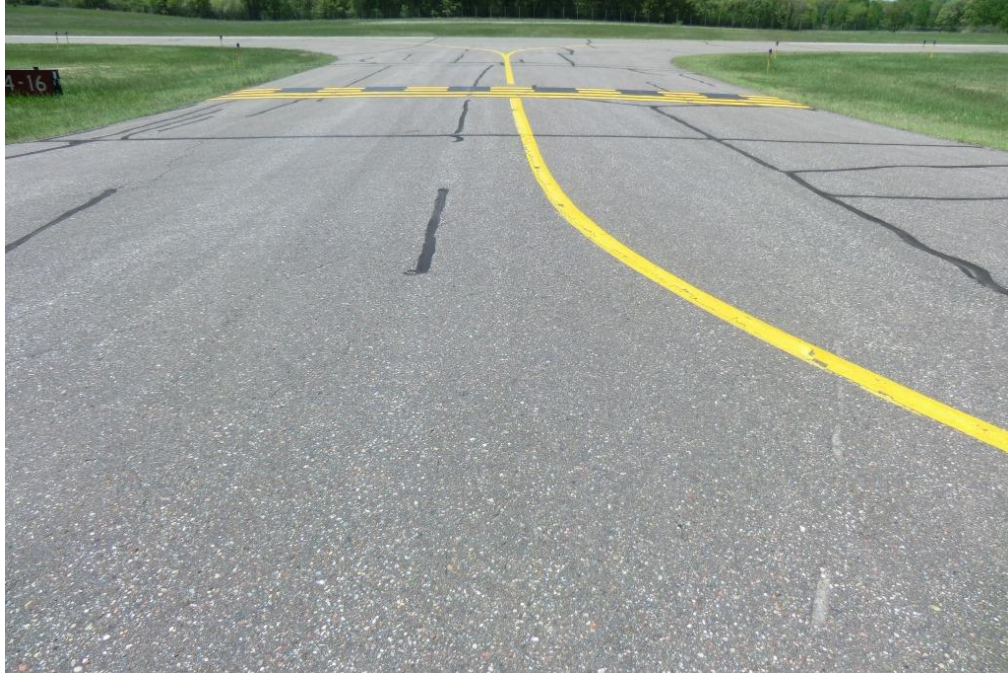
CBG CTC 001 (PCI = 64)

Conditions: PCI: 64

48 LONGITUDINAL/TRANSVERSE CRACKING L 734.00 Ft Comments:

48 LONGITUDINAL/TRANSVERSE CRACKING M 10.00 Ft Comments:

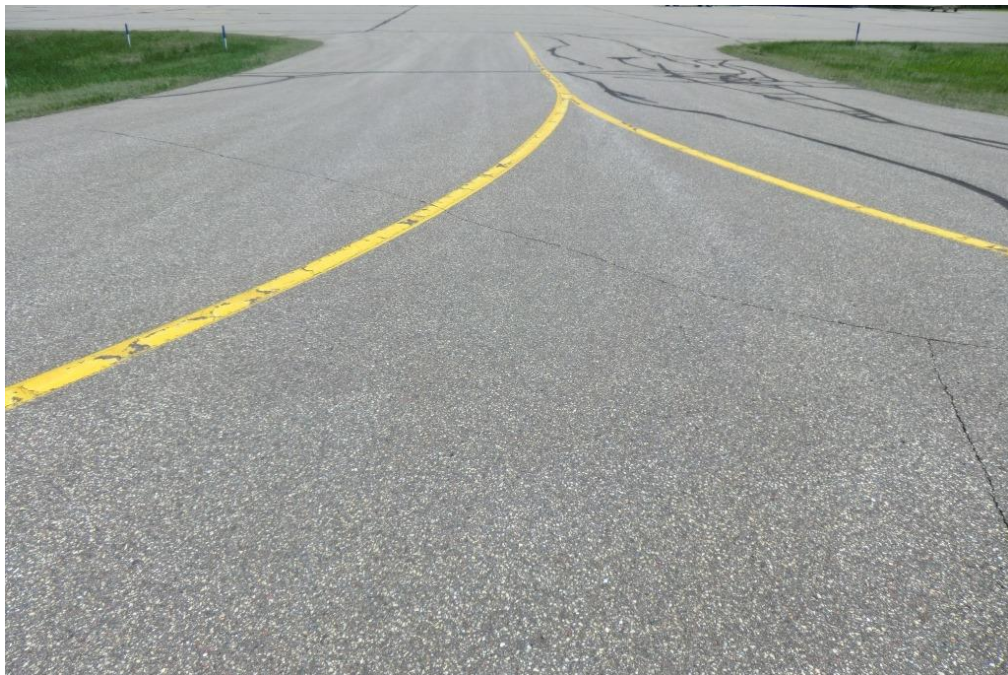
CBG CTD 001 (PCI = 63)

Conditions: PCI: 63

41 ALLIGATOR CRACKING L 48.00 SqFt Comments:

48 LONGITUDINAL/TRANSVERSE CRACKING L 635.00 Ft Comments:

48 LONGITUDINAL/TRANSVERSE CRACKING M 12.00 Ft Comments:

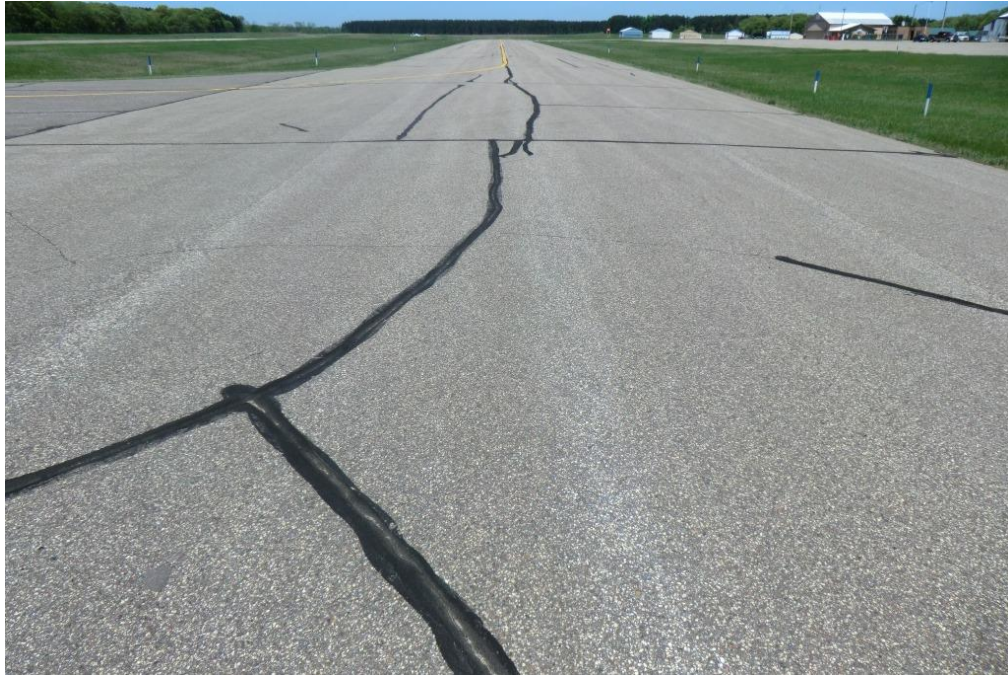
CBG PPTA 001 (PCI = 75)

Conditions: PCI : 75

48 LONGITUDINAL/TRANSVERSE CRACKING L 314.00 Ft Comments:

48 LONGITUDINAL/TRANSVERSE CRACKING L 269.00 Ft Comments:

48 LONGITUDINAL/TRANSVERSE CRACKING M 15.00 Ft Comments:

48 LONGITUDINAL/TRANSVERSE CRACKING L 325.00 Ft Comments:

48 LONGITUDINAL/TRANSVERSE CRACKING M 12.00 Ft Comments:

48 LONGITUDINAL/TRANSVERSE CRACKING L 523.00 Ft Comments:

48 LONGITUDINAL/TRANSVERSE CRACKING M 25.00 Ft Comments:

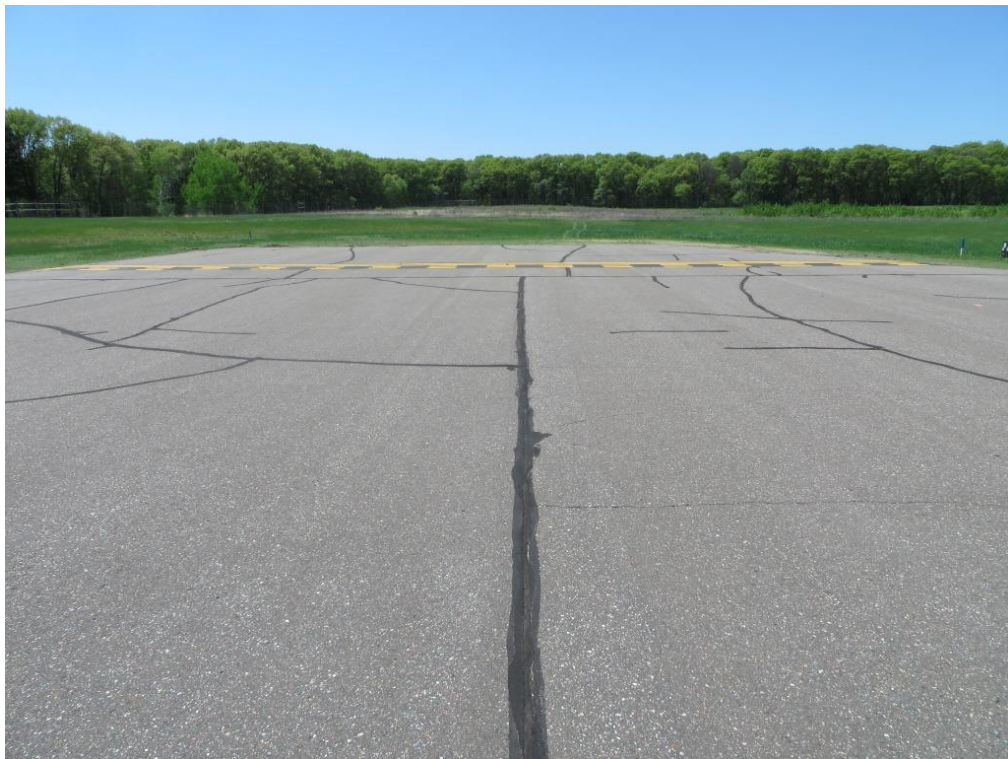
CBG RTA 001 (PCI = 68)

Conditions: PCI : 68

48	LONGITUDINAL/TRANSVERSE CRACKING	L	354.00 Ft	Comments:
48	LONGITUDINAL/TRANSVERSE CRACKING	M	8.00 Ft	Comments:
57	WEATHERING	M	300.00 SqFt	Comments:

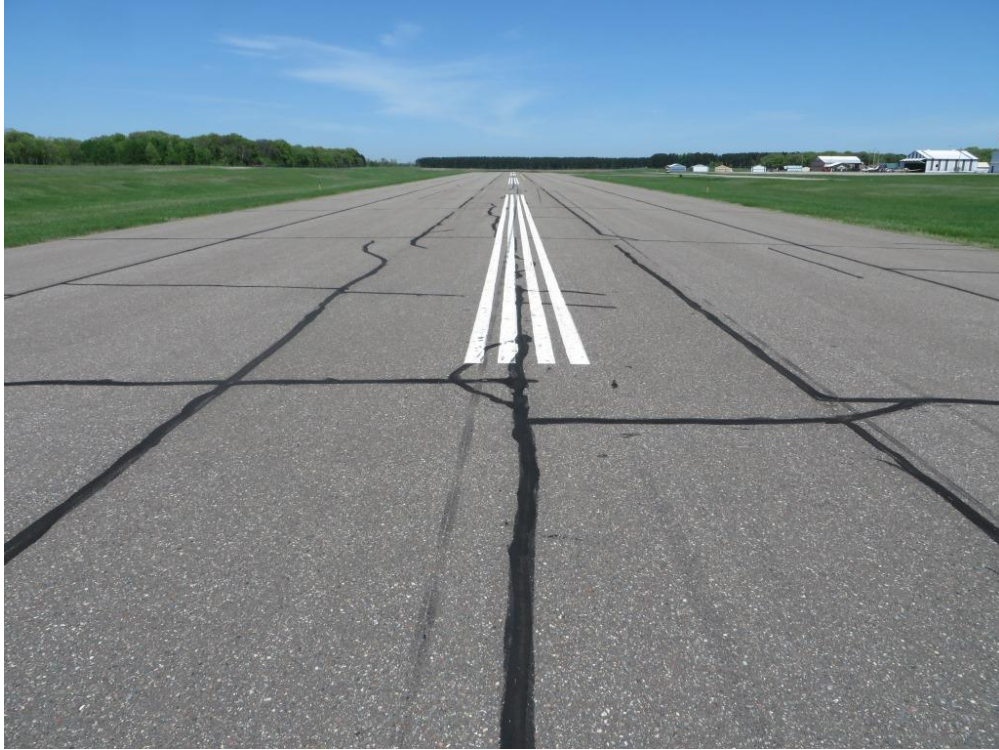
CBG RY1634 001 (PCI = 66)

Conditions: PCI: 66

Sample Number: 105 Type: R Area: 3,750.00SqFt PCI = 73
Sample Comments:
48 LONGITUDINAL/TRANSVERSE CRACKING L 344.00 Ft Comments:
57 WEATHERING M 600.00 SqFt Comments:

Sample Number: 114 Type: R Area: 3,750.00SqFt PCI = 62
Sample Comments:
48 LONGITUDINAL/TRANSVERSE CRACKING L 559.00 Ft Comments:
48 LONGITUDINAL/TRANSVERSE CRACKING M 6.00 Ft Comments:
57 WEATHERING M 300.00 SqFt Comments:

Sample Number: 123 Type: R Area: 3,750.00SqFt PCI = 67
Sample Comments:
48 LONGITUDINAL/TRANSVERSE CRACKING L 407.00 Ft Comments:
48 LONGITUDINAL/TRANSVERSE CRACKING M 2.00 Ft Comments:
57 WEATHERING M 400.00 SqFt Comments:

Sample Number: 132 Type: R Area: 3,750.00SqFt PCI = 66
Sample Comments:
48 LONGITUDINAL/TRANSVERSE CRACKING L 427.00 Ft Comments:
48 LONGITUDINAL/TRANSVERSE CRACKING M 3.00 Ft Comments:
57 WEATHERING M 400.00 SqFt Comments:
