# Pavement Condition Report

## Houston County Airport (CHU)

**December 2014**

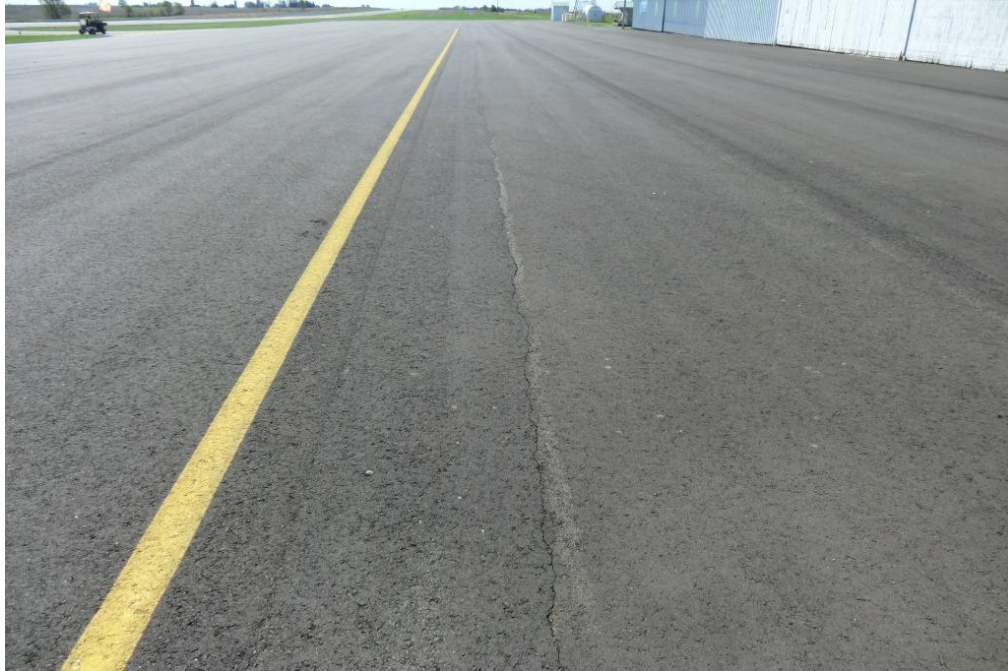
CHU APA 001 (PCI = 94)

Conditions: PCI : 94

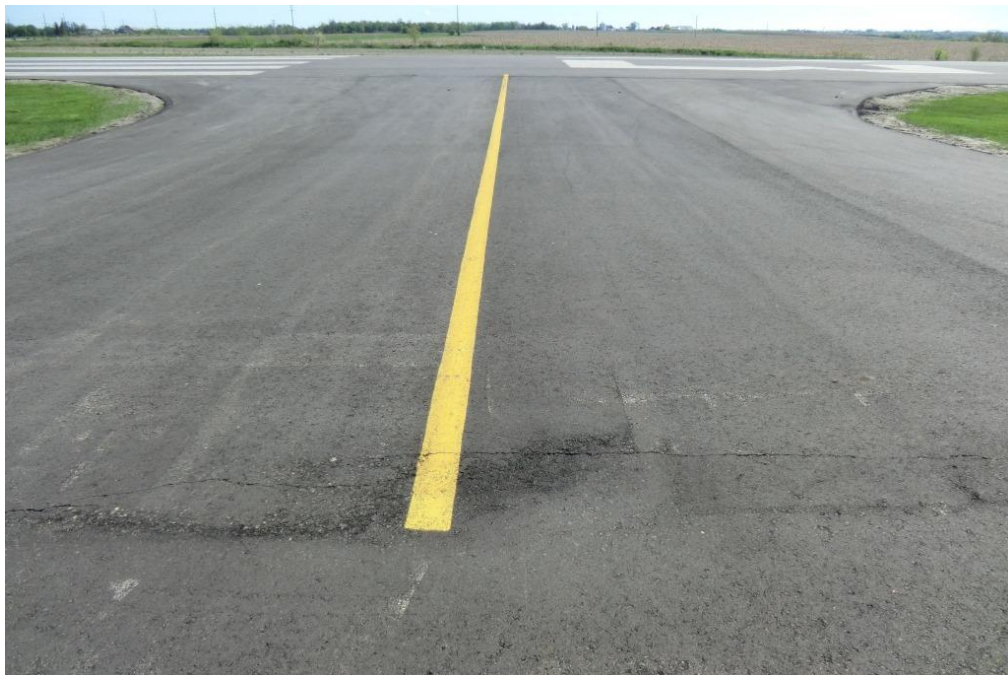
CHU CTA 001 (PCI = 95)

Conditions: PCI : 95

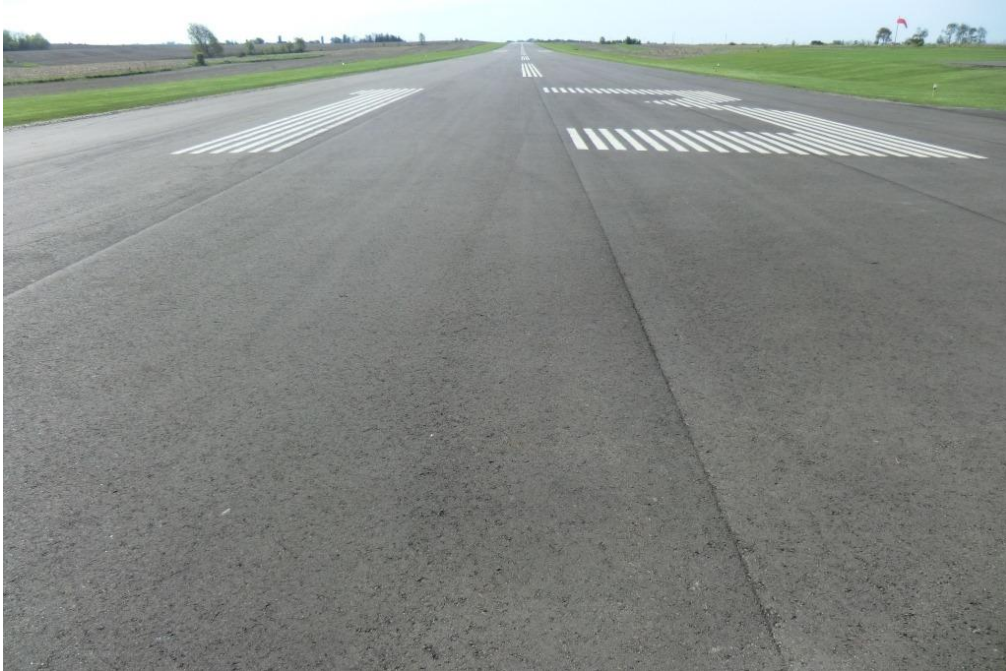
CHU RY1331 001 (PCI = 92)

Conditions: PCI : 92

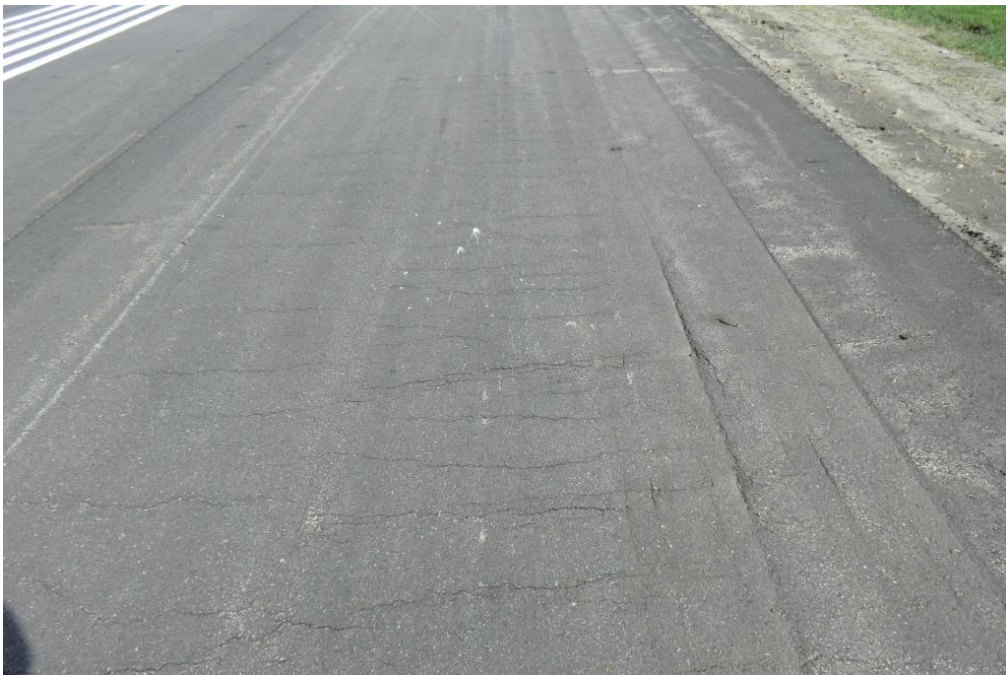
CHU RY1331 001 (Roller Marks)

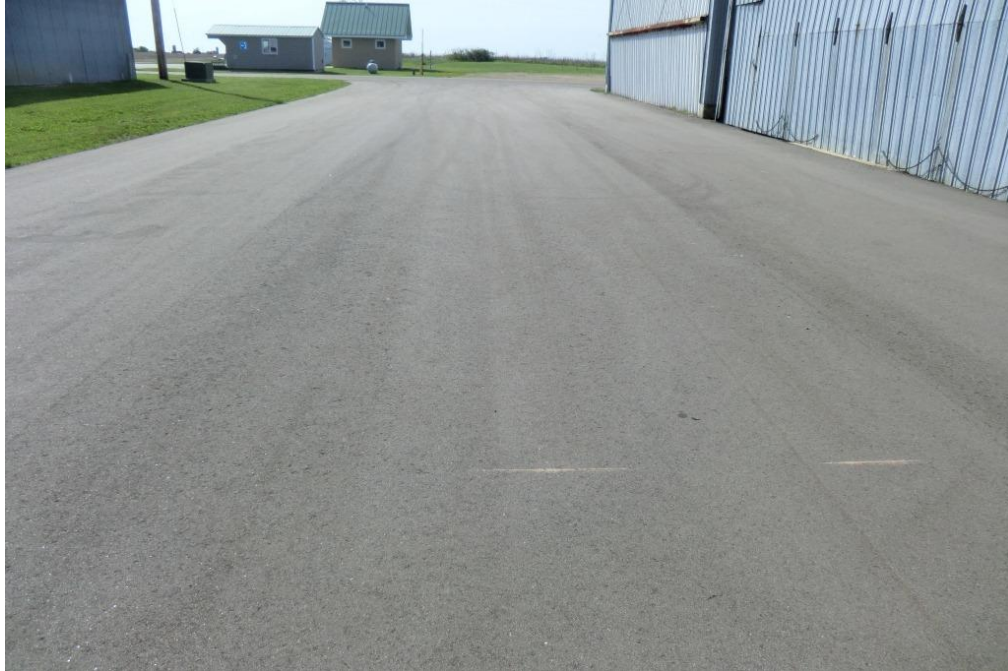
CHU TLA 001 (PCI = 100)

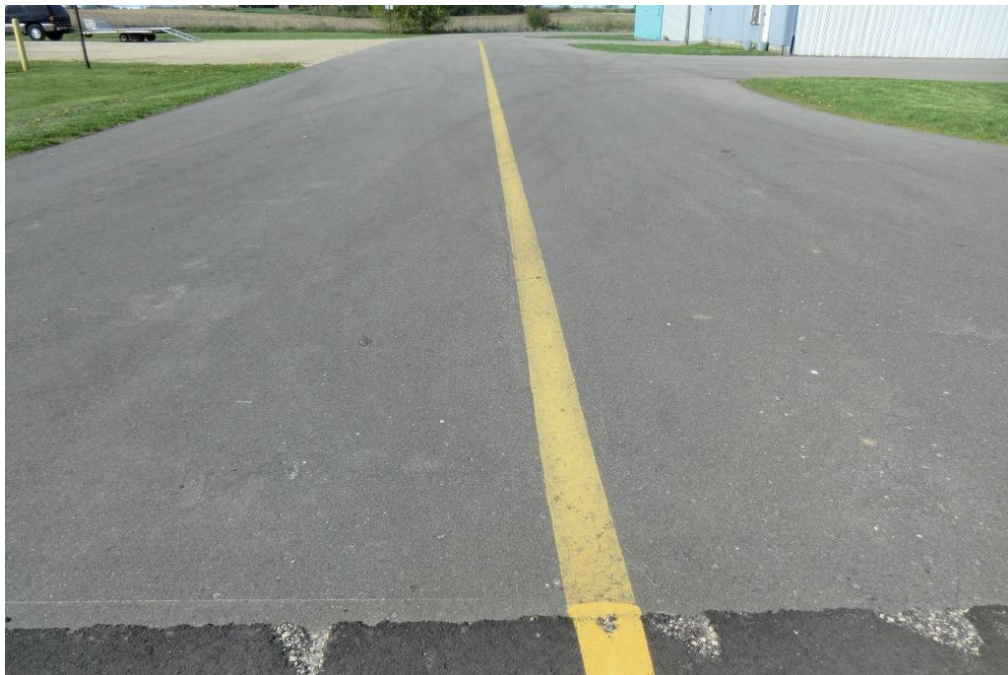
CHU TLA 002 (PCI = 100)
