Final Report

Pavement Condition Report

Canby Municipal Airport (CNB)

December 2014

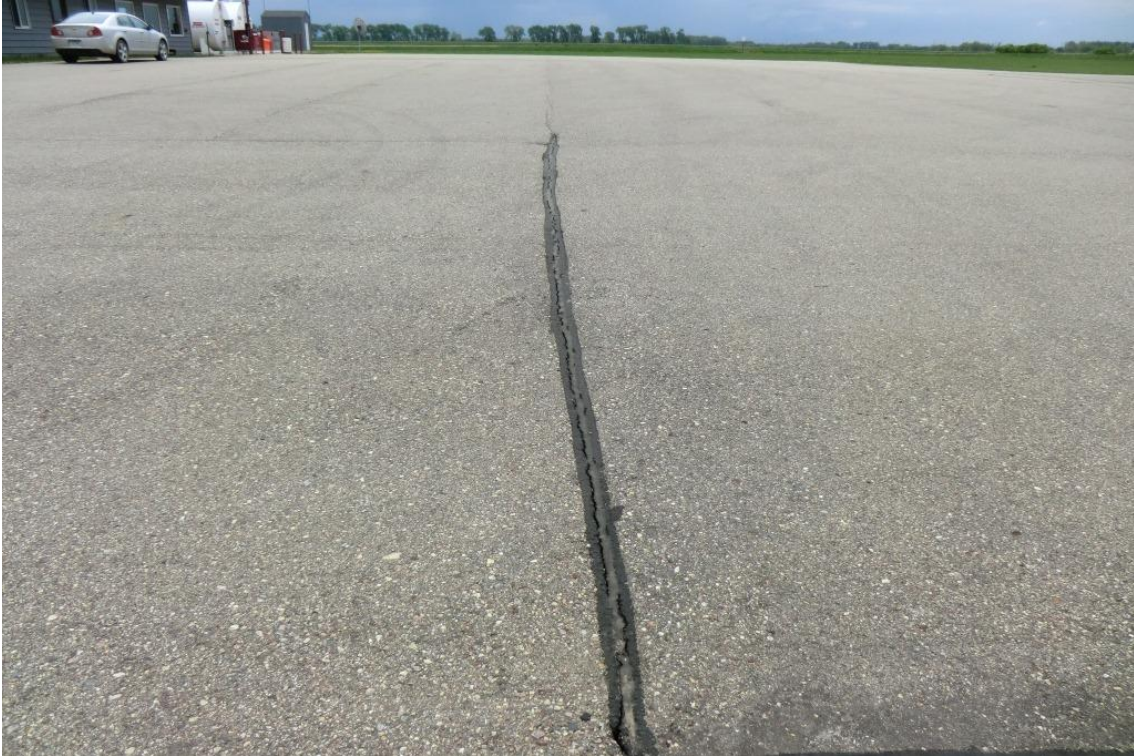
CNB APA 001 (PCI = 84)

Conditions: PCI : 84

48 LONGITUDINAL/TRANSVERSE CRACKING L 137.00 Ft Comments:

48 LONGITUDINAL/TRANSVERSE CRACKING L 295.00 Ft Comments:

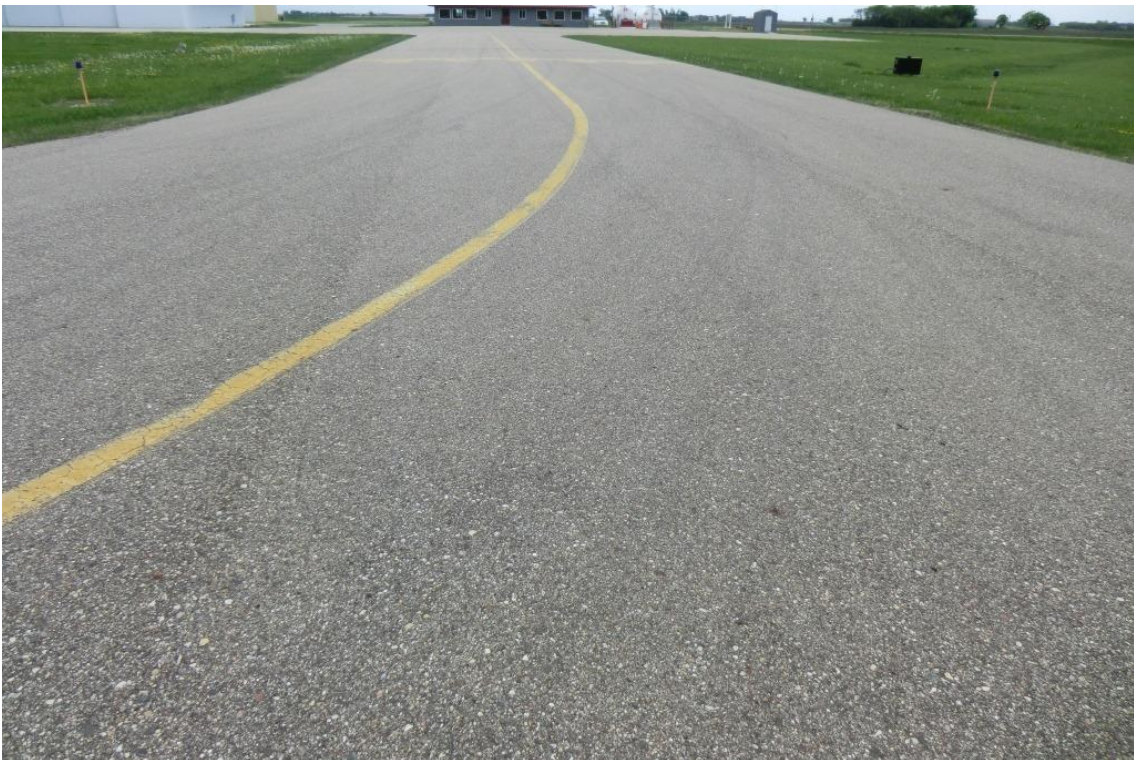
CNB CTA 001 (PCI = 87)

Conditions: PCI : 87

48 LONGITUDINAL/TRANSVERSE CRACKING L 15.00 Ft Comments:

48 LONGITUDINAL/TRANSVERSE CRACKING M 25.00 Ft Comments:

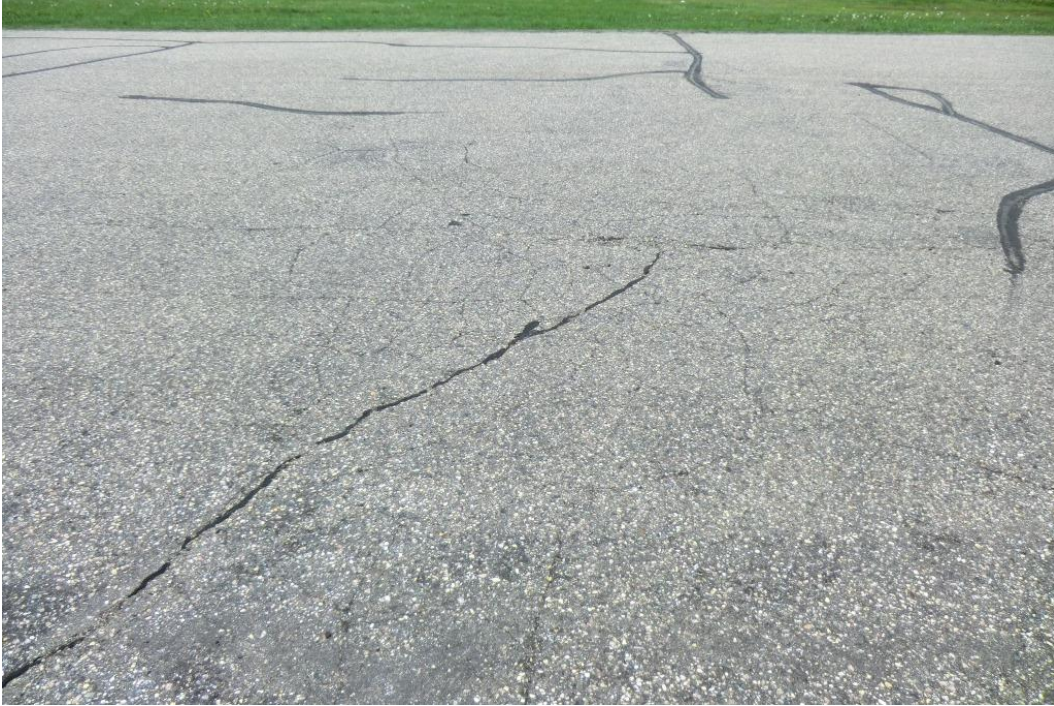
CNB CTB 002 (PCI = 30)

Conditions: PCI : 30

41 ALLIGATOR CRACKING	M	330.00 SqFt	Comments:
48 LONGITUDINAL/TRANSVERSE CRACKING	L	230.00 Ft	Comments:
57 WEATHERING	M	500.00 SqFt	Comments:

41 ALLIGATOR CRACKING	M	70.00 SqFt	Comments:
41 ALLIGATOR CRACKING	H	80.00 SqFt	Comments:
48 LONGITUDINAL/TRANSVERSE CRACKING	L	414.00 Ft	Comments:
48 LONGITUDINAL/TRANSVERSE CRACKING	M	17.00 Ft	Comments:
53 RUTTING	L	8.00 SqFt	Comments:
57 WEATHERING	M	300.00 SqFt	Comments:

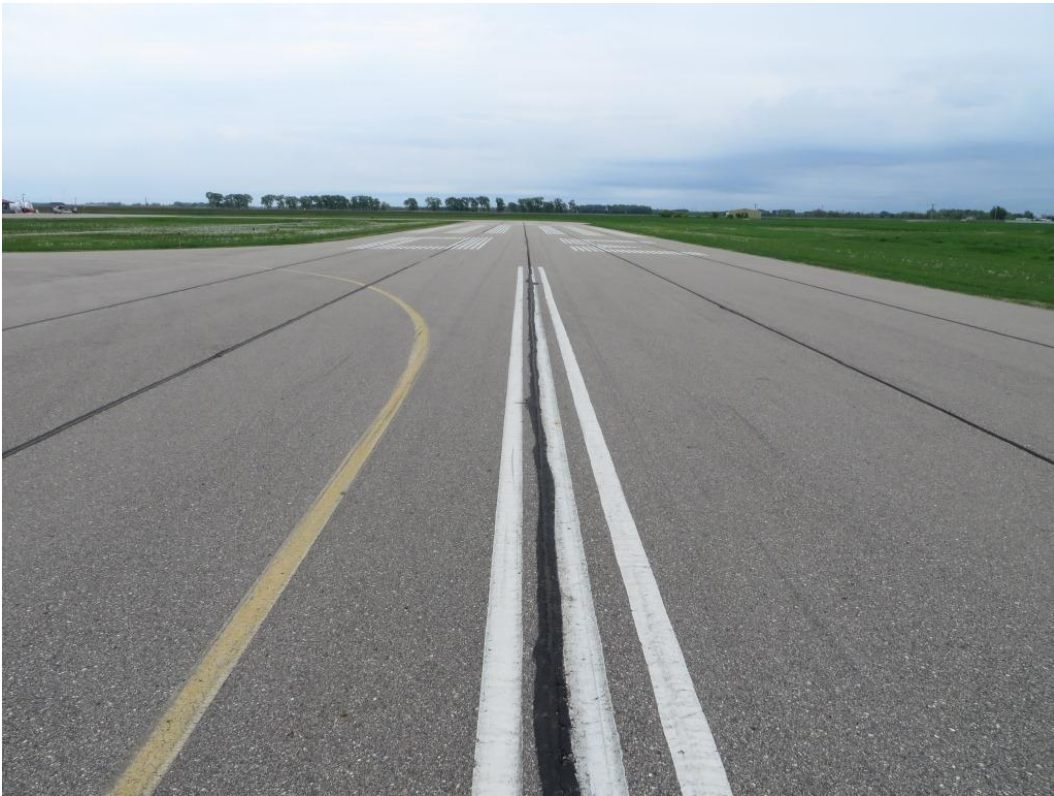
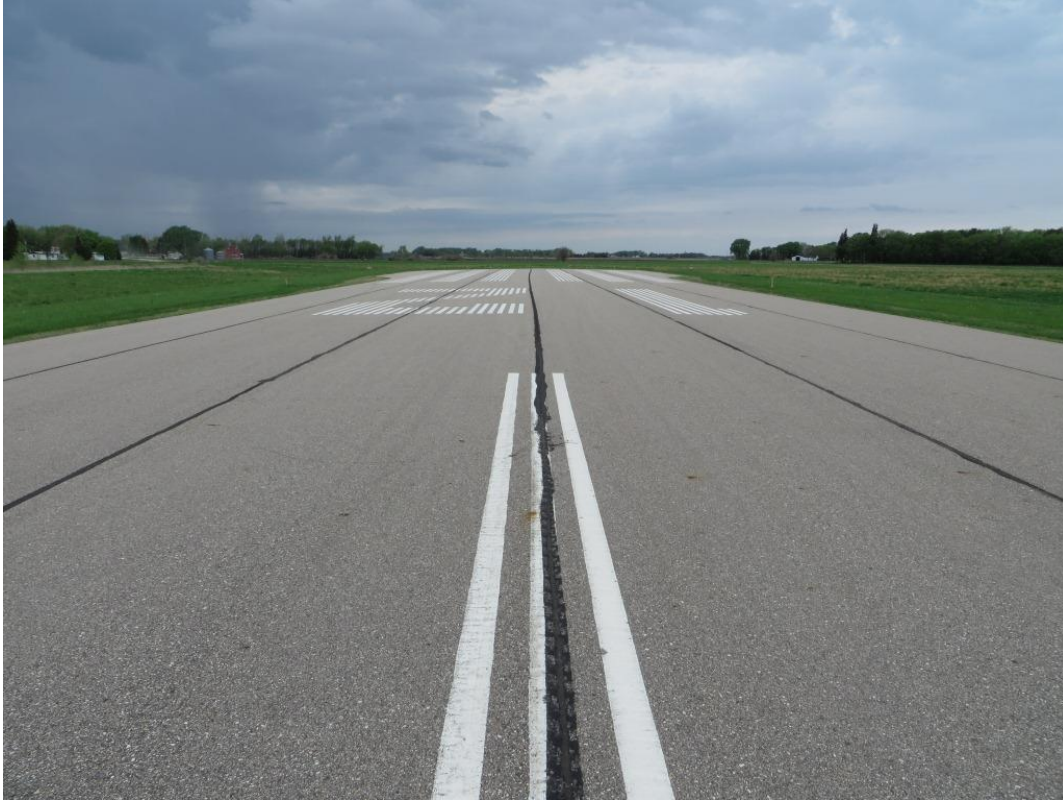
CNB RY1230 001 (PCI = 82)

Conditions: PCI : 82

48 LONGITUDINAL/TRANSVERSE CRACKING L 240.00 Ft Comments:

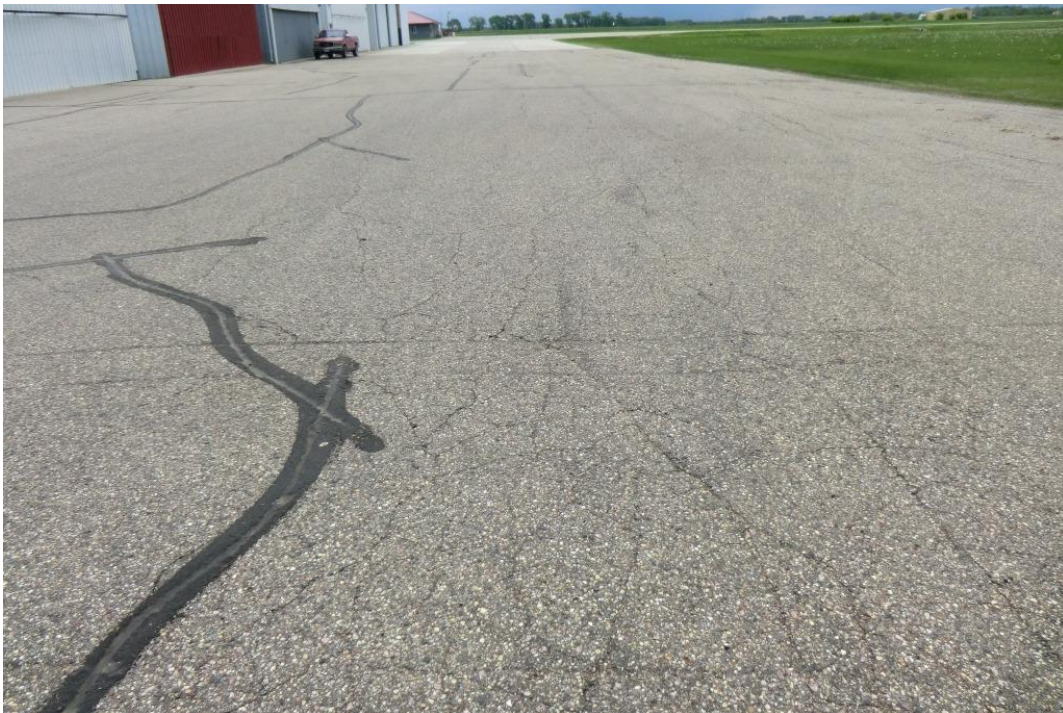
CNB TLA 001 (PCI = 18)

Conditions: PCI: 18

43 BLOCK CRACKING H 500.00 SqFt Comments:

41 ALLIGATOR CRACKING M 500.00 SqFt Comments:

41 ALLIGATOR CRACKING M 800.00 SqFt Comments:

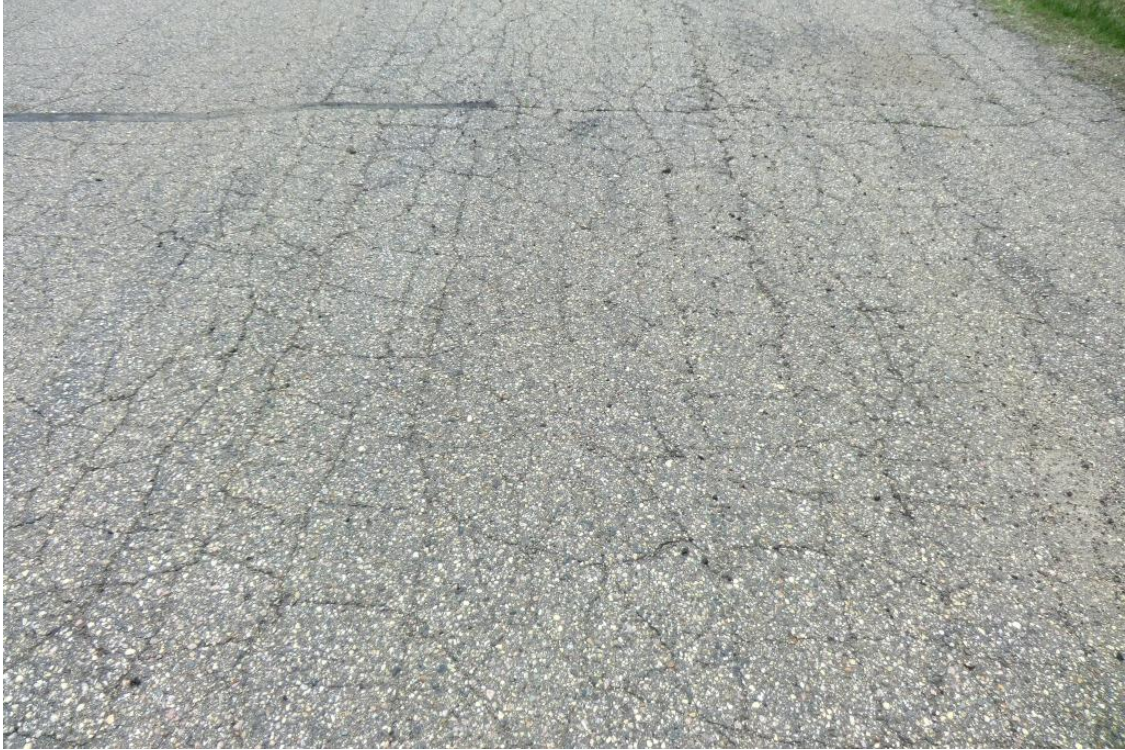
CNB TLA 001 (Alligator Cracking)

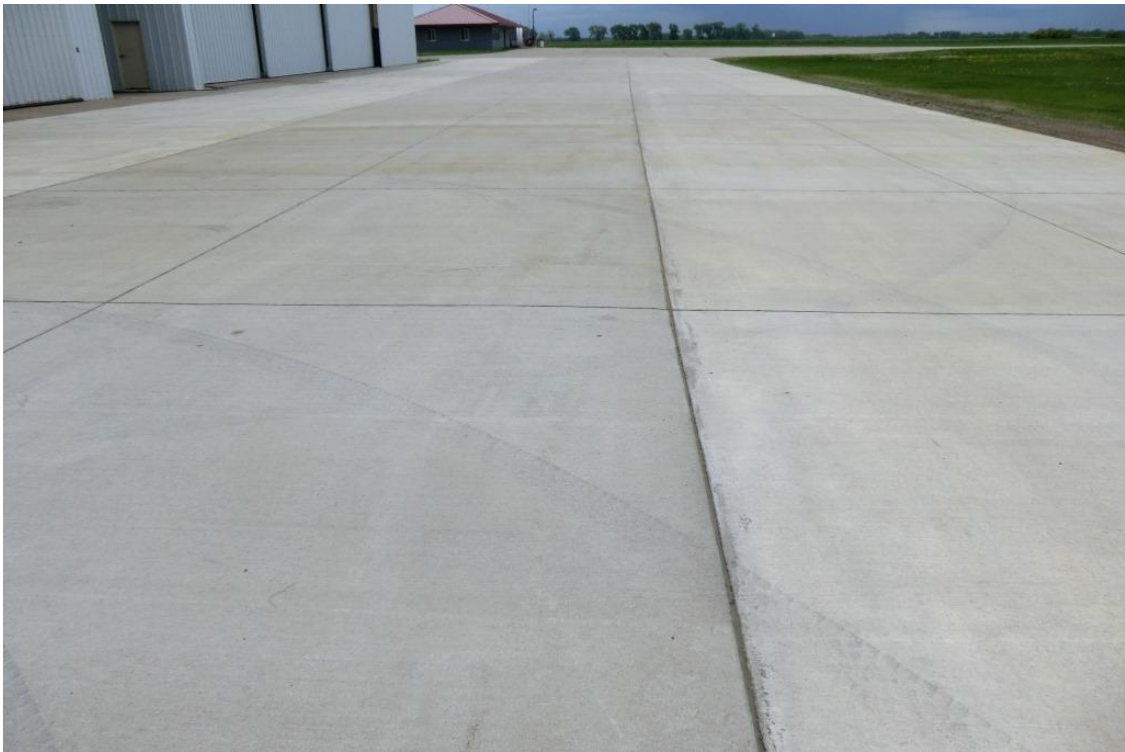
CNB TLA 002 (PCI = 95)

Conditions: PCI : 95

Sample Comments:
62 CORNER BREAK L 1.00 Slabs Comments:
63 LINEAR CRACKING L 3.00 Slabs Comments:

Sample Comments:
75 CORNER SPALLING L 1.00 Slabs Comments:

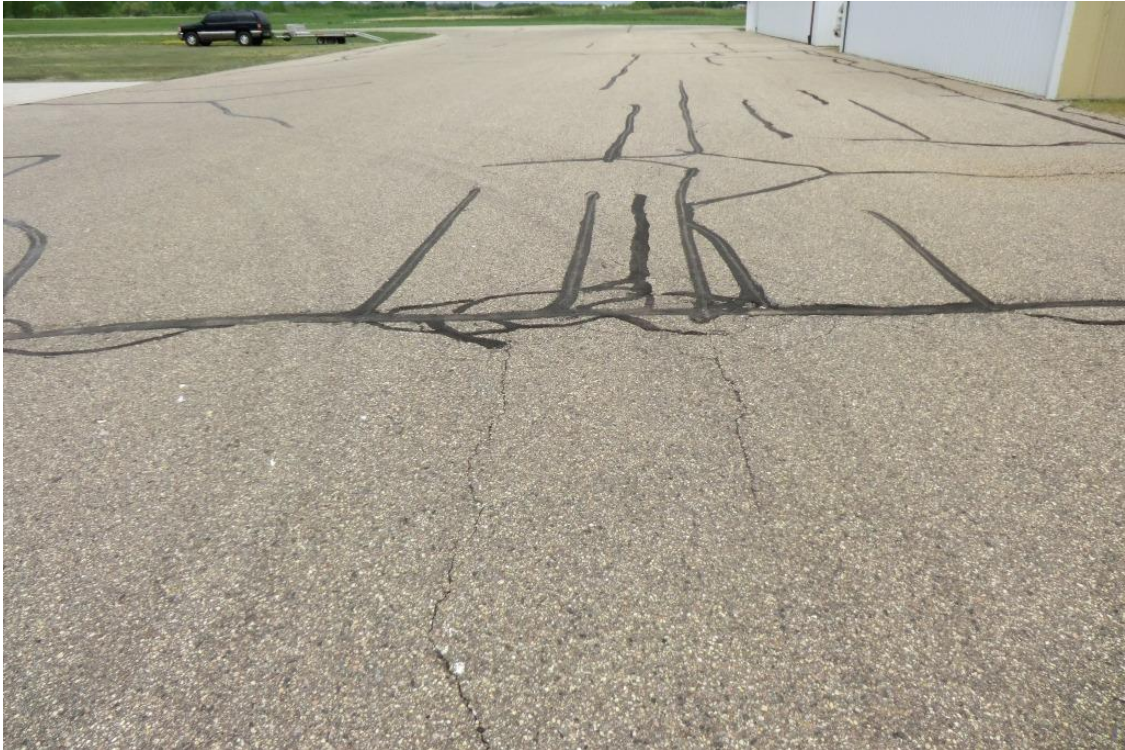
CNB TLB 001 (PCI = 61)

Conditions: PCI: 61

48 LONGITUDINAL/TRANSVERSE CRACKING L 400.00 Ft Comments:

41 ALLIGATOR CRACKING M 16.00 SqFt Comments:

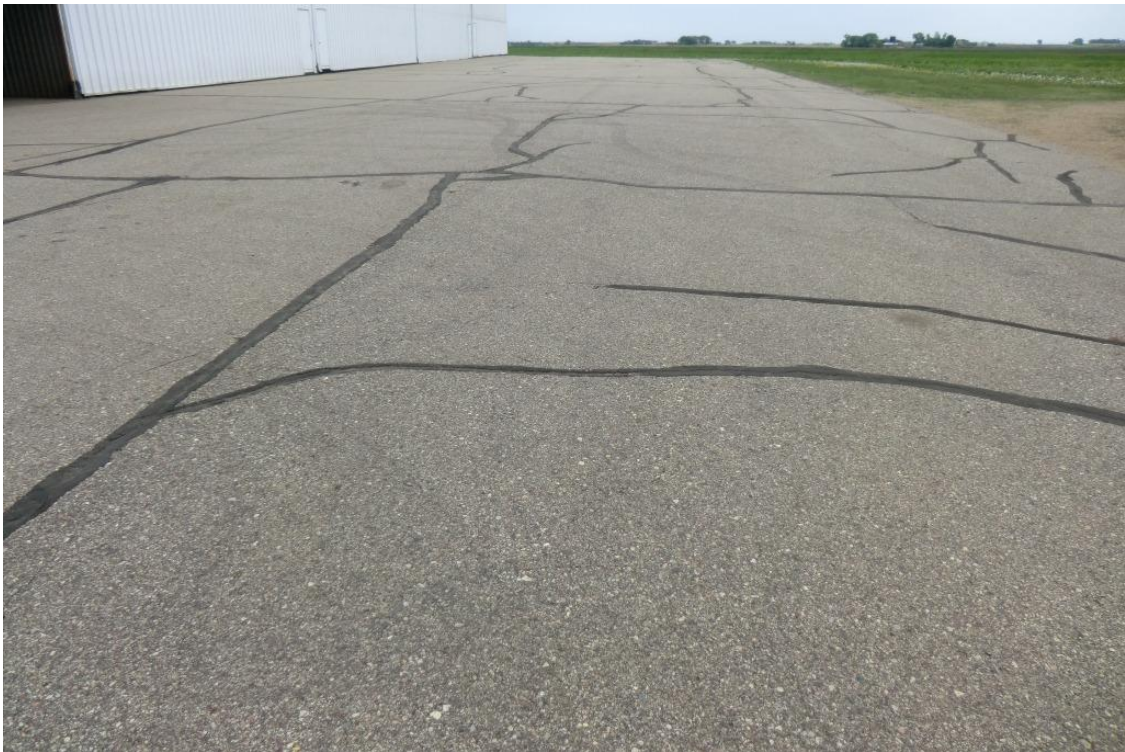
CNB TLC 001 (PCI = 65)

Conditions: PCI: 65

41 ALLIGATOR CRACKING	M	24.00 SqFt	Comments:
48 LONGITUDINAL/TRANSVERSE CRACKING	L	496.00 Ft	Comments:
48 LONGITUDINAL/TRANSVERSE CRACKING	M	20.00 Ft	Comments:
50 PATCHING	L	91.00 SqFt	Comments:
