Final Report

Pavement Condition Report

Cloquet-Carlton County Airport (COQ)

December 2014

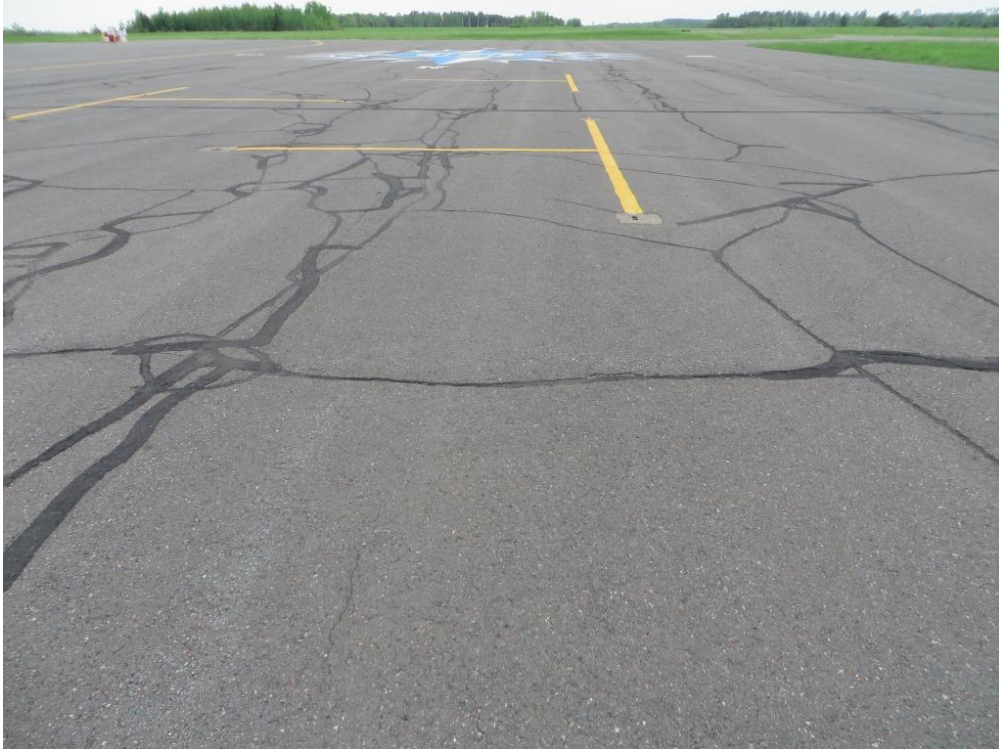
COQ APA 001 (PCI = 57)

Conditions: PCI : 57

41 ALLIGATOR CRACKING	L	60.00 SqFt	Comments:
48 LONGITUDINAL/TRANSVERSE CRACKING	L	850.00 Ft	Comments:
48 LONGITUDINAL/TRANSVERSE CRACKING	M	64.00 Ft	Comments:

41 ALLIGATOR CRACKING	L	63.00 SqFt	Comments:
41 ALLIGATOR CRACKING	M	120.00 SqFt	Comments:
48 LONGITUDINAL/TRANSVERSE CRACKING	L	750.00 Ft	Comments:
48 LONGITUDINAL/TRANSVERSE CRACKING	M	24.00 Ft	Comments:
43 BLOCK CRACKING	L	152.00 SqFt	Comments:

48 LONGITUDINAL/TRANSVERSE CRACKING	L	792.00 Ft	Comments:
48 LONGITUDINAL/TRANSVERSE CRACKING	M	35.00 Ft	Comments:

48 LONGITUDINAL/TRANSVERSE CRACKING	L	814.00 Ft	Comments:
48 LONGITUDINAL/TRANSVERSE CRACKING	M	23.00 Ft	Comments:

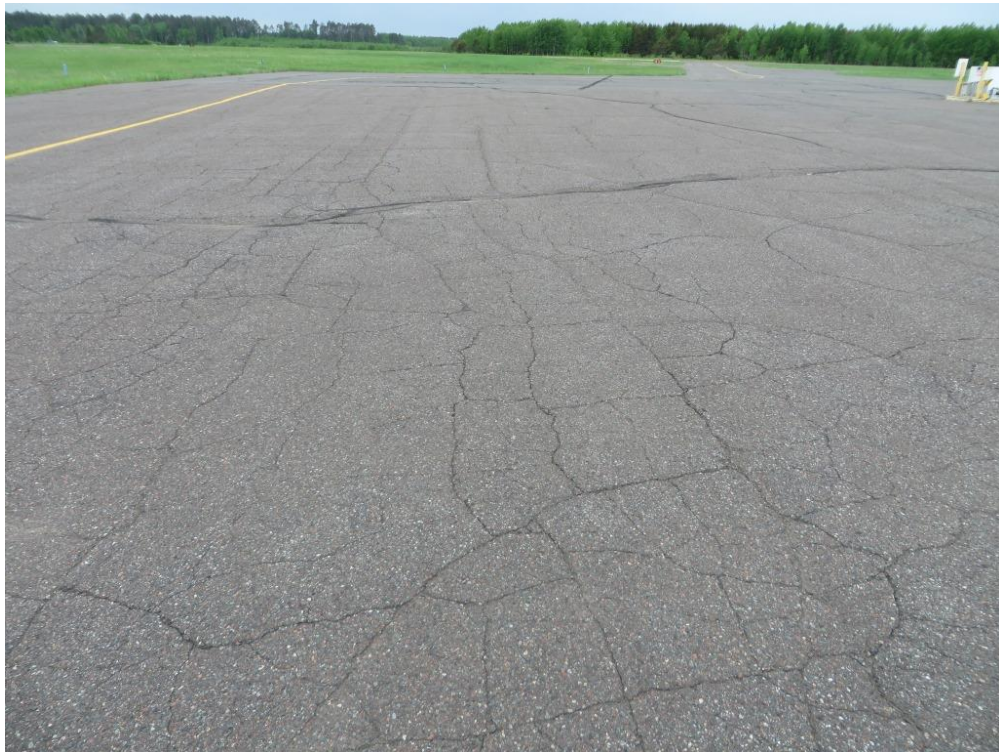
COQ APB 001 (PCI = 23)

Conditions: PCI : 23

41 ALLIGATOR CRACKING	M	500.00 SqFt	Comments:
43 BLOCK CRACKING	M	2,700.00 SqFt	Comments:
43 BLOCK CRACKING	H	1,800.00 SqFt	Comments:

41 ALLIGATOR CRACKING	M	150.00 SqFt	Comments:
43 BLOCK CRACKING	M	4,850.00 SqFt	Comments:

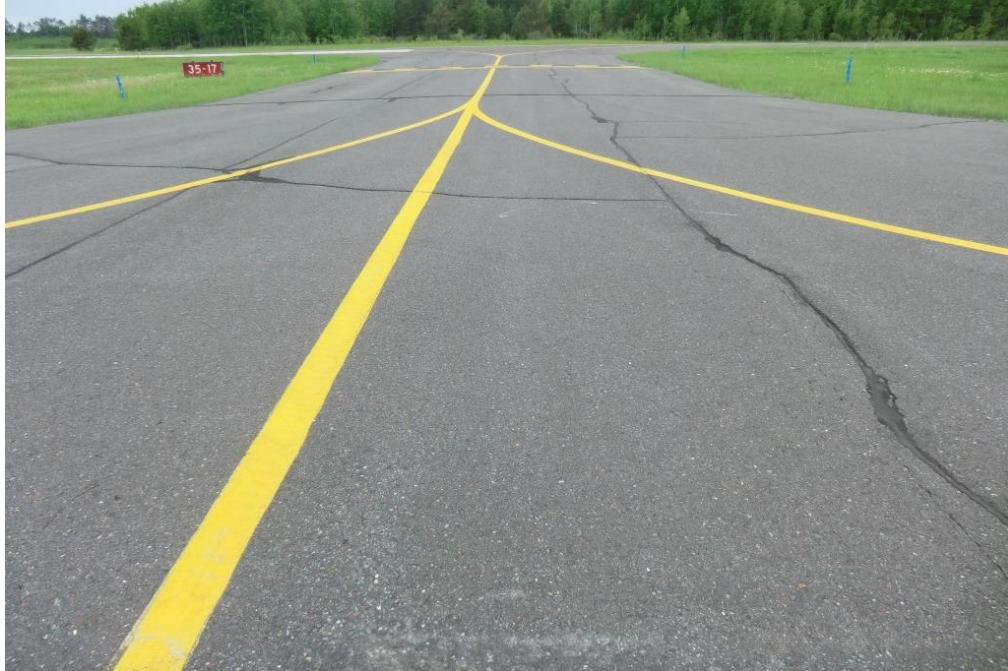
COQ CTA1 001 (PCI = 63)

Conditions: PCI: 63

48	LONGITUDINAL/TRANSVERSE CRACKING	L	725.00 Ft	Comments:
48	LONGITUDINAL/TRANSVERSE CRACKING	M	20.00 Ft	Comments:
56	SWELLING	L	35.00 SqFt	Comments:

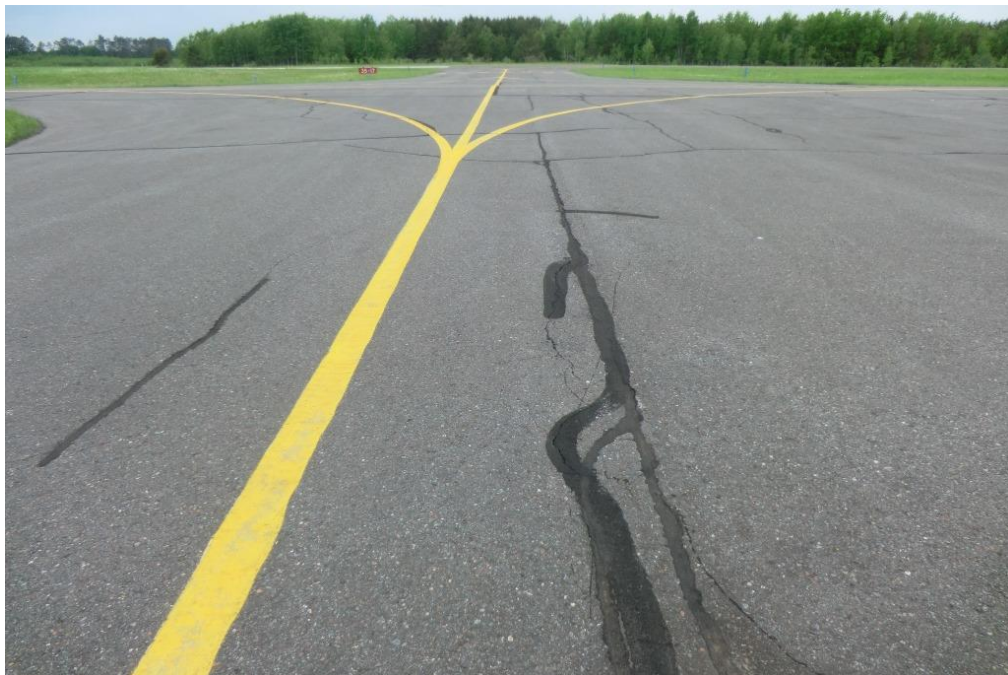
COQ CTA1X 001 (PCI = 65)

Conditions: PCI: 65

41 ALLIGATOR CRACKING	M	6.00 SqFt	Comments:
48 LONGITUDINAL/TRANSVERSE CRACKING	L	364.00 Ft	Comments:
48 LONGITUDINAL/TRANSVERSE CRACKING	M	20.00 Ft	Comments:

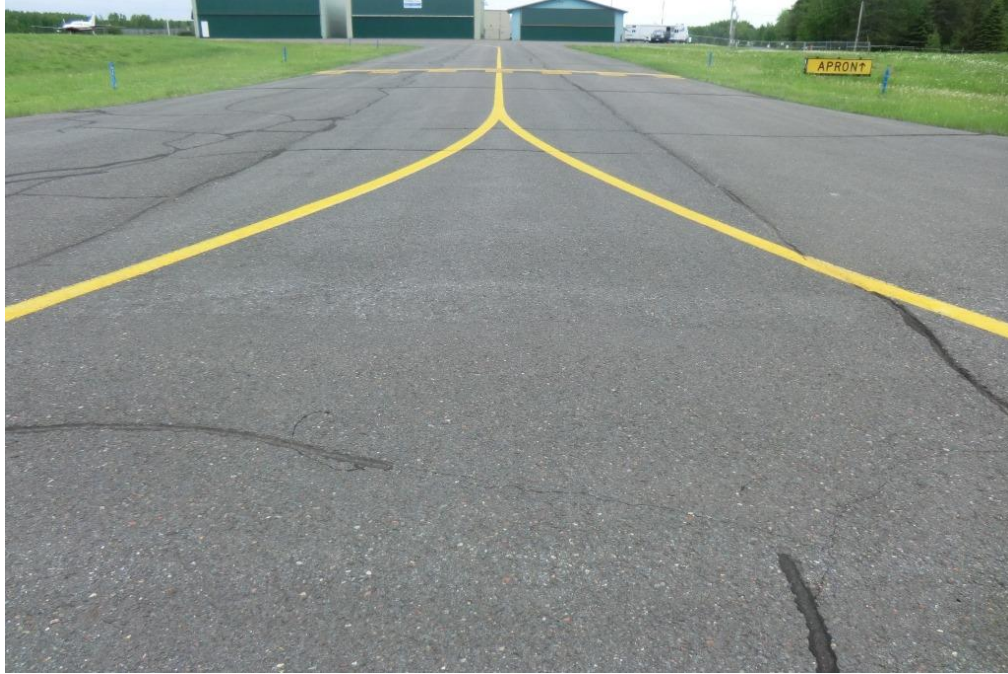
COQ CTB1 001 (PCI = 65)

Conditions: PCI : 65

41 ALLIGATOR CRACKING L 8.00 SqFt Comments:

48 LONGITUDINAL/TRANSVERSE CRACKING L 703.00 Ft Comments:

48 LONGITUDINAL/TRANSVERSE CRACKING M 12.00 Ft Comments:

48 LONGITUDINAL/TRANSVERSE CRACKING L 532.00 Ft Comments:

48 LONGITUDINAL/TRANSVERSE CRACKING M 4.00 Ft Comments:

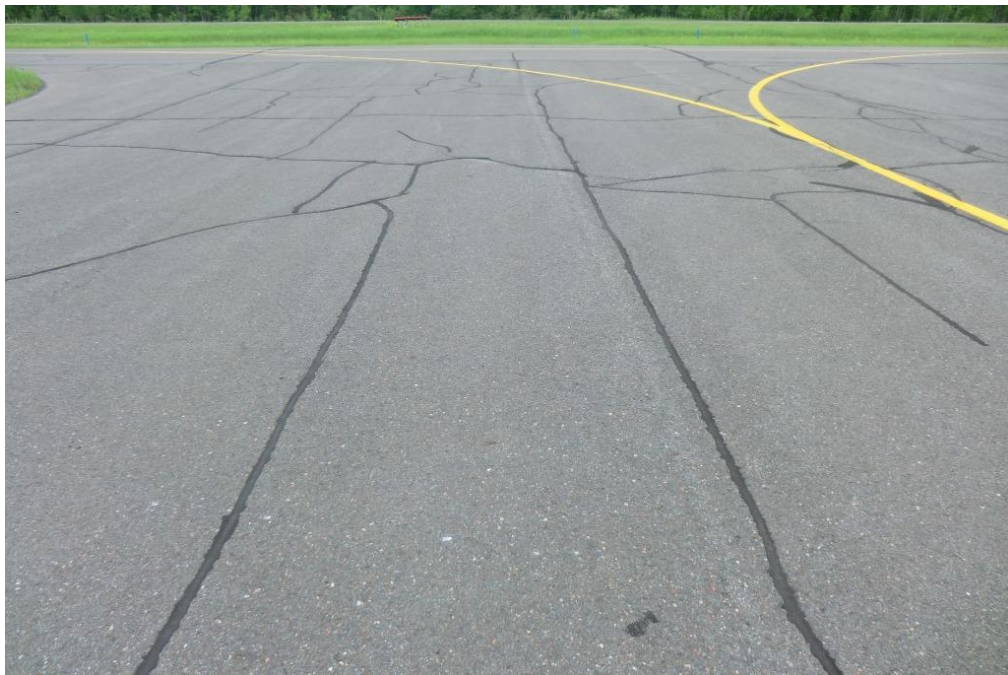
COQ CTC 001 (PCI = 58)

Conditions: PCI: 58

41 ALLIGATOR CRACKING	M	5.00 SqFt	Comments:
43 BLOCK CRACKING	L	560.00 SqFt	Comments:
48 LONGITUDINAL/TRANSVERSE CRACKING	L	422.00 Ft	Comments:
48 LONGITUDINAL/TRANSVERSE CRACKING	M	22.00 Ft	Comments:

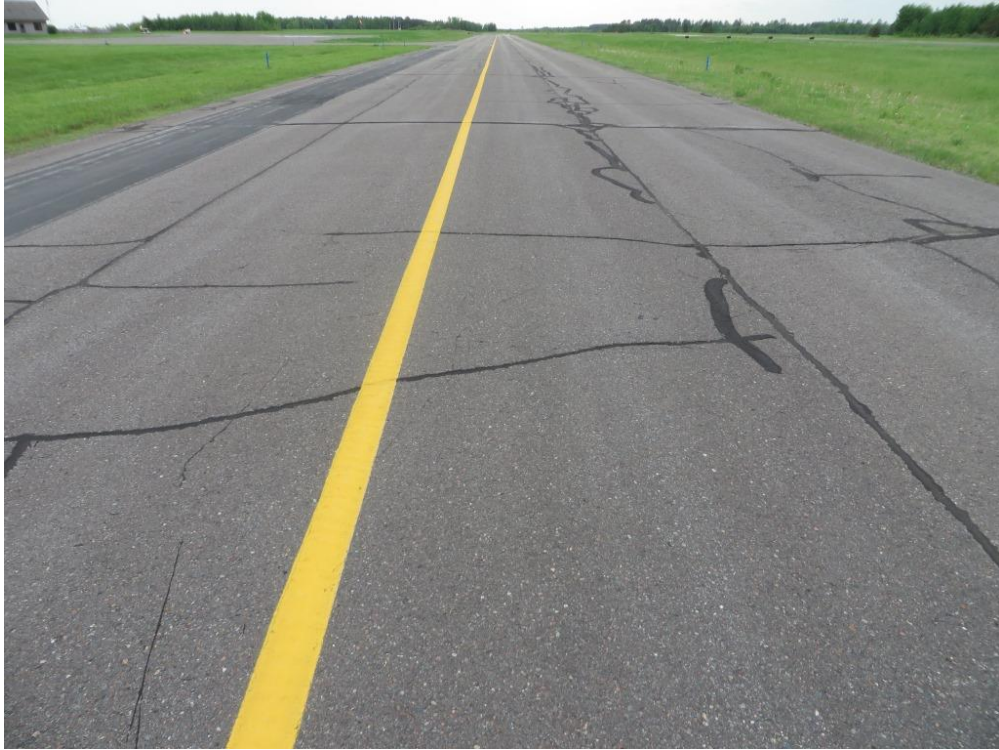
COQ PPTA 001 (PCI = 61)

Conditions: PCI: 61

41 ALLIGATOR CRACKING	L	26.00 SqFt	Comments:
48 LONGITUDINAL/TRANSVERSE CRACKING	L	470.00 Ft	Comments:
48 LONGITUDINAL/TRANSVERSE CRACKING	M	24.00 Ft	Comments:

41 ALLIGATOR CRACKING	L	6.00 SqFt	Comments:
45 DEPRESSION	L	8.00 SqFt	Comments:
48 LONGITUDINAL/TRANSVERSE CRACKING	L	488.00 Ft	Comments:
48 LONGITUDINAL/TRANSVERSE CRACKING	M	14.00 Ft	Comments:

41 ALLIGATOR CRACKING	L	20.00 SqFt	Comments:
45 DEPRESSION	L	12.00 SqFt	Comments:
48 LONGITUDINAL/TRANSVERSE CRACKING	L	486.00 Ft	Comments:
48 LONGITUDINAL/TRANSVERSE CRACKING	M	42.00 Ft	Comments:

41 ALLIGATOR CRACKING	L	50.00 SqFt	Comments:
48 LONGITUDINAL/TRANSVERSE CRACKING	L	613.00 Ft	Comments:
48 LONGITUDINAL/TRANSVERSE CRACKING	M	33.00 Ft	Comments:
53 RUTTING	L	150.00 SqFt	Comments:
