Pavement Condition Report

Sauk Centre Municipal Airport (D39)

December 2014

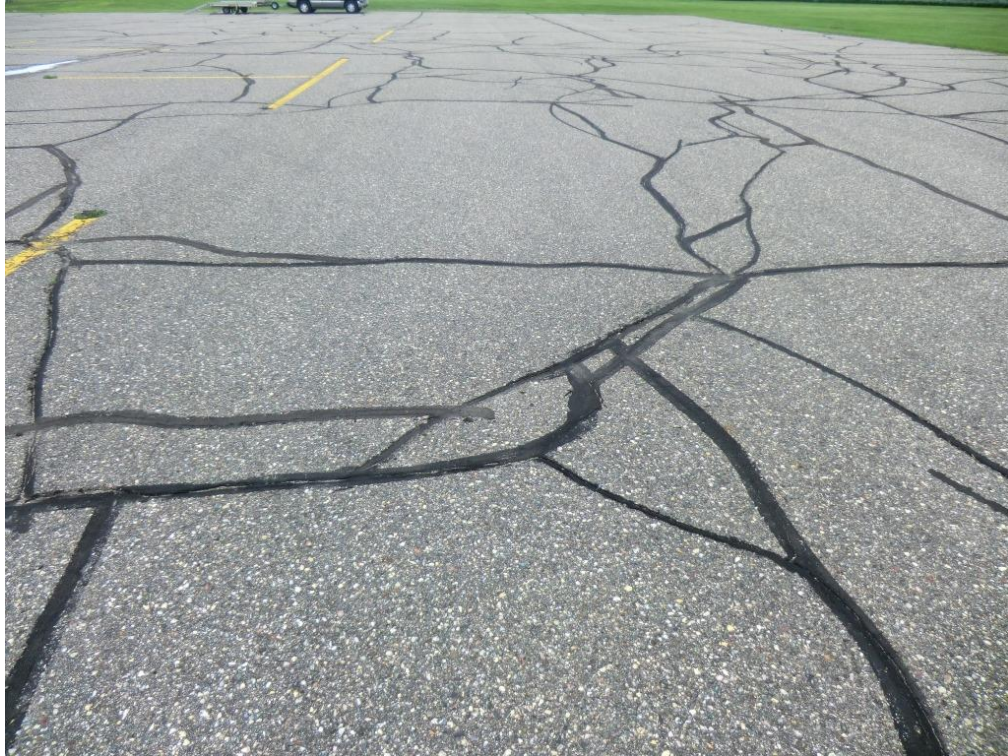
D39 APA 001 (PCI = 54)

Conditions: PCI : 54

41 ALLIGATOR CRACKING	M	10.00 SqFt	Comments:
43 BLOCK CRACKING	L	2,800.00 SqFt	Comments:
48 LONGITUDINAL/TRANSVERSE CRACKING	L	281.00 Ft	Comments:
48 LONGITUDINAL/TRANSVERSE CRACKING	M	34.00 Ft	Comments:
50 PATCHING	L	33.00 SqFt	Comments:
57 WEATHERING	M	5,000.00 SqFt	Comments:

43 BLOCK CRACKING	L	1,225.00 SqFt	Comments:
48 LONGITUDINAL/TRANSVERSE CRACKING	L	256.00 Ft	Comments:
48 LONGITUDINAL/TRANSVERSE CRACKING	M	25.00 Ft	Comments:
57 WEATHERING	M	4,000.00 SqFt	Comments:
57 WEATHERING	H	150.00 SqFt	Comments:

48 LONGITUDINAL/TRANSVERSE CRACKING	L	594.00 Ft	Comments:
48 LONGITUDINAL/TRANSVERSE CRACKING	M	21.00 Ft	Comments:
57 WEATHERING	M	4,700.00 SqFt	Comments:
57 WEATHERING	H	300.00 SqFt	Comments:

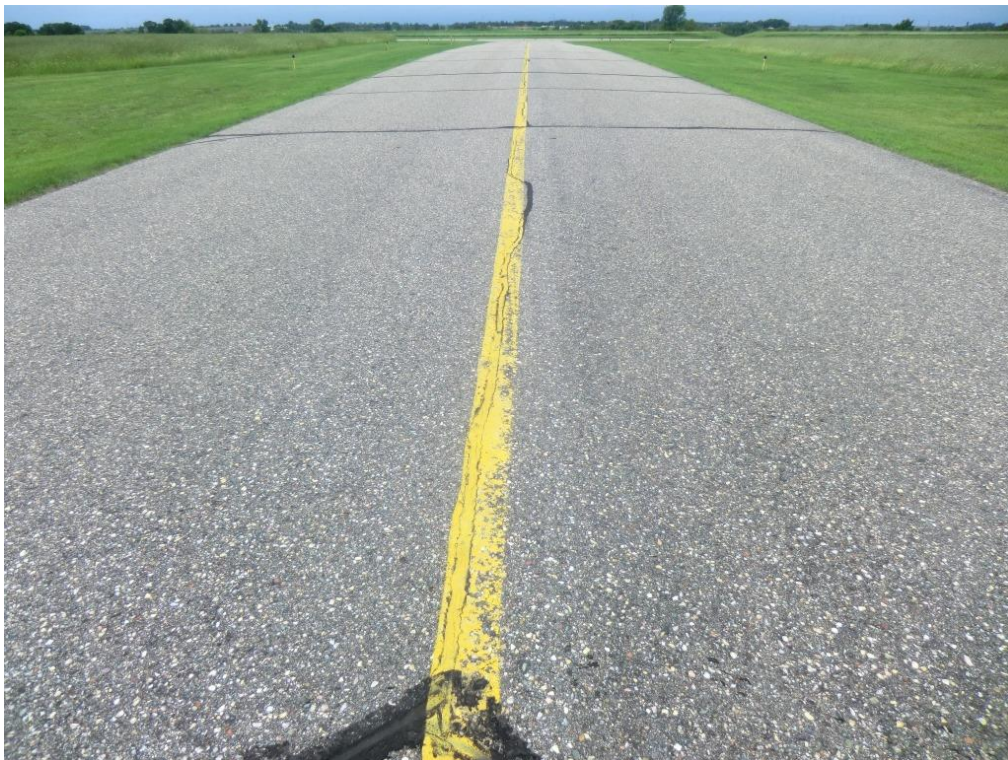
D39 CTA 001 (PCI = 64)

Conditions: PCI: 64

48 LONGITUDINAL/TRANSVERSE CRACKING L 198.00 Ft Comments:

48 LONGITUDINAL/TRANSVERSE CRACKING M 19.00 Ft Comments:

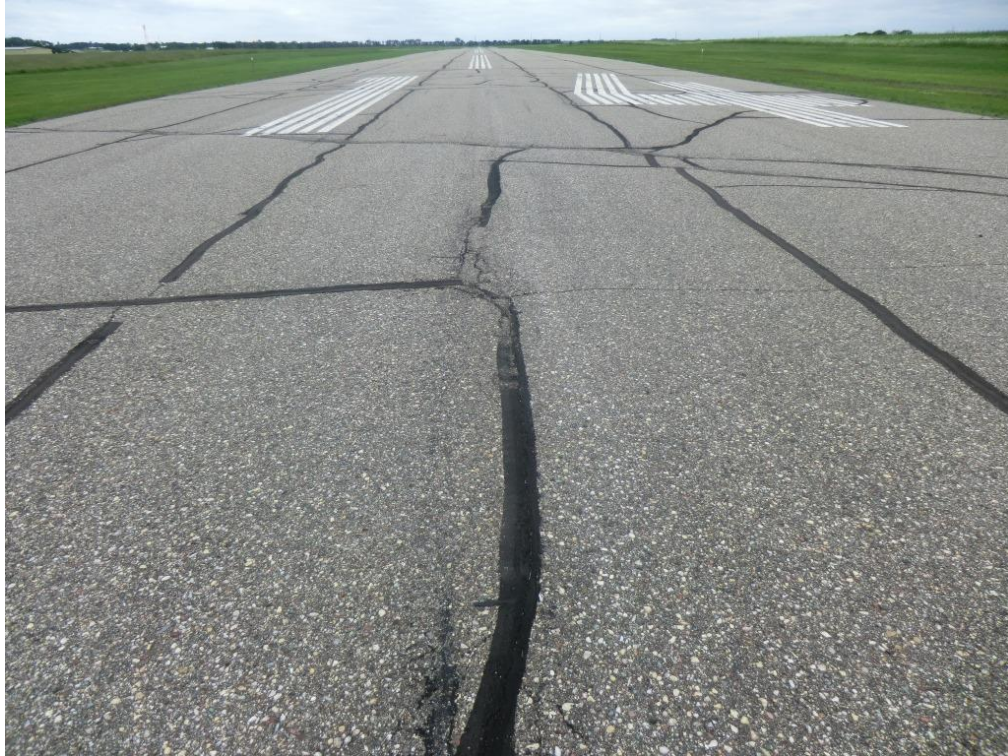
D39 RY1432 001 (PCI=60)

Conditions: PCI: 60

48 LONGITUDINAL/TRANSVERSE CRACKING L 486.00 Ft Comments:
48 LONGITUDINAL/TRANSVERSE CRACKING M 74.00 Ft Comments:
57 WEATHERING M 3,000.00 SqFt Comments:

48 LONGITUDINAL/TRANSVERSE CRACKING L 228.00 Ft Comments:
48 LONGITUDINAL/TRANSVERSE CRACKING M 75.00 Ft Comments:
57 WEATHERING M 3,000.00 SqFt Comments:

48 LONGITUDINAL/TRANSVERSE CRACKING L 260.00 Ft Comments:
48 LONGITUDINAL/TRANSVERSE CRACKING M 83.00 Ft Comments:
48 LONGITUDINAL/TRANSVERSE CRACKING H 55.00 Ft Comments:
57 WEATHERING M 3,000.00 SqFt Comments:

48 LONGITUDINAL/TRANSVERSE CRACKING L 200.00 Ft Comments:
48 LONGITUDINAL/TRANSVERSE CRACKING M 77.00 Ft Comments:
48 LONGITUDINAL/TRANSVERSE CRACKING H 45.00 Ft Comments:
57 WEATHERING M 3,000.00 SqFt Comments:

48 LONGITUDINAL/TRANSVERSE CRACKING L 200.00 Ft Comments:
48 LONGITUDINAL/TRANSVERSE CRACKING M 88.00 Ft Comments:
48 LONGITUDINAL/TRANSVERSE CRACKING H 24.00 Ft Comments:
57 WEATHERING M 3,000.00 SqFt Comments:

48 LONGITUDINAL/TRANSVERSE CRACKING L 333.00 Ft Comments:
48 LONGITUDINAL/TRANSVERSE CRACKING M 37.00 Ft Comments:
48 LONGITUDINAL/TRANSVERSE CRACKING H 6.00 Ft Comments:
57 WEATHERING M 3,000.00 SqFt Comments:

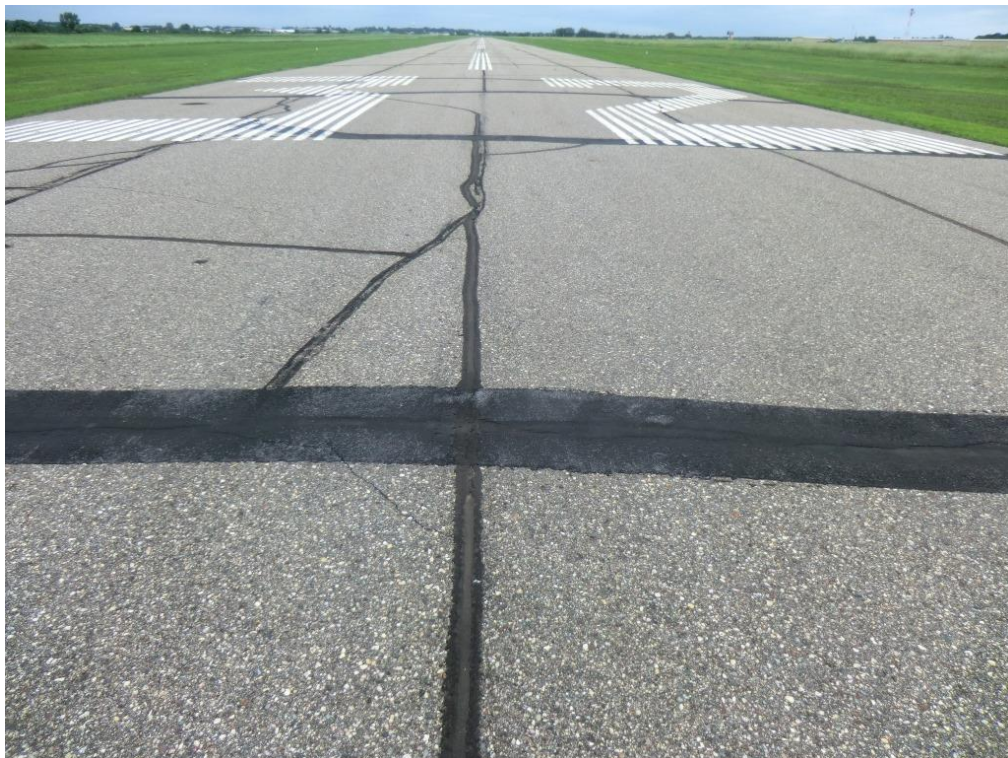
D39 RY1432 002 (PCI = 68)

Conditions: PCI: 68

48	LONGITUDINAL/TRANSVERSE CRACKING	L	197.00 Ft	Comments:
48	LONGITUDINAL/TRANSVERSE CRACKING	M	55.00 Ft	Comments:
57	WEATHERING	M	3,000.00 SqFt	Comments:

48	LONGITUDINAL/TRANSVERSE CRACKING	L	181.00 Ft	Comments:
48	LONGITUDINAL/TRANSVERSE CRACKING	M	86.00 Ft	Comments:
57	WEATHERING	L	3,000.00 SqFt	Comments:

48	LONGITUDINAL/TRANSVERSE CRACKING	L	144.00 Ft	Comments:
48	LONGITUDINAL/TRANSVERSE CRACKING	M	55.00 Ft	Comments:
48	LONGITUDINAL/TRANSVERSE CRACKING	H	27.00 Ft	Comments:
57	WEATHERING	M	3,000.00 SqFt	Comments:

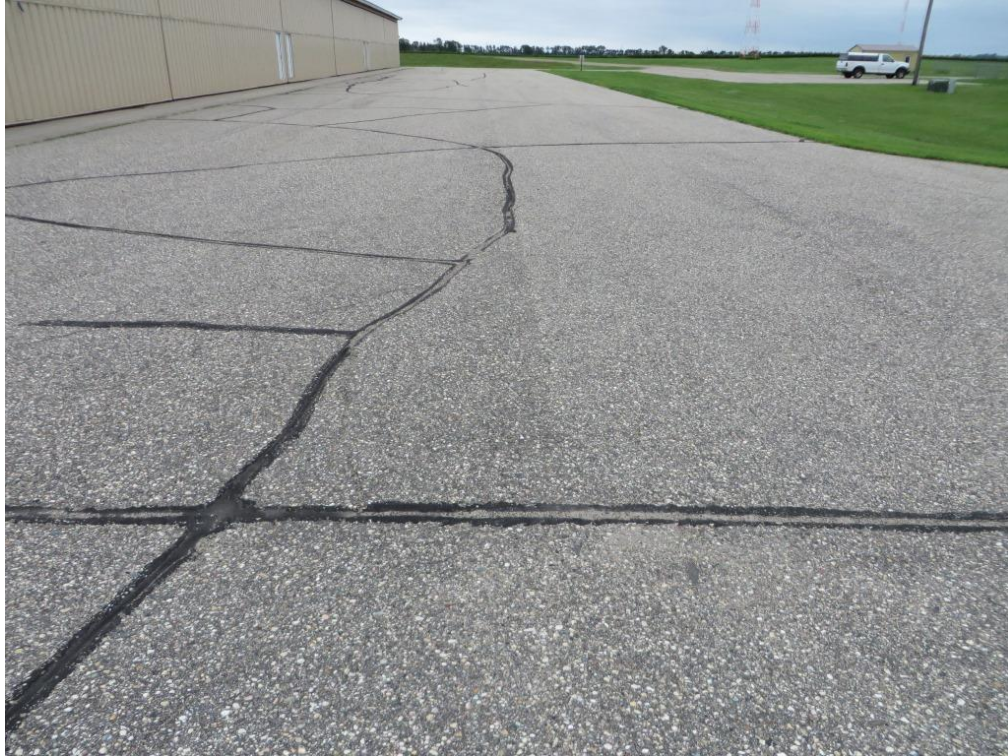
D39 TLA 001 (PCI = 59)

Conditions: PCI : 59

43 BLOCK CRACKING	L	1,000.00 SqFt	Comments:
48 LONGITUDINAL/TRANSVERSE CRACKING	L	252.00 Ft	Comments:
48 LONGITUDINAL/TRANSVERSE CRACKING	M	40.00 Ft	Comments:
57 WEATHERING	M	4,100.00 SqFt	Comments:
57 WEATHERING	H	100.00 SqFt	Comments:

43 BLOCK CRACKING	L	990.00 SqFt	Comments:
48 LONGITUDINAL/TRANSVERSE CRACKING	L	324.00 Ft	Comments:
57 WEATHERING	M	4,200.00 SqFt	Comments:

48 LONGITUDINAL/TRANSVERSE CRACKING	L	432.00 Ft	Comments:
57 WEATHERING	M	2,200.00 SqFt	Comments:

48 LONGITUDINAL/TRANSVERSE CRACKING	L	650.00 Ft	Comments:
48 LONGITUDINAL/TRANSVERSE CRACKING	M	2.00 Ft	Comments:
57 WEATHERING	M	2,200.00 SqFt	Comments:

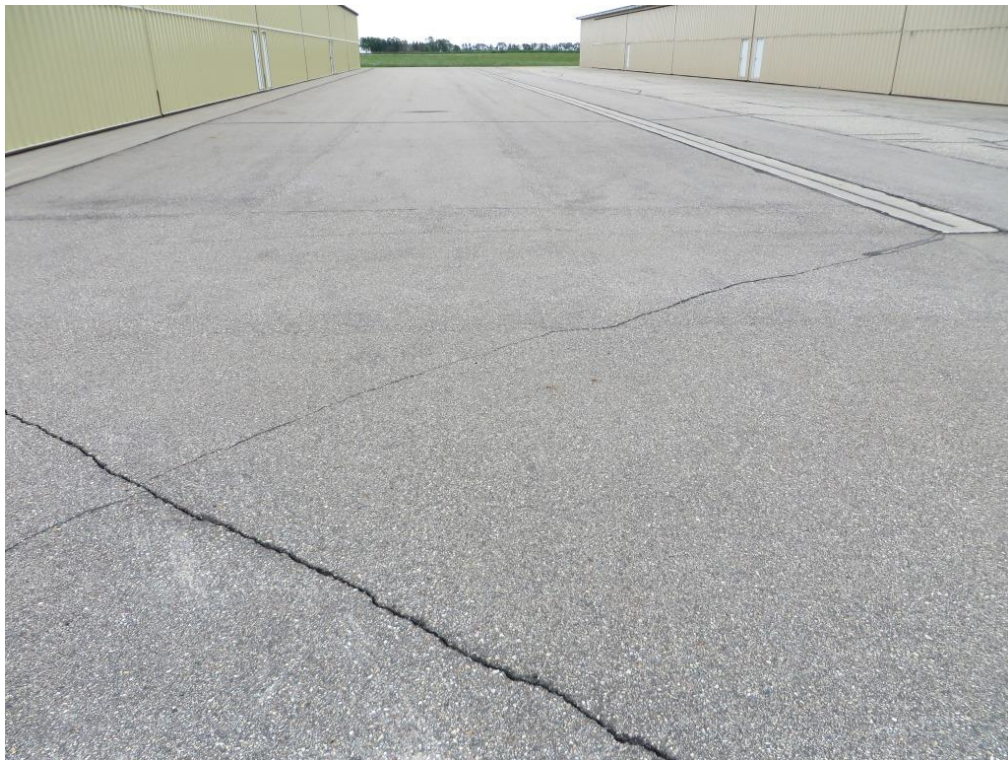
D39 TLA 002 (PCI = 79)

Conditions: PCI: 79

48 LONGITUDINAL/TRANSVERSE CRACKING L 48.00 Ft Comments:
