Final Report

Pavement Condition Report

Detroit Lakes Airport (DTL)

December 2014

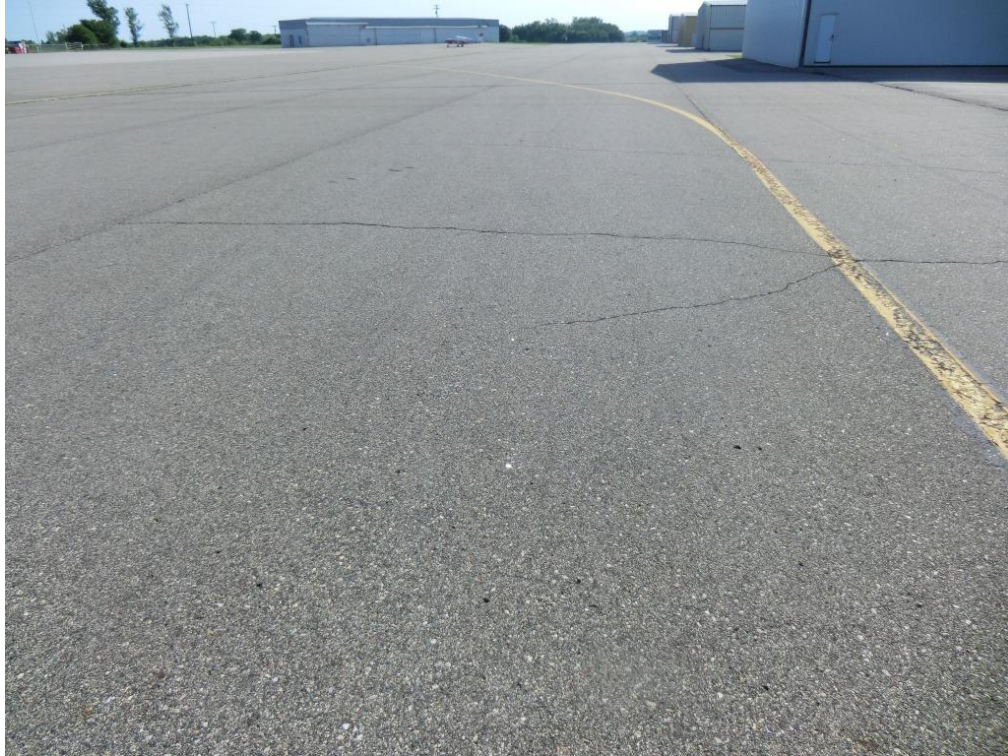
DTL APA 001 (PCI = 70)

48 LONGITUDINAL/TRANSVERSE CRACKING L 40.00 Ft Comments:
48 LONGITUDINAL/TRANSVERSE CRACKING M 224.00 Ft Comments:
48 LONGITUDINAL/TRANSVERSE CRACKING H 3.00 Ft Comments:

48 LONGITUDINAL/TRANSVERSE CRACKING L 12.00 Ft Comments:
48 LONGITUDINAL/TRANSVERSE CRACKING M 158.00 Ft Comments:
50 PATCHING L 450.00 SqFt Comments:

48 LONGITUDINAL/TRANSVERSE CRACKING M 162.00 Ft Comments:
48 LONGITUDINAL/TRANSVERSE CRACKING M 41.00 Ft Comments:

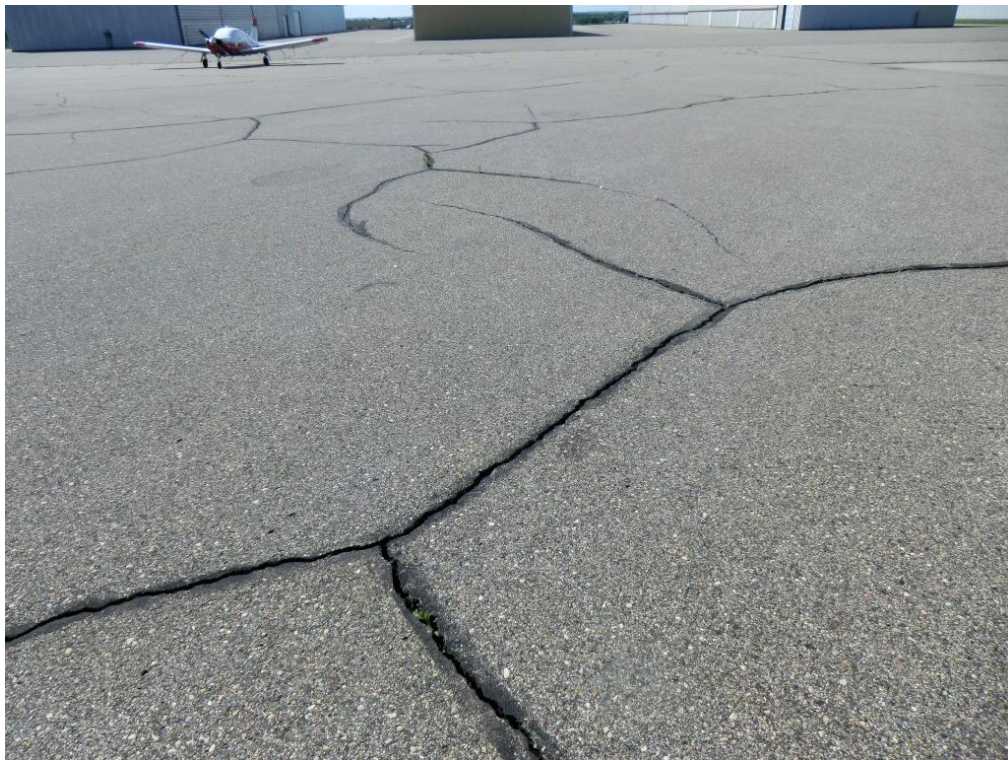
DTL APA 002 (PCI = 65)

48 LONGITUDINAL/TRANSVERSE CRACKING L 103.00 Ft Comments:
48 LONGITUDINAL/TRANSVERSE CRACKING M 317.00 Ft Comments:
48 LONGITUDINAL/TRANSVERSE CRACKING H 26.00 Ft Comments:

48 LONGITUDINAL/TRANSVERSE CRACKING L 37.00 Ft Comments:
48 LONGITUDINAL/TRANSVERSE CRACKING M 233.00 Ft Comments:

48 LONGITUDINAL/TRANSVERSE CRACKING L 42.00 Ft Comments:
48 LONGITUDINAL/TRANSVERSE CRACKING M 299.00 Ft Comments:

48 LONGITUDINAL/TRANSVERSE CRACKING L 126.00 Ft Comments:
48 LONGITUDINAL/TRANSVERSE CRACKING M 291.00 Ft Comments:

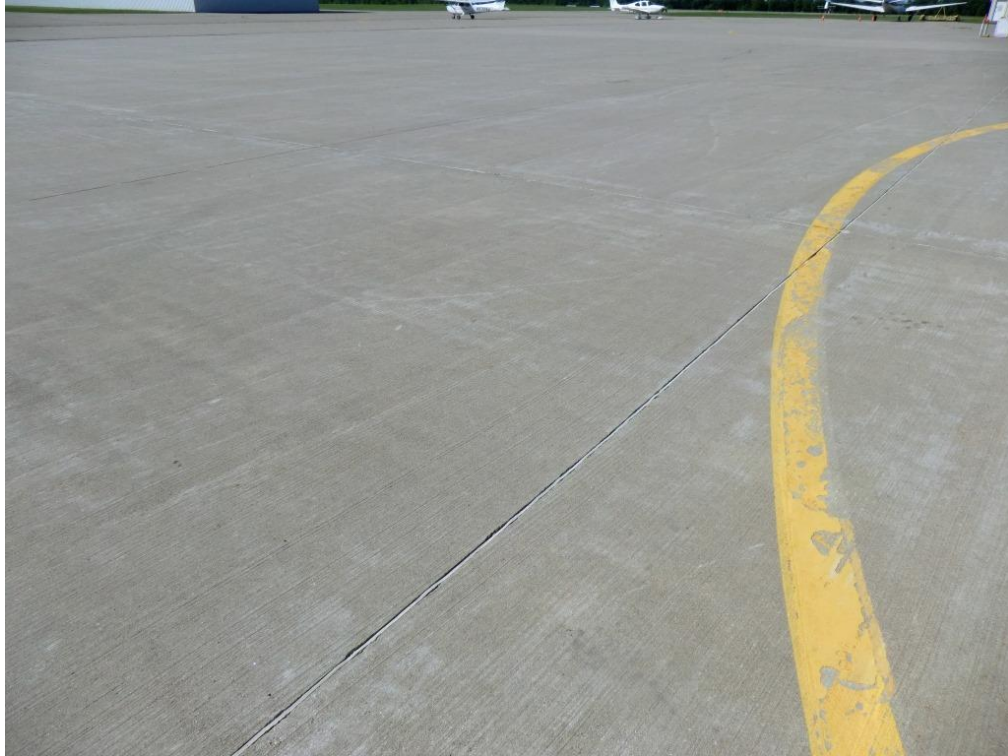
DTL APA 003 (PCI = 86)

Sample Number: 100 Type: R Area: 20.00Slabs PCI = 88
Sample Comments:
65 JOINT SEAL DAMAGE H 20.00 Slabs Comments:

Sample Number: 200 Type: R Area: 20.00Slabs PCI = 88
Sample Comments:
65 JOINT SEAL DAMAGE H 20.00 Slabs Comments:

Sample Number: 202 Type: R Area: 20.00Slabs PCI = 80
Sample Comments:
65 JOINT SEAL DAMAGE H 20.00 Slabs Comments:
74 JOINT SPALLING H 1.00 Slabs Comments:

Sample Number: 203 Type: R Area: 20.00Slabs PCI = 86
Sample Comments:
65 JOINT SEAL DAMAGE H 20.00 Slabs Comments:
75 CORNER SPALLING L 1.00 Slabs Comments:

Sample Number: 204 Type: R Area: 25.00Slabs PCI = 88
Sample Comments:
65 JOINT SEAL DAMAGE H 25.00 Slabs Comments:

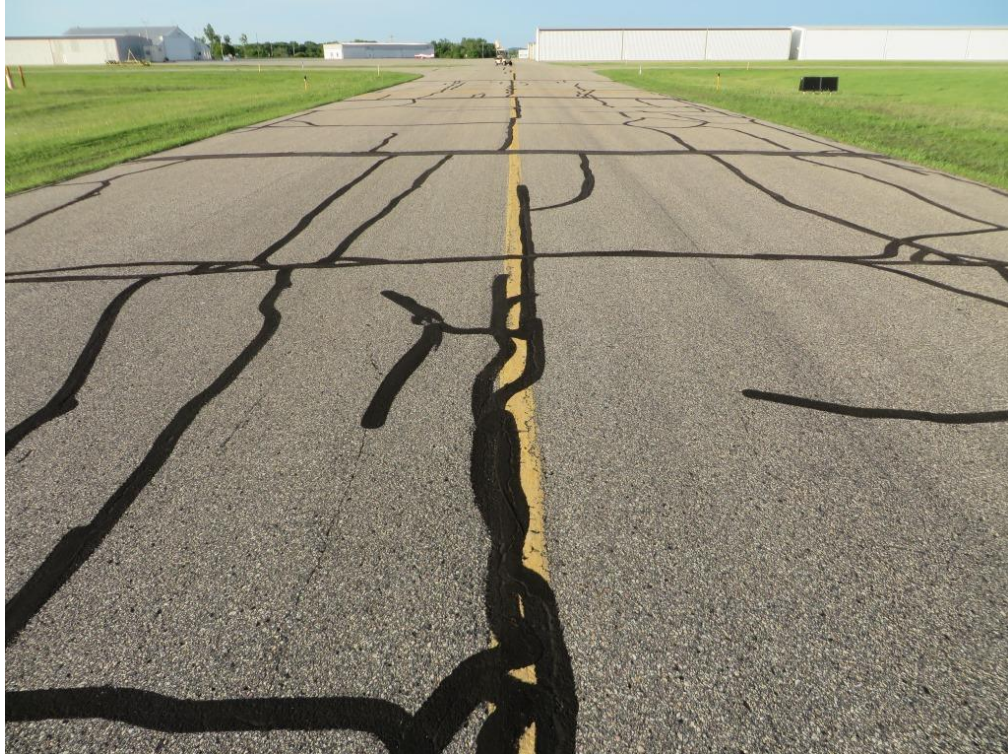
DTL CTA 001 (PCI = 51)

41 ALLIGATOR CRACKING	L	32.00 SqFt	Comments:
43 BLOCK CRACKING	L	350.00 SqFt	Comments:
48 LONGITUDINAL/TRANSVERSE CRACKING	L	604.00 Ft	Comments:
48 LONGITUDINAL/TRANSVERSE CRACKING	M	24.00 Ft	Comments:
57 WEATHERING	M	4,000.00 SqFt	Comments:

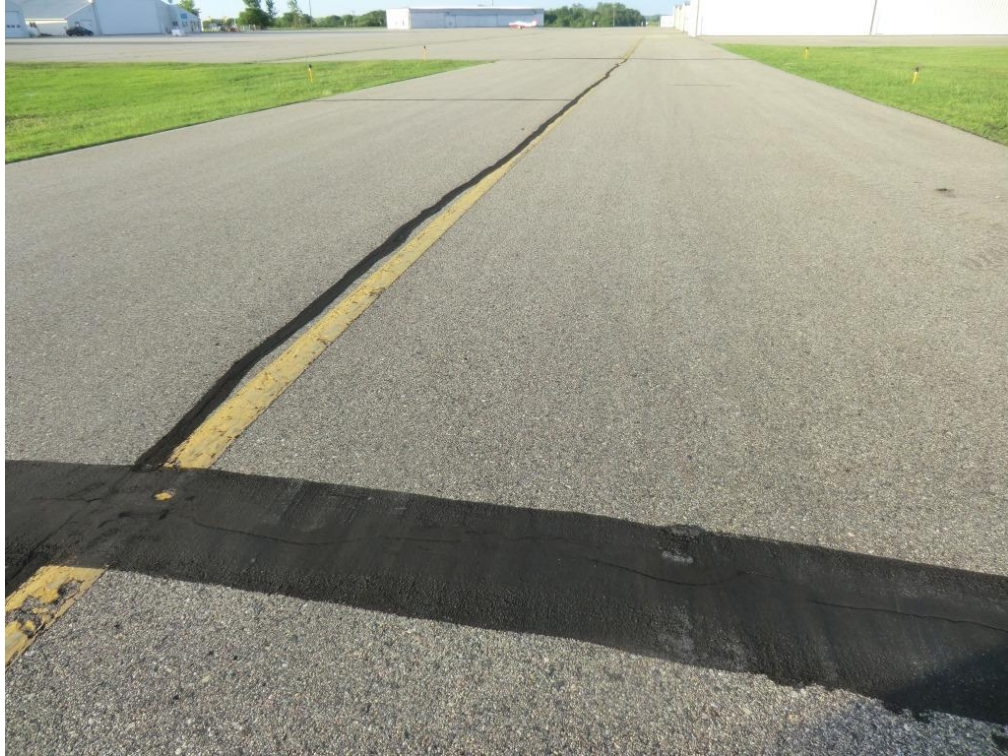
DTL CTA 002 (PCI = 85)

48 LONGITUDINAL/TRANSVERSE CRACKING L 204.00 Ft Comments:

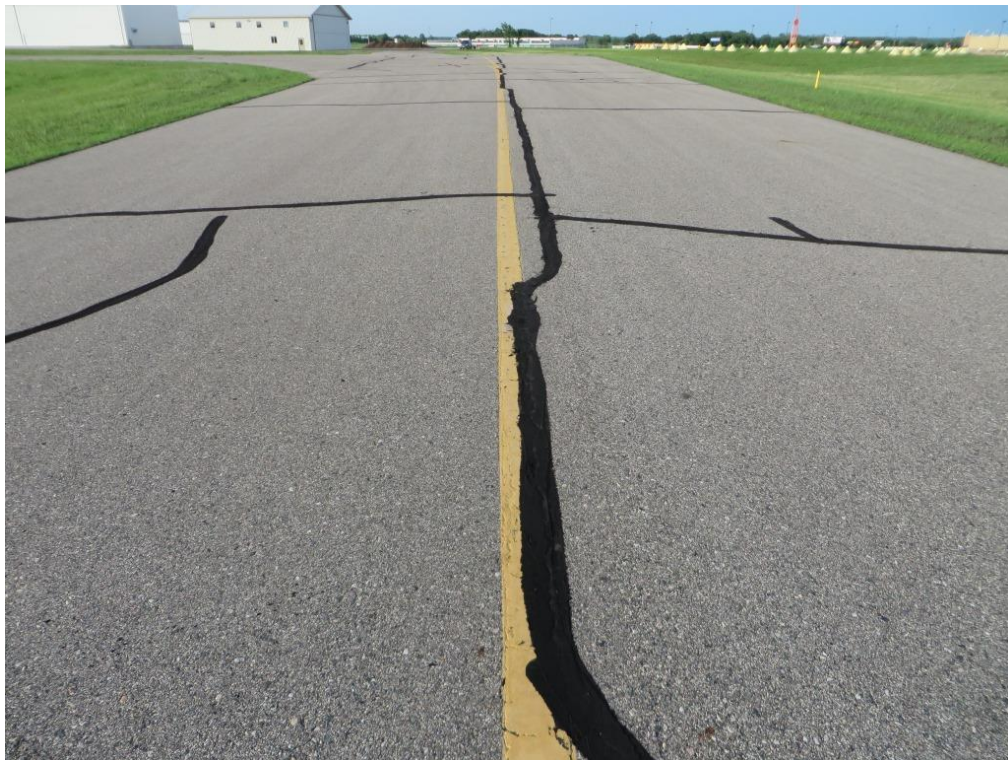
DTL CTB 001 (PCI = 74)

48 LONGITUDINAL/TRANSVERSE CRACKING L 325.00 Ft Comments:

48 LONGITUDINAL/TRANSVERSE CRACKING M 21.00 Ft Comments:

48 LONGITUDINAL/TRANSVERSE CRACKING L 332.00 Ft Comments:

48 LONGITUDINAL/TRANSVERSE CRACKING M 11.00 Ft Comments:

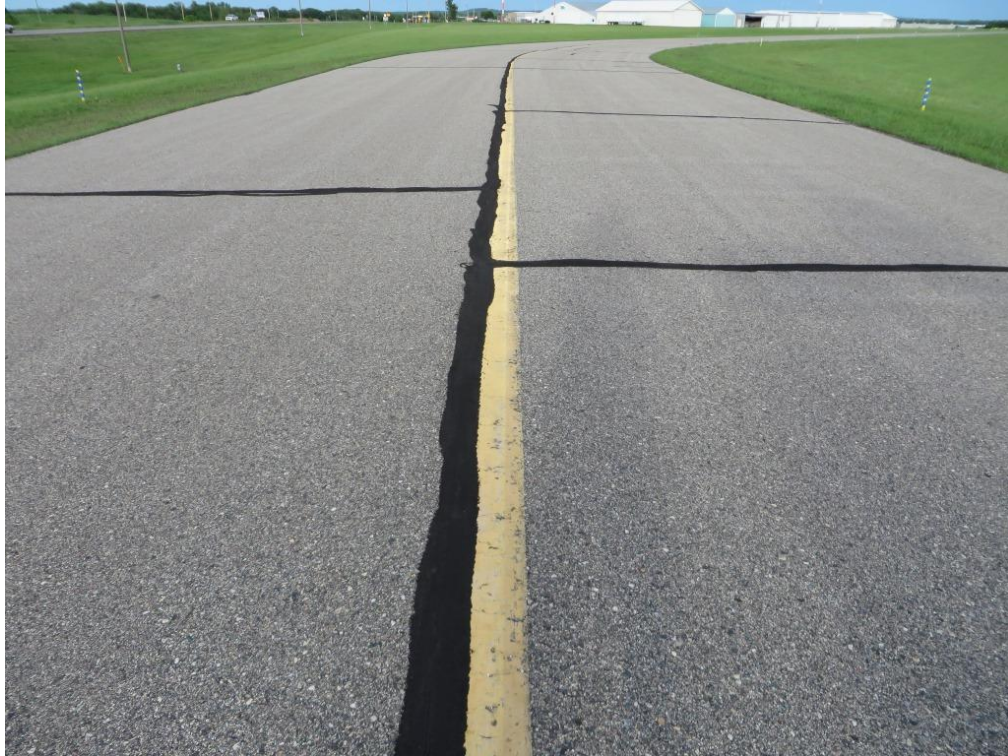
DTL PPTA 001 (PCI = 80)

48 LONGITUDINAL/TRANSVERSE CRACKING L 232.00 Ft Comments:

48 LONGITUDINAL/TRANSVERSE CRACKING M 1.00 Ft Comments:

48 LONGITUDINAL/TRANSVERSE CRACKING L 353.00 Ft Comments:
