# Pavement Condition Report

## Slayton Municipal Airport (DVP)

**December 2014**

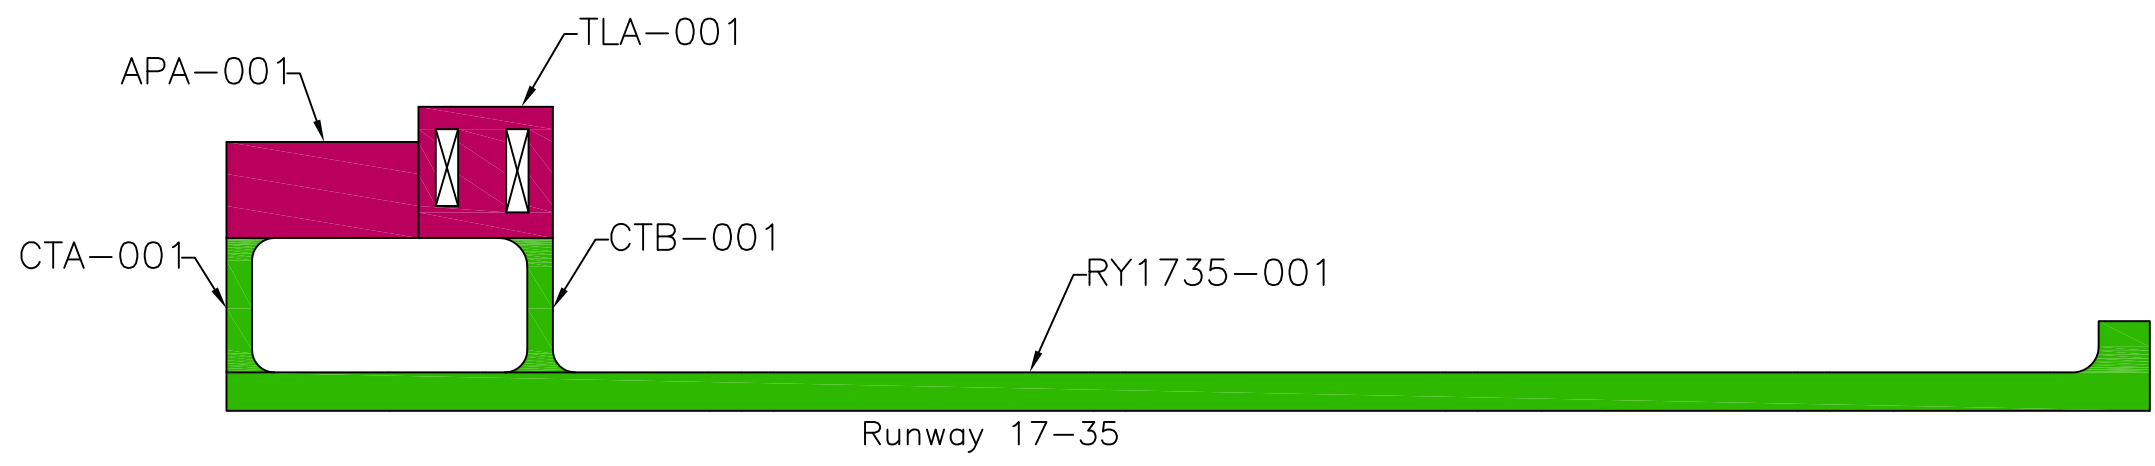
Figure 4. 2014 Pavement Condition Index Rating at Slayton Municipal Airport (DVP).

FAILED	VERY POOR	POOR	FAIR	GOOD	VERY GOOD	EXCELLENT	PCI INDEX
NS	0-10	11-25	26-40	41-55	56-70	71-85	86-100

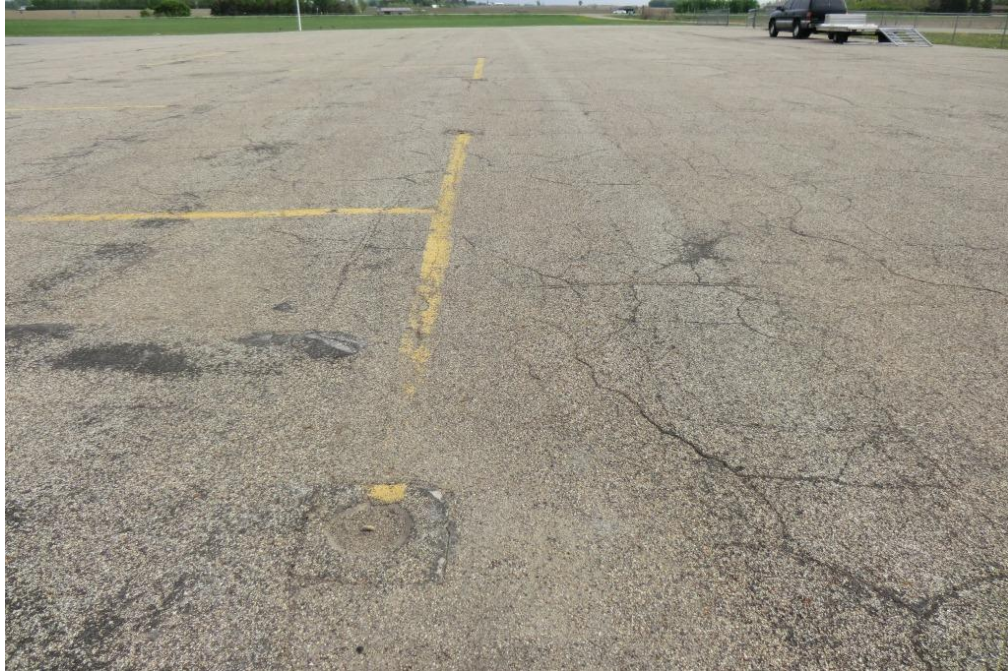
DVP APA 001 (PCI = 18)

Conditions: PCI: 18

43 BLOCK CRACKING	L	1,500.00 SqFt	Comments:
43 BLOCK CRACKING	M	2,500.00 SqFt	Comments:
43 BLOCK CRACKING	H	1,000.00 SqFt	Comments:
52 RAVELING	L	5,000.00 SqFt	Comments:
53 RUTTING	L	40.00 SqFt	Comments:

43 BLOCK CRACKING	M	2,500.00 SqFt	Comments:
43 BLOCK CRACKING	H	2,500.00 SqFt	Comments:
52 RAVELING	L	5,000.00 SqFt	Comments:
53 RUTTING	L	432.00 SqFt	Comments:
53 RUTTING	M	68.00 SqFt	Comments:

43 BLOCK CRACKING	M	1,000.00 SqFt	Comments:
43 BLOCK CRACKING	H	2,500.00 SqFt	Comments:
48 LONGITUDINAL/TRANSVERSE CRACKING	L	120.00 Ft	Comments:
52 RAVELING	L	5,000.00 SqFt	Comments:
53 RUTTING	L	40.00 SqFt	Comments:

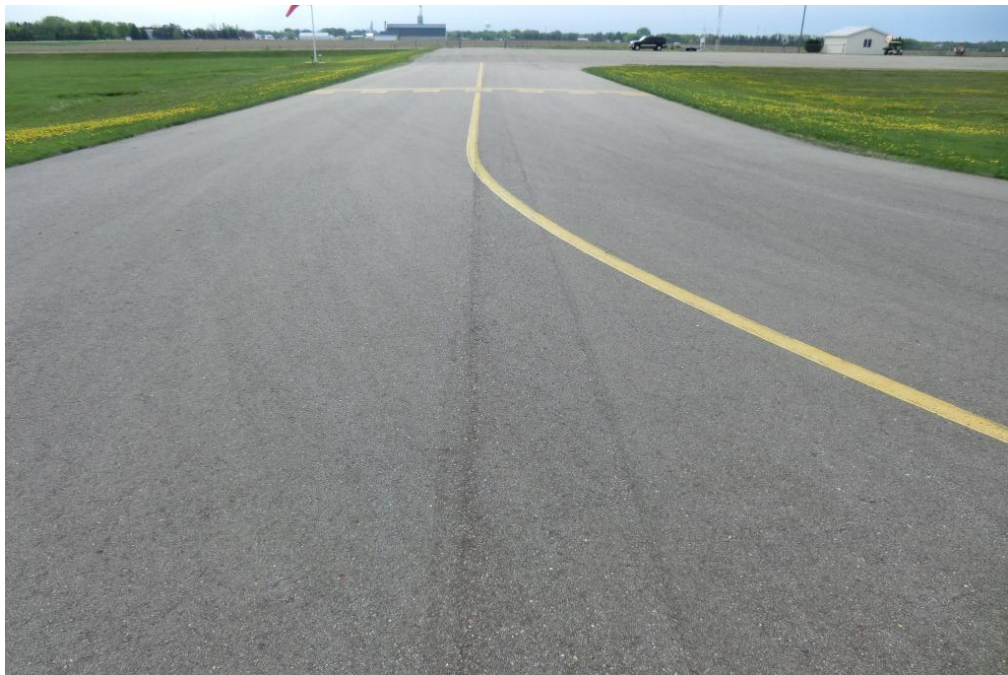
DVP CTA 001 (PCI = 100)

Conditions: PCI: 100

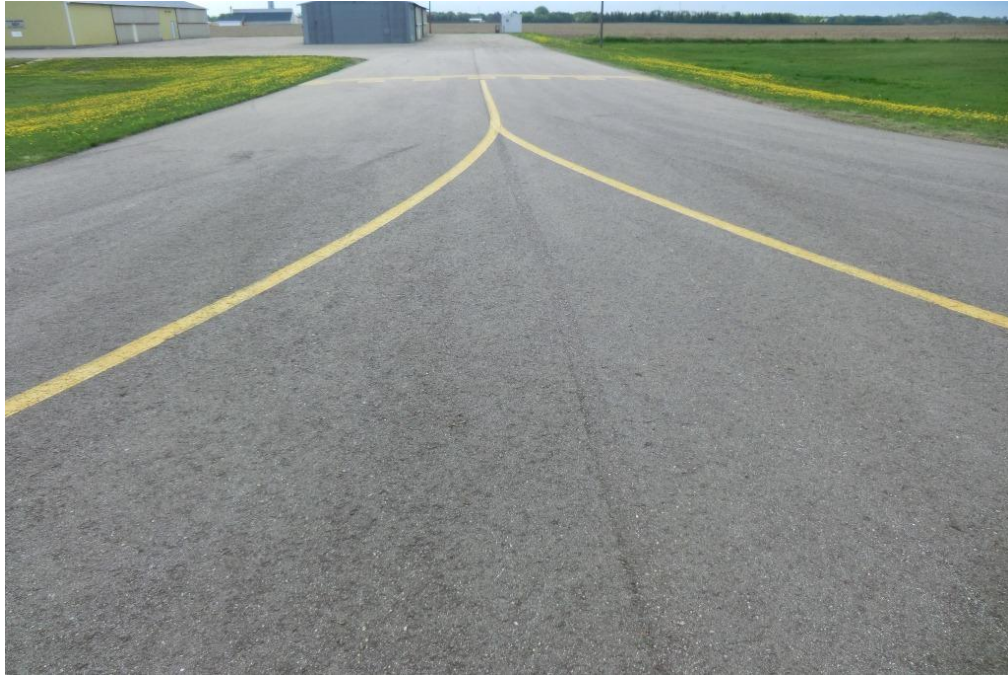
DVP CTB 001 (PCI = 100)

Conditions: PCI: 100

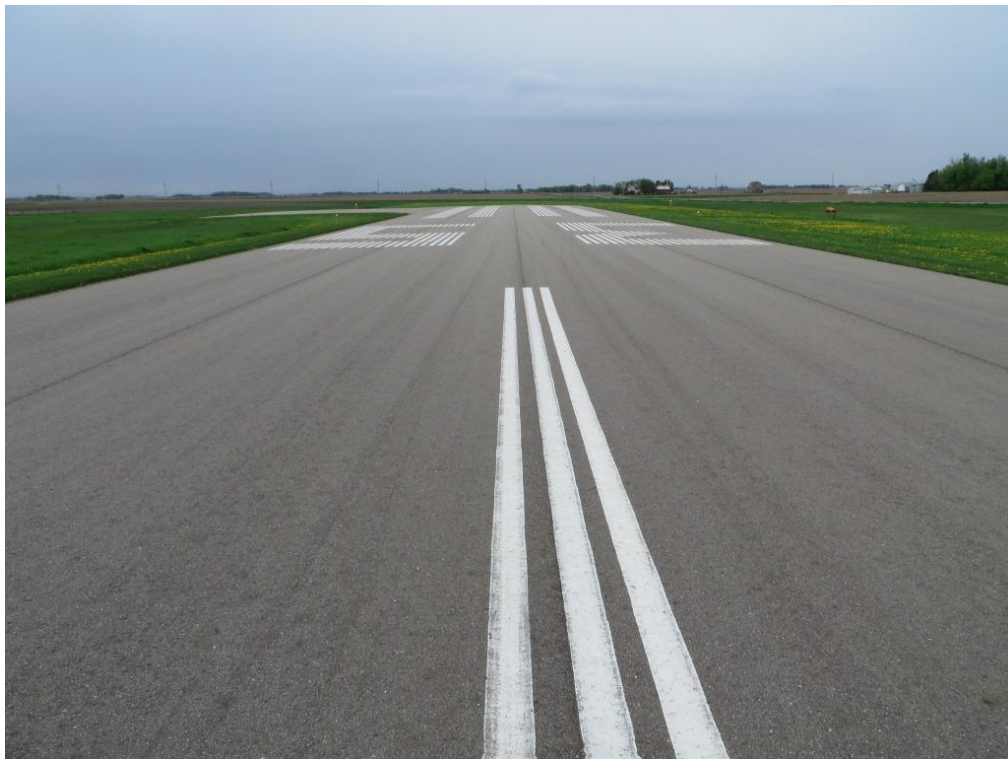
DVP RY1735 001 (PCI = 100)

Conditions: PCI: 100

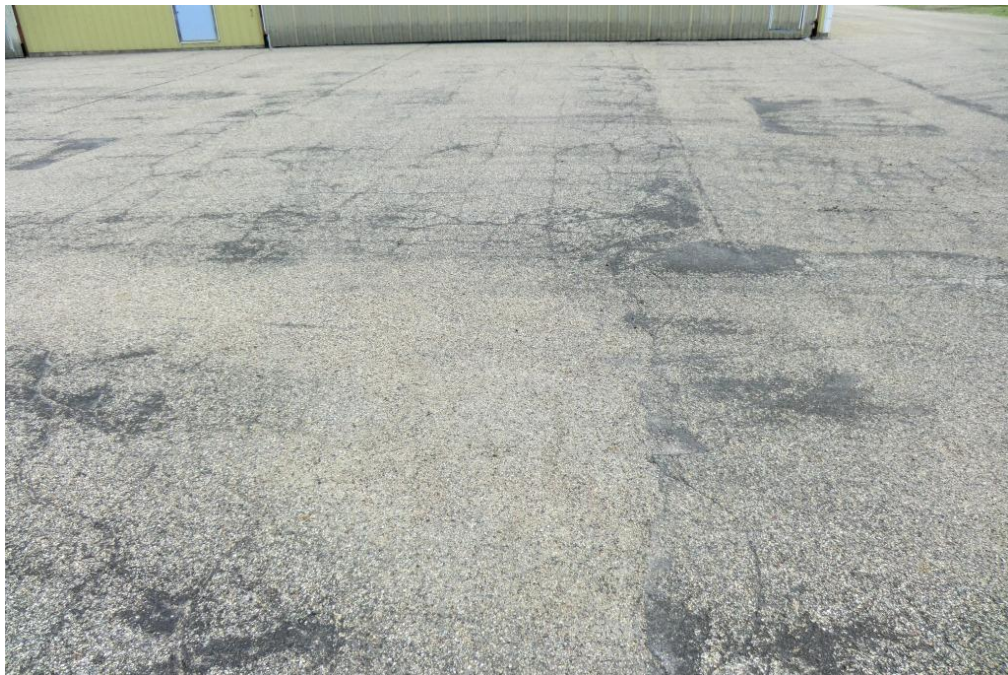
DVP TLA 001 (PCI = 25)

Conditions: PCI: 25

43 BLOCK CRACKING	L	600.00 SqFt	Comments:
43 BLOCK CRACKING	M	600.00 SqFt	Comments:
43 BLOCK CRACKING	H	3,000.00 SqFt	Comments:
45 DEPRESSION	L	120.00 SqFt	Comments:
52 RAVELING	L	4,200.00 SqFt	Comments:

43 BLOCK CRACKING	L	1,800.00 SqFt	Comments:
43 BLOCK CRACKING	M	600.00 SqFt	Comments:
43 BLOCK CRACKING	H	600.00 SqFt	Comments:
45 DEPRESSION	L	130.00 SqFt	Comments:
48 LONGITUDINAL/TRANSVERSE CRACKING	L	40.00 Ft	Comments:
48 LONGITUDINAL/TRANSVERSE CRACKING	M	30.00 Ft	Comments:
52 RAVELING	L	3,750.00 SqFt	Comments:

43 BLOCK CRACKING	H	500.00 SqFt	Comments:
48 LONGITUDINAL/TRANSVERSE CRACKING	L	440.00 Ft	Comments:
48 LONGITUDINAL/TRANSVERSE CRACKING	M	48.00 Ft	Comments:
52 RAVELING	L	4,000.00 SqFt	Comments:
53 RUTTING	L	60.00 SqFt	Comments:
