Final Report

Pavement Condition Report

Sky Harbor Airport (DYT)

December 2014

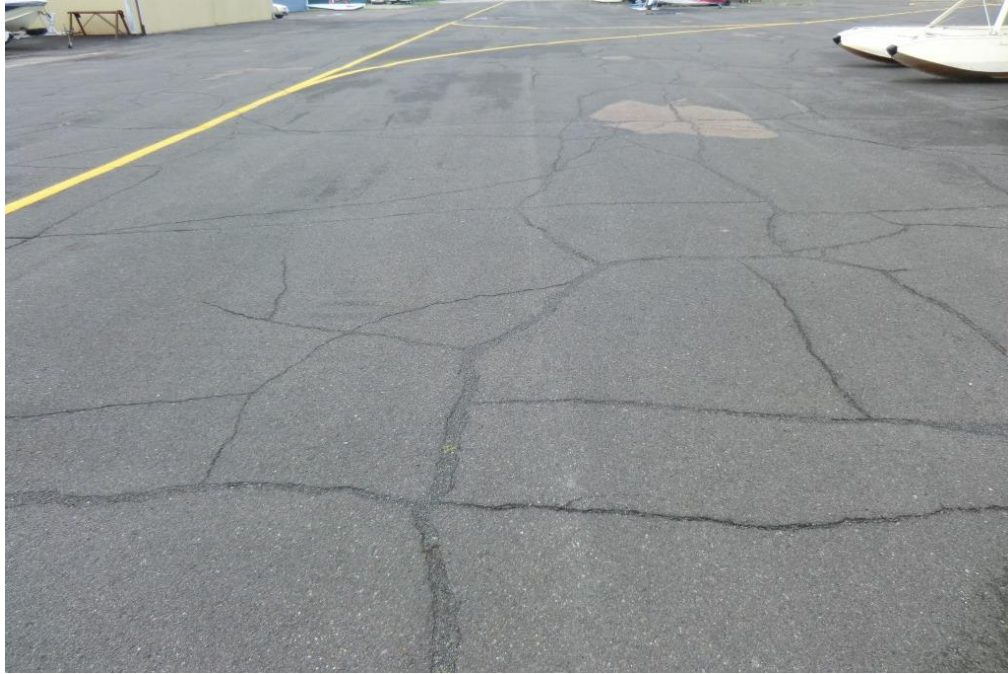
DYT APA 001 (PCI = 13)

Conditions: PCI : 13

41 ALLIGATOR CRACKING	M	70.00 SqFt	Comments:
41 ALLIGATOR CRACKING	H	28.00 SqFt	Comments:
43 BLOCK CRACKING	M	2,010.00 SqFt	Comments:
43 BLOCK CRACKING	H	400.00 SqFt	Comments:
48 LONGITUDINAL/TRANSVERSE CRACKING	L	225.00 Ft	Comments:
48 LONGITUDINAL/TRANSVERSE CRACKING	M	375.00 Ft	Comments:
57 WEATHERING	M	80.00 SqFt	Comments:

43 BLOCK CRACKING	L	500.00 SqFt	Comments:
43 BLOCK CRACKING	M	1,500.00 SqFt	Comments:
43 BLOCK CRACKING	H	2,000.00 SqFt	Comments:
48 LONGITUDINAL/TRANSVERSE CRACKING	L	50.00 Ft	Comments:
48 LONGITUDINAL/TRANSVERSE CRACKING	M	50.00 Ft	Comments:

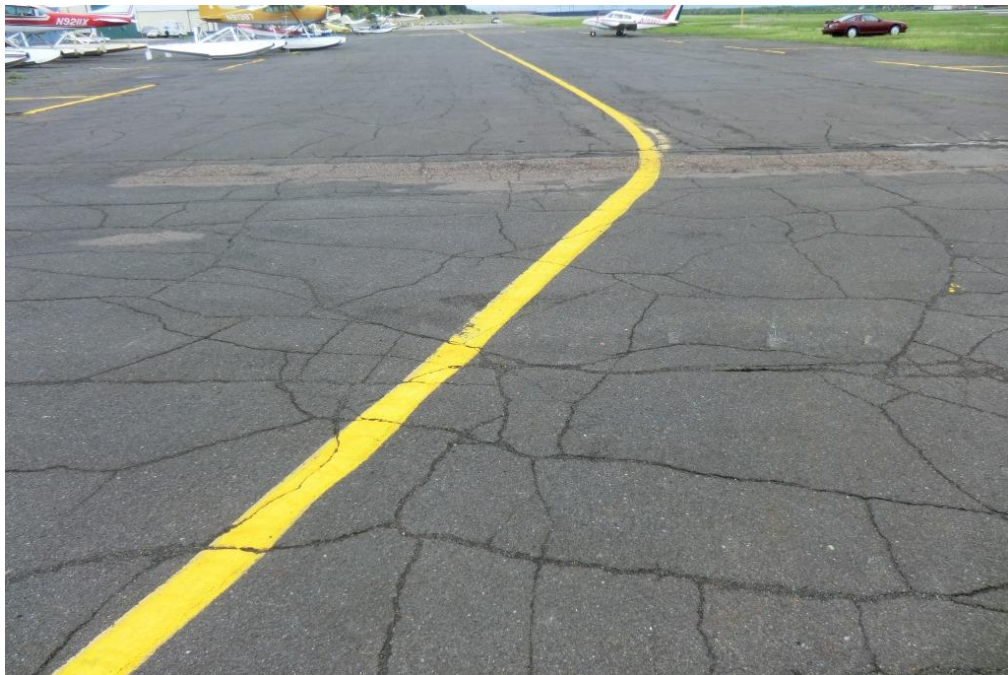
DYT APA 002 (PCI = 23)

Conditions: PCI : 23

43 BLOCK CRACKING	M	3,700.00 SqFt	Comments:
43 BLOCK CRACKING	H	800.00 SqFt	Comments:
52 RAVELING	M	85.00 SqFt	Comments:

41 ALLIGATOR CRACKING	M	150.00 SqFt	Comments:
43 BLOCK CRACKING	M	4,500.00 SqFt	Comments:
43 BLOCK CRACKING	H	500.00 SqFt	Comments:
45 DEPRESSION	L	125.00 SqFt	Comments:
52 RAVELING	L	32.00 SqFt	Comments:

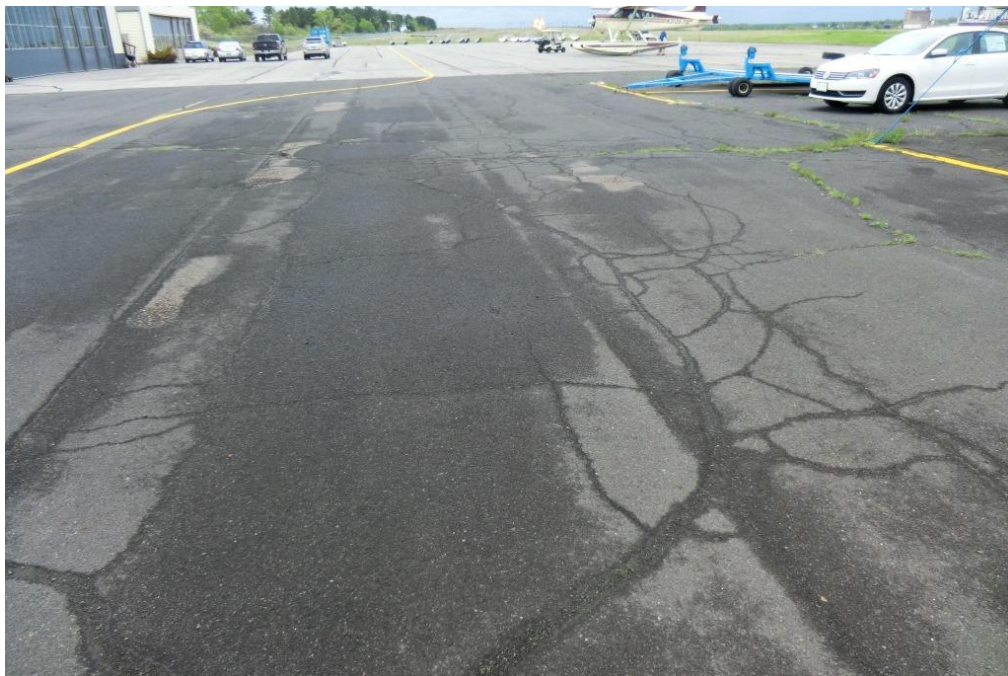
DYT APA 003 (PCI = 18)

Conditions: PCI: 18

41 ALLIGATOR CRACKING	M	35.00 SqFt	Comments:
43 BLOCK CRACKING	L	3,400.00 SqFt	Comments:
43 BLOCK CRACKING	M	1,500.00 SqFt	Comments:
48 LONGITUDINAL/TRANSVERSE CRACKING	M	50.00 Ft	Comments:
48 LONGITUDINAL/TRANSVERSE CRACKING	H	50.00 Ft	Comments:

41 ALLIGATOR CRACKING	M	105.00 SqFt	Comments:
43 BLOCK CRACKING	L	1,000.00 SqFt	Comments:
43 BLOCK CRACKING	M	2,500.00 SqFt	Comments:
43 BLOCK CRACKING	H	1,500.00 SqFt	Comments:
56 SWELLING	L	170.00 SqFt	Comments:

41 ALLIGATOR CRACKING	M	210.00 SqFt	Comments:
48 LONGITUDINAL/TRANSVERSE CRACKING	M	3,500.00 Ft	Comments:
48 LONGITUDINAL/TRANSVERSE CRACKING	H	1,500.00 Ft	Comments:
53 RUTTING	L	250.00 SqFt	Comments:

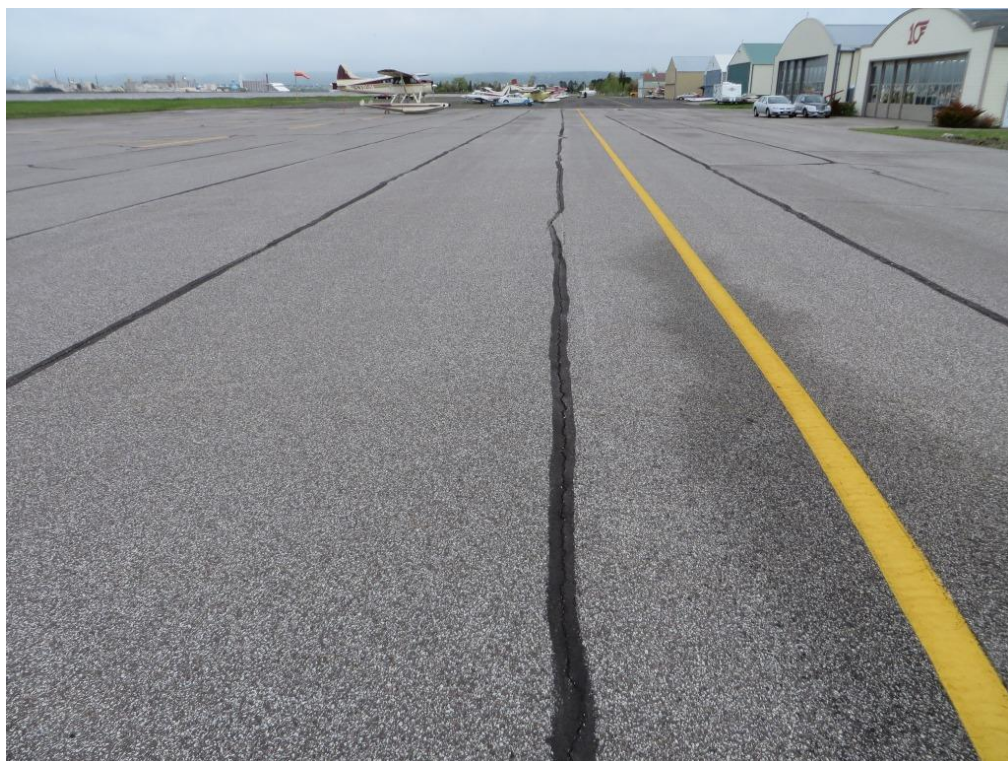
DYT APA 004 (PCI = 72)

Conditions: PCI: 72

48 LONGITUDINAL/TRANSVERSE CRACKING L 295.00 Ft Comments:

48 LONGITUDINAL/TRANSVERSE CRACKING M 36.00 Ft Comments:

48 LONGITUDINAL/TRANSVERSE CRACKING L 468.00 Ft Comments:

48 LONGITUDINAL/TRANSVERSE CRACKING M 93.00 Ft Comments:

48 LONGITUDINAL/TRANSVERSE CRACKING L 448.00 Ft Comments:

48 LONGITUDINAL/TRANSVERSE CRACKING M 211.00 Ft Comments:

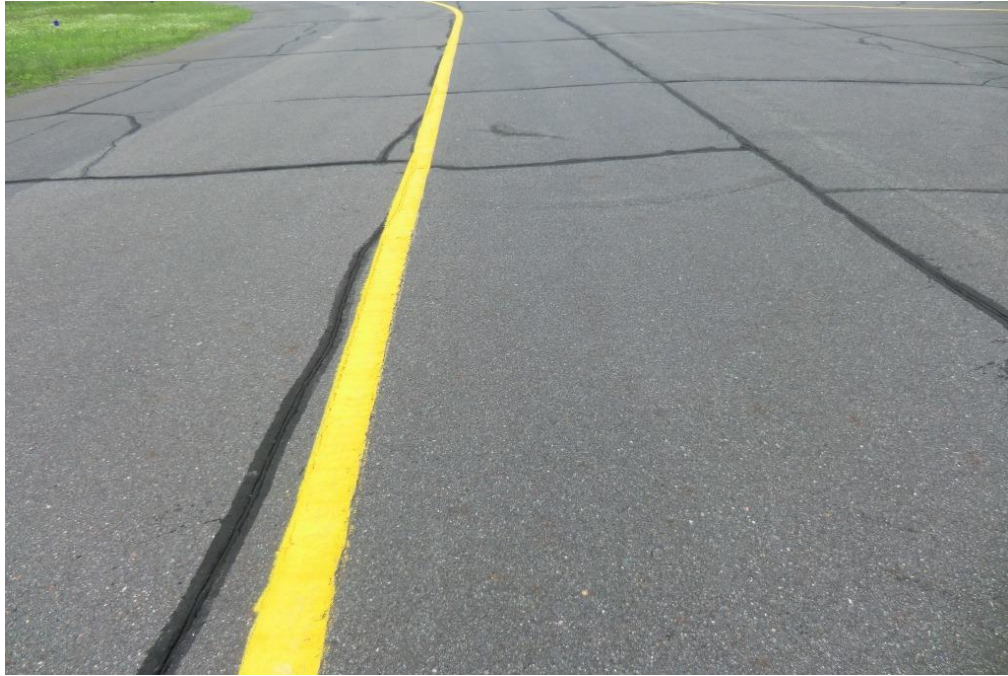
DYT CTA 001 (PCI = 54)

Conditions: PCI : 54

48	LONGITUDINAL/TRANSVERSE CRACKING	L	474.00 Ft	Comments:
48	LONGITUDINAL/TRANSVERSE CRACKING	M	102.00 Ft	Comments:
48	LONGITUDINAL/TRANSVERSE CRACKING	H	3.00 Ft	Comments:
50	PATCHING	L	210.00 SqFt	Comments:
50	PATCHING	M	30.00 SqFt	Comments:

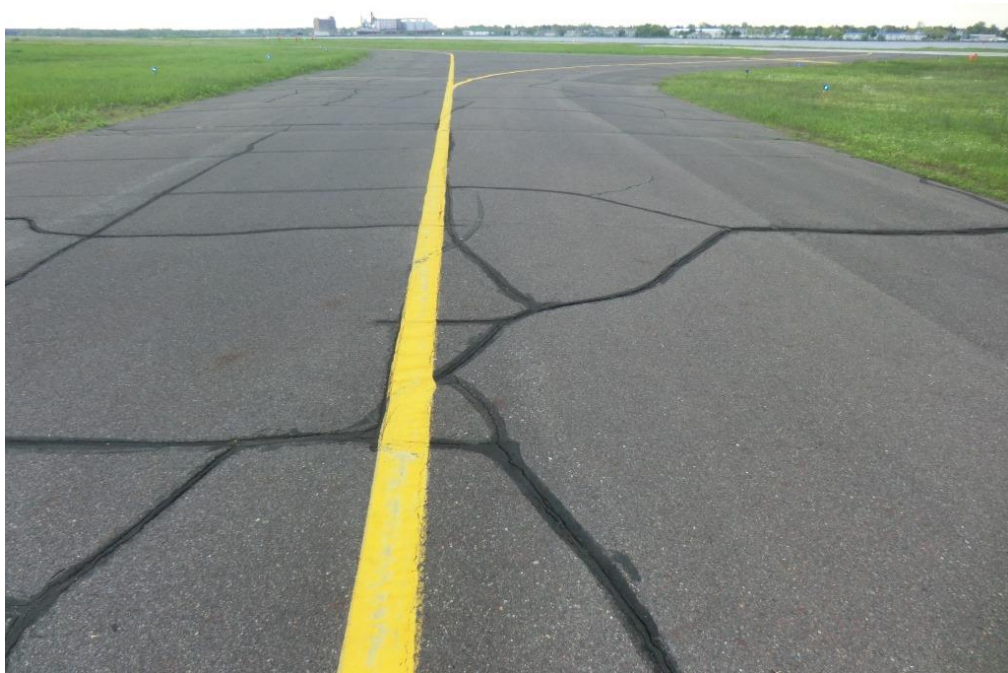
DYT CTA 002 (PCI = 44)

Conditions: PCI : 44

45 DEPRESSION	L	30.00	SqFt	Comments:
48 LONGITUDINAL/TRANSVERSE CRACKING	L	613.00	Ft	Comments:
48 LONGITUDINAL/TRANSVERSE CRACKING	M	94.00	Ft	Comments:
50 PATCHING	L	176.00	SqFt	Comments:
50 PATCHING	M	176.00	SqFt	Comments:

41 ALLIGATOR CRACKING	M	16.00	SqFt	Comments:
43 BLOCK CRACKING	L	800.00	SqFt	Comments:
43 BLOCK CRACKING	M	3,200.00	SqFt	Comments:
45 DEPRESSION	L	40.00	SqFt	Comments:

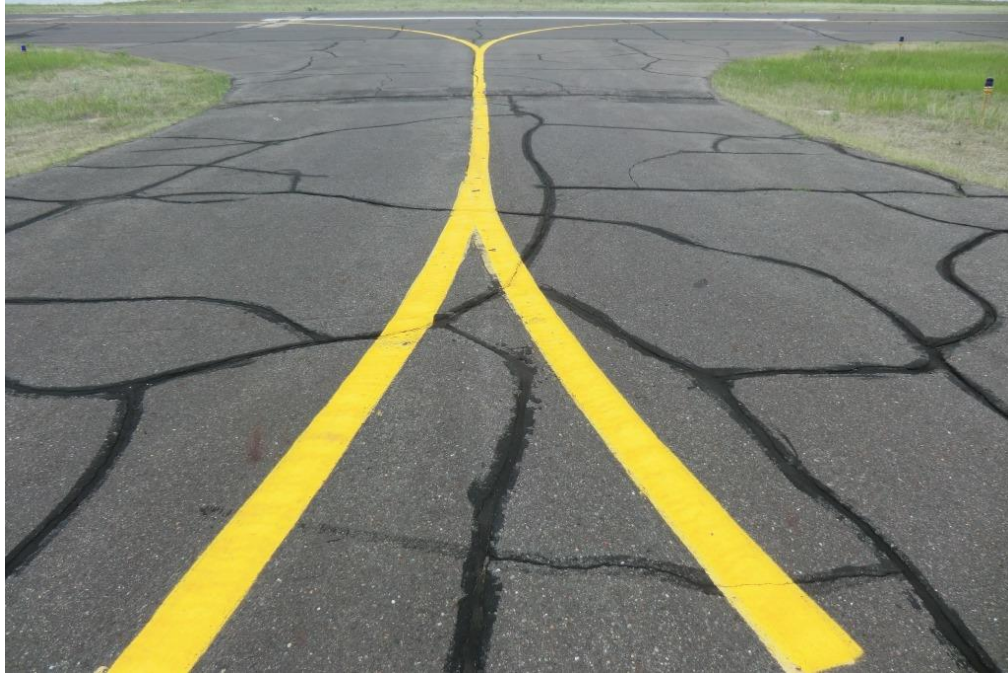
DYT CTB 001 (PCI = 45)

Conditions: PCI : 45

43 BLOCK CRACKING	L	2,000.00 SqFt	Comments:
48 LONGITUDINAL/TRANSVERSE CRACKING	L	259.00 Ft	Comments:
48 LONGITUDINAL/TRANSVERSE CRACKING	M	41.00 Ft	Comments:
50 PATCHING	L	100.00 SqFt	Comments:
50 PATCHING	M	25.00 SqFt	Comments:
43 BLOCK CRACKING	M	100.00 SqFt	Comments:

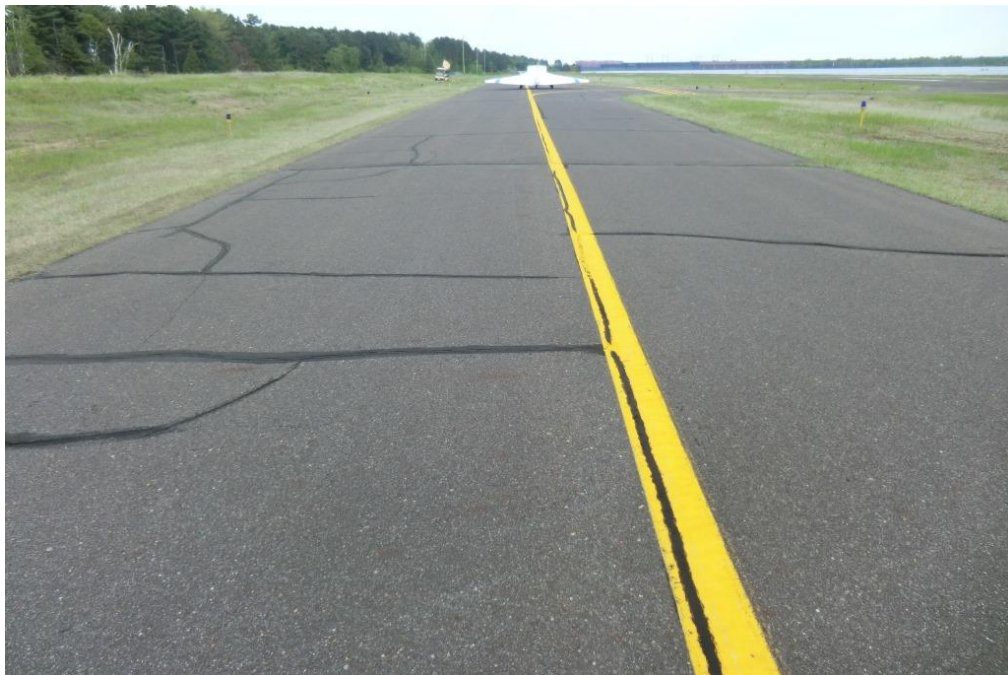
DYT PTA 001 (PCI = 56)

Conditions: PCI : 56

48	LONGITUDINAL/TRANSVERSE CRACKING	L	928.00	Ft	Comments:
48	LONGITUDINAL/TRANSVERSE CRACKING	M	50.00	Ft	Comments:
50	PATCHING	L	48.00	SqFt	Comments:
50	PATCHING	M	2.00	SqFt	Comments:

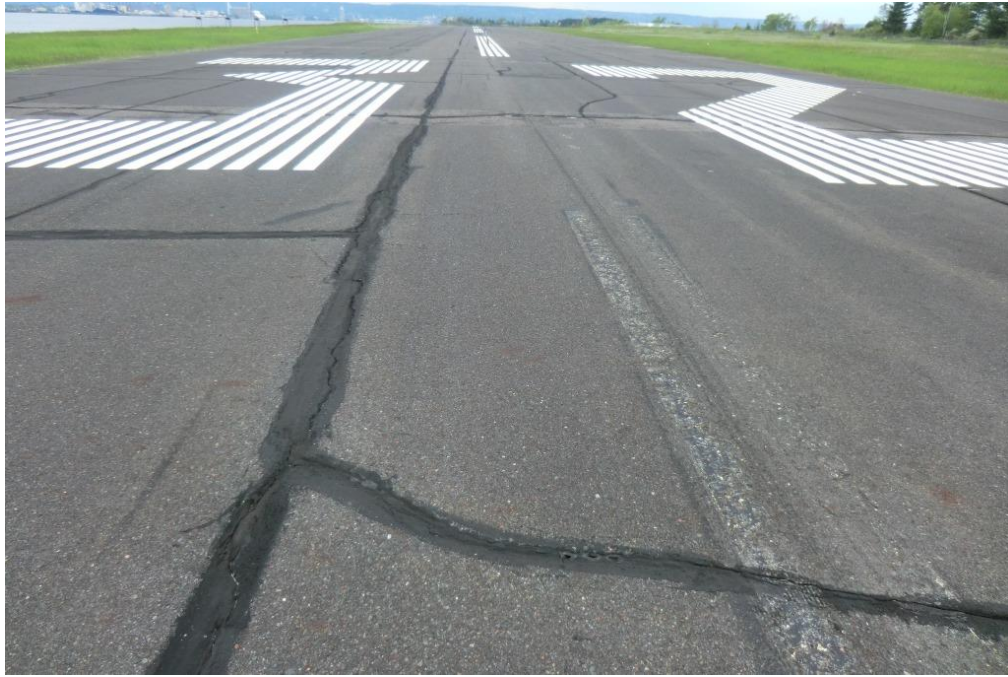
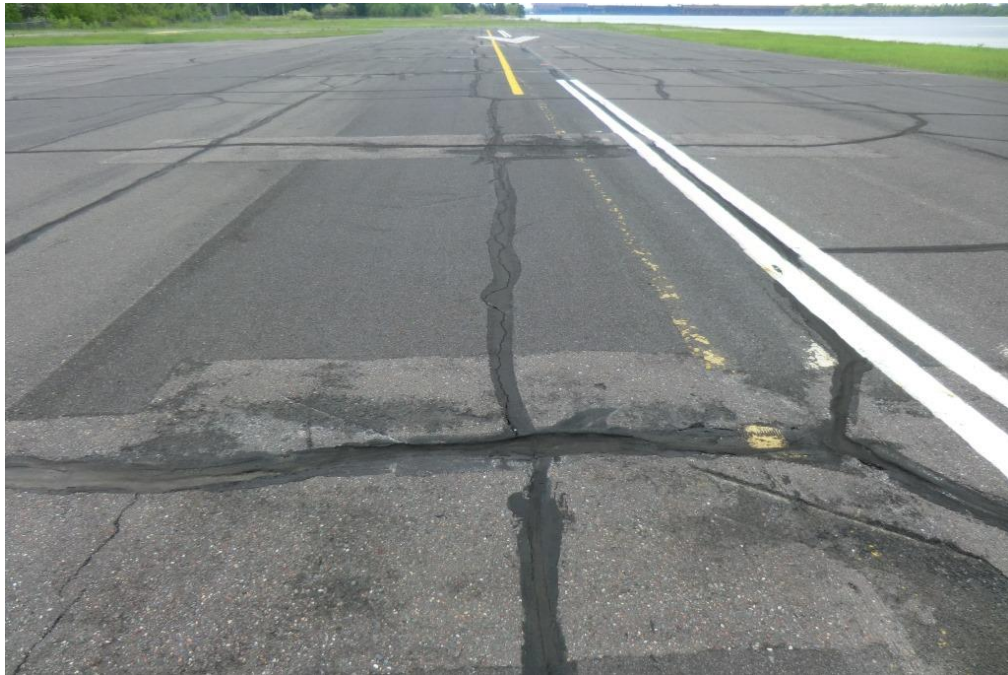
DYT RY1432 001 (PCI = 57)

Conditions: PCI : 57
