Final Report

Pavement Condition Report

Wheaton Municipal Airport (ETH)

December 2014

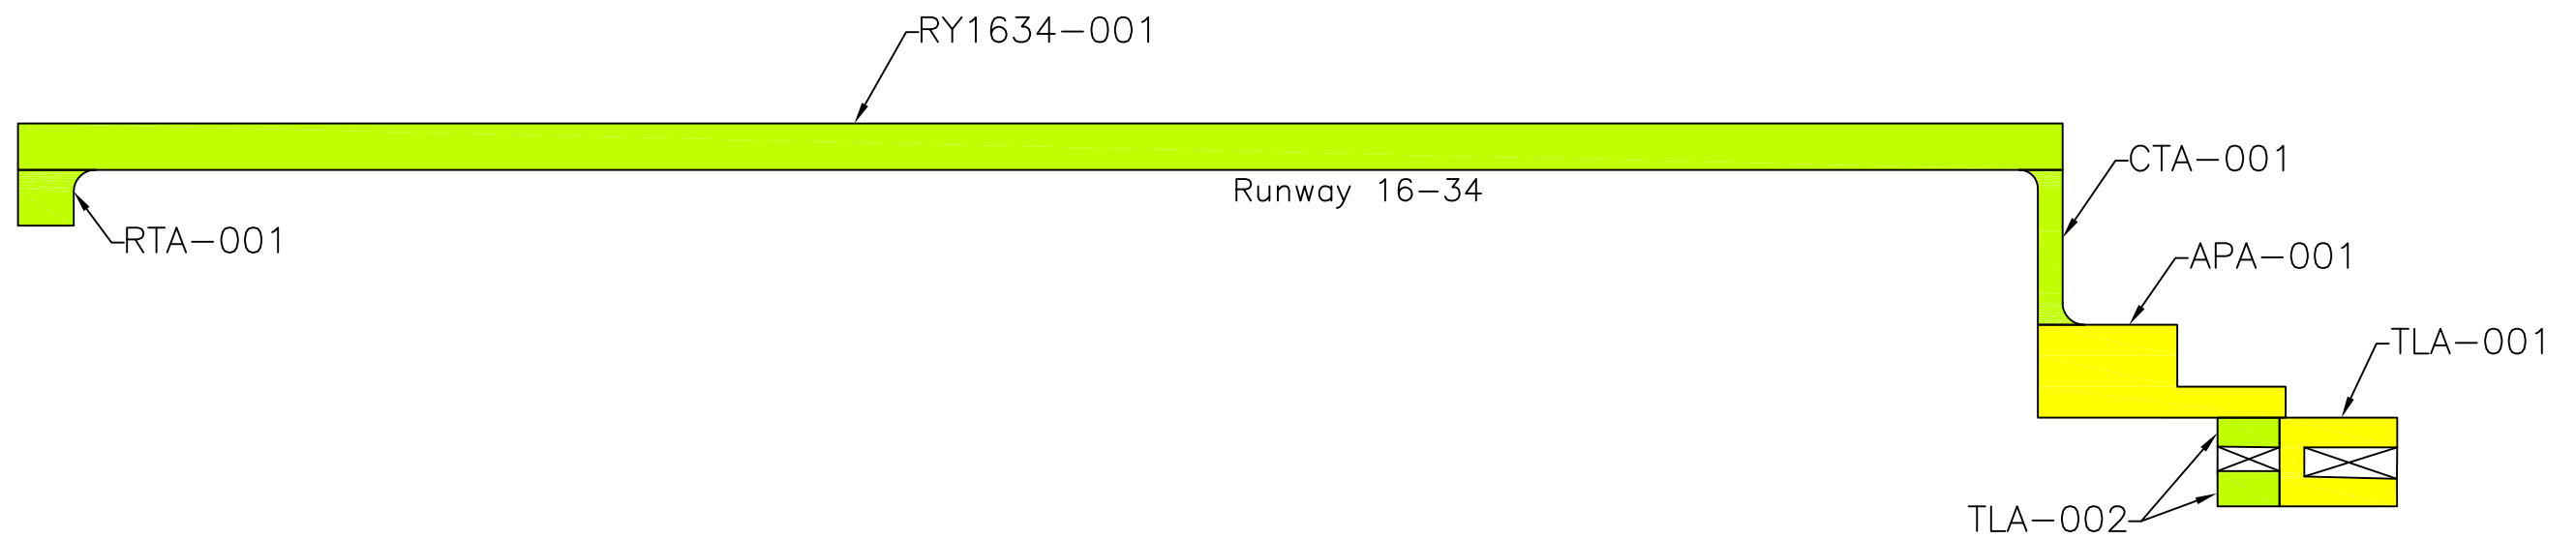
Figure 4. 2014 Pavement Condition Index Rating at Wheaton Municipal Airport (ETH).

Branch ID	Section ID	Surface type ¹	Section area (SF)	LCD ²	2011 PCI	2014 PCI	Drop in PCI/Yr ³	% Deduct due to		Distress types
								Load ⁴	Climate ⁵	
APA	1	AC	42,500	2008	73	64	6.0	0	77	L&T cracking, raveling, swelling
CTA	1	AC	10,450	2007	84	72	4.0	0	100	L&T cracking, , raveling, weathering
RTA	1	AC	8,350	2007	90	84	2.3	0	100	L&T cracking, weathering
RY1634	1	AC	247,500	2007	82	71	4.1	0	97	L&T cracking, raveling, swelling
TLA	1	AC	21,844	2008	69	65	5.8	0	97	L&T cracking, raveling, swelling
TLA	2	AC	11,000	2008	74	73	4.5	0	100	L&T cracking, weathering

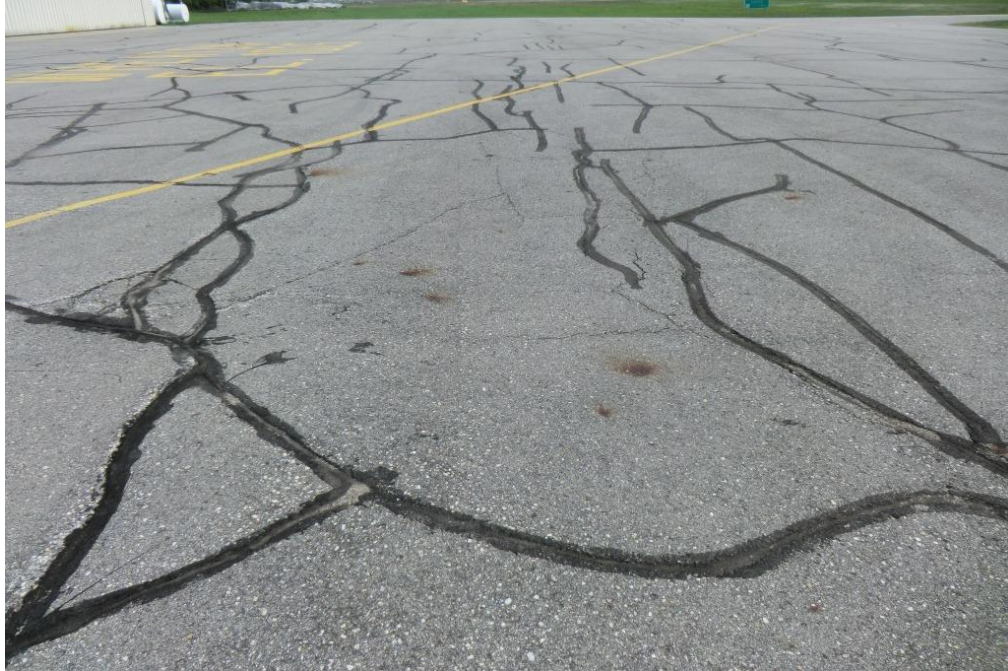
ETH APA 001 (PCI = 64)

Conditions: PCI : 64

48	LONGITUDINAL/TRANSVERSE CRACKING	L	706.00 Ft	Comments:
48	LONGITUDINAL/TRANSVERSE CRACKING	M	17.00 Ft	Comments:
52	RAVELING	L	150.00 SqFt	Comments:

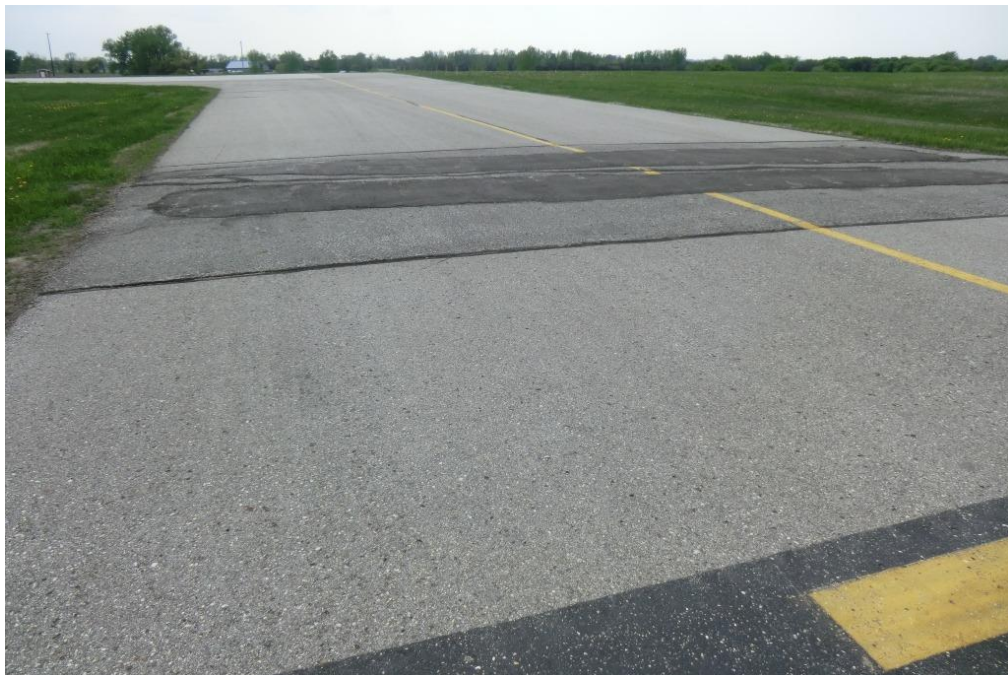
ETH CTA 001 (PCI = 72)

Conditions: PCI : 72

48	LONGITUDINAL/TRANSVERSE CRACKING	L	129.00 Ft	Comments:
48	LONGITUDINAL/TRANSVERSE CRACKING	M	13.00 Ft	Comments:
52	RAVELING	L	125.00 SqFt	Comments:
57	WEATHERING	M	90.00 SqFt	Comments:

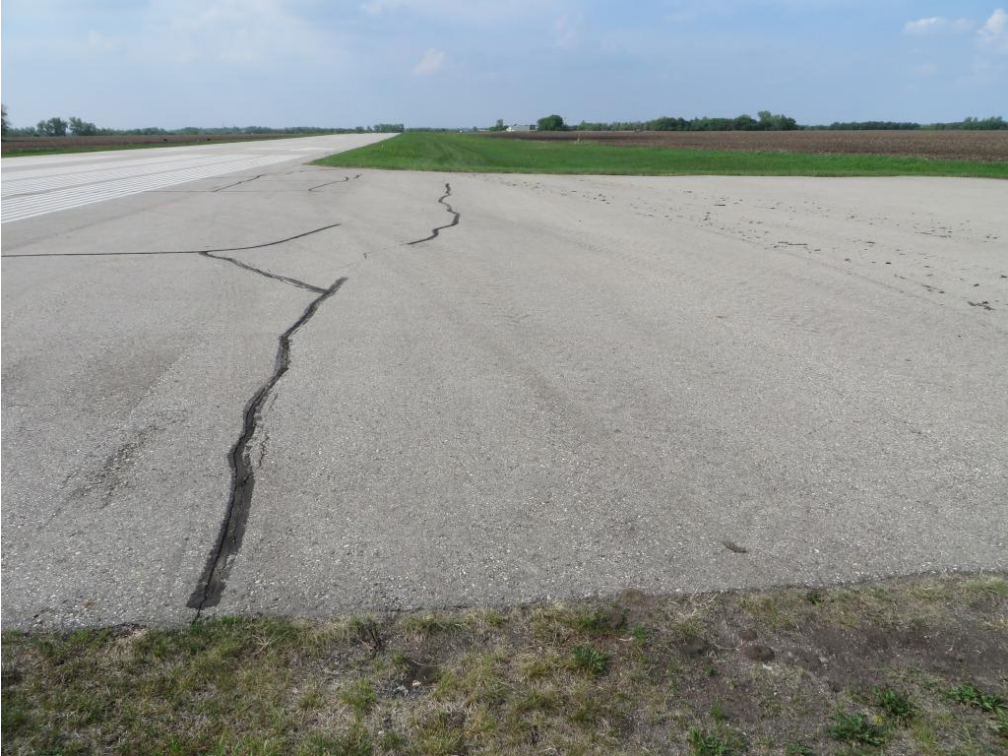
ETH RTA 001 (PCI = 84)

Conditions: PCI : 84

48 LONGITUDINAL/TRANSVERSE CRACKING L 81.00 Ft Comments:

48 LONGITUDINAL/TRANSVERSE CRACKING M 18.00 Ft Comments:

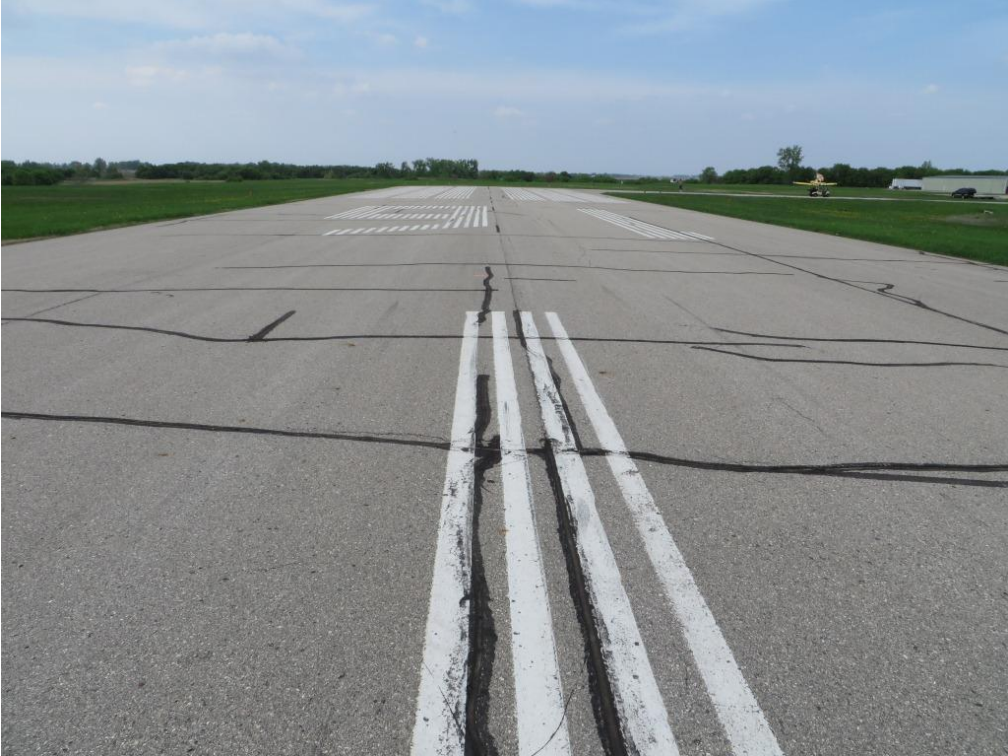
ETH RY1634 001 (PCI = 71)

Conditions: PCI: 71

48	LONGITUDINAL/TRANSVERSE CRACKING	L	466.00	Ft	Comments:
48	LONGITUDINAL/TRANSVERSE CRACKING	M	14.00	Ft	Comments:
52	RAVELING	L	300.00	SqFt	Comments:
56	SWELLING	L	6.00	SqFt	Comments:

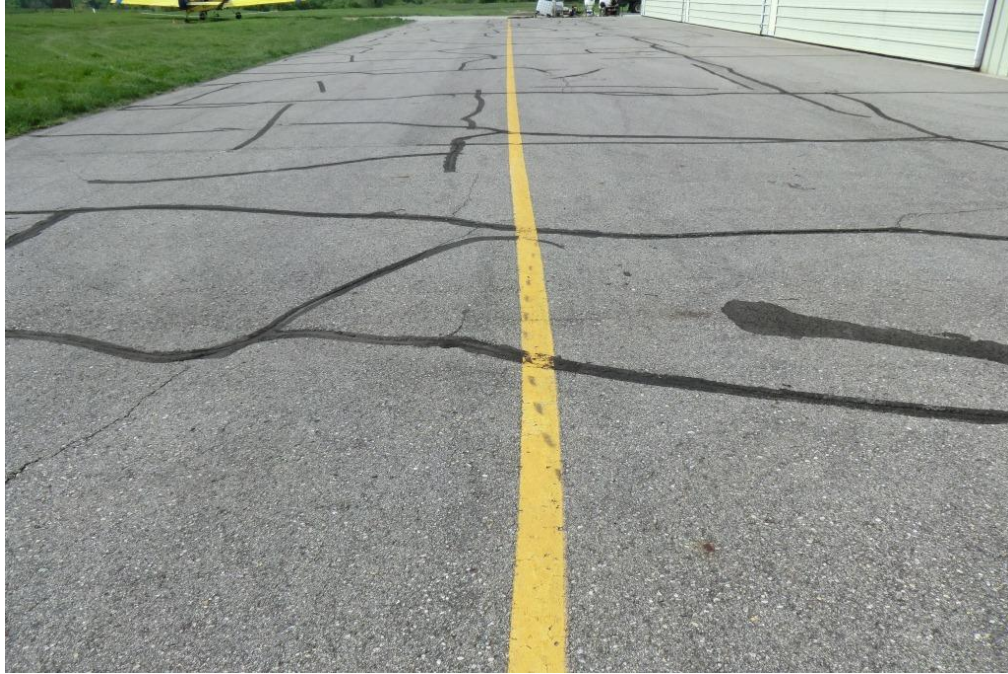
ETH TLA 001 (PCI = 65)

Conditions: PCI: 65

48	LONGITUDINAL/TRANSVERSE CRACKING	L	716.00 Ft	Comments:
52	RAVELING	L	400.00 SqFt	Comments:
56	SWELLING	L	4.00 SqFt	Comments:

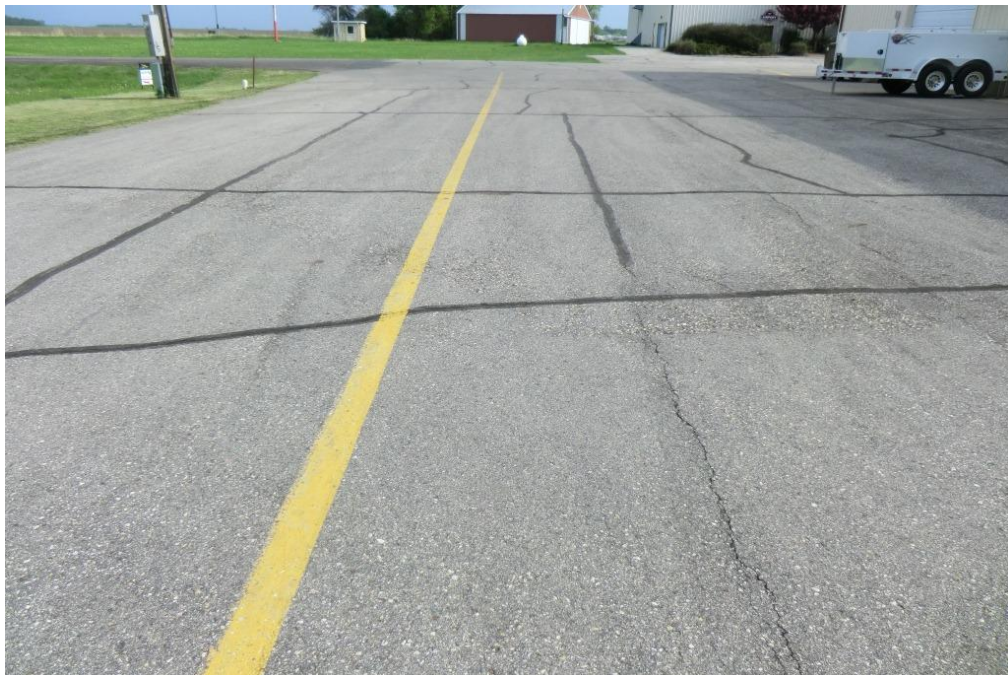
ETH TLA 002 (PCI = 73)

Conditions: PCI: 73

48 LONGITUDINAL/TRANSVERSE CRACKING L 539.00 Ft Comments:
57 WEATHERING M 60.00 SqFt Comments:
