Final Report

Pavement Condition Report

Faribault Municipal Airport (FBL)

December 2014

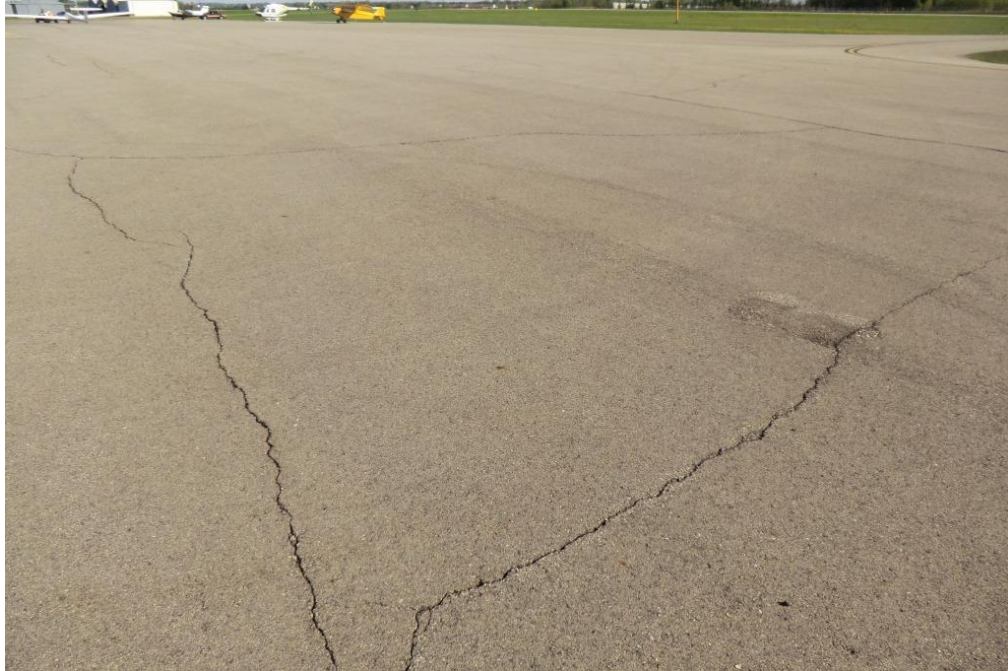
FBL APA 001 (PCI = 76)

Conditions: PCI: 76

48 LONGITUDINAL/TRANSVERSE CRACKING L 358.00 Ft Comments:
48 LONGITUDINAL/TRANSVERSE CRACKING M 73.00 Ft Comments:

48 LONGITUDINAL/TRANSVERSE CRACKING L 224.00 Ft Comments:
48 LONGITUDINAL/TRANSVERSE CRACKING M 198.00 Ft Comments:

48 LONGITUDINAL/TRANSVERSE CRACKING L 285.00 Ft Comments:
48 LONGITUDINAL/TRANSVERSE CRACKING M 18.00 Ft Comments:

48 LONGITUDINAL/TRANSVERSE CRACKING L 380.00 Ft Comments:
48 LONGITUDINAL/TRANSVERSE CRACKING M 136.00 Ft Comments:

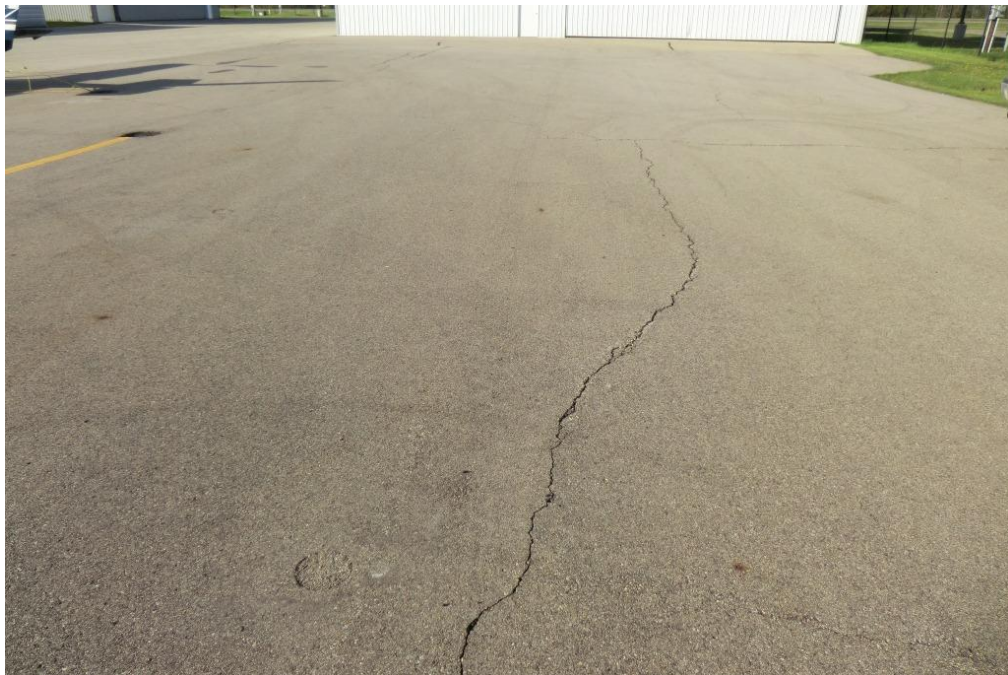
FBL APA 002 (PCI = 81)

Conditions: PCI : 81

48 LONGITUDINAL/TRANSVERSE CRACKING L 132.00 Ft Comments:
48 LONGITUDINAL/TRANSVERSE CRACKING M 65.00 Ft Comments:

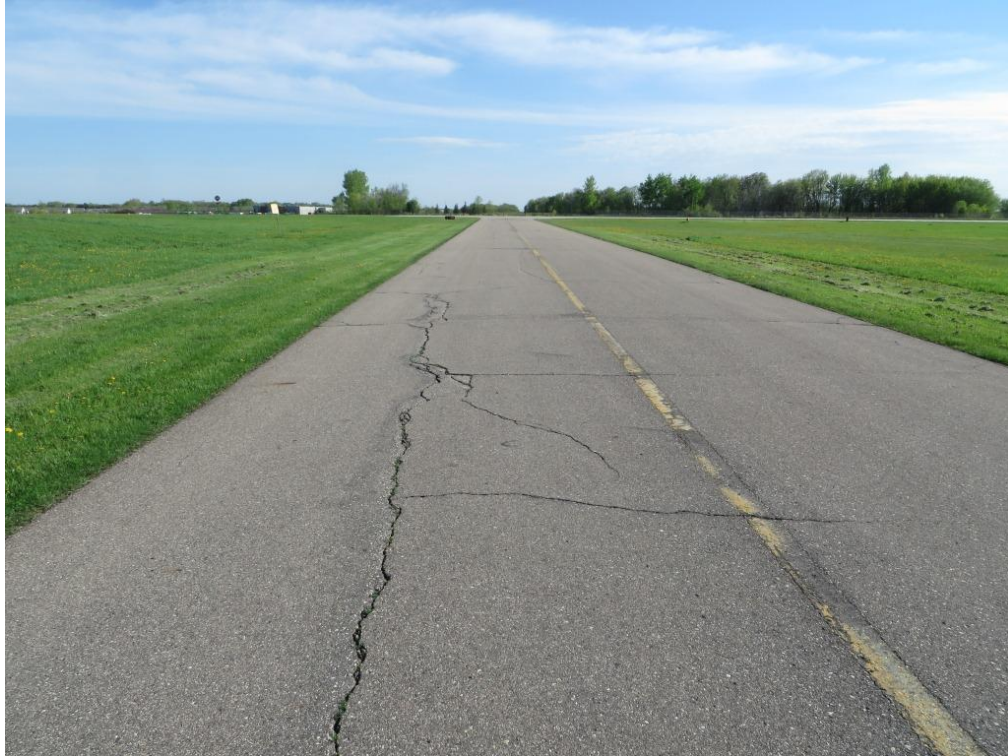
FBL CTA 002 (PCI = 64)

Conditions: PCI: 64

48 LONGITUDINAL/TRANSVERSE CRACKING L 54.00 Ft Comments:

48 LONGITUDINAL/TRANSVERSE CRACKING M 64.00 Ft Comments:

41 ALLIGATOR CRACKING M 40.00 SqFt Comments:

48 LONGITUDINAL/TRANSVERSE CRACKING L 200.00 Ft Comments:

48 LONGITUDINAL/TRANSVERSE CRACKING M 156.00 Ft Comments:

48 LONGITUDINAL/TRANSVERSE CRACKING H 8.00 Ft Comments:

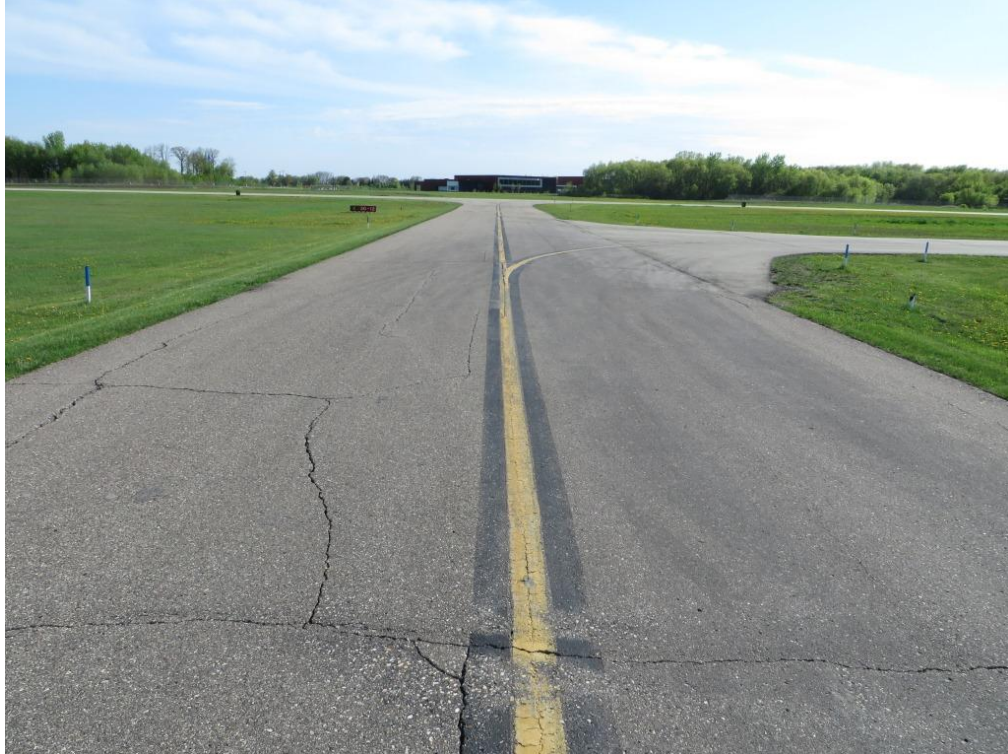
FBL CTB 002 (PCI = 76)

Conditions: PCI: 76

48 LONGITUDINAL/TRANSVERSE CRACKING L 210.00 Ft Comments:

48 LONGITUDINAL/TRANSVERSE CRACKING M 85.00 Ft Comments:

48 LONGITUDINAL/TRANSVERSE CRACKING L 187.00 Ft Comments:

48 LONGITUDINAL/TRANSVERSE CRACKING M 62.00 Ft Comments:

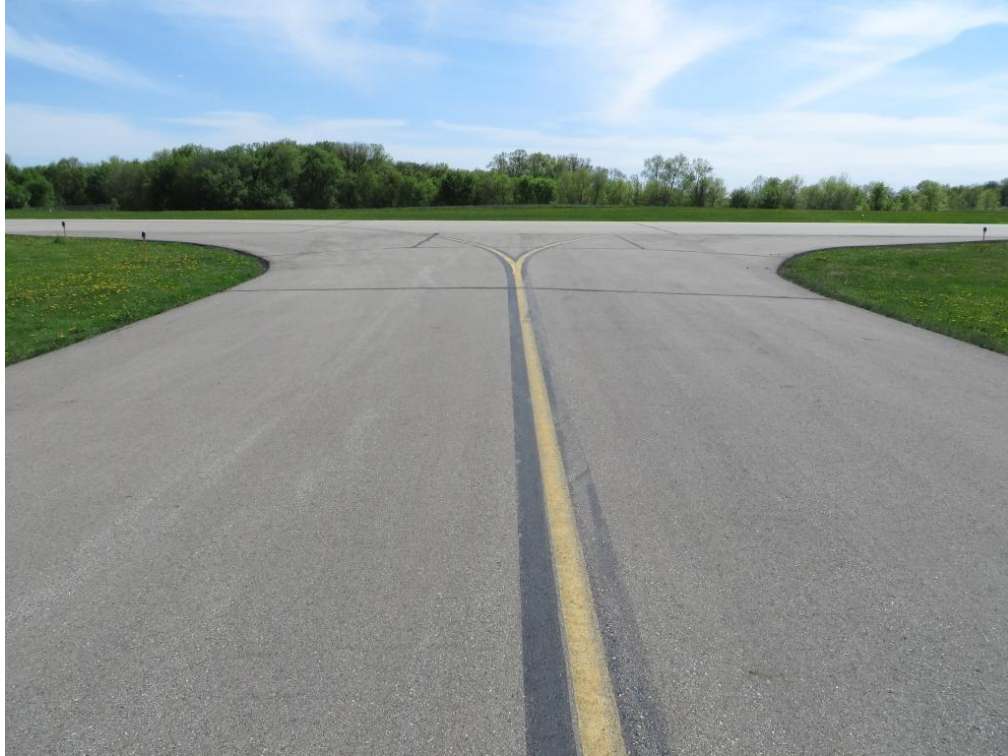
FBL CTC 001 (PCI = 90)

Conditions: PCI: 90

48 LONGITUDINAL/TRANSVERSE CRACKING M 36.00 Ft Comments:

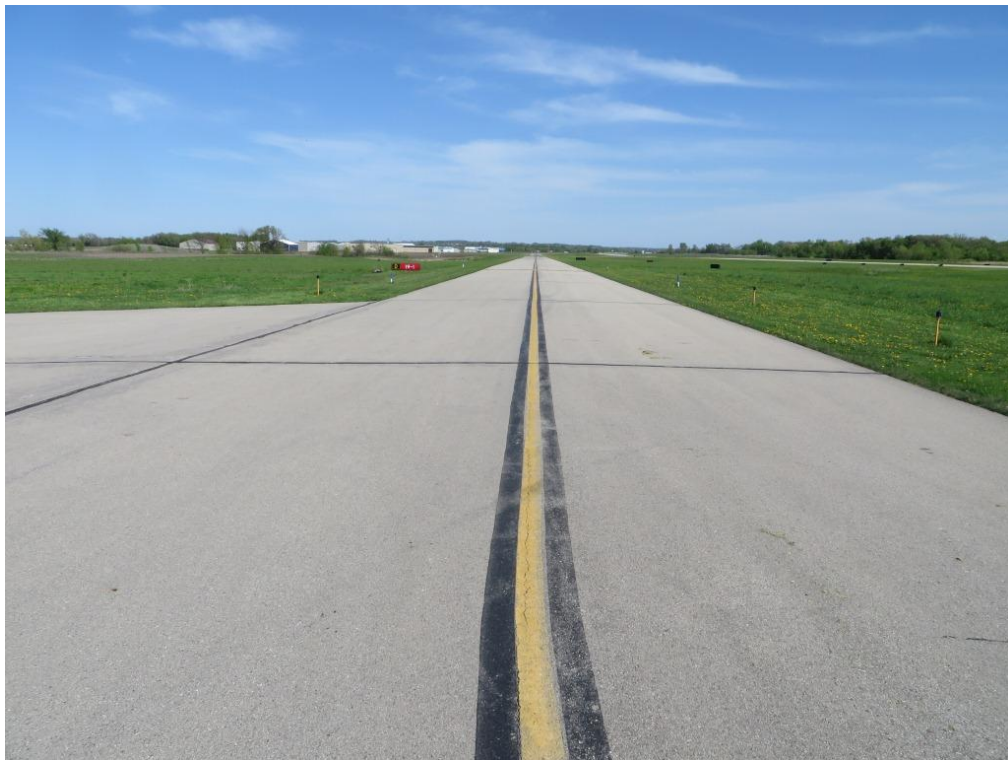
FBL PPTA 001 (PCI = 89)

Conditions: PCI : 89

Sample Number: 101 Type: R Area: 3,750.00SqFt PCI = 91
Sample Comments:
48 LONGITUDINAL/TRANSVERSE CRACKING M 20.00 Ft Comments:

Sample Number: 106 Type: R Area: 3,750.00SqFt PCI = 92
Sample Comments:
48 LONGITUDINAL/TRANSVERSE CRACKING M 17.00 Ft Comments:

Sample Number: 116 Type: R Area: 3,750.00SqFt PCI = 83
Sample Comments:
48 LONGITUDINAL/TRANSVERSE CRACKING L 10.00 Ft Comments:
48 LONGITUDINAL/TRANSVERSE CRACKING M 55.00 Ft Comments:

Sample Number: 123 Type: R Area: 3,750.00SqFt PCI = 89
Sample Comments:
48 LONGITUDINAL/TRANSVERSE CRACKING M 35.00 Ft Comments:

Sample Number: 130 Type: R Area: 3,750.00SqFt PCI = 88
Sample Comments:
48 LONGITUDINAL/TRANSVERSE CRACKING M 46.00 Ft Comments:

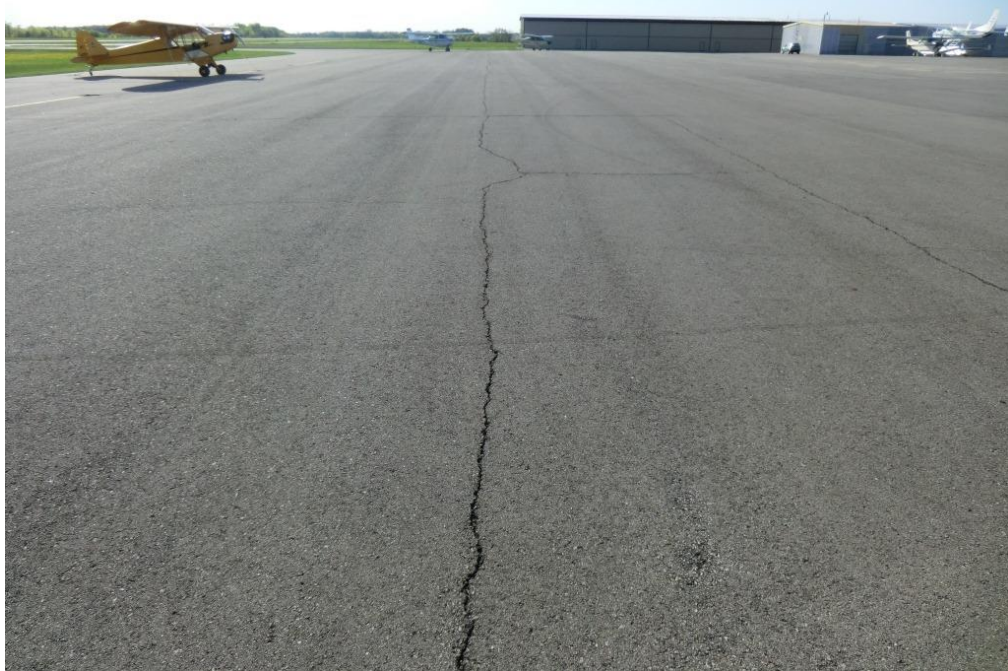
FBL PPTA1 001 (PCI = 82)

Conditions: PCI: 82

48 LONGITUDINAL/TRANSVERSE CRACKING L 242.00 Ft Comments:

48 LONGITUDINAL/TRANSVERSE CRACKING M 52.00 Ft Comments:

48 LONGITUDINAL/TRANSVERSE CRACKING L 132.00 Ft Comments:

48 LONGITUDINAL/TRANSVERSE CRACKING M 55.00 Ft Comments:

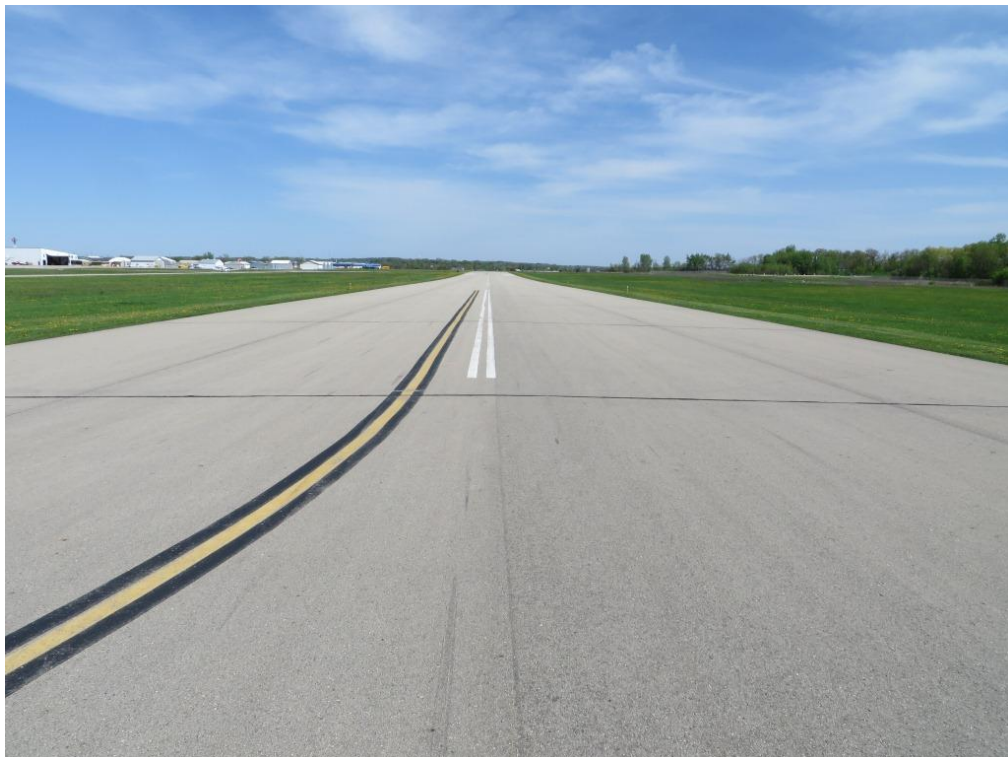
FBL RY1230 001 (PCI = 85)

Conditions: PCI : 85

48 LONGITUDINAL/TRANSVERSE CRACKING L 78.00 Ft Comments:

48 LONGITUDINAL/TRANSVERSE CRACKING M 20.00 Ft Comments:

48 LONGITUDINAL/TRANSVERSE CRACKING M 72.00 Ft Comments:

48 LONGITUDINAL/TRANSVERSE CRACKING L 131.00 Ft Comments:

48 LONGITUDINAL/TRANSVERSE CRACKING M 12.00 Ft Comments:

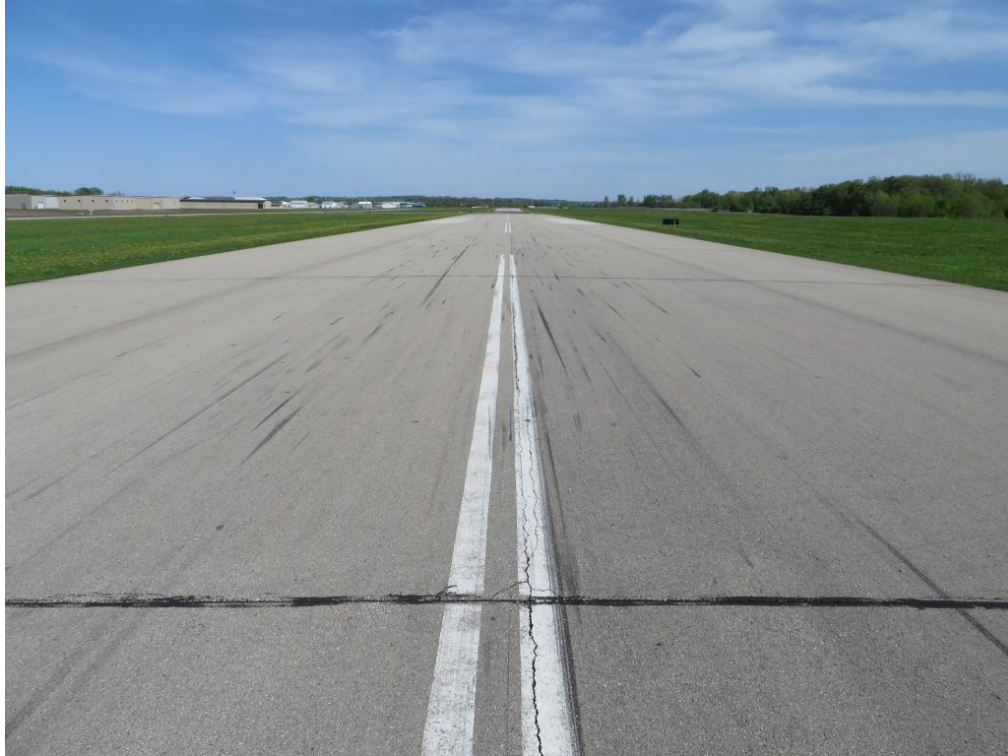
FBL RY1230 002 (PCI = 82)

Conditions: PCI : 82

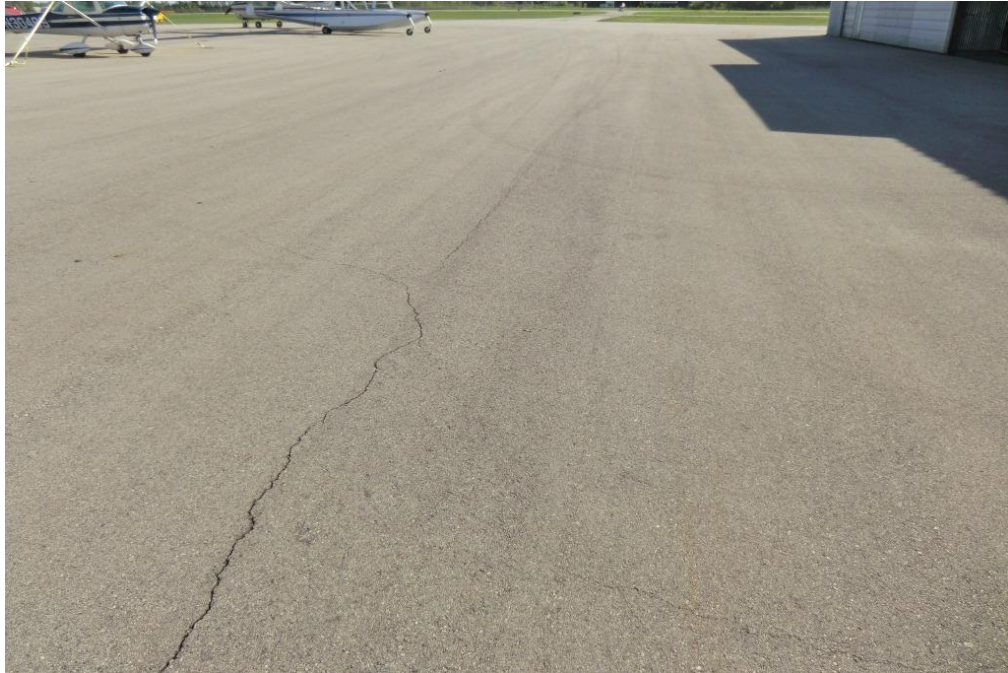
FBL TLE 001 (PCI = 89)

Branch ID	Section ID	Surface type ¹	Section area (SF)	LCD ²	2011 PCI	2014 PCI	Drop in PCI/Yr ³	% Deduct due to		Distress types
								Load ⁴	Climate ⁵	
APA	1	AC	107,850	2011	100	76	8.0	0	100	L&T cracking
APA	2	AC	11,643	2011	100	81	6.3	0	100	L&T cracking
CTA	2	AC	21,050	1980	66	64	1.1	37	63	alligator cracking, L&T cracking
CTB	2	AC	12,900	1980	77	76	0.7	0	100	L&T cracking
CTC	1	AC	9,575	2011	100	90	3.3	0	100	L&T cracking
PPTA	1	AC	133,600	2011	100	89	3.7	0	100	L&T cracking
PPTA1	1	AC	25,300	2011	100	82	6.0	0	100	L&T cracking
RY1230	1	AC	219,204	2011	100	85	5.0	0	100	L&T cracking
RY1230	2	AC	97,500	2011	100	82	6.0	0	100	L&T cracking
TLA	1	AC	43,000	1993	59	45	2.6	17	82	multiple and extensive
TLB	1	AAC	22,500	2005	77	68	3.6	0	89	L&T cracking, swelling
TLC	1	AAC	11,250	2005	53	53	5.2	0	32	depression, L&T cracking, swelling
TLD	1	AAC	12,000	2005	56	49	5.7	31	39	Alligator and L&T cracking, swelling
TLE	1	AC	32,364	2011	100	89	3.7	0	100	L&T cracking

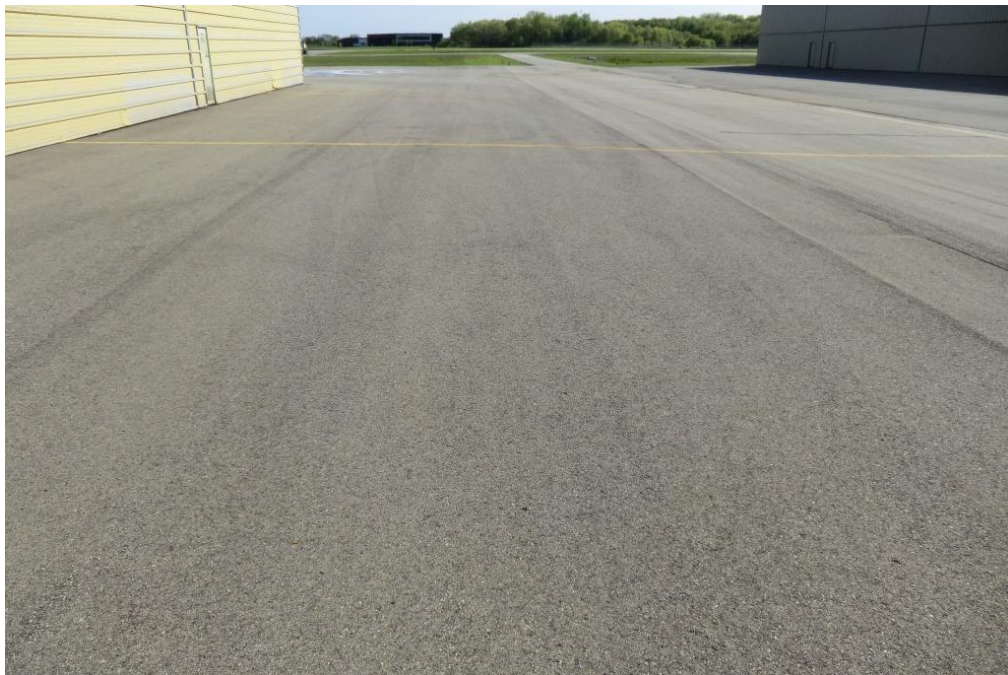
FBL TLE 002 (PCI = 88)

TLE	2	AC	7,990	2011	100	88	4.0	0	100	L&T cracking
TLF	1	AC	17,400	2011	100	92	2.7	0	85	L&T cracking, swelling
TLG	1	AC	30,450	2006	71	57	5.4	47	53	alligator and L&T cracking, patching
TLH	1	AC	17,771	2012	71	100	0.0	0	0	no distress
