Final Report

Pavement Condition Report

Fairmont Municipal Airport (FRM)

December 2014

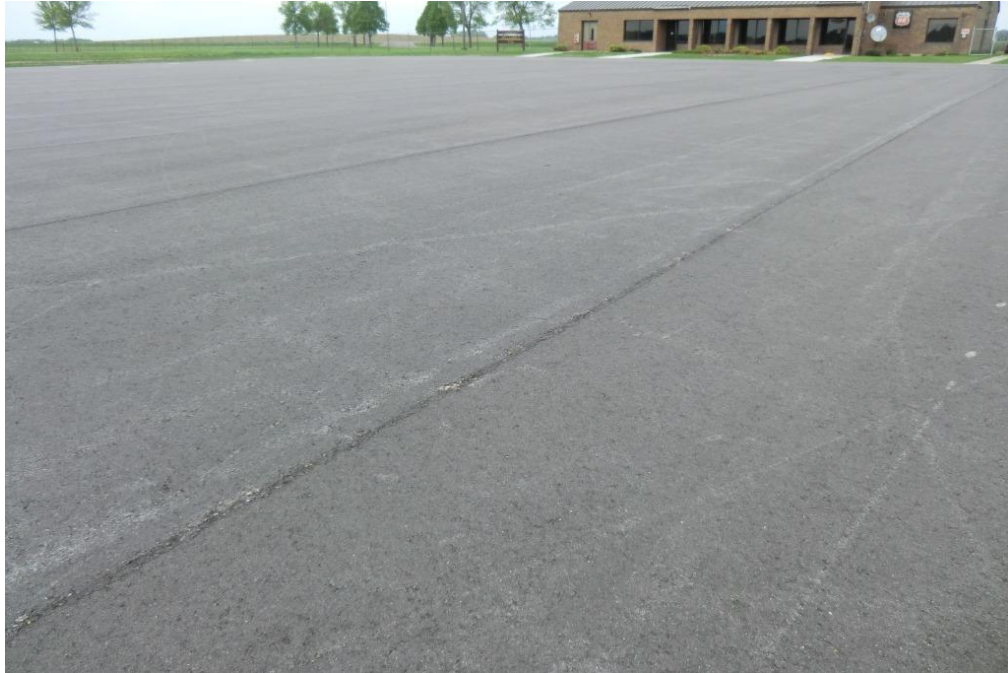
FRM APA 001 (PCI = 100)

Conditions: PCI: 100

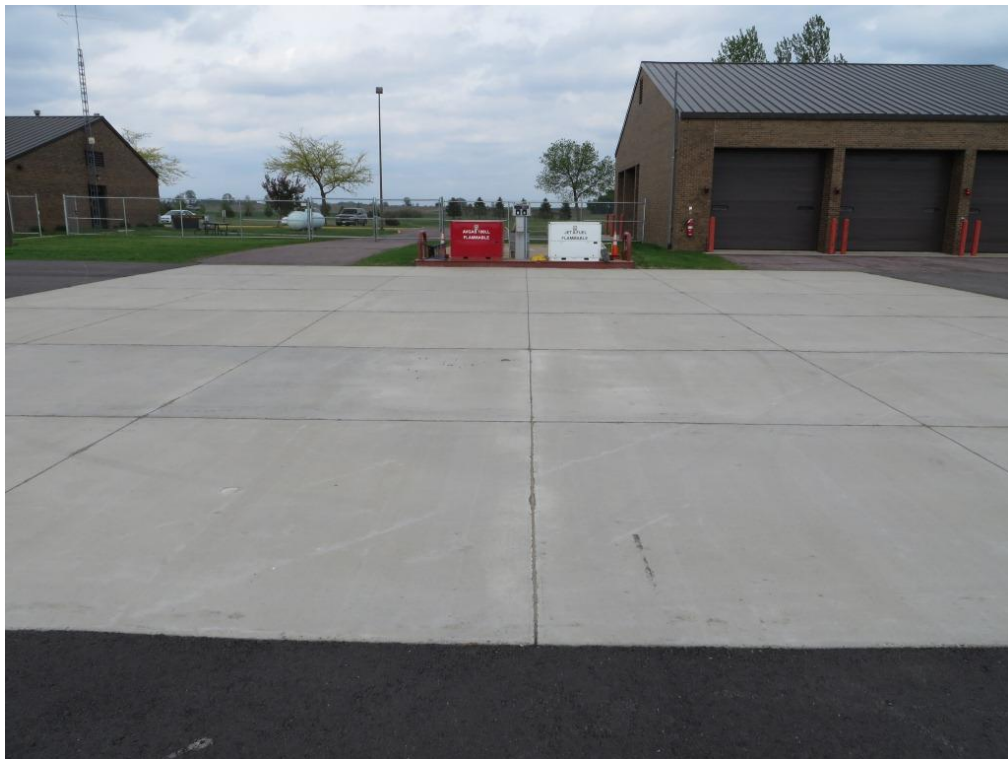
FRM APA 002 (PCI = 100)

Conditions: PCI : 100

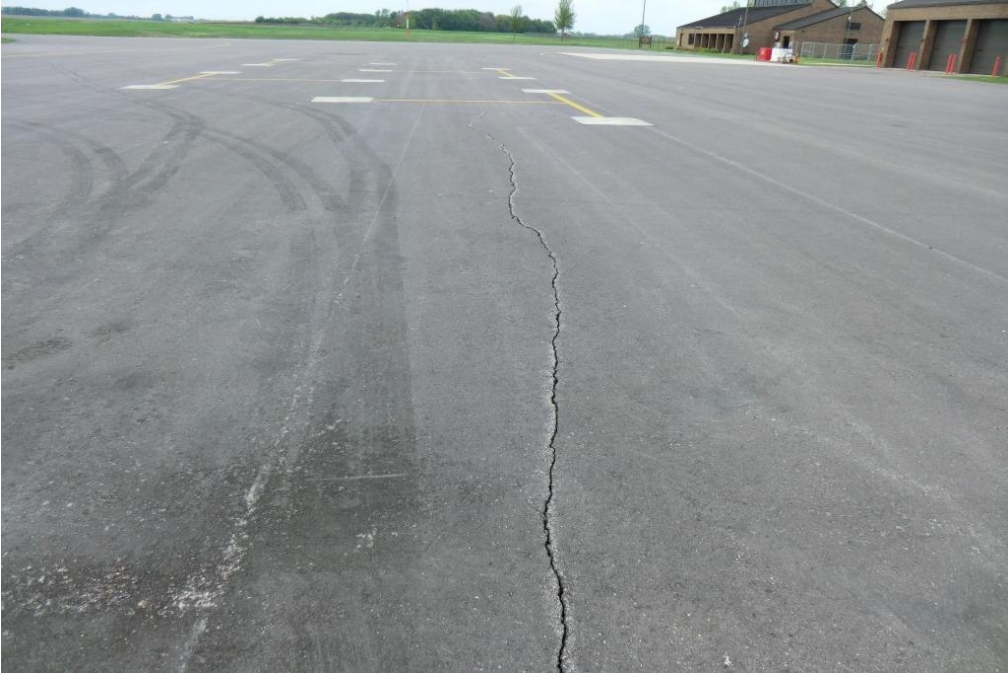
FRM APA 003 (PCI = 83)

Conditions: PCI : 83

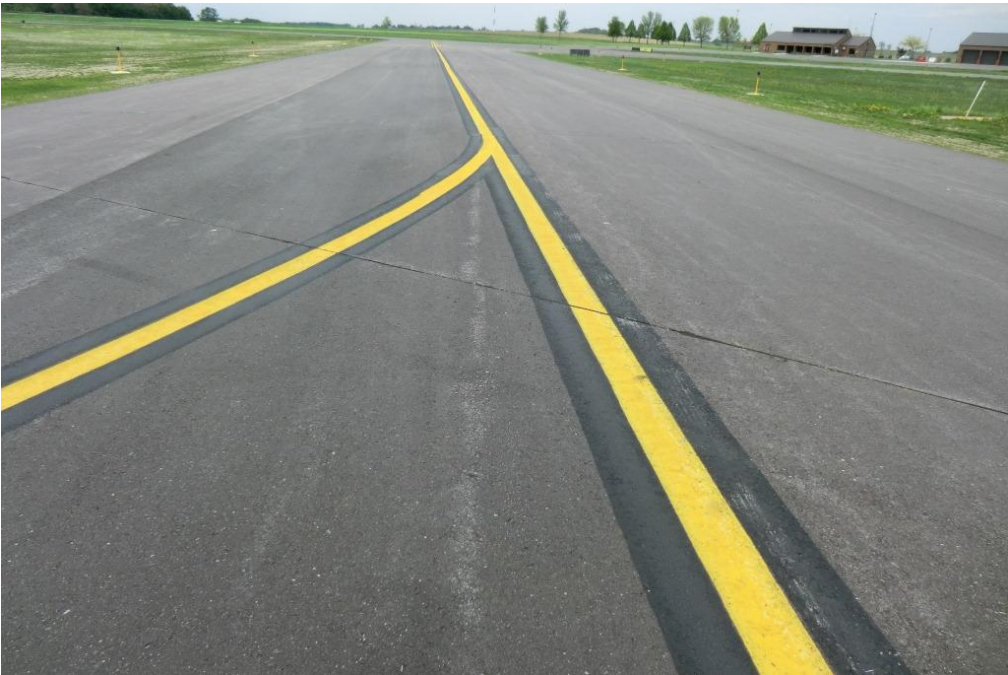
FRM CTB 001 (PCI = 100)

Conditions: PCI: 100

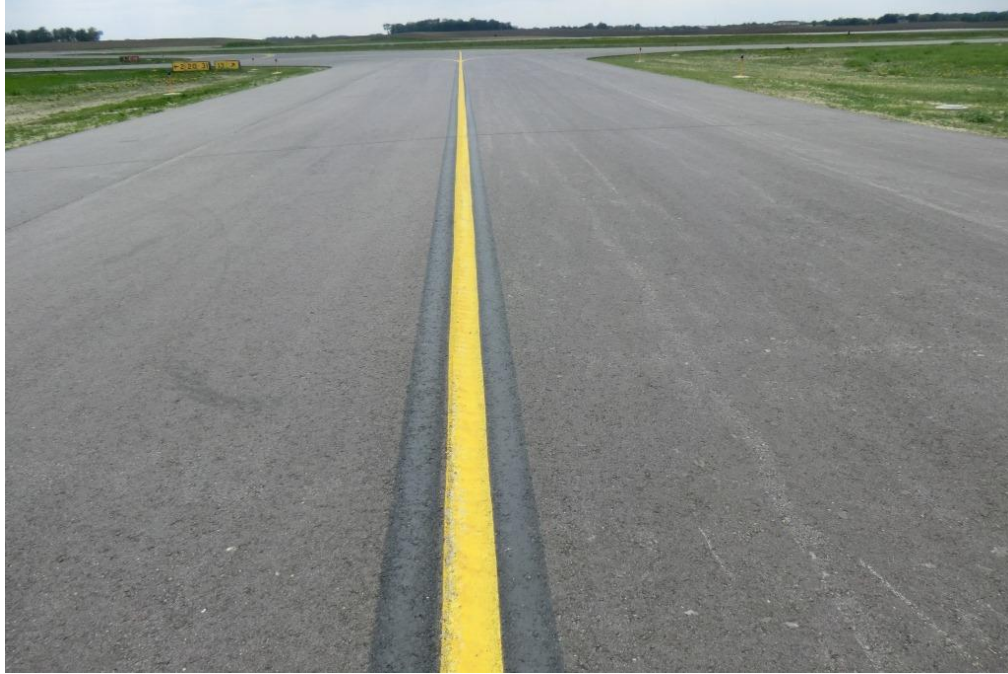
FRM CTBX 001 (PCI = 100)

Conditions: PCI: 100

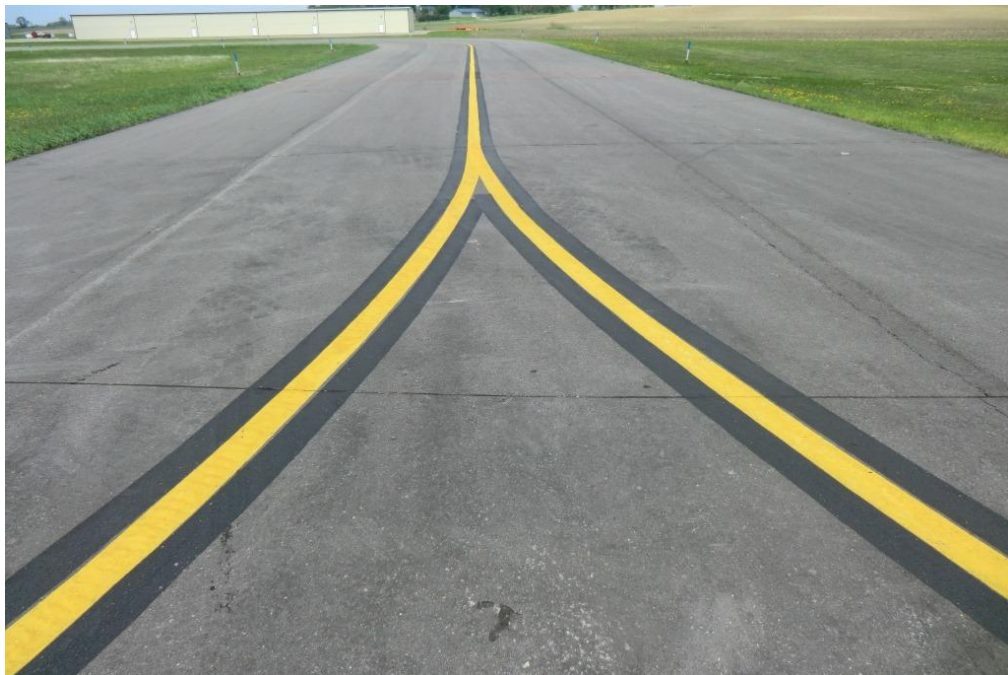
FRM CTC 001 (PCI = 92)

Conditions: PCI: 92

48 LONGITUDINAL/TRANSVERSE CRACKING L 140.00 Ft Comments:

48 LONGITUDINAL/TRANSVERSE CRACKING L 44.00 Ft Comments:

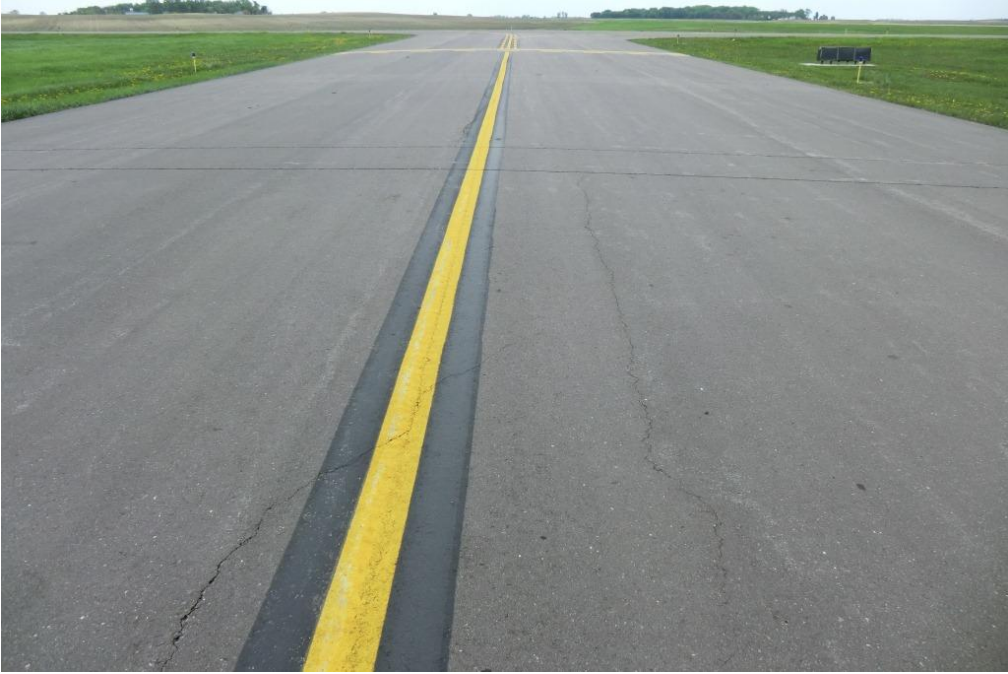
FRM CTE 001 (PCI = 86)

Conditions: PCI: 86

48 LONGITUDINAL/TRANSVERSE CRACKING L 235.00 Ft Comments:

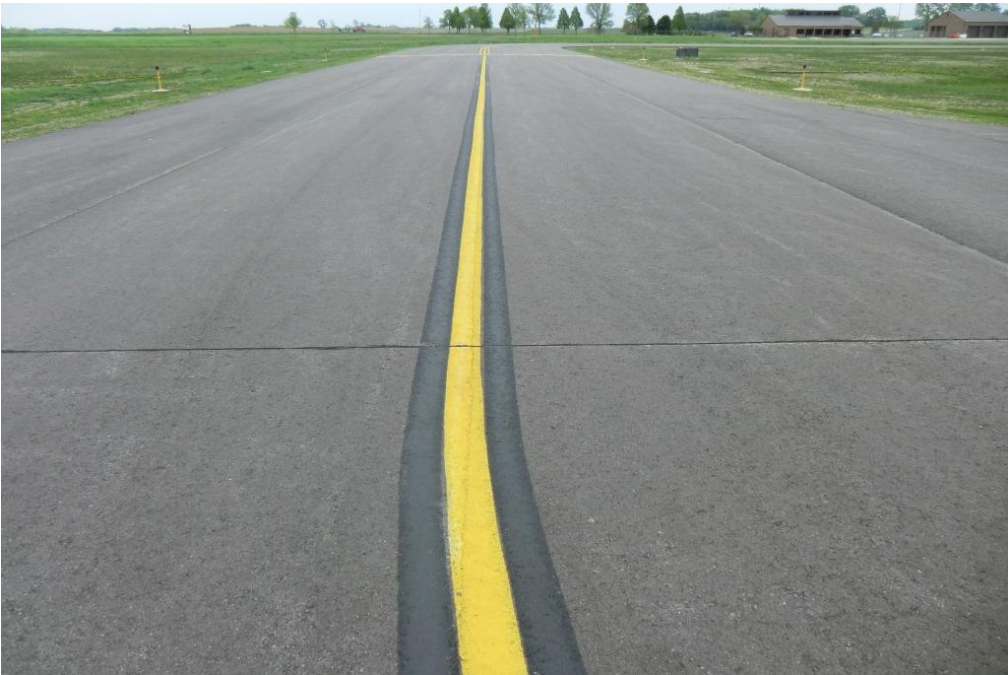
FRM PTA 001 (PCI = 100)

Conditions: PCI: 100

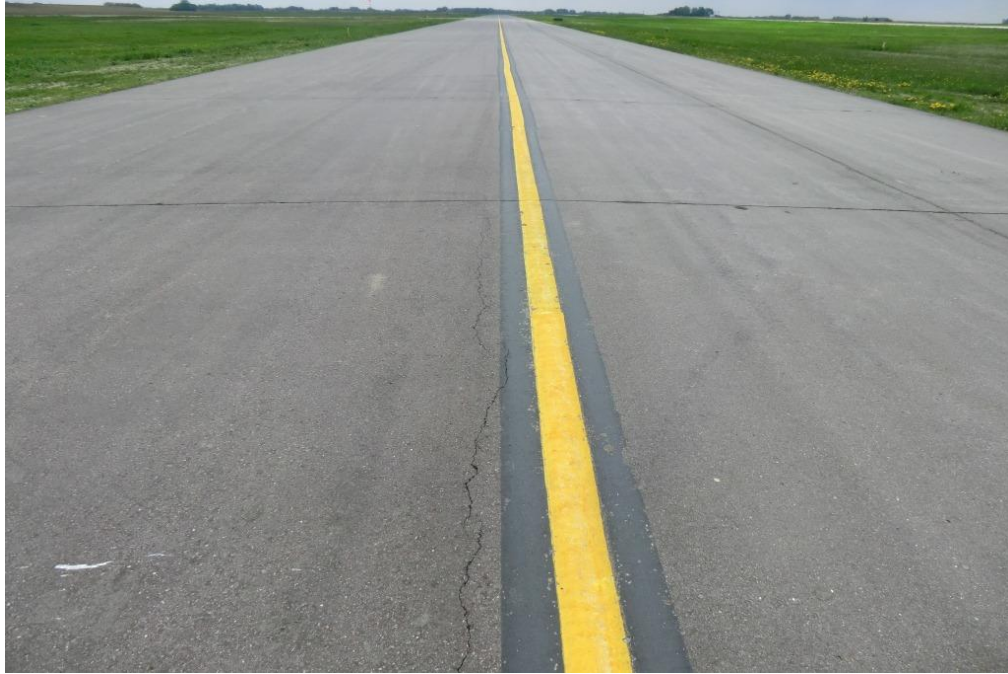
FRM PTA 002 (PCI = 93)

Conditions: PCI: 93

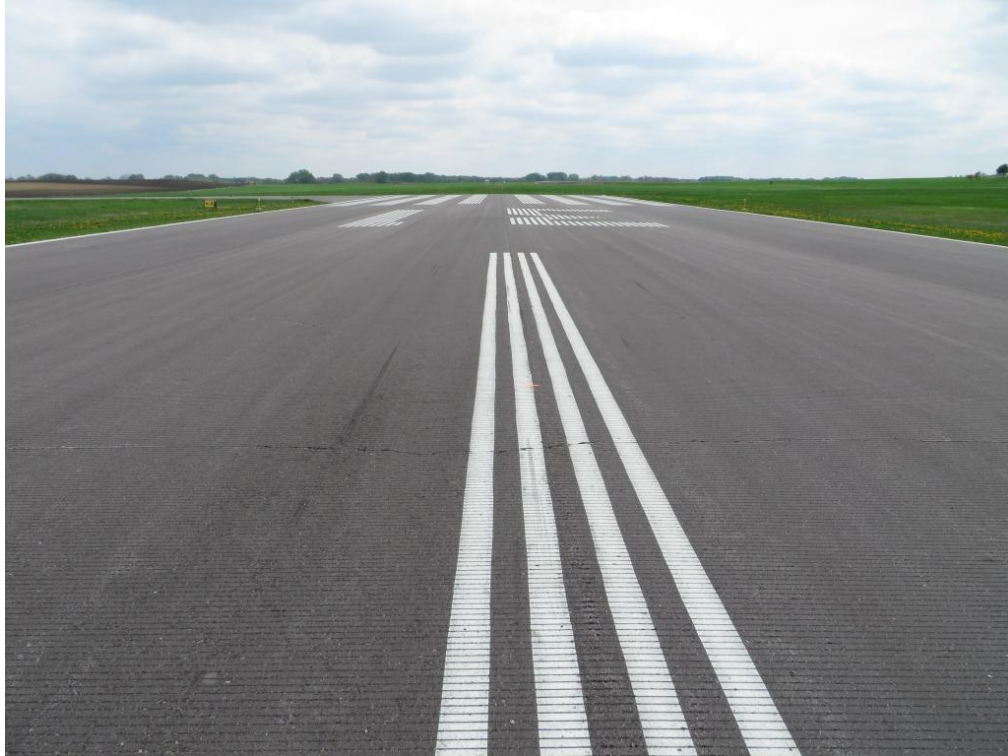
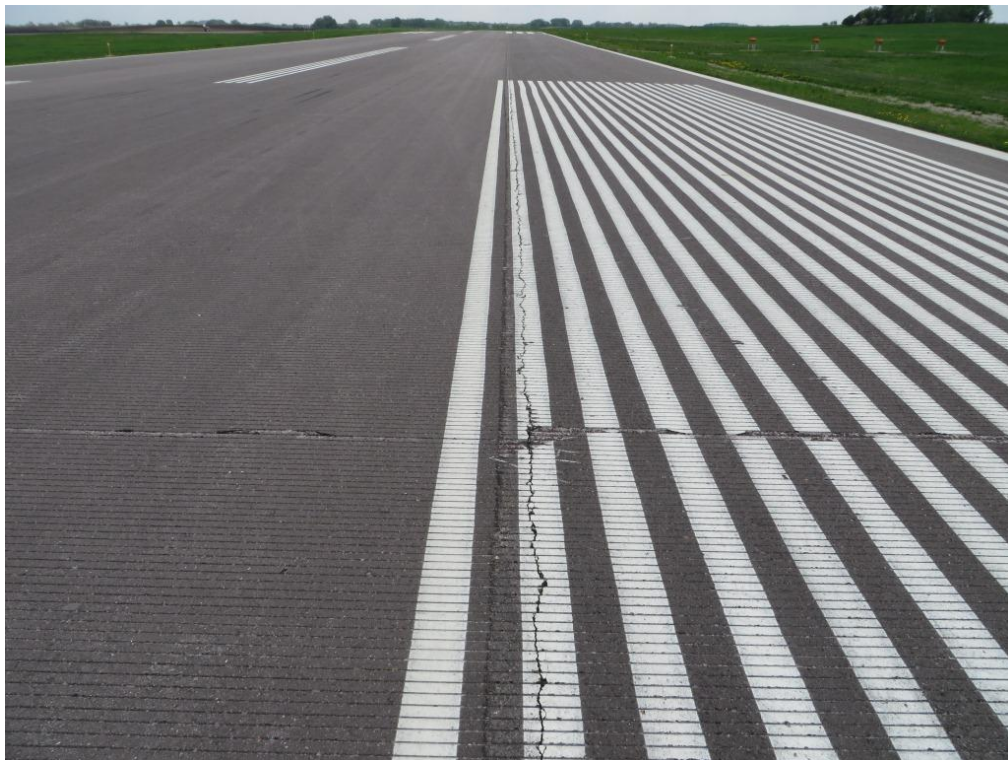
FRM RY1331 001 (PCI = 87)

Conditions: PCI: 87
