# Pavement Condition Report

## Hibbing-Range Regional Airport (HIB)

**December 2014**

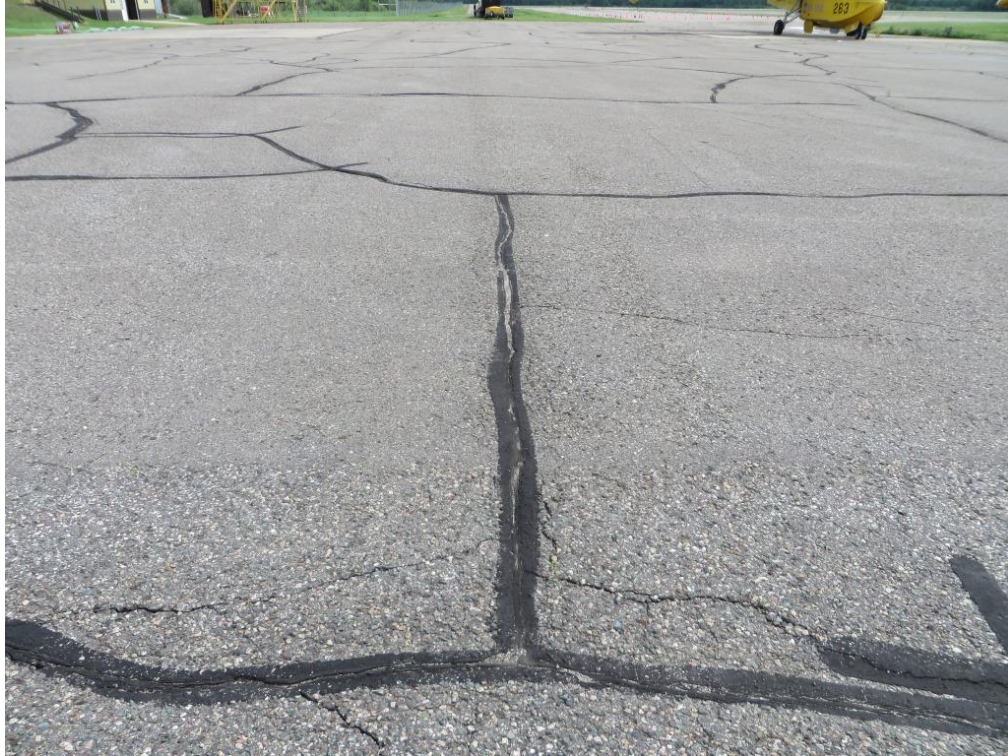
HIB ADNR 001 (PCI = 28)

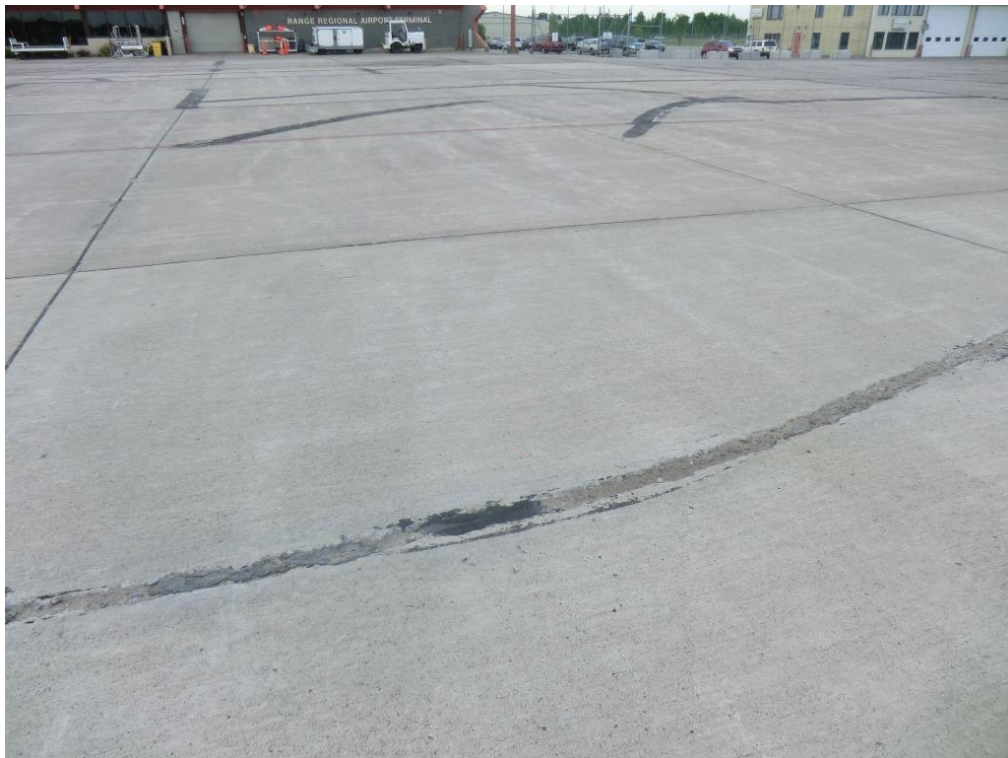
HIB APA 001 (PCI = 27)

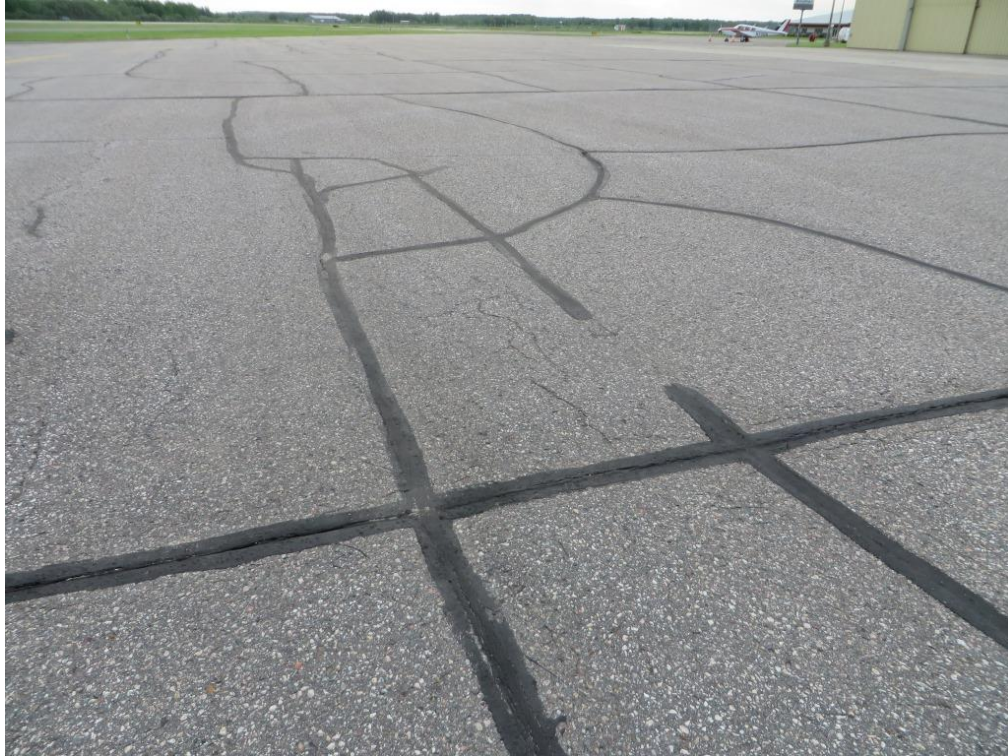
HIB APA 002 (PCI = 32)

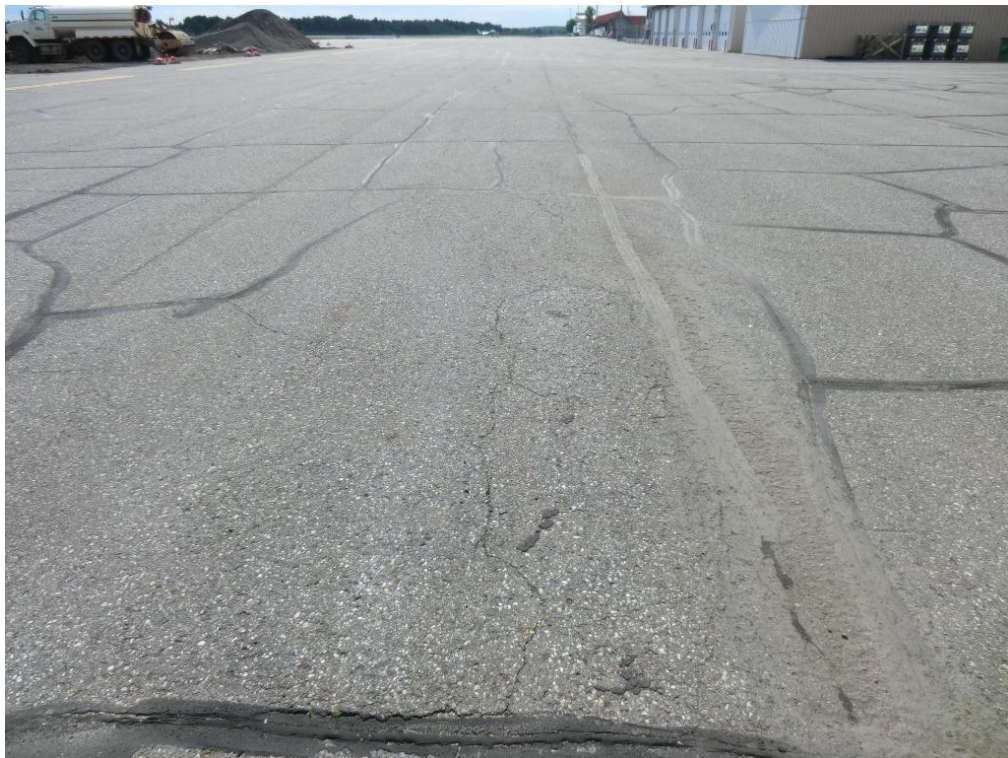
HIB APA 003 (PCI = 28)

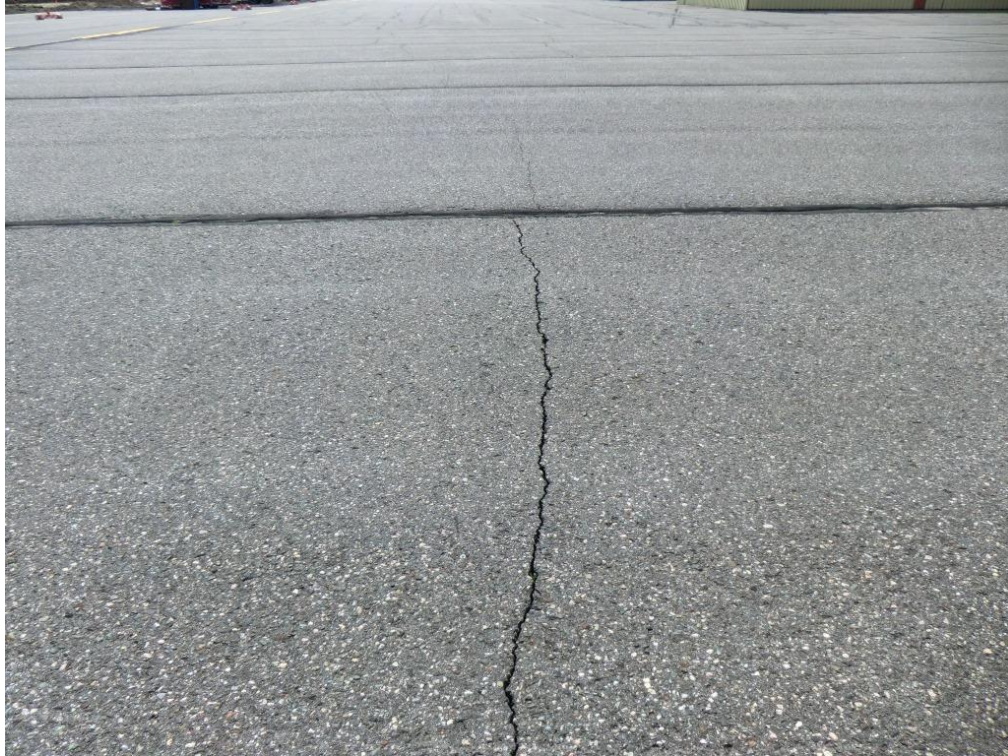
HIB APA 004 (PCI = 51)

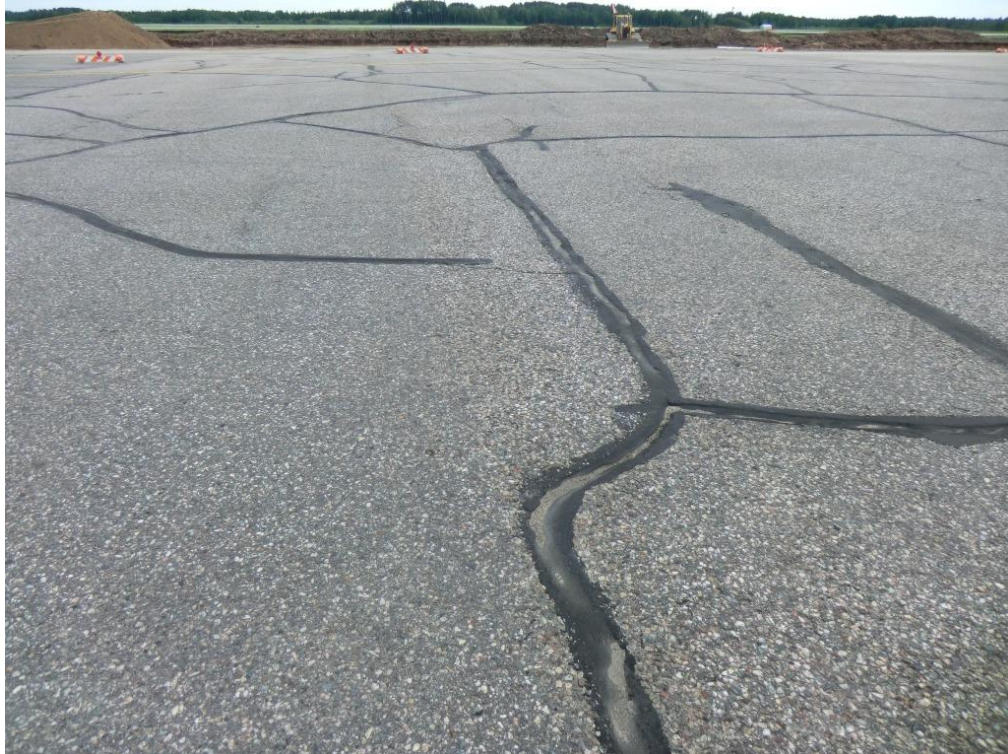
HIB APA 005 (PCI = 36)

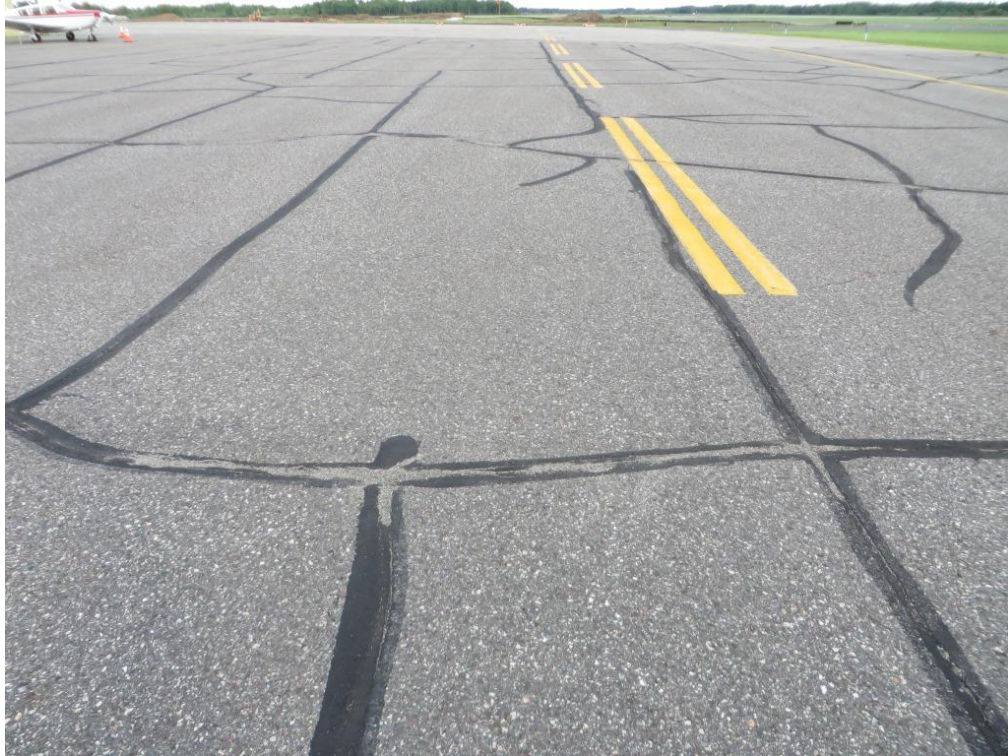
HIB APB 001 (PCI = 54)

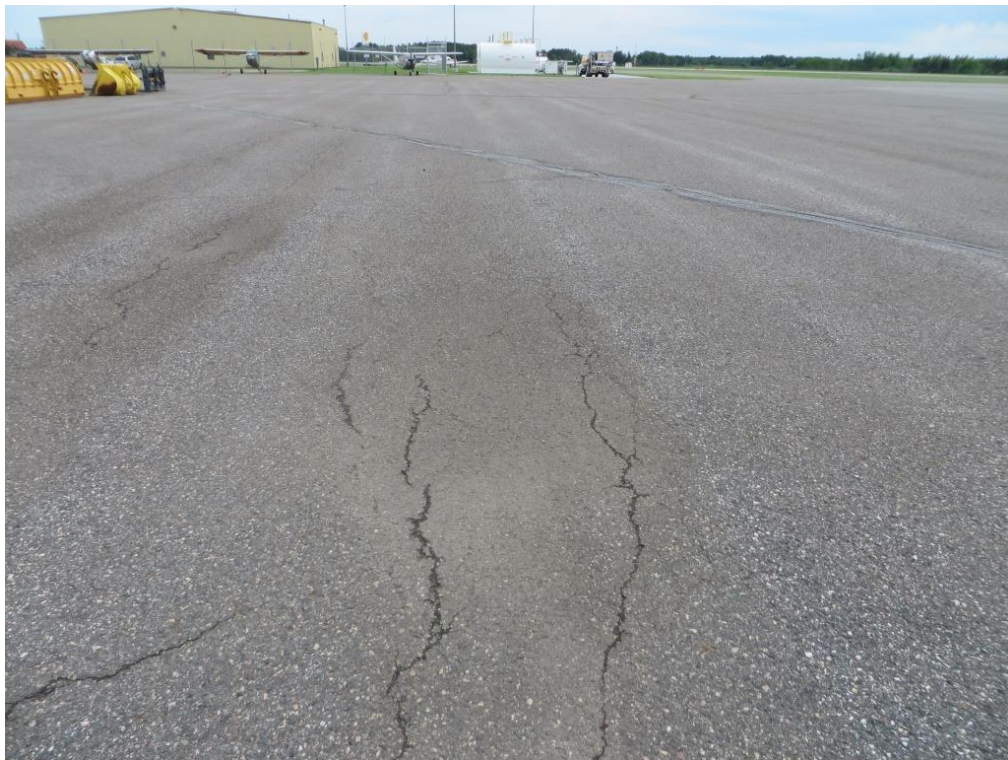
HIB APC 001 (PCI = 60)

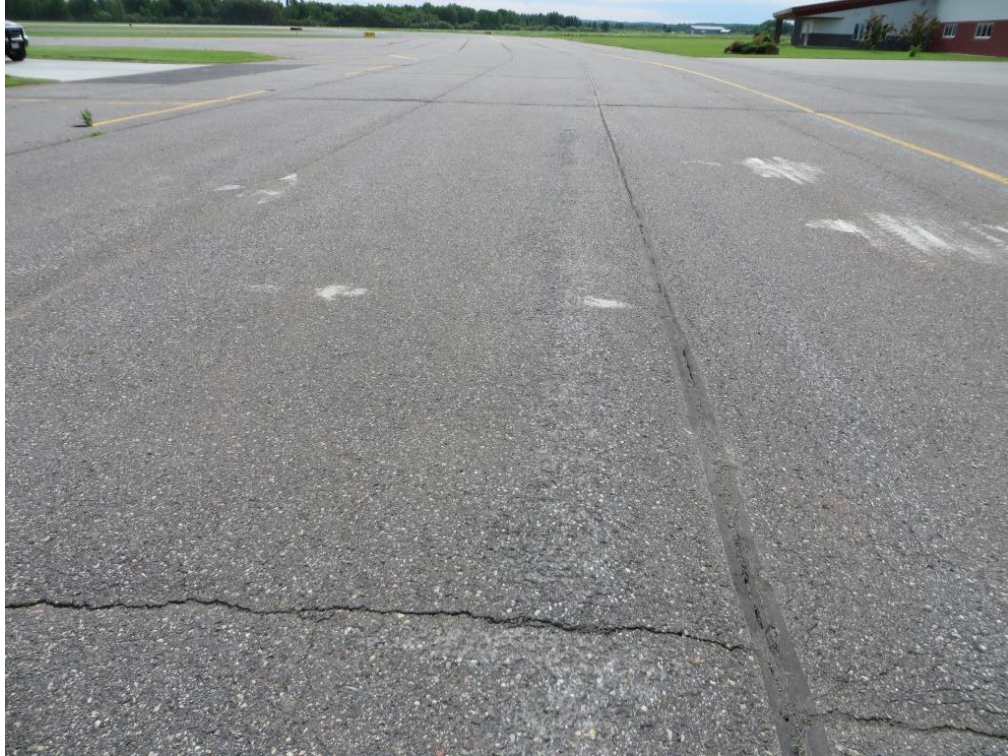
HIB APC 002 (PCI = 46)

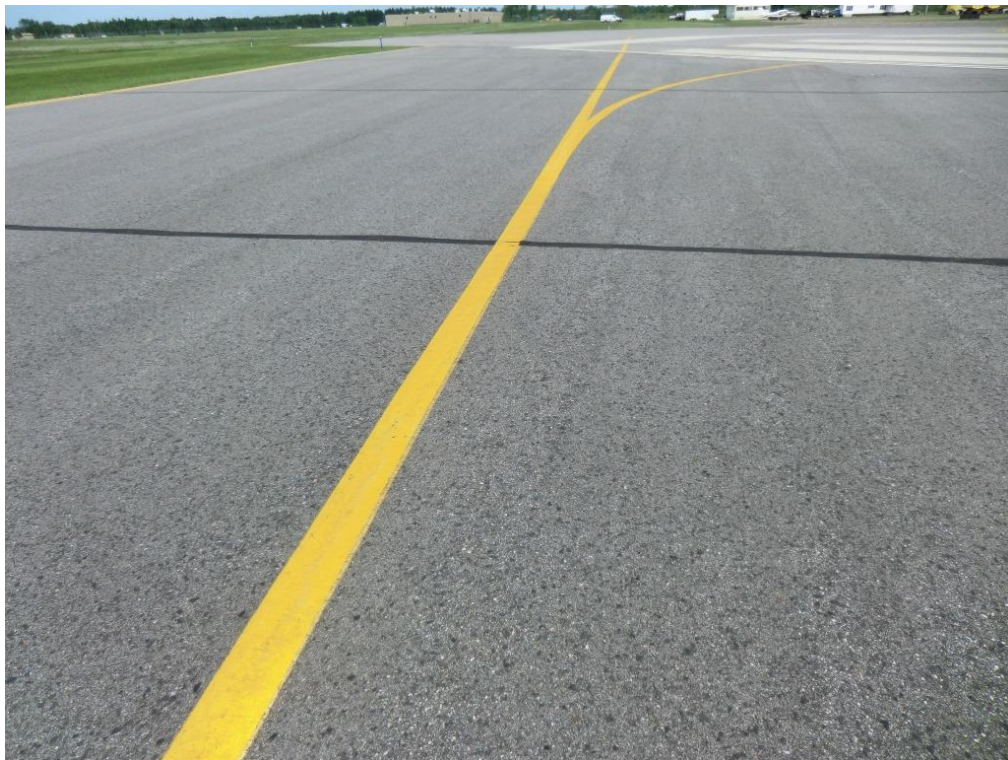
HIB CTA 001 (PCI=100)

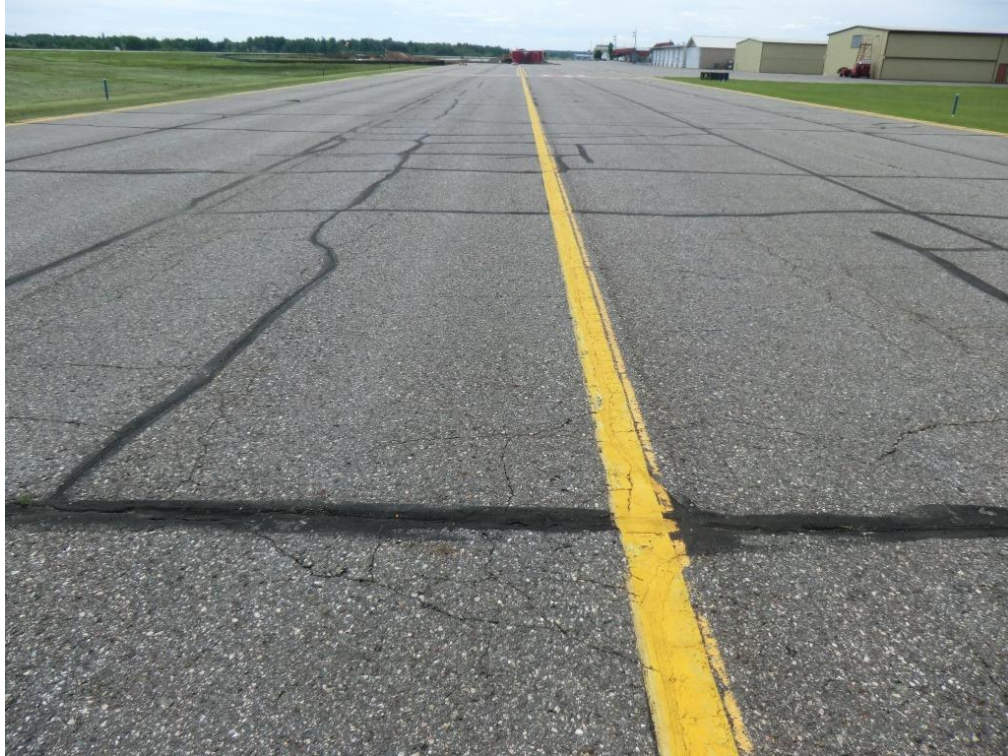
HIB CTA 002 (PCI = 33)

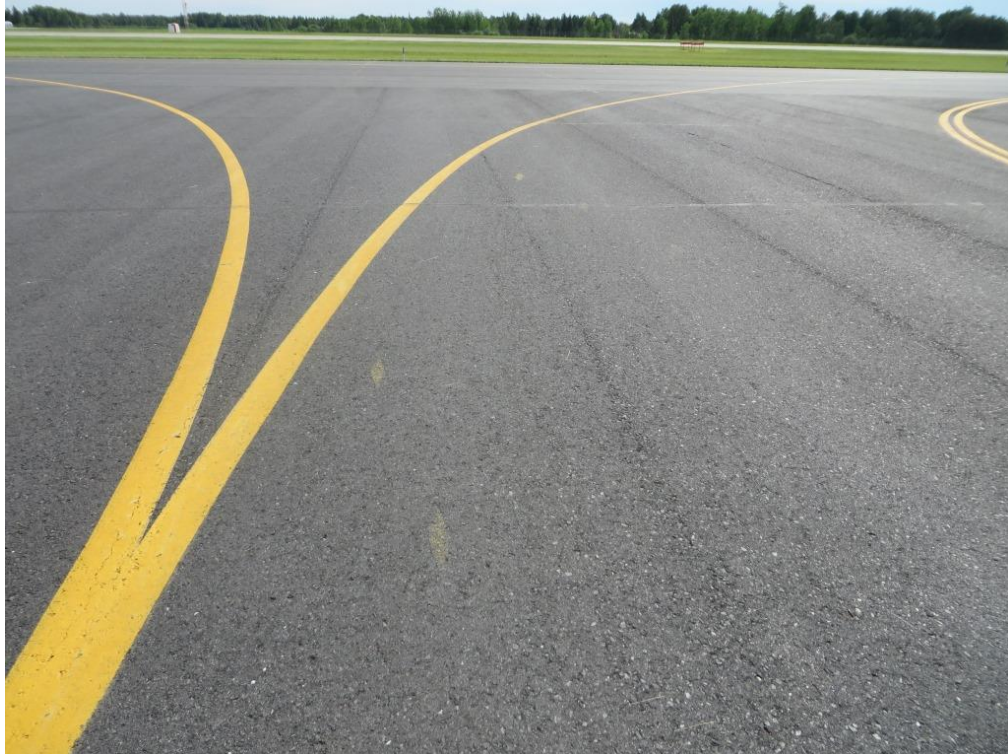
HIB CTA 003 (PCI = 92)

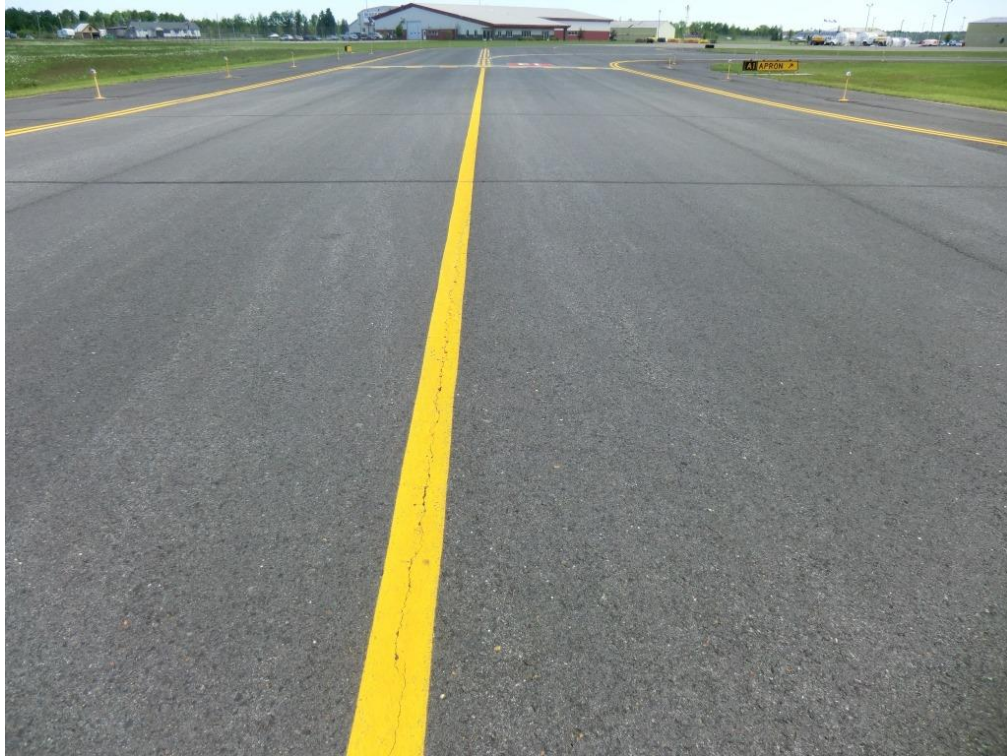
HIB CTA1 001 (PCI = 90)

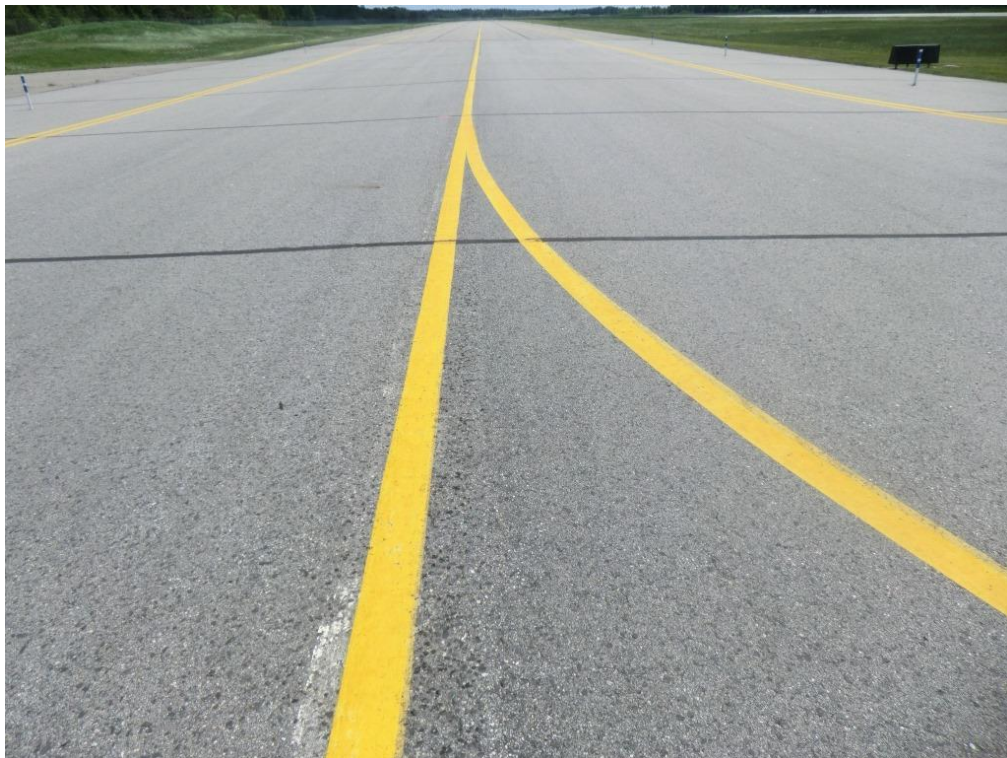
HIB CTB 001 (PCI = 98)

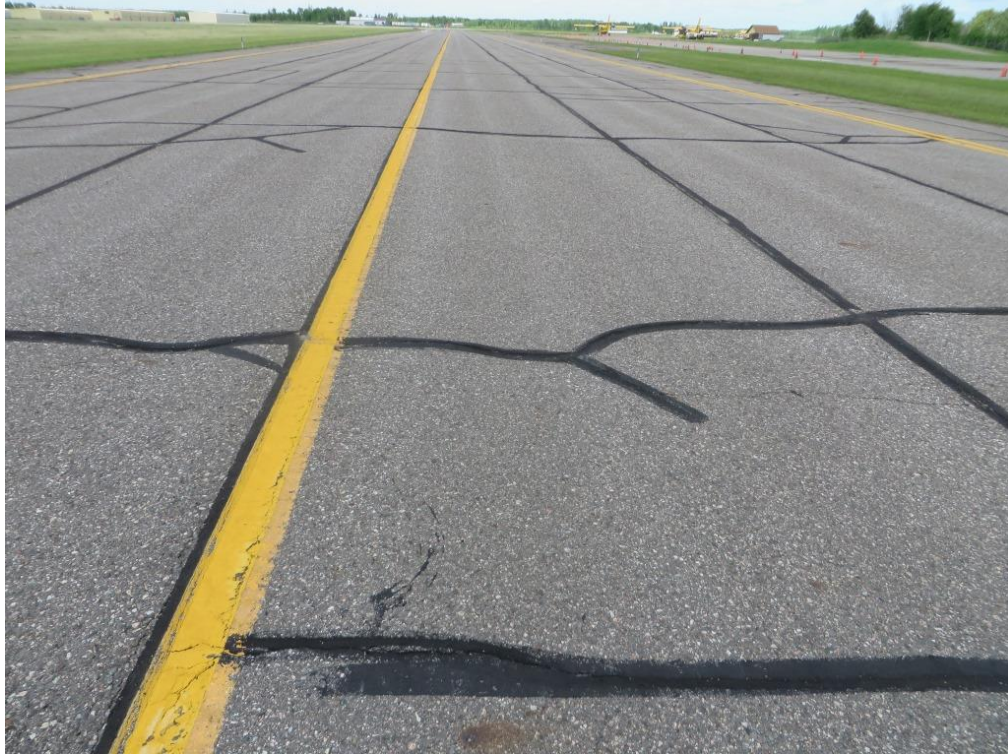
HIB CTB 002 (PCI = 49)

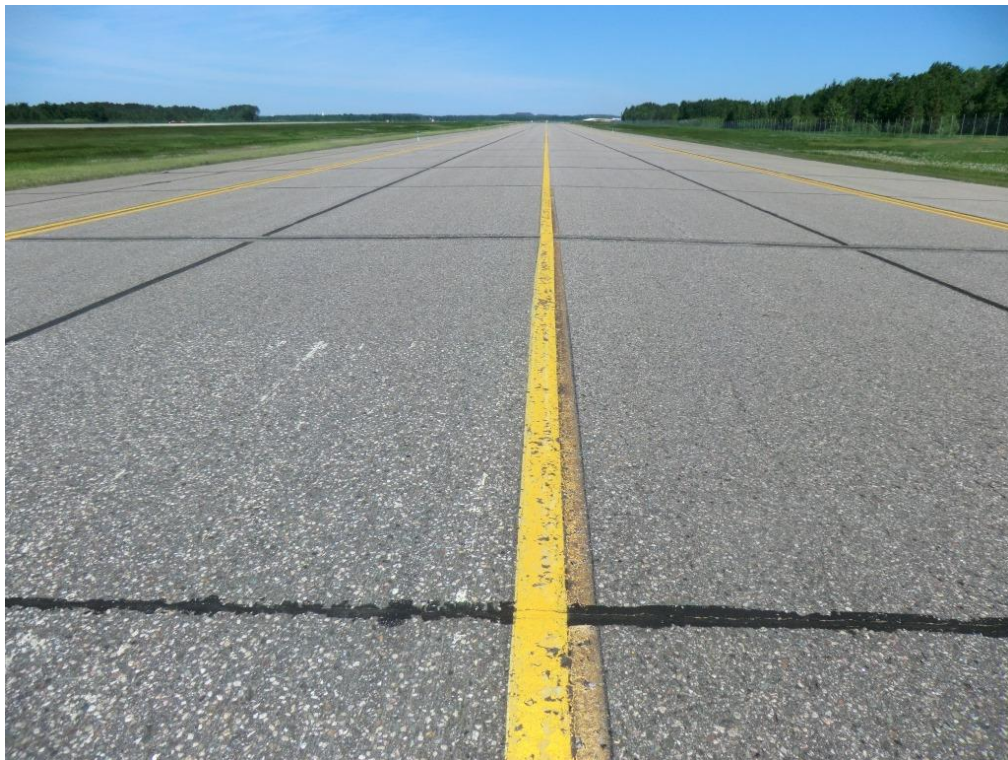
HIB PTC 001 (PCI = 52)

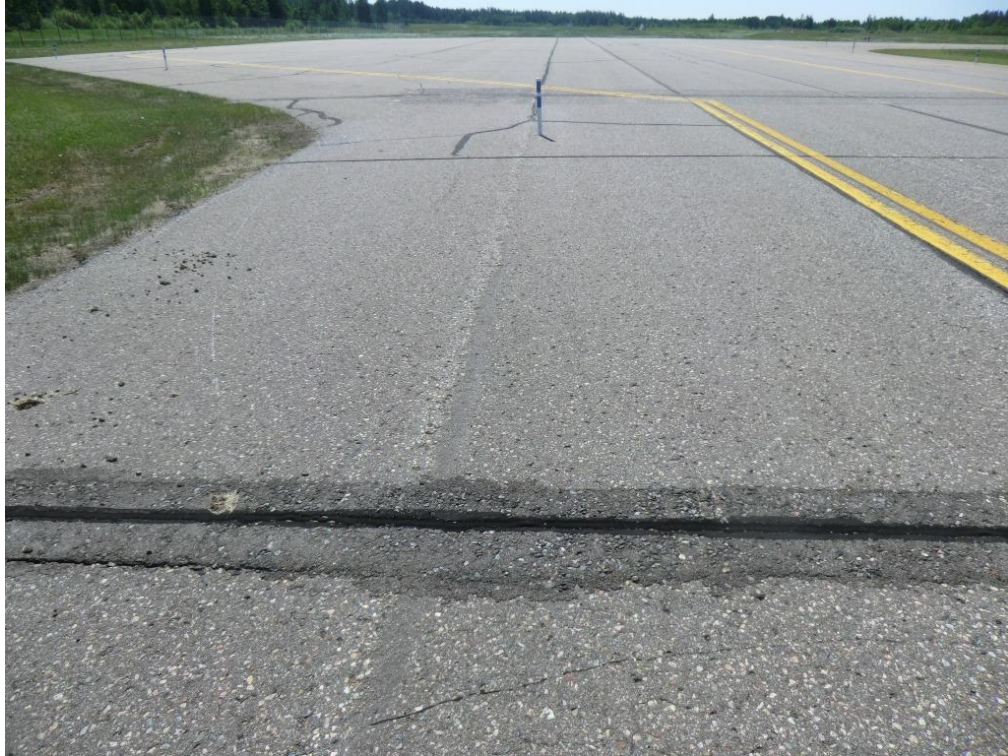
HIB PTC 002 (PCI = 54)

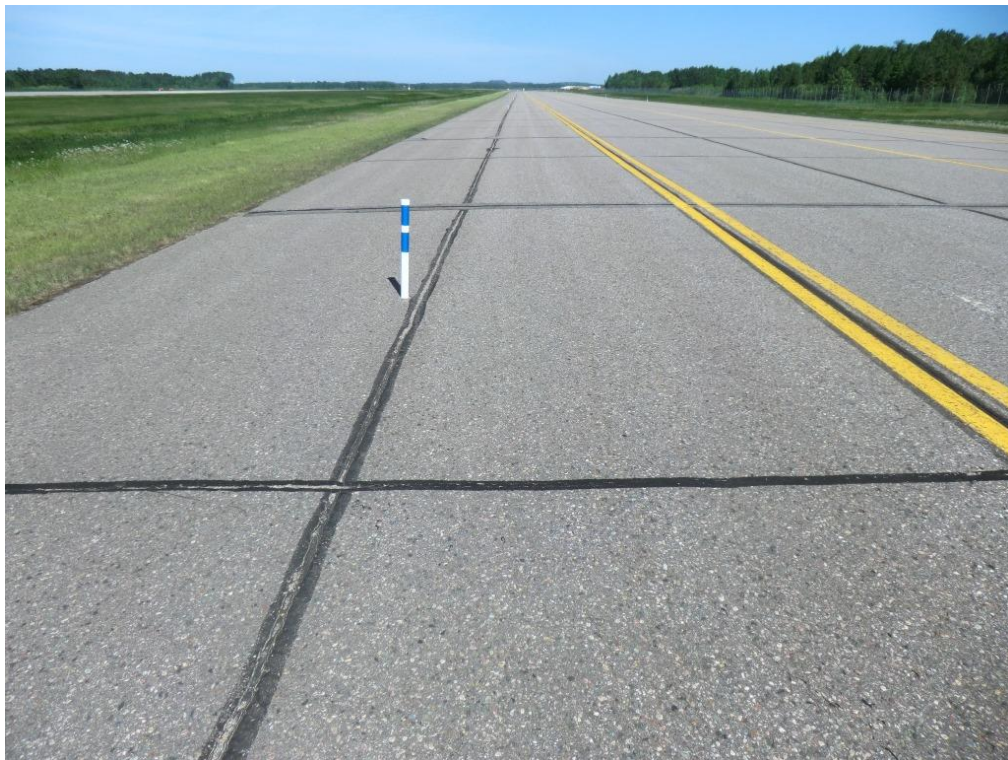
HIB PTC 003 (PCI = 57)

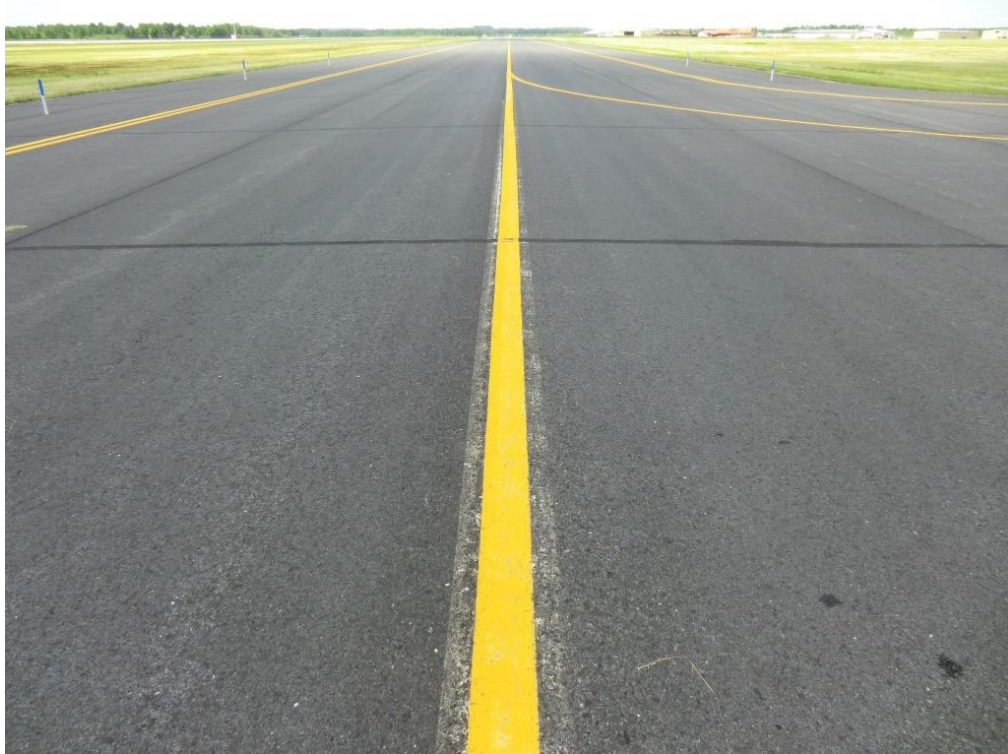
HIB PTC 004 (PCI = 86)

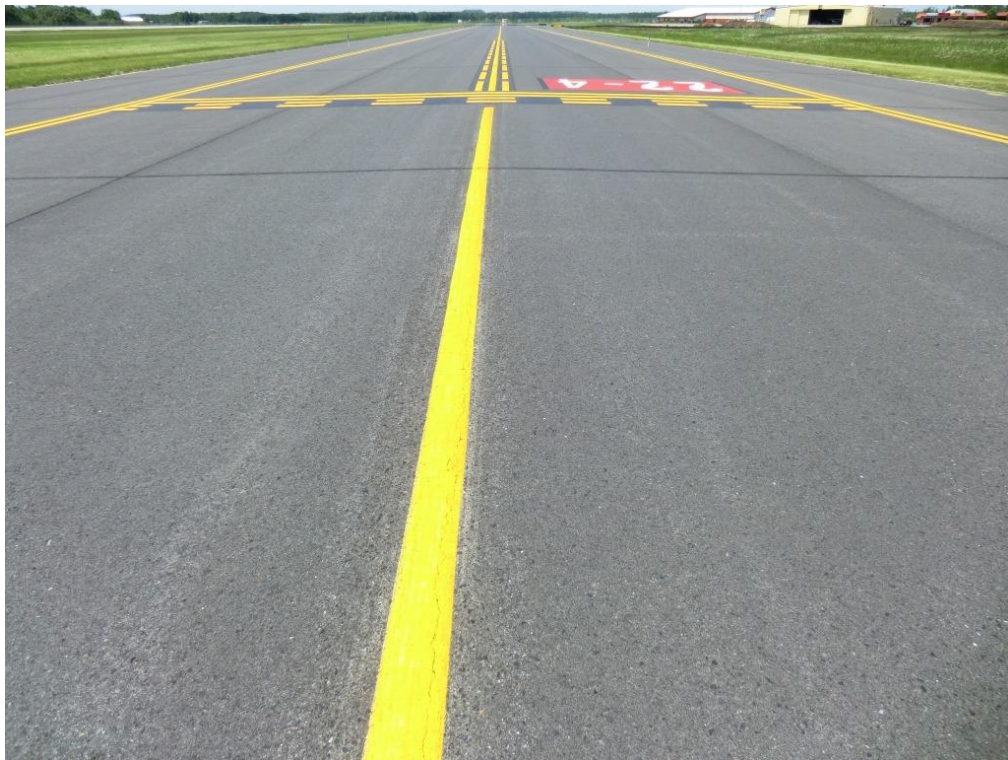
HIB PTC 005 (PCI 87)

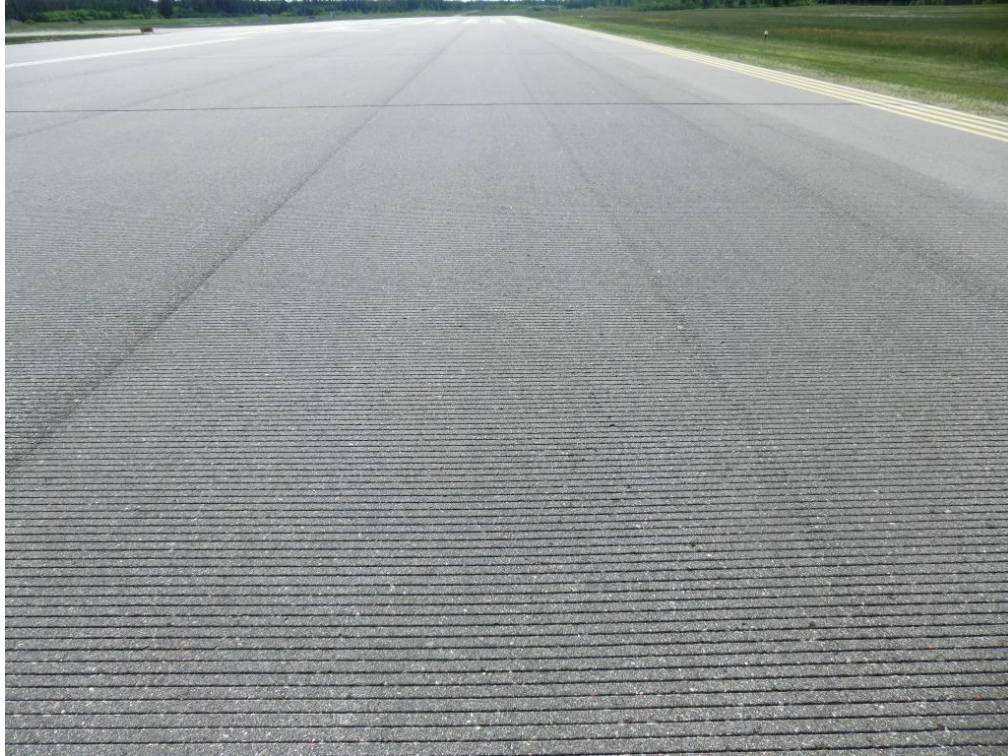
HIB RY1331 001 (PCI = 96)

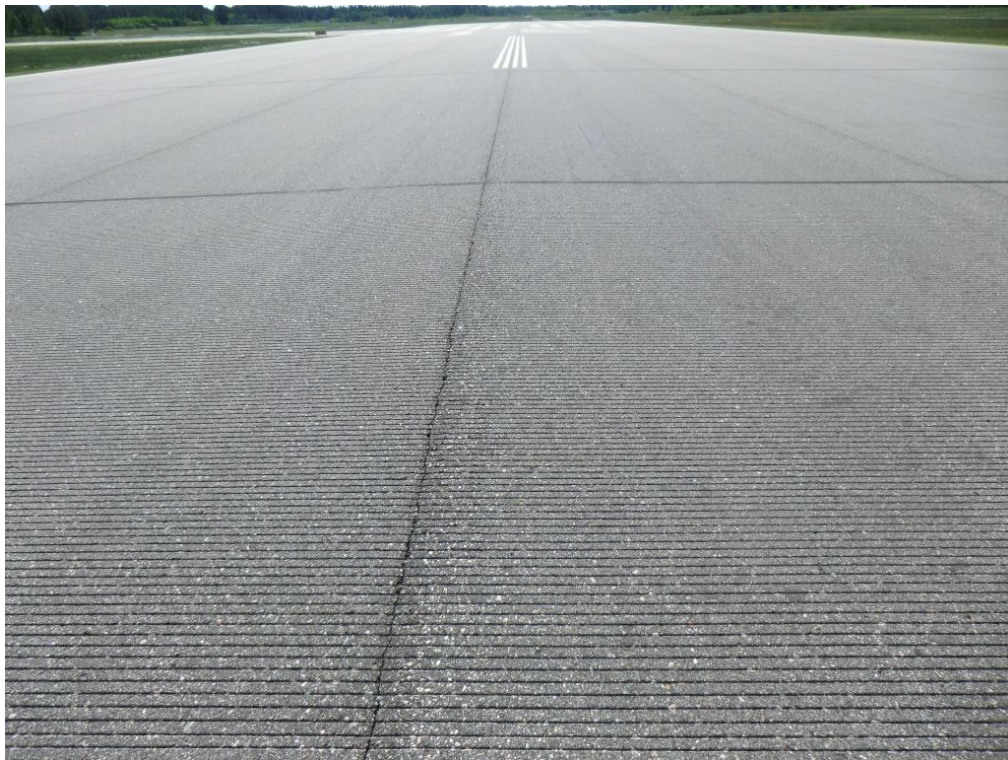
HIB RY1331 002 (PCI = 93)

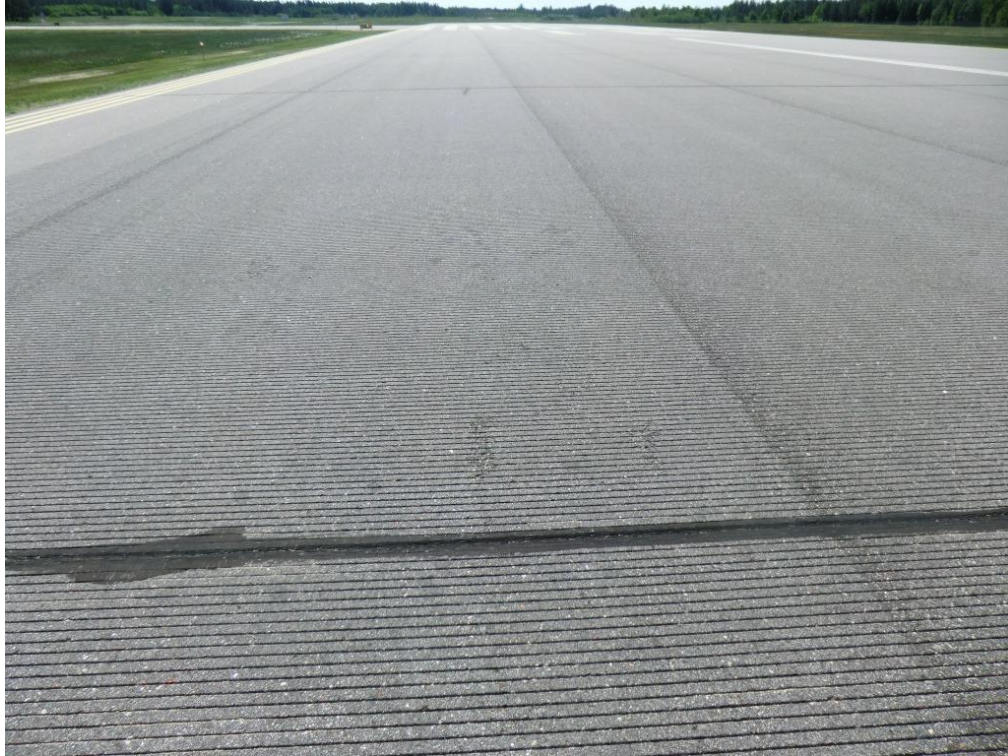
HIB RY1331 003 (PCI = 95)

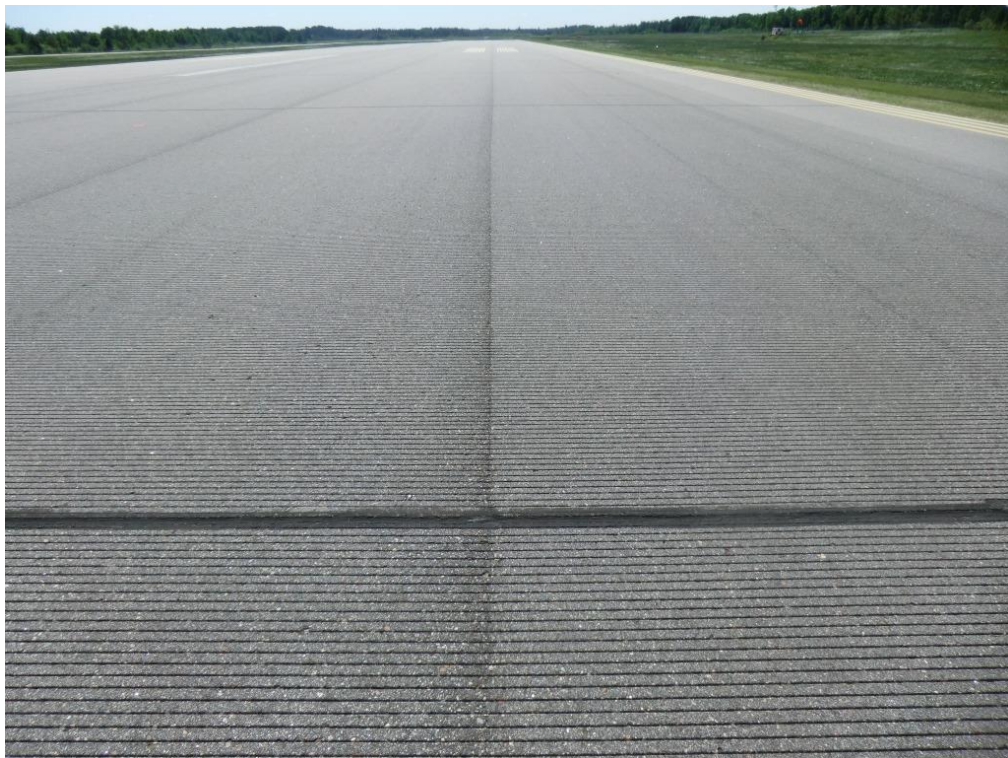
HIB RY1331 004 (PCI = 95)

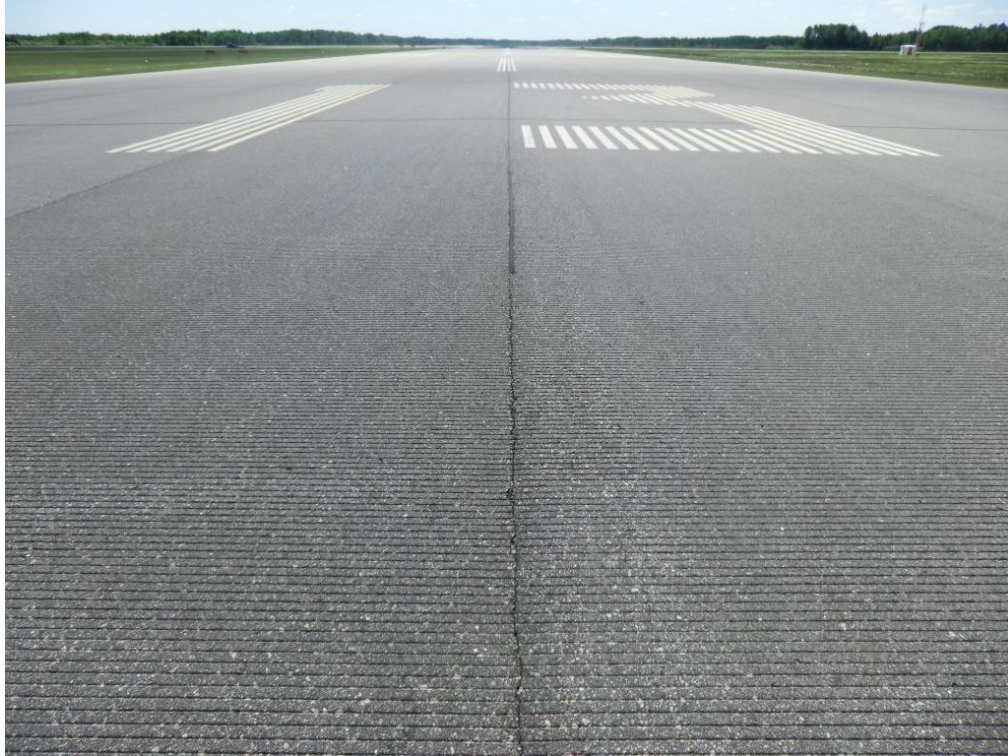
HIB RY1331 005 (PCI = 91)

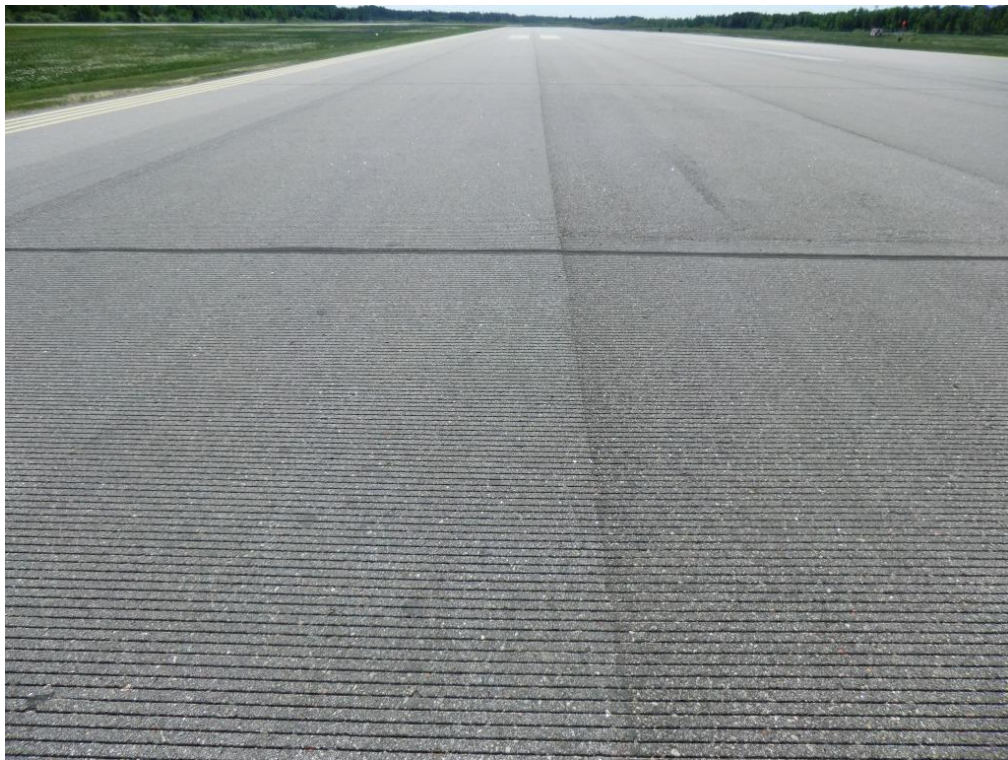
HIB RY1331 006 (PCI = 97)

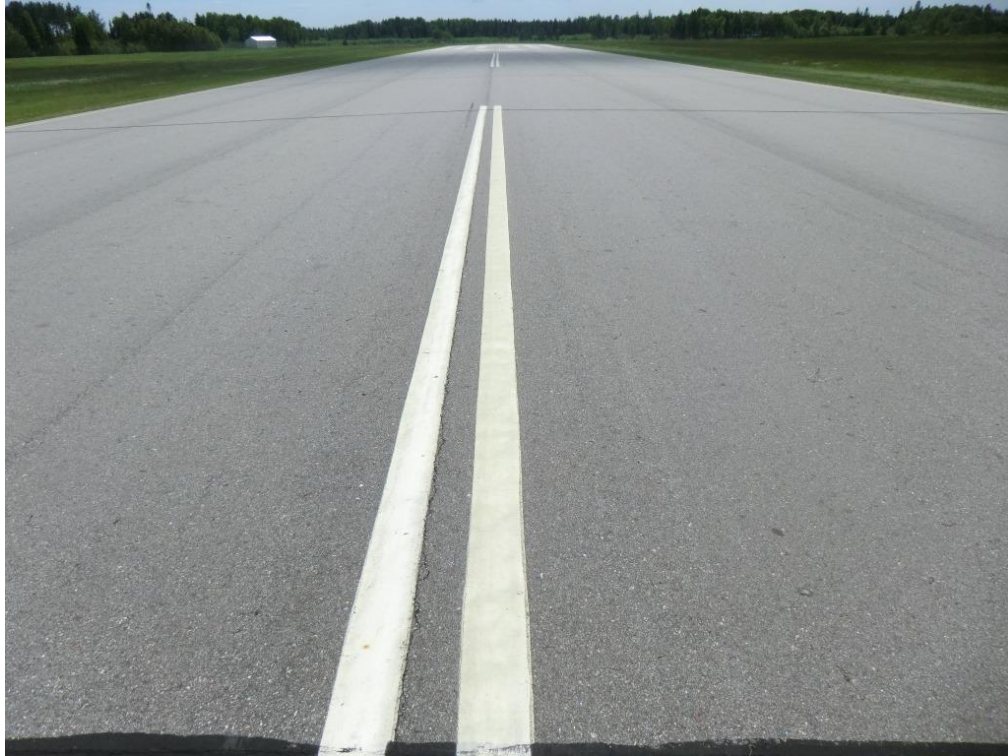
HIB RY422 001 (PCI = 97)

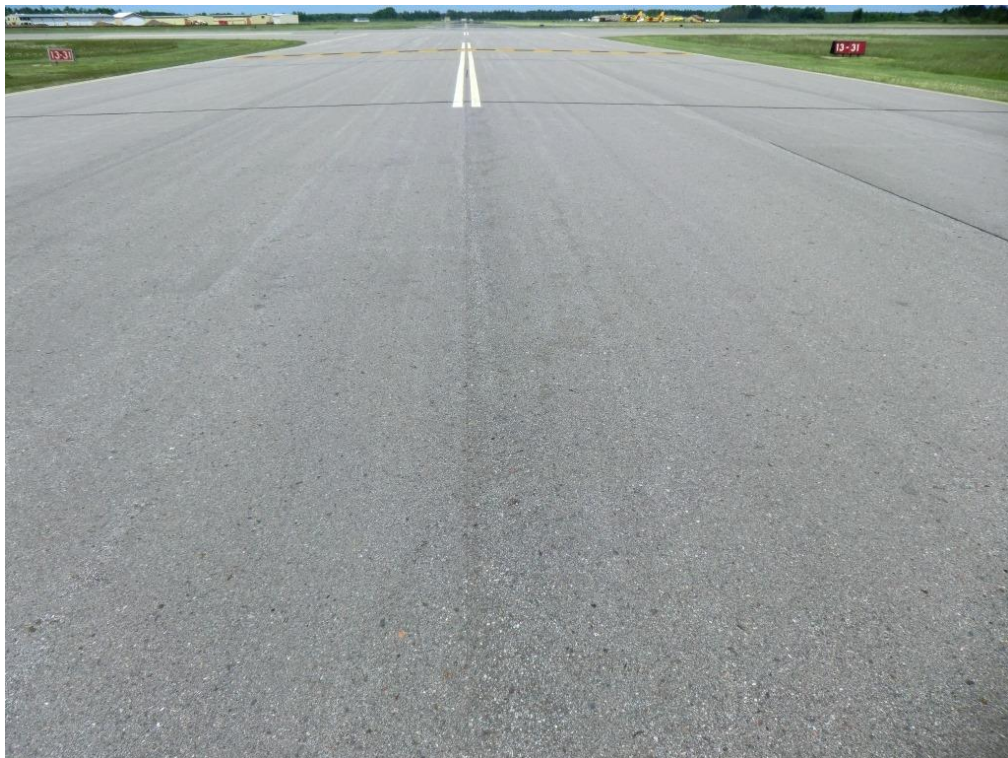
HIB RY422 002 (PCI = 95)

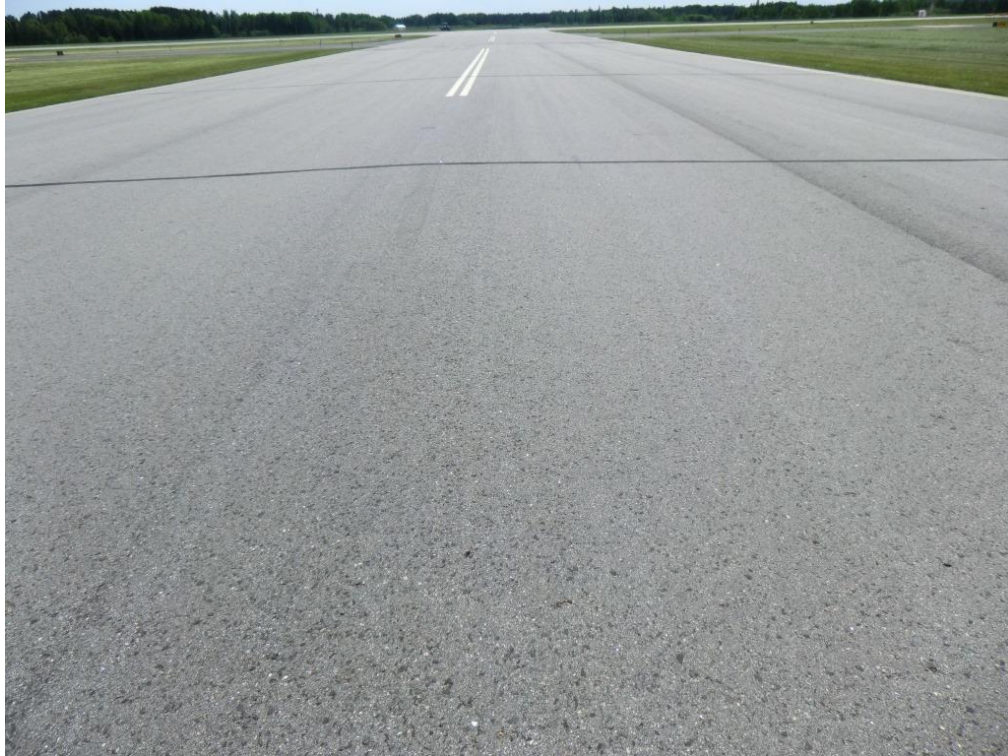
HIB RY422 003 (PCI = 96)

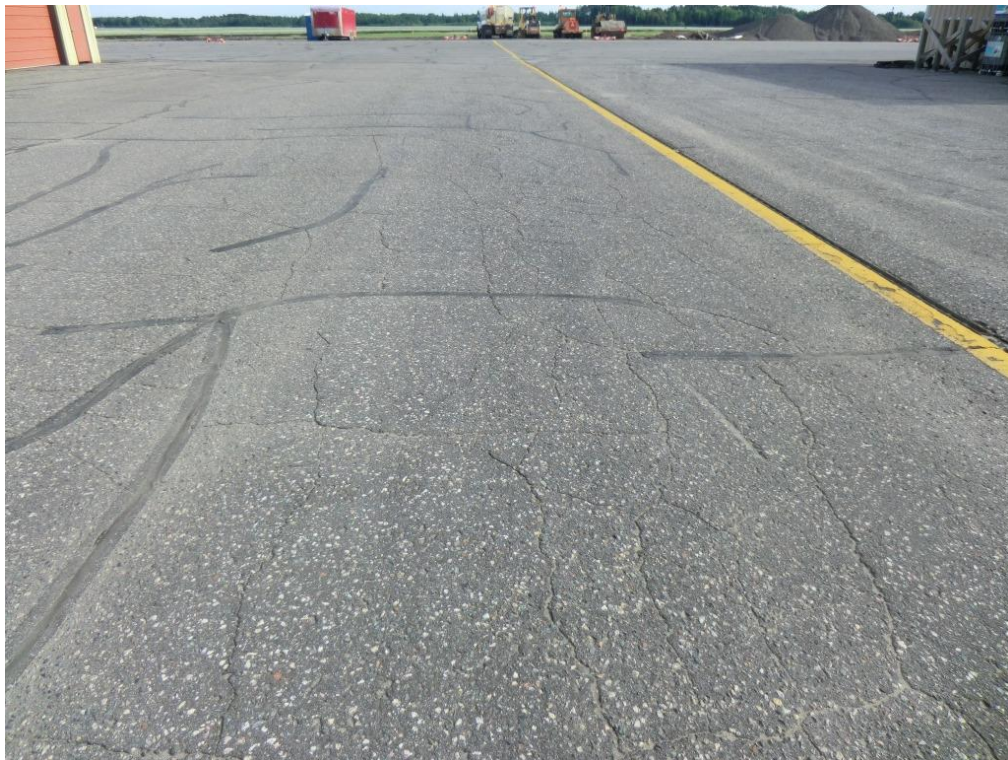
HIB TLA 001 (PCI = 26)
