# Pavement Condition Report

## Hibbing-Range Regional Airport (HIB)

**December 2014**

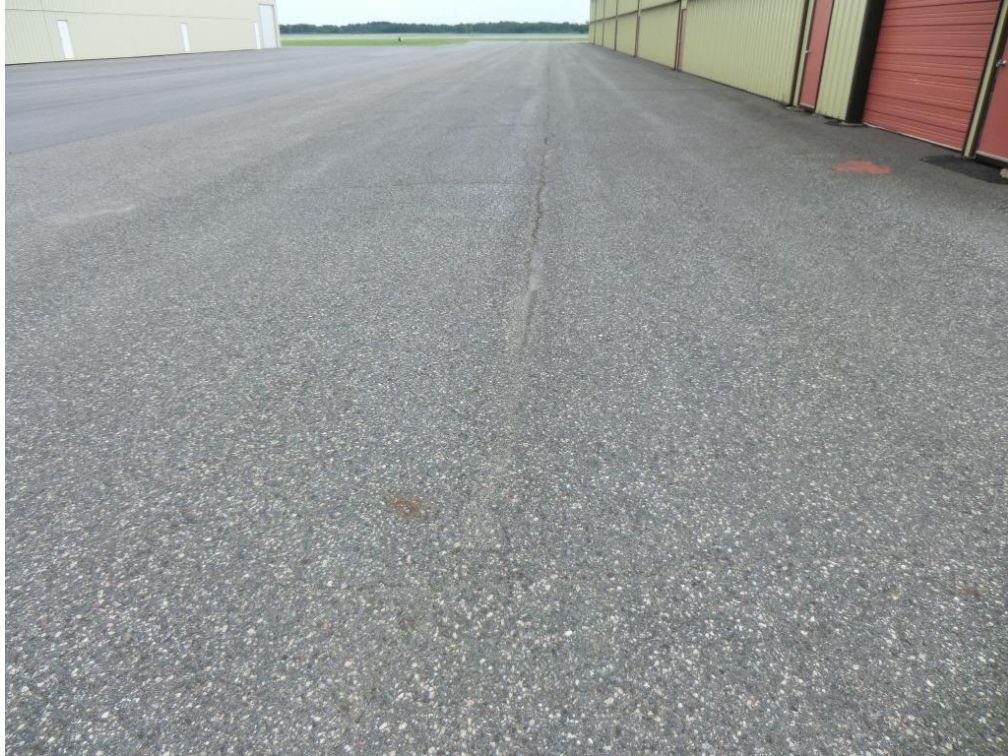
HIB TLA 002 (PCI = 44)

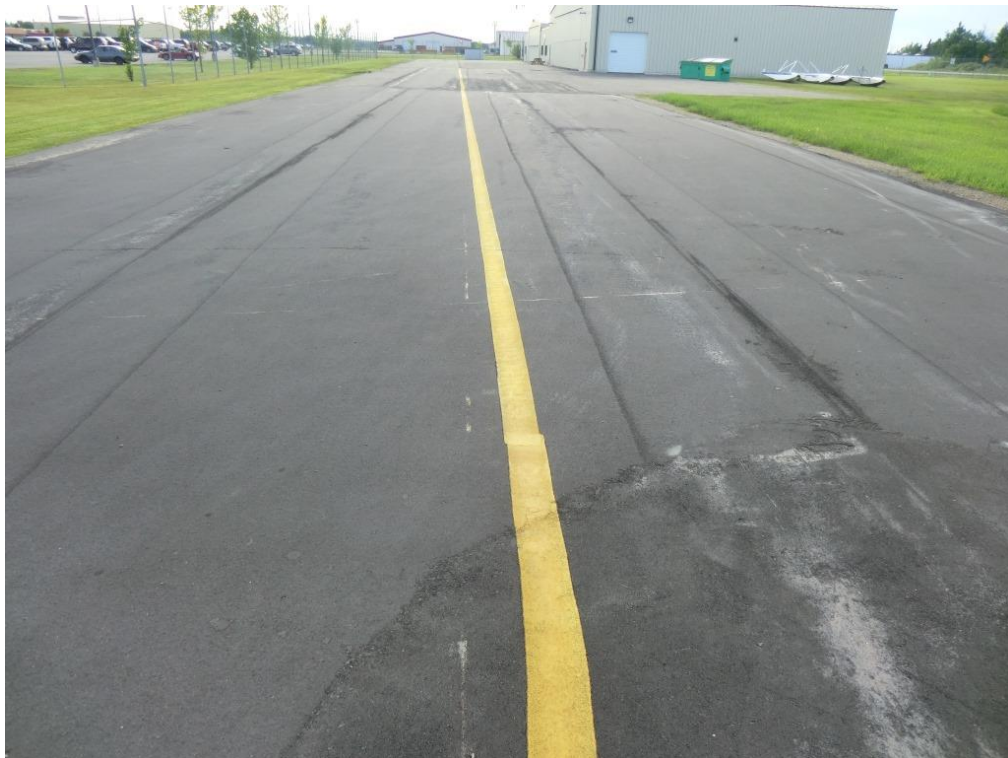
HIB TLA 003 (PCI = 62)

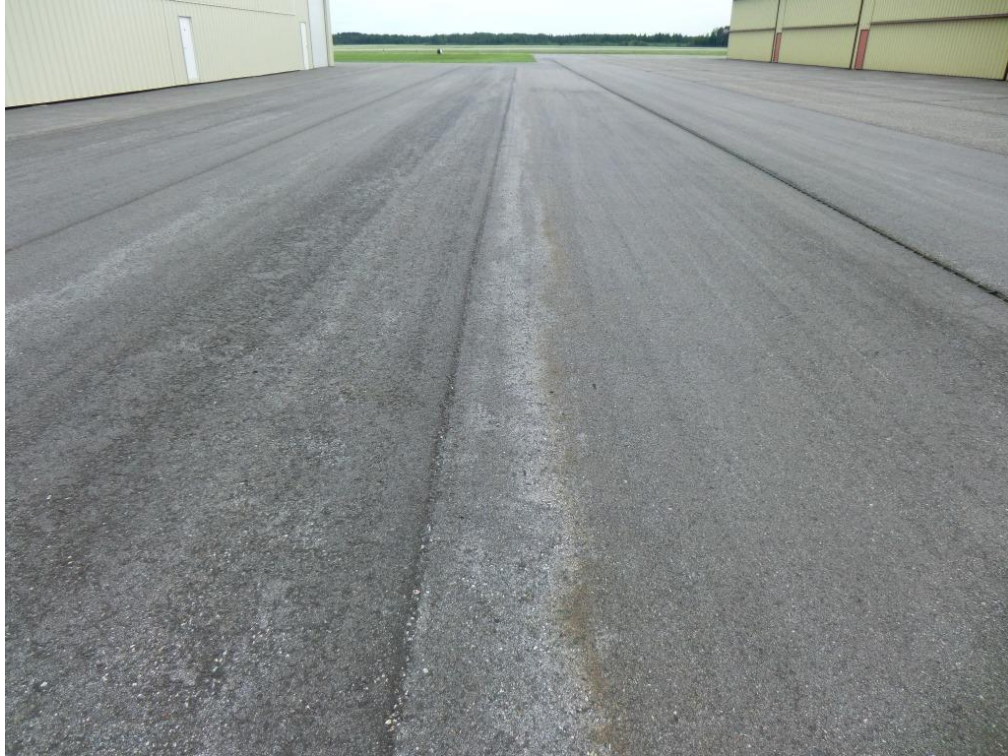
HIB TLA 004 (PCI = 99)
