Final Report

Pavement Condition Report

Mora Municipal Airport (JMR)

December 2014

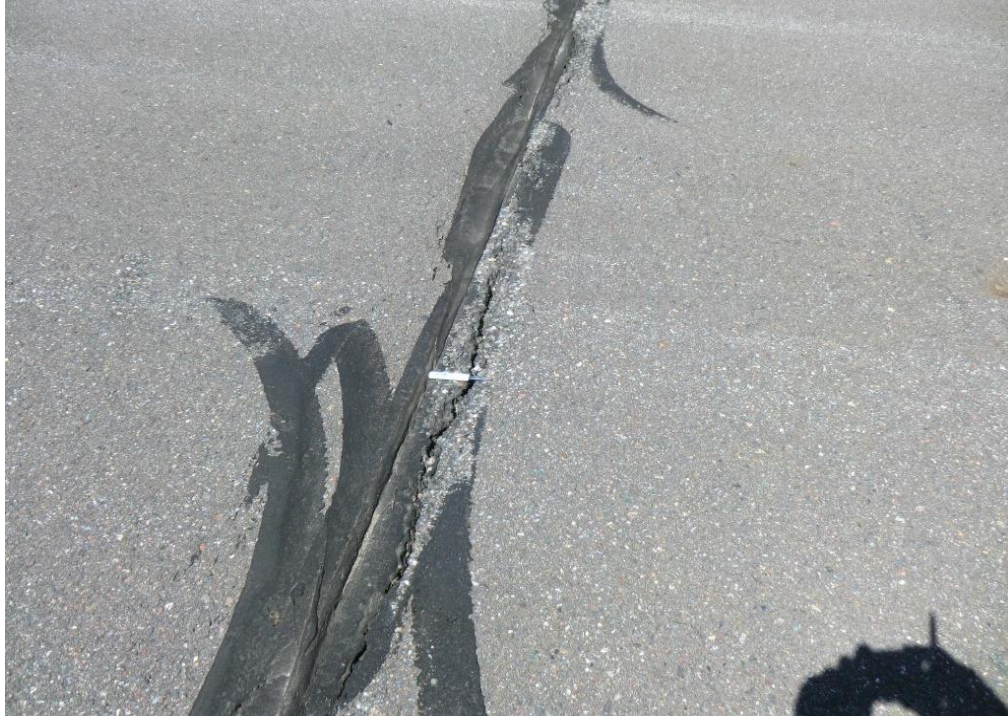
JMR APA 001 (PCI = 77)

Branch ID	Section ID	Surface type ¹	Section area (SF)	LCD ²	2011 PCI	2014 PCI	Drop in PCI/Yr ³	% Deduct due to		Distress types
								Load ⁴	Climate ⁵	
APA	1	AC	45,900	2007	93	77	3.3	0	100	L&T cracking
APA	2	AC	3,485	1985	19	15	2.9	55	31	multiple and extensive
CTA	1	AC	9,920	2007	100	85	2.1	0	100	L&T cracking
CTAX	1	AC	24,750	2007	95	76	3.4	0	100	L&T cracking, weathering
CTB	1	AC	9,070	2007	96	79	3.0	0	100	L&T cracking
CTC	1	AC	9,750	2007	97	94	0.9	0	100	L&T cracking
CTD	1	AC	10,270	2007	86	77	3.3	0	100	L&T cracking, patching, weathering
PTA	1	AC	159,920	2007	93	81	2.7	0	100	L&T cracking
PTA	2	AC	32,000	2007	94	81	2.7	0	87	depression, L&T cracking, weathering
RY1129	1	AC	6,375	2007	100	95	0.7	0	100	L&T cracking
RY1129	2	AC	22,500	2007	95	94	0.9	0	100	L&T cracking
RY1129	3	AC	6,000	2007	96	93	1.0	0	100	L&T cracking
RY1735	1	AC	299,850	2007	84	79	3.0	0	100	L&T cracking
RY1735	2	AC	60,000	2007	85	80	2.9	0	100	L&T cracking

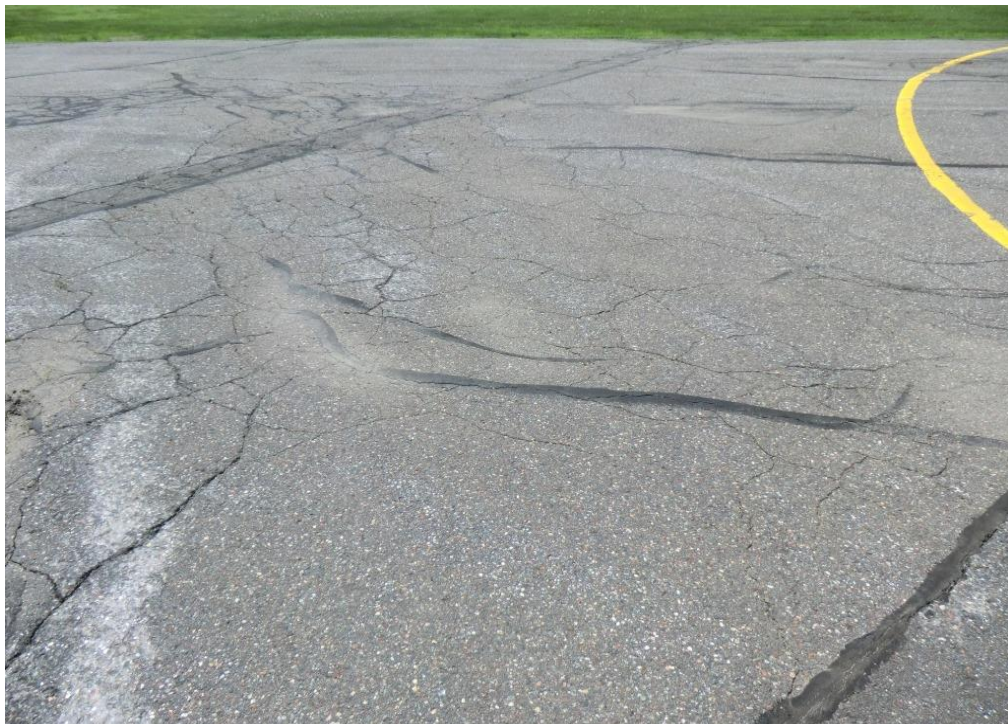
JMR APA 002 (PCI = 15)

41 ALLIGATOR CRACKING	L	120.00	SqFt	Comments:
41 ALLIGATOR CRACKING	M	650.00	SqFt	Comments:
45 DEPRESSION	L	350.00	SqFt	Comments:
48 LONGITUDINAL/TRANSVERSE CRACKING	L	150.00	Ft	Comments:
48 LONGITUDINAL/TRANSVERSE CRACKING	M	20.00	Ft	Comments:
48 LONGITUDINAL/TRANSVERSE CRACKING	H	17.00	Ft	Comments:
50 PATCHING	M	50.00	SqFt	Comments:
50 PATCHING	H	50.00	SqFt	Comments:
53 RUTTING	L	150.00	SqFt	Comments:
56 SWELLING	L	30.00	SqFt	Comments:

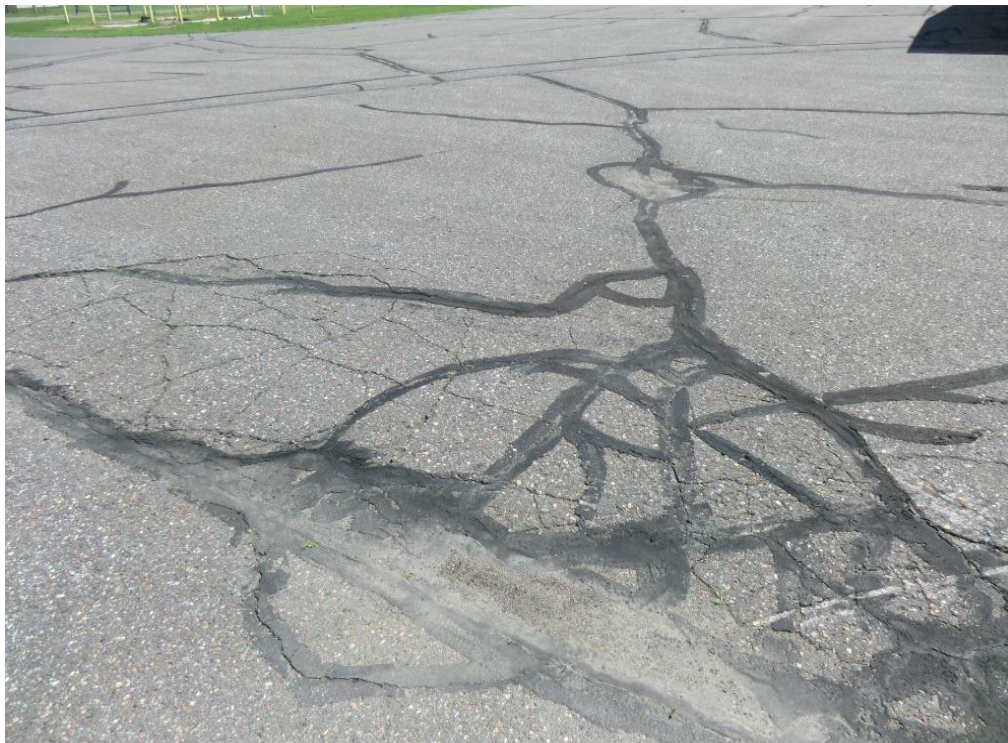
JMR TLA 001 (PCI = 47)

TLA	1	AC	36,450	1988	67	47	2.0	34	59	Multiple and extensive
TLB	1	AC	5,560	2007	100	88	1.7	0	100	L&T cracking
TLC	1	AC	11,120	1988	19	16	3.2	60	31	multiple and extensive
TLD	1	AC	5,560	1988	81	64	1.4	17	83	Alligator and L&T cracking, weathering
