# Pavement Condition Report

## Mankato Regional Airport (MKT)

**December 2014**

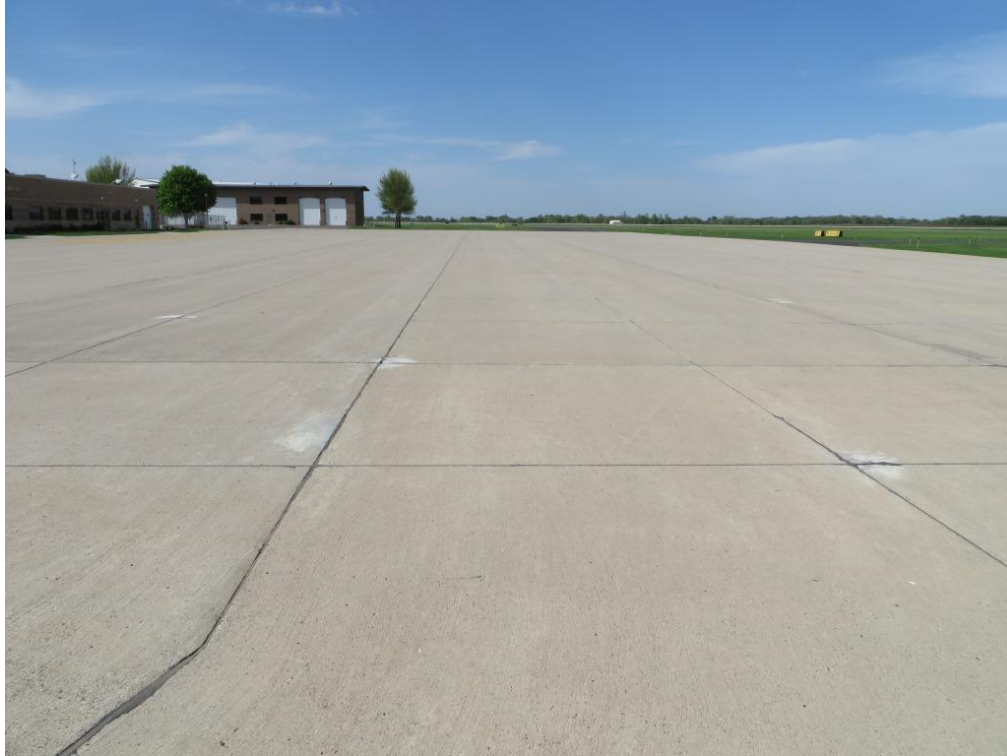
MKT APA 001 (PCI = 96)

Conditions: PCI : 96

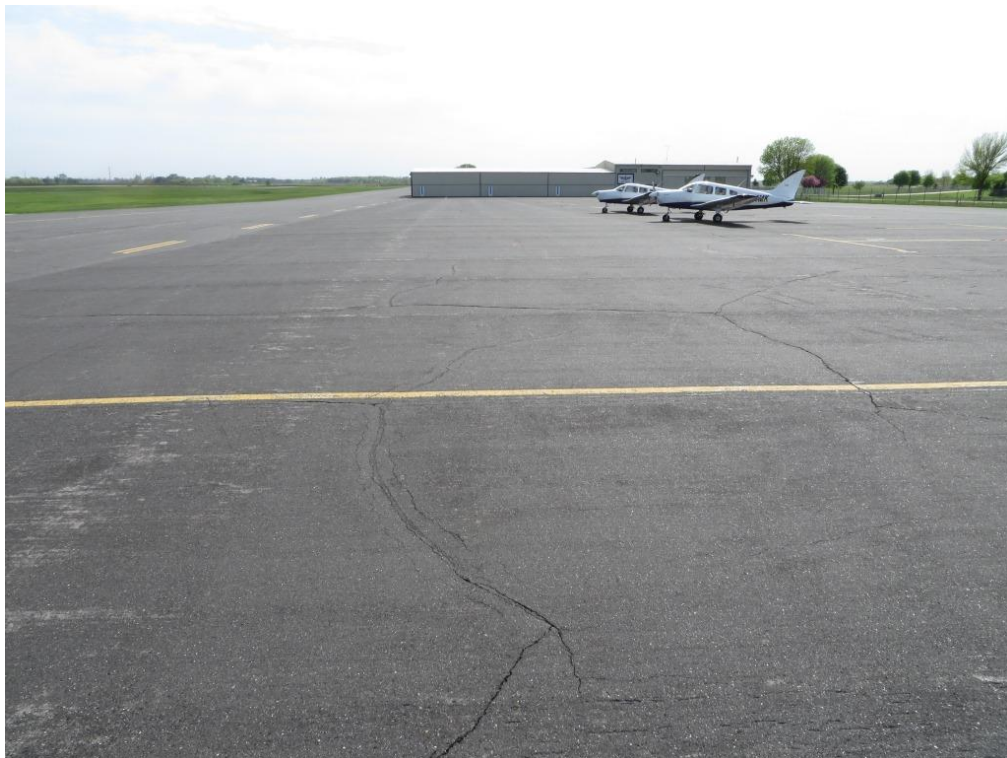
MKT APB 001 (PCI = 75)

Conditions: PCI : 75

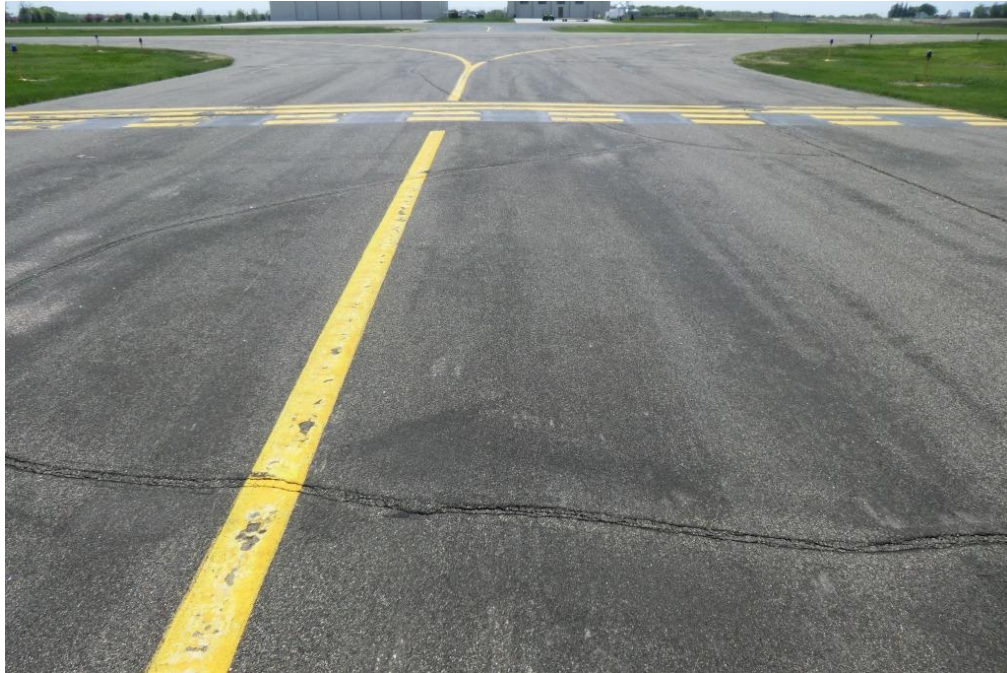
MKT CTA2 001 (PCI = 72)

Conditions: PCI : 72

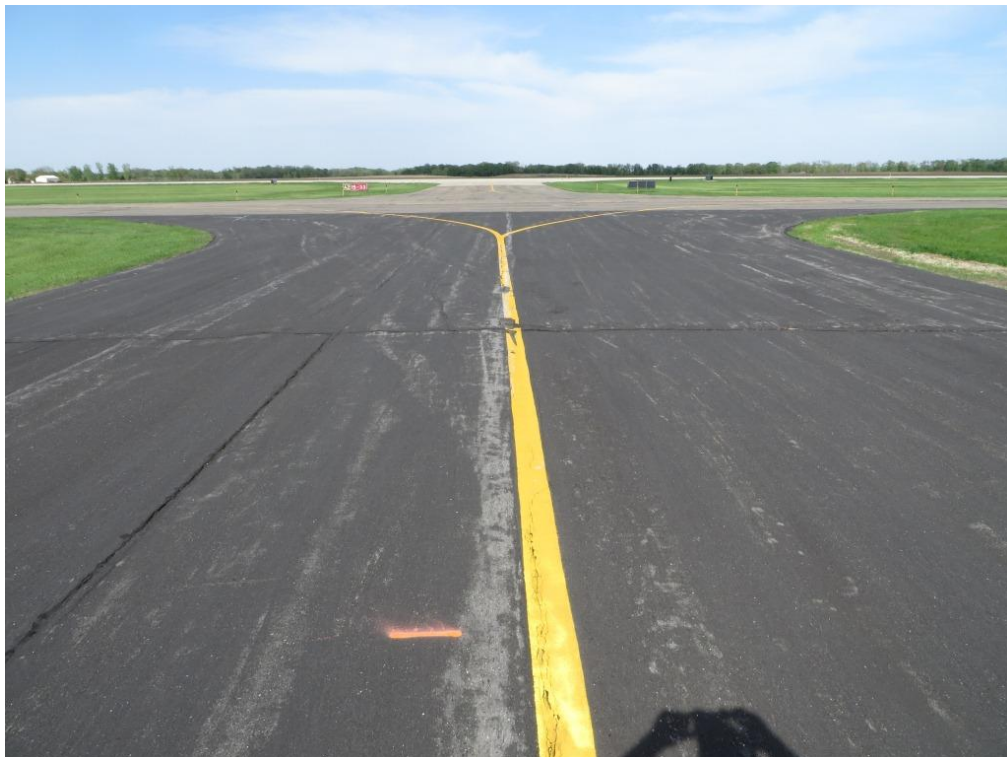
MKT CTA2X 001 (PCI = 74)

Conditions: PCI : 74

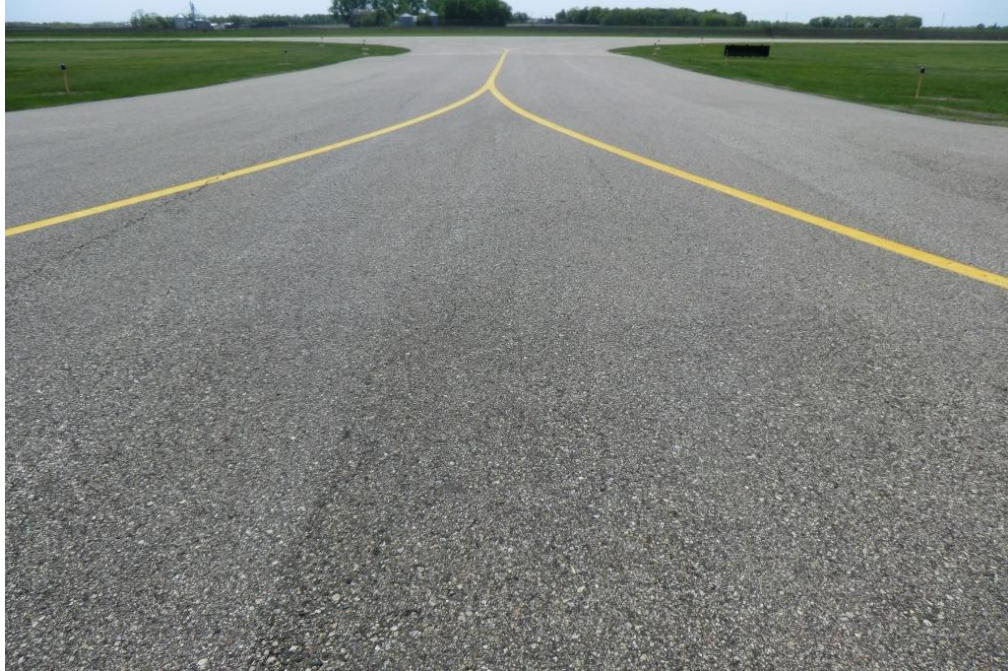
MKT CTA3 001 (PCI = 79)

Conditions: PCI : 79

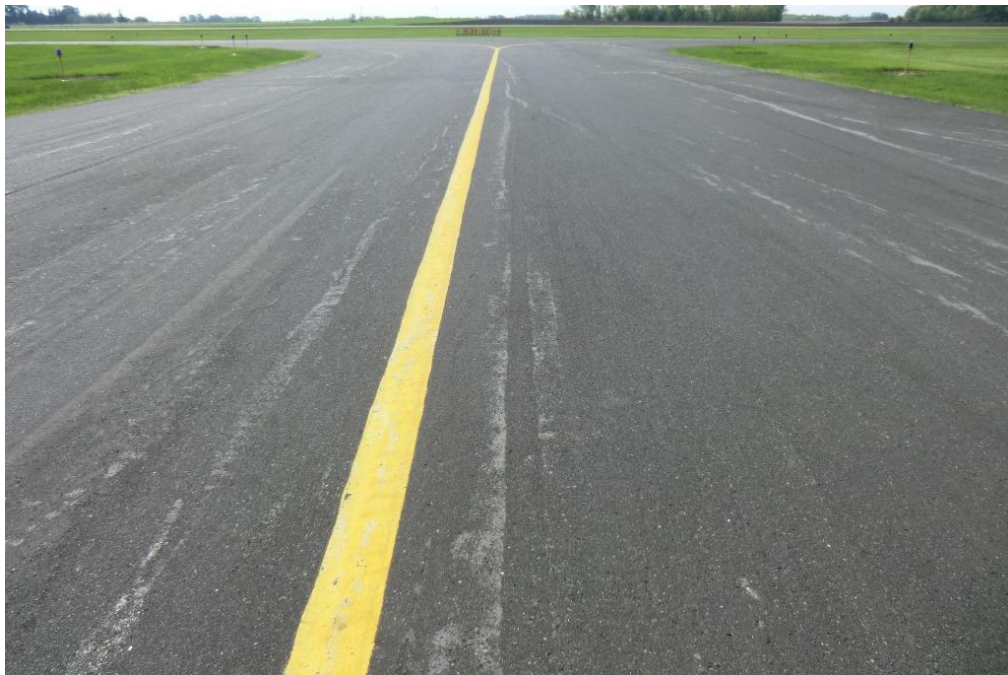
MKT CTB2 001 (PCI = 77)

Conditions: PCI : 77

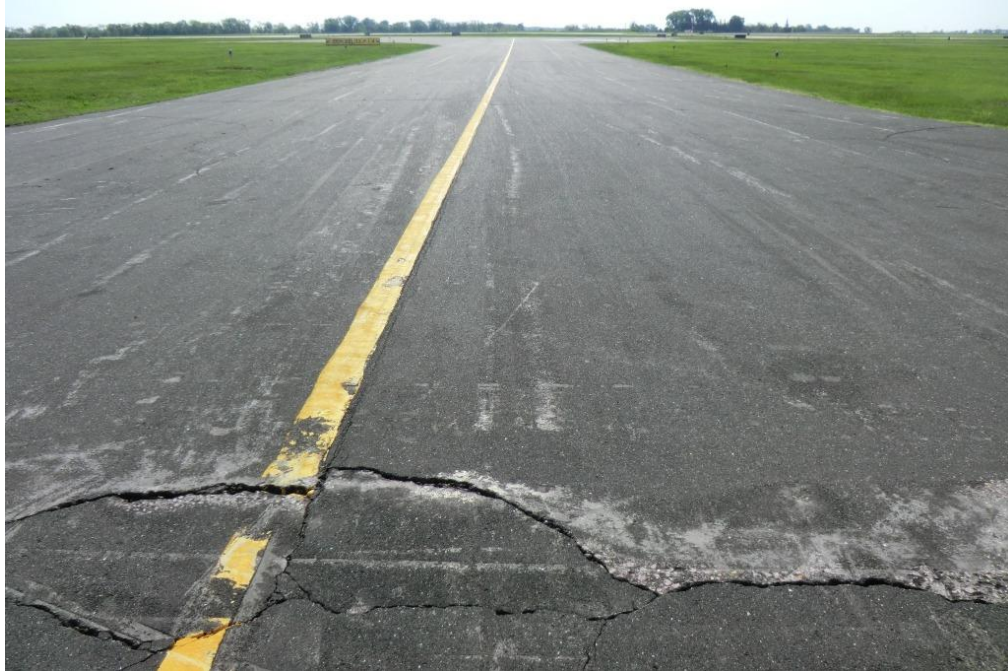
MKT CTC 001 (PCI = 75)

Conditions: PCI : 75

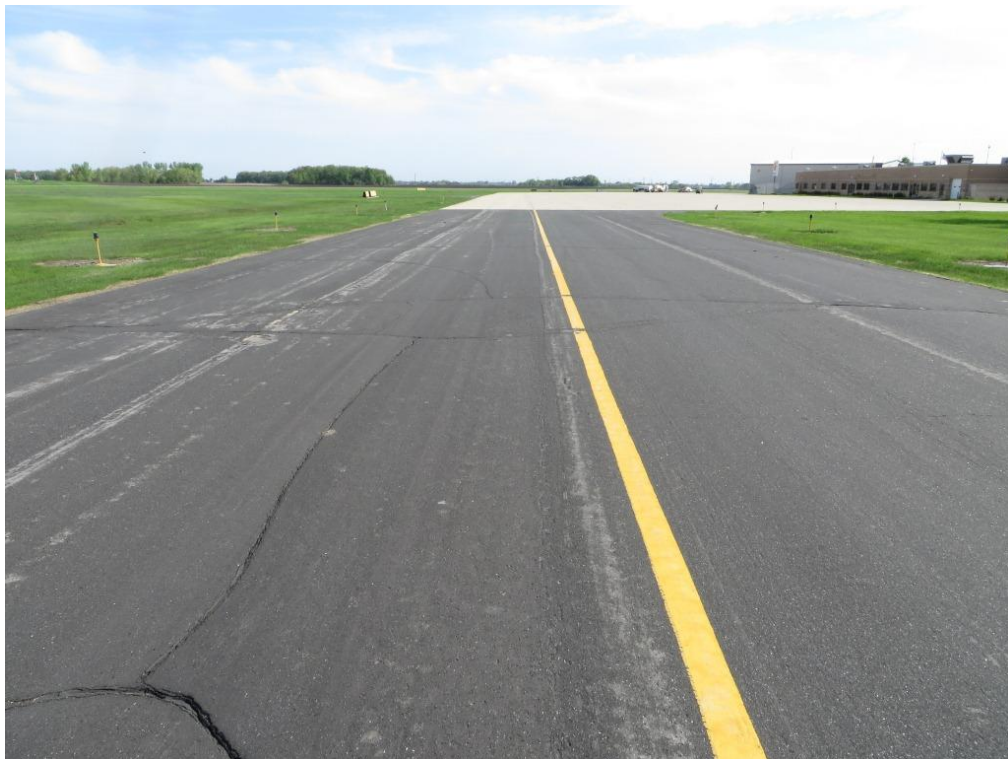
MKT CTD 001 (PCI = 73)

Conditions: PCI : 73

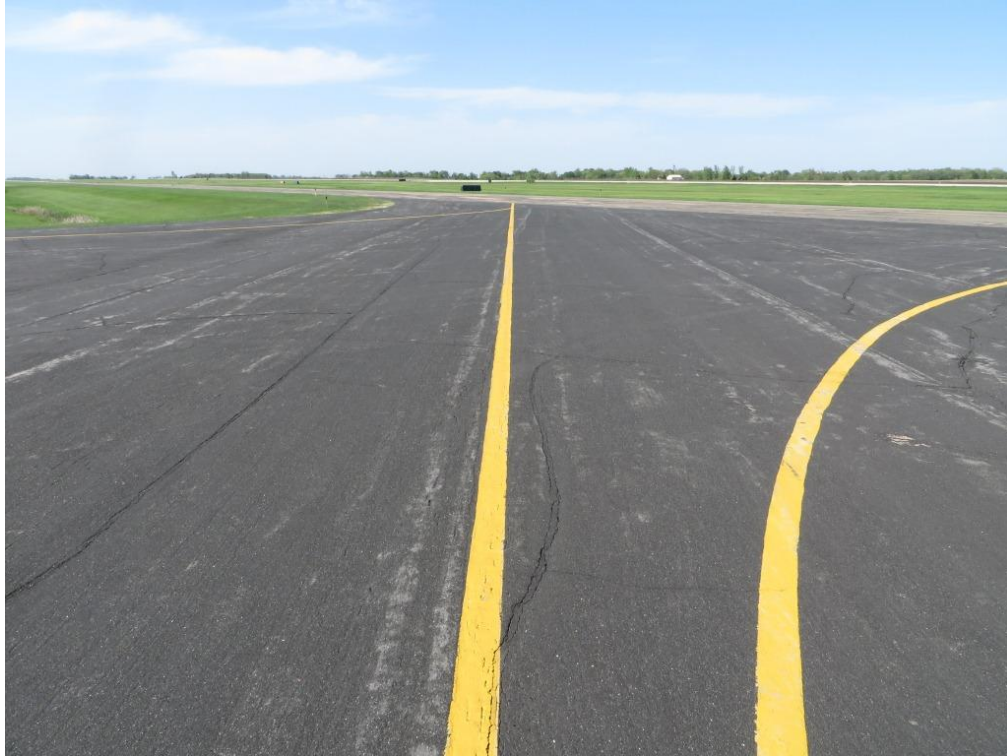
MKT CTD 002 (PCI = 72)

Conditions: PCI : 72

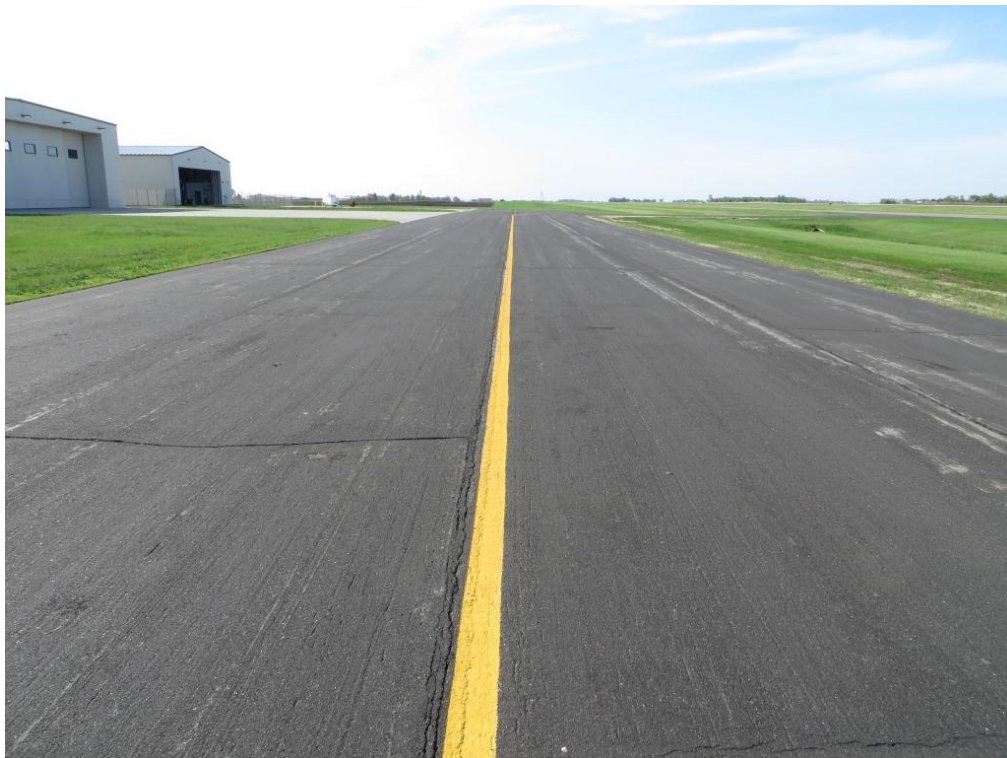
MKT CTE 001 (PCI = 71)

Conditions: PCI : 71

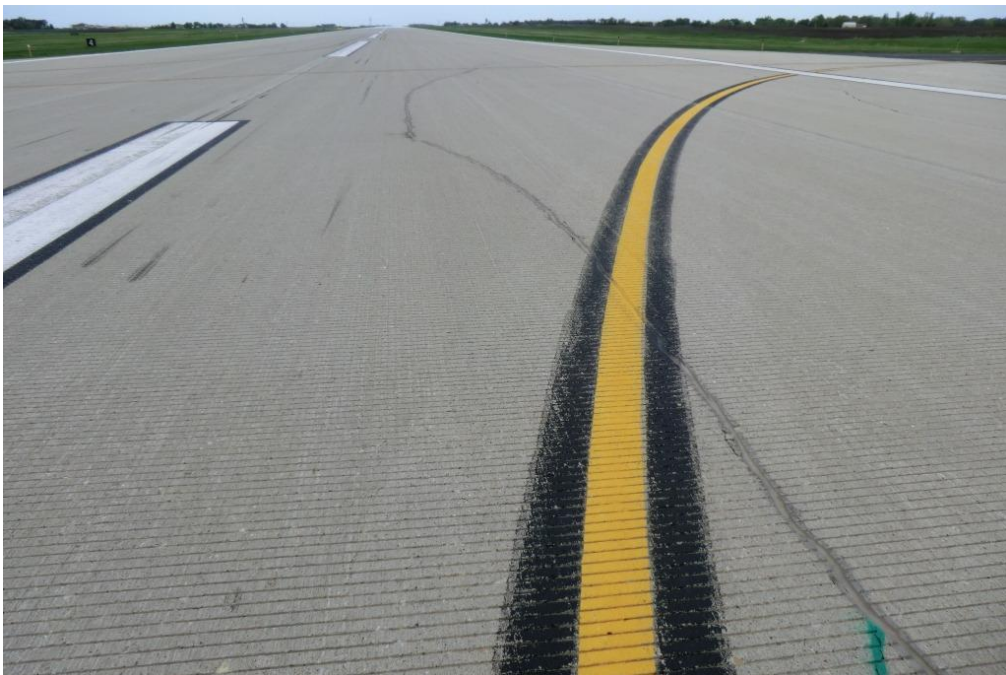
MKT RY1533 001 (Low-Severity LTD Cracking)

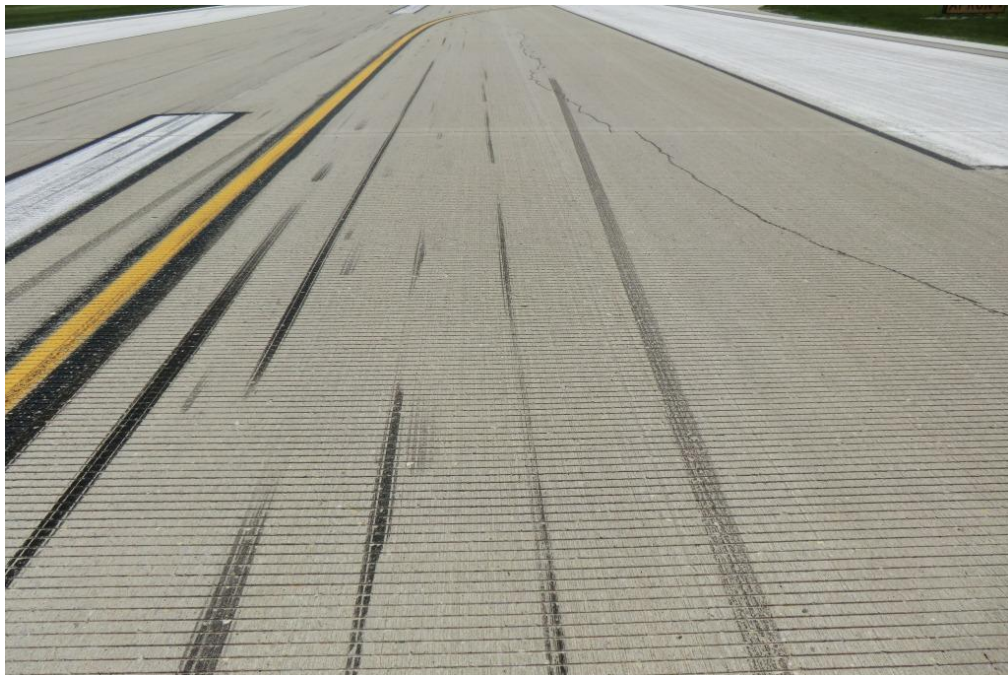
MKT RY1533 002 (Low-Severity LTD Cracking)

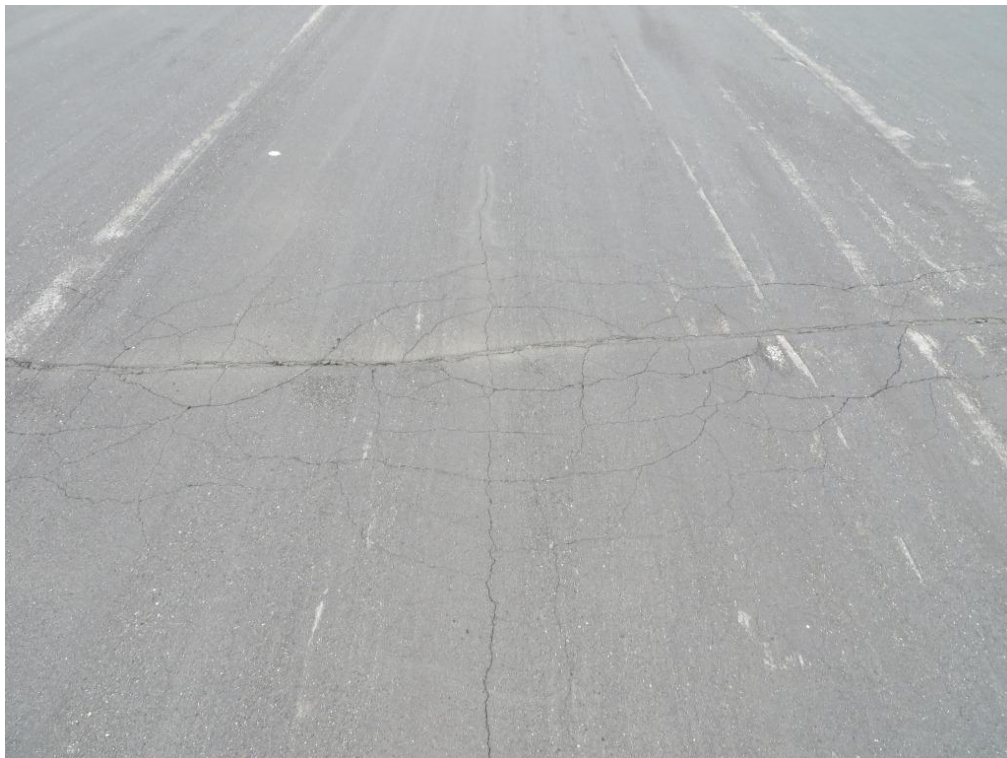
MKT TLE 001 (Alligator Cracking)
