Final Report

Pavement Condition Report

Roseau Municipal Airport (ROX)

December 2014

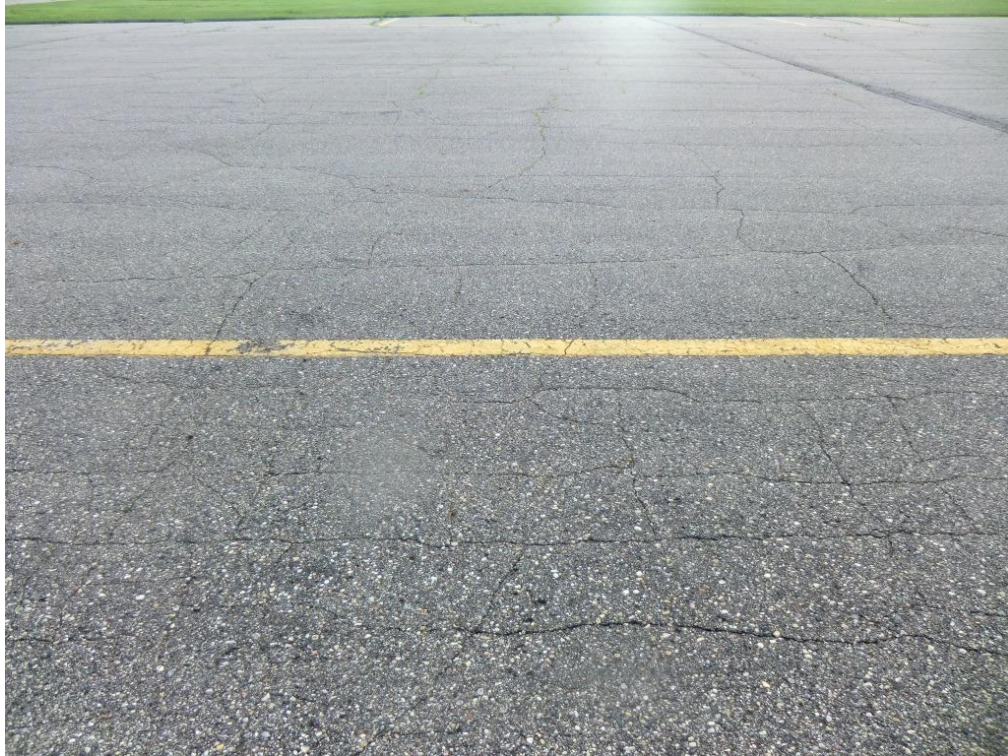
ROX APA 001 (PCI = 30)

Conditions: PCI : 30

43 BLOCK CRACKING	M	4,100.00 SqFt	Comments:
43 BLOCK CRACKING	H	165.00 SqFt	Comments:
45 DEPRESSION	L	16.00 SqFt	Comments:
48 LONGITUDINAL/TRANSVERSE CRACKING	L	70.00 Ft	Comments:
48 LONGITUDINAL/TRANSVERSE CRACKING	M	50.00 Ft	Comments:
48 LONGITUDINAL/TRANSVERSE CRACKING	H	50.00 Ft	Comments:
57 WEATHERING	M	150.00 SqFt	Comments:

41 ALLIGATOR CRACKING	M	50.00 SqFt	Comments:
43 BLOCK CRACKING	M	4,550.00 SqFt	Comments:
43 BLOCK CRACKING	H	400.00 SqFt	Comments:
57 WEATHERING	M	300.00 SqFt	Comments:

43 BLOCK CRACKING	M	3,000.00 SqFt	Comments:
43 BLOCK CRACKING	H	210.00 SqFt	Comments:
48 LONGITUDINAL/TRANSVERSE CRACKING	M	192.00 Ft	Comments:
53 RUTTING	L	1.00 SqFt	Comments:

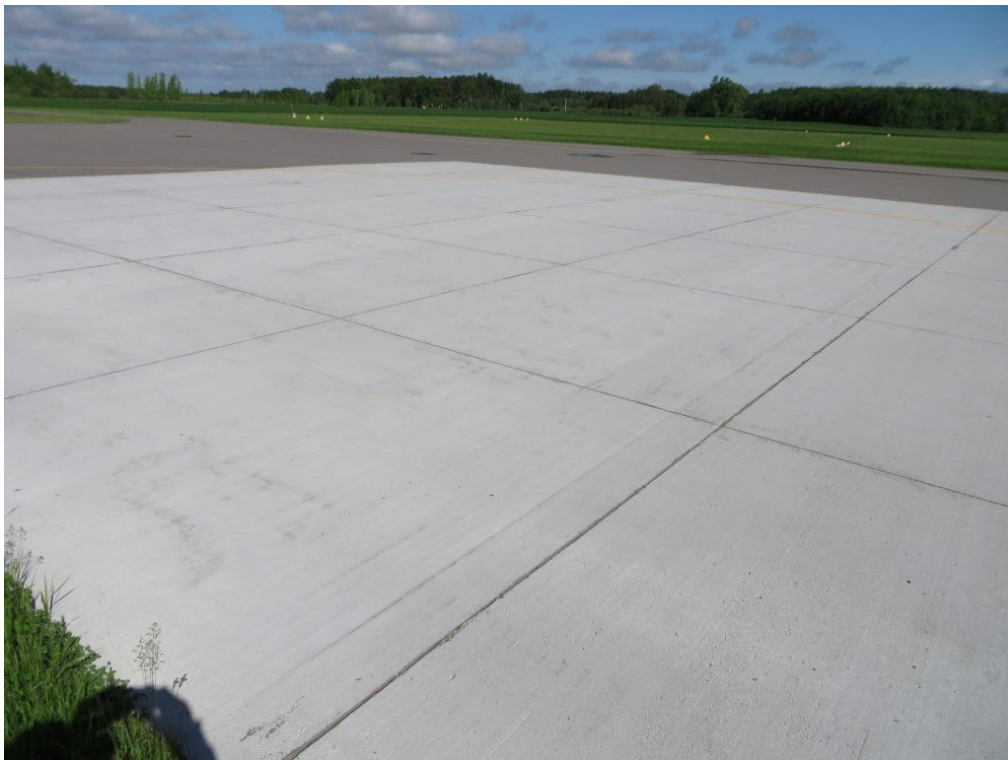
ROX APA 003 (PCI = 100)

Conditions: PCI : 100

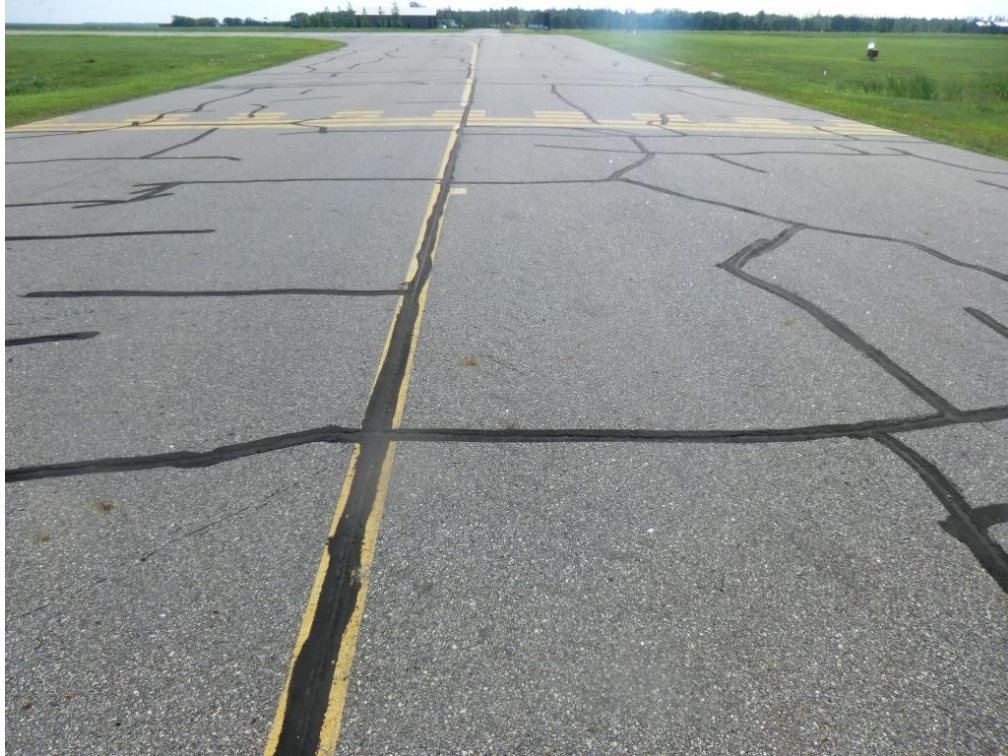
ROX CTA 001 (PCI=63)

Conditions: PCI : 63

48 LONGITUDINAL/TRANSVERSE CRACKING L 931.00 Ft Comments:

48 LONGITUDINAL/TRANSVERSE CRACKING M 9.00 Ft Comments:

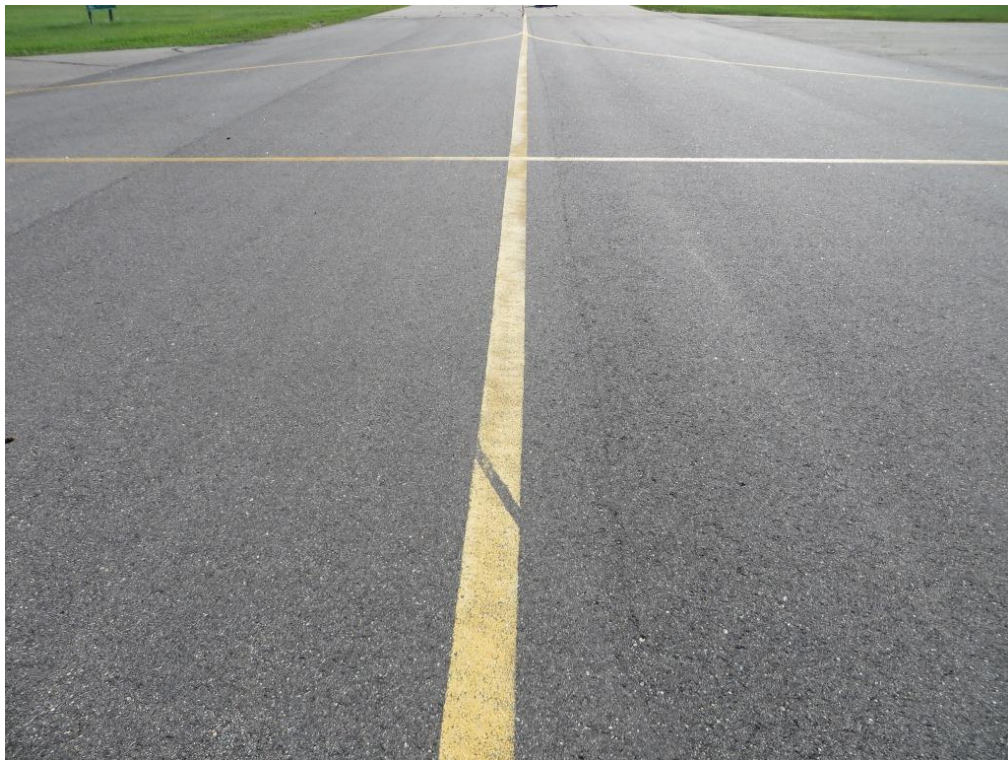
ROX CTA 002 (PCI = 98)

Conditions: PCI : 98

48 LONGITUDINAL/TRANSVERSE CRACKING L 10.00 Ft Comments:

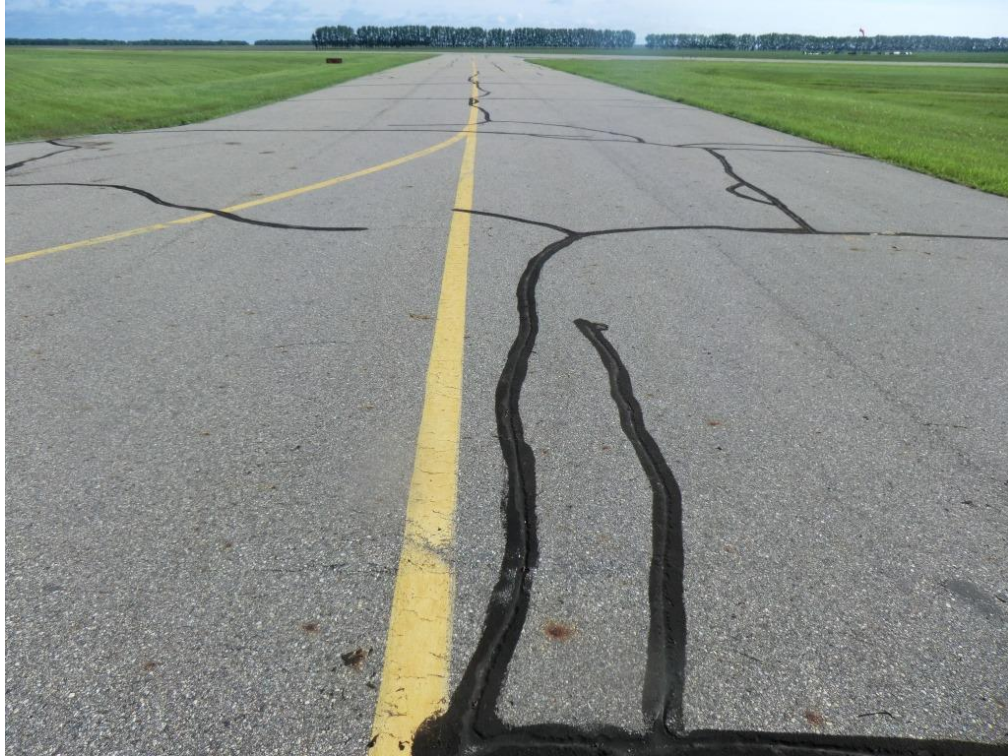
ROX CTB 001 (PCI = 72)

Conditions: PCI : 72

48 LONGITUDINAL/TRANSVERSE CRACKING L 431.00 Ft Comments:

48 LONGITUDINAL/TRANSVERSE CRACKING M 25.00 Ft Comments:

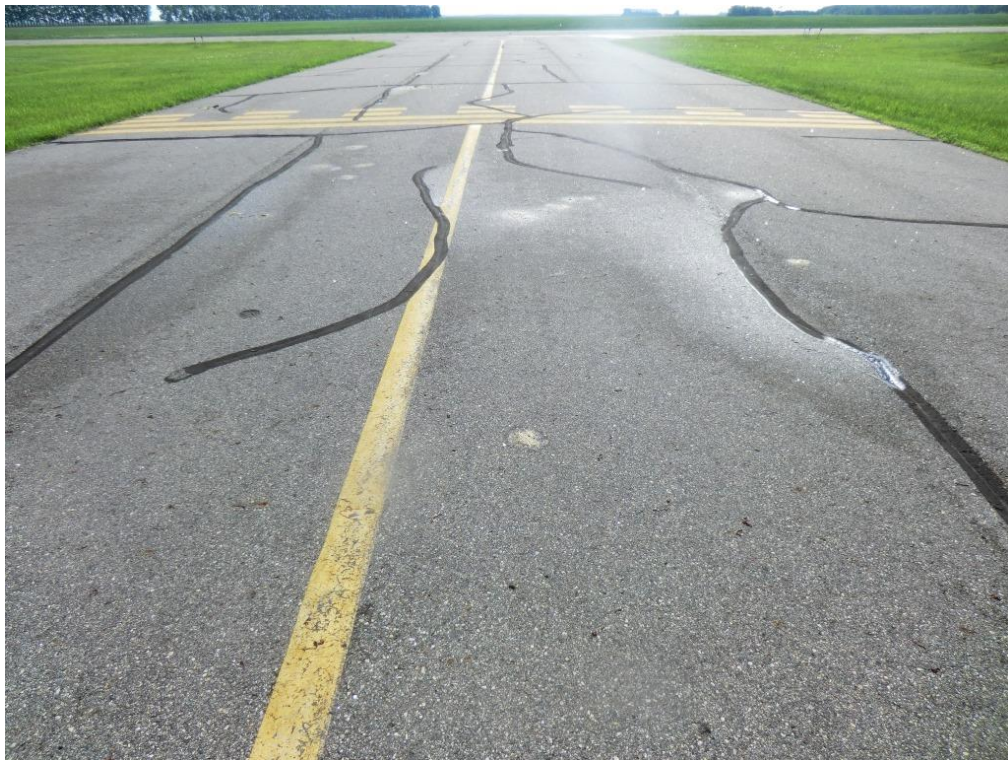
ROX CTC 001 (PCI = 69)

Conditions: PCI : 69

48 LONGITUDINAL/TRANSVERSE CRACKING L 489.00 Ft Comments:

48 LONGITUDINAL/TRANSVERSE CRACKING M 32.00 Ft Comments:

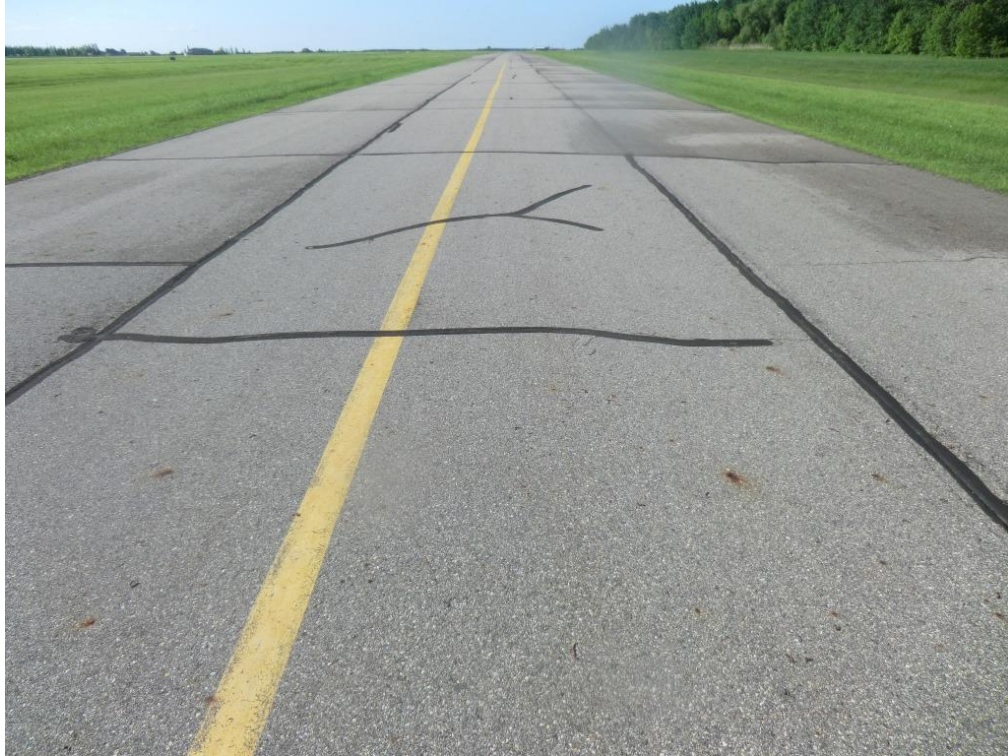
ROX PTA 001 (PCI = 72)

Conditions: PCI : 72

48 LONGITUDINAL/TRANSVERSE CRACKING L 518.00 Ft Comments:

48 LONGITUDINAL/TRANSVERSE CRACKING M 20.00 Ft Comments:

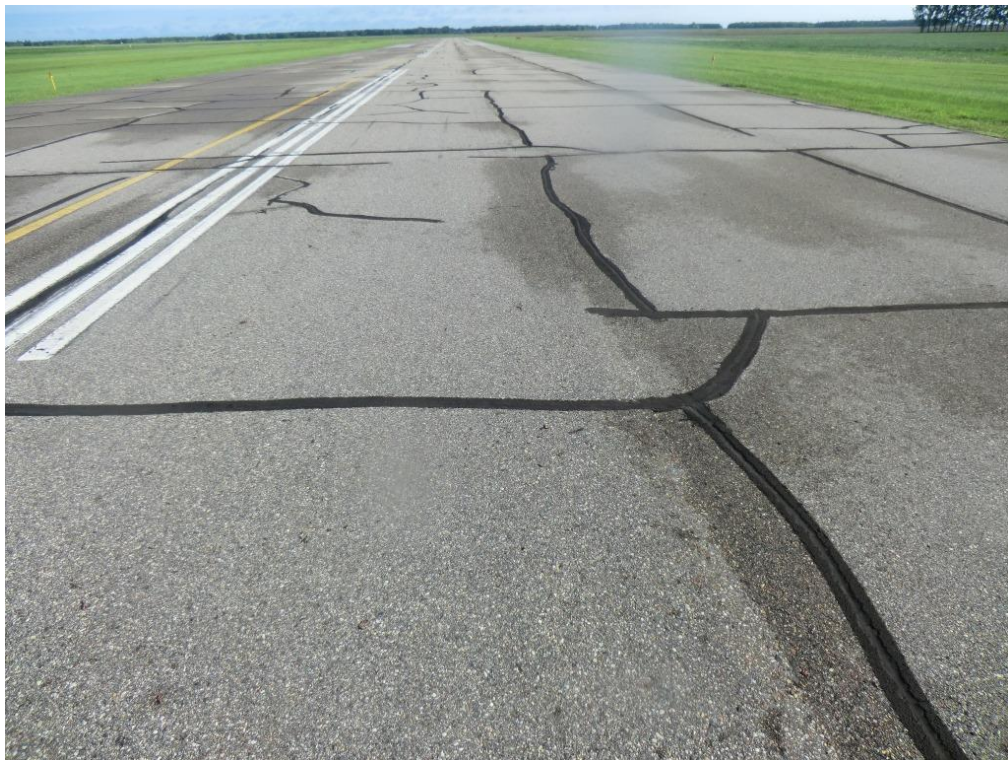
ROX RY1634 001 (PCI = 65)

Conditions: PCI: 65

48 LONGITUDINAL/TRANSVERSE CRACKING L 432.00 Ft Comments:
48 LONGITUDINAL/TRANSVERSE CRACKING M 2.00 Ft Comments:

48 LONGITUDINAL/TRANSVERSE CRACKING L 489.00 Ft Comments:
48 LONGITUDINAL/TRANSVERSE CRACKING M 40.00 Ft Comments:

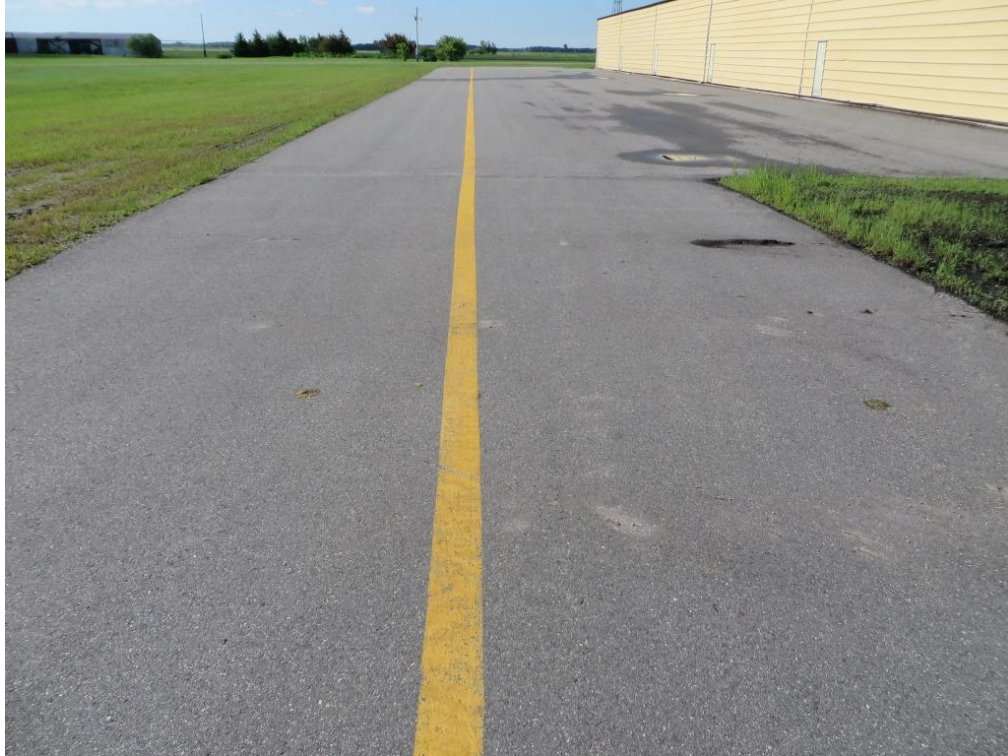
ROX TLA 001 (PCI = 100)

Conditions: PCI : 100

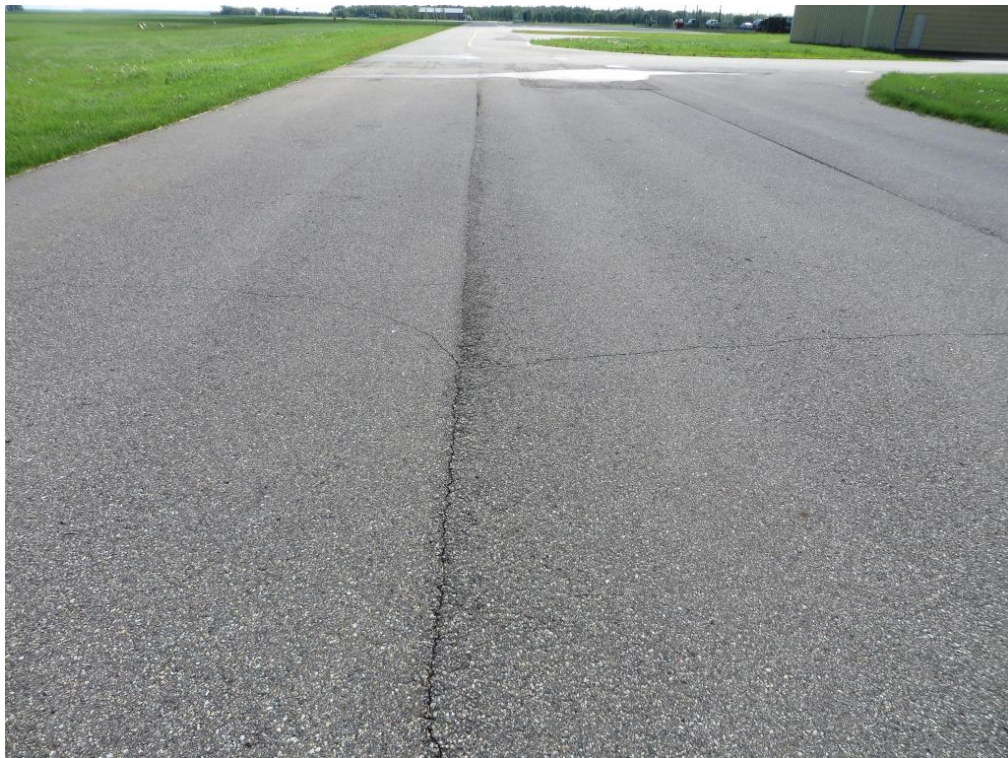
ROX TLA 002 (PCI 86)

Conditions: PCI : 86
