Final Report

Pavement Condition Report

Dodge Center Municipal Airport (TOB)

December 2014

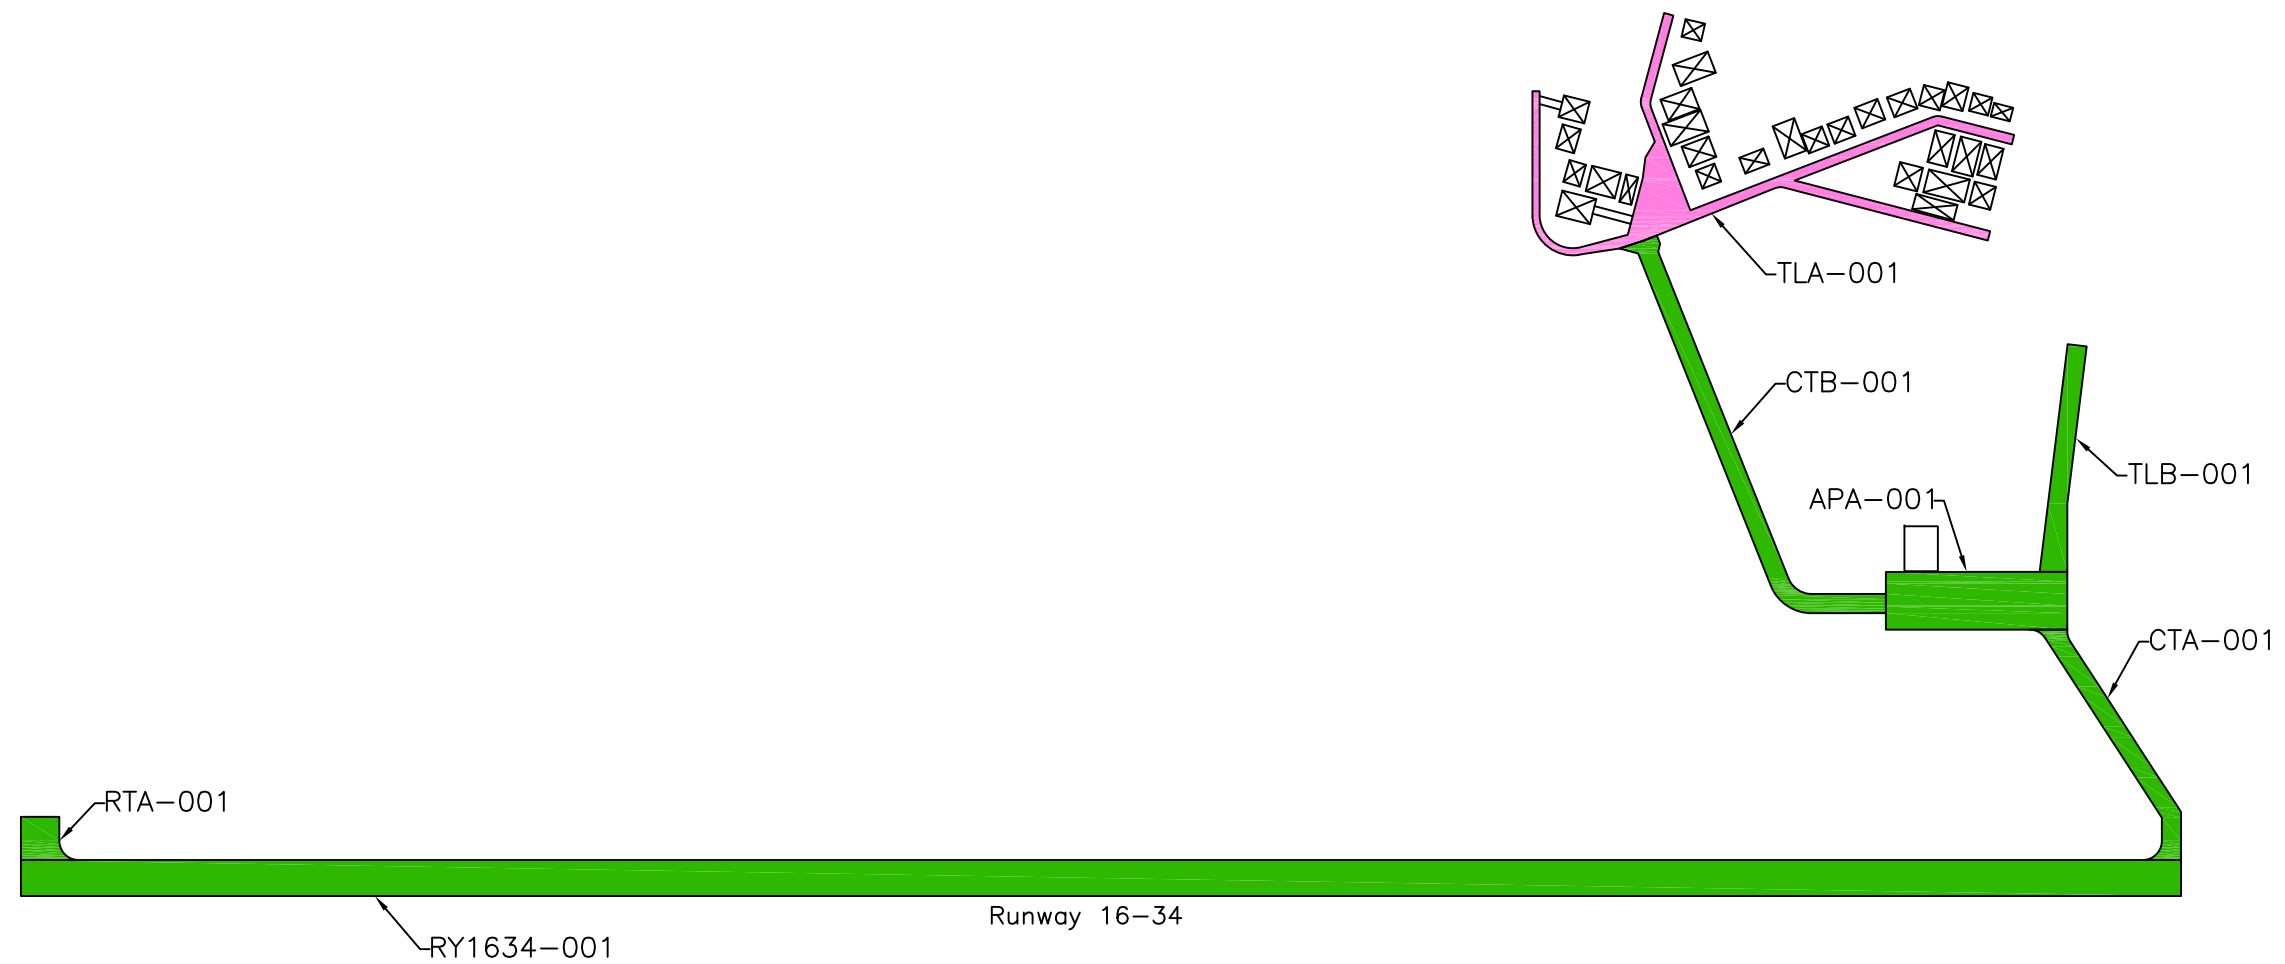
Figure 4. 2014 Pavement Condition Index Rating at Dodge Center Municipal Airport (TOB).

Branch ID	Section ID	Surface type ¹	Section area (SF)	LCD ²	2011 PCI	2014 PCI	Drop in PCI/Yr ³	% Deduct due to		Distress types
								Load ⁴	Climate ⁵	
APA	1	PCC	45,360	1991	93	91	0.4	0	76	jt. seal damage, joint spall
CTA	1	PCC	22,200	1991	99	95	0.2	0	33	jt. seal damage, corner spall
CTB	1	PCC	40,000	1991	94	94	0.3	0	34	jt. seal damage, faulting
RTA	1	PCC	7,200	1991	98	96	0.2	0	53	jt. seal damage, corner spall
RY1634	1	PCC	337,500	1991	97	96	0.2	19	35	multiple
TLA	1	AC	38,250	1991	49	43	2.5	65	35	alligator and L&T cracking, rutting
TLB	1	PCC	19,930	2007	98	98	0.3	0	0	joint spall

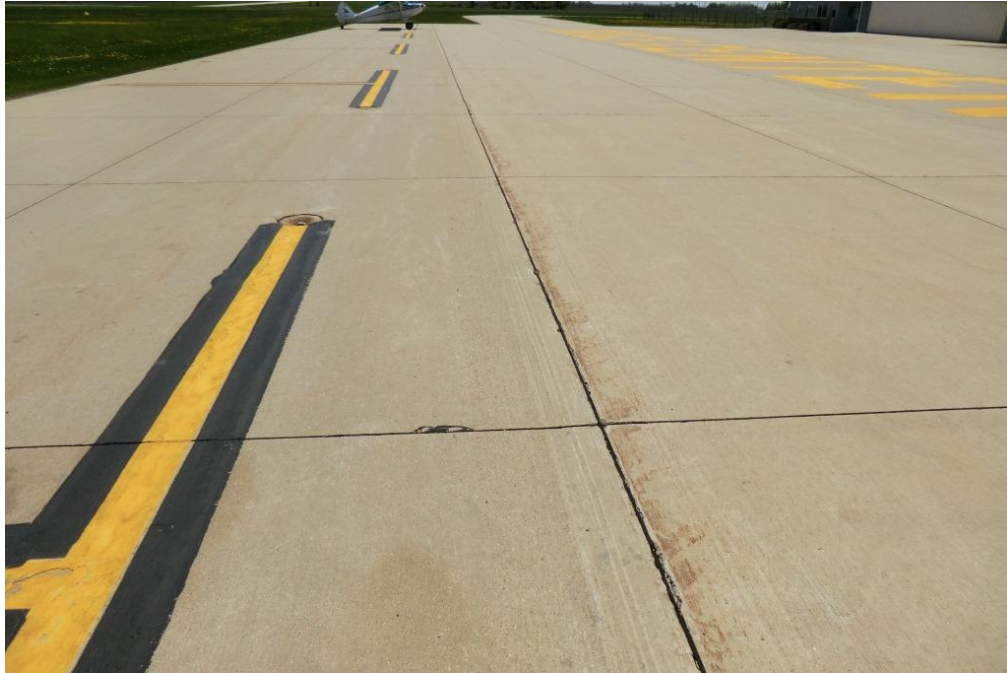
TOB APA 001 (PCI = 91)

Conditions: PCI : 91

65 JOINT SEAL DAMAGE M 24.00 Slabs Comments:
74 JOINT SPALLING M 1.00 Slabs Comments:

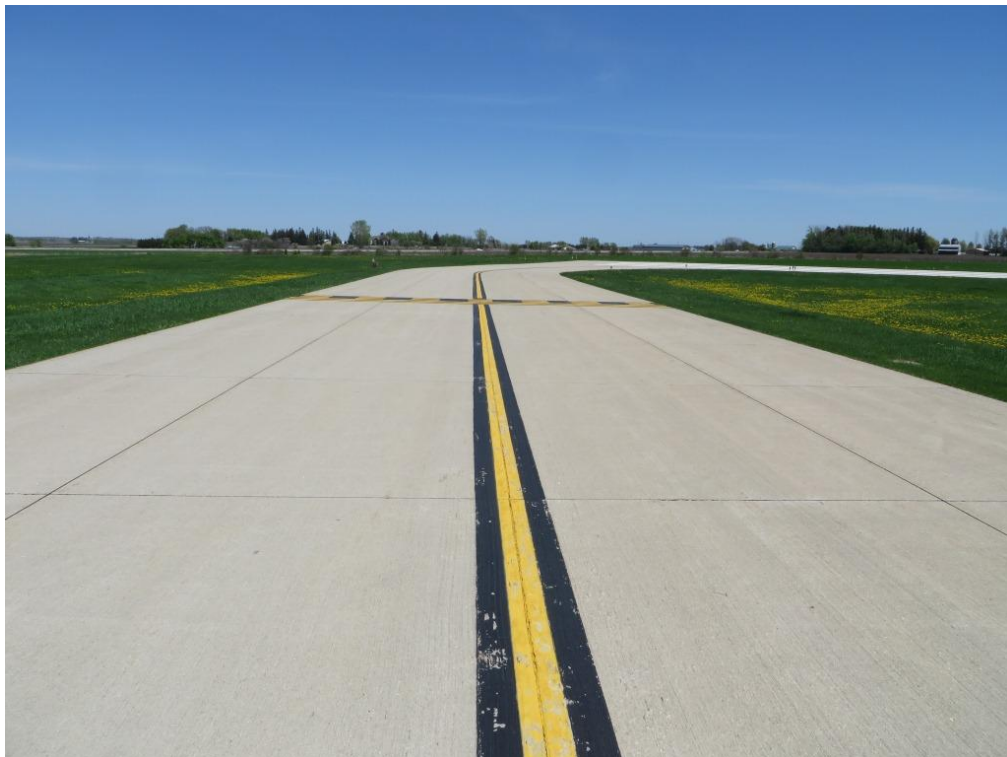
TOB CTA 001 (PCI = 95)

Conditions: PCI : 95

65 JOINT SEAL DAMAGE L 24.00 Slabs Comments:

75 CORNER SPALLING H 2.00 Slabs Comments:

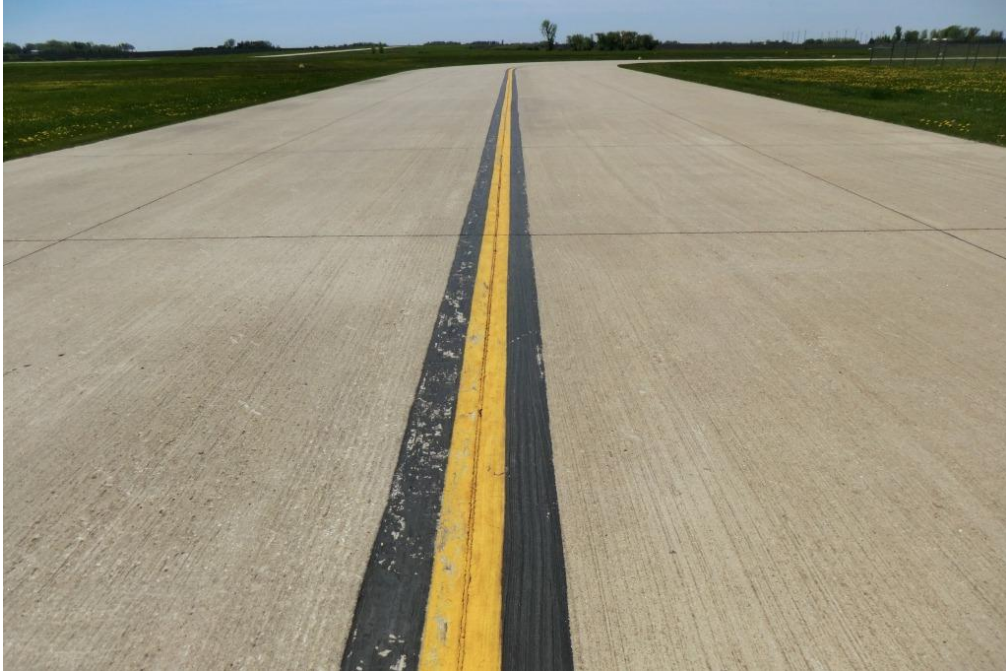
TOB CTB 001 (PCI = 94)

Conditions: PCI : 94

65 JOINT SEAL DAMAGE L 24.00 Slabs Comments:
71 FAULTING L 2.00 Slabs Comments:

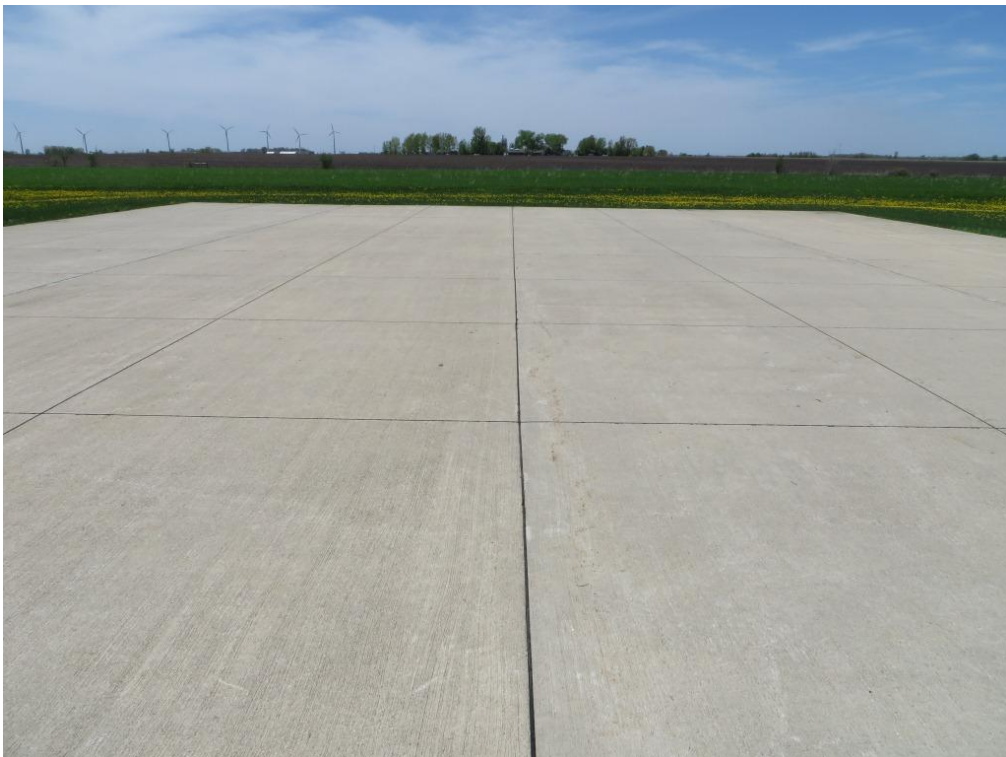
TOB RTA 001 (PCI = 96)

Conditions: PCI : 96

65 JOINT SEAL DAMAGE L 24.00 Slabs Comments:

75 CORNER SPALLING L 1.00 Slabs Comments:

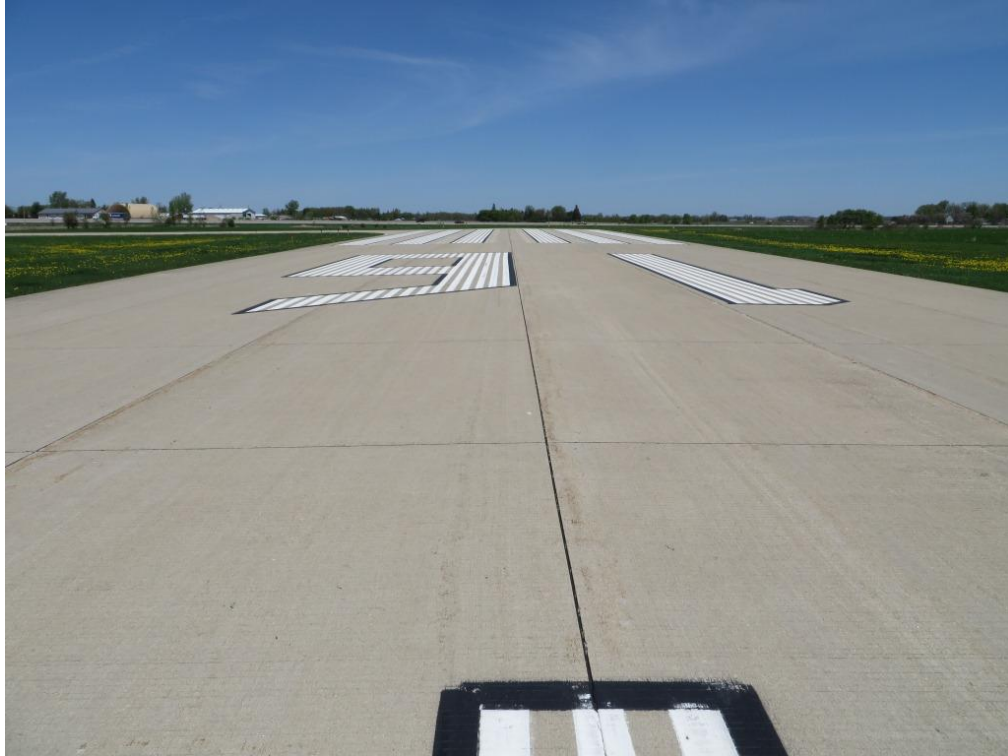
TOB RY1634 001 (PCI = 96)

Conditions: PCI : 96

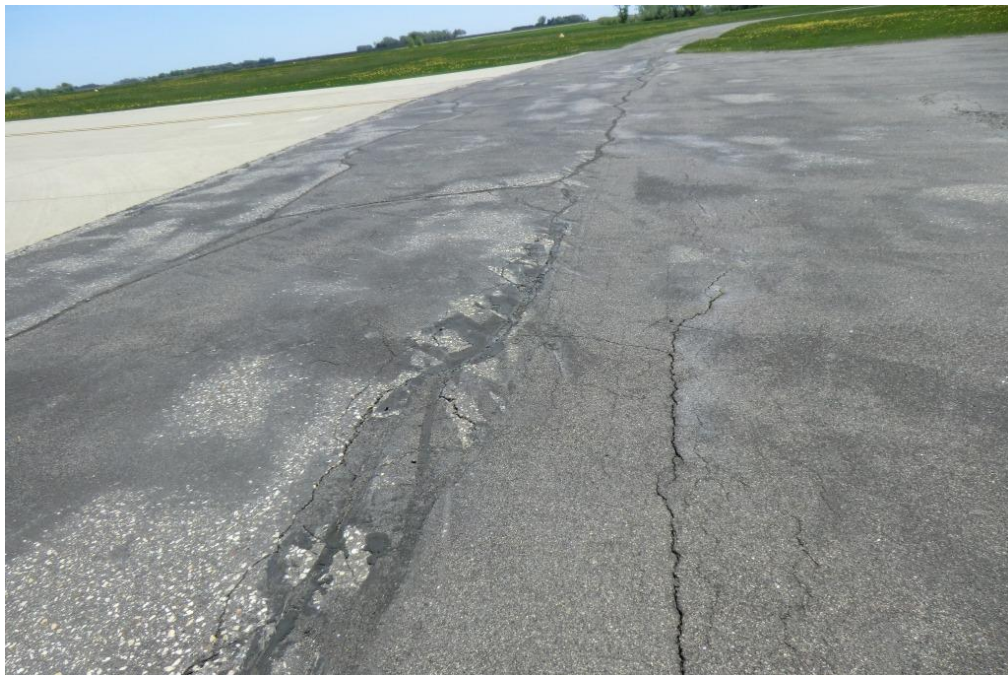
TOB TLA 001 (PCI = 43)

Conditions: PCI : 43

41 ALLIGATOR CRACKING L 610.00 SqFt Comments:
48 LONGITUDINAL/TRANSVERSE CRACKING L 97.00 Ft Comments:
48 LONGITUDINAL/TRANSVERSE CRACKING M 30.00 Ft Comments:

41 ALLIGATOR CRACKING L 133.00 SqFt Comments:
41 ALLIGATOR CRACKING M 81.00 SqFt Comments:
48 LONGITUDINAL/TRANSVERSE CRACKING L 420.00 Ft Comments:
48 LONGITUDINAL/TRANSVERSE CRACKING M 49.00 Ft Comments:

41 ALLIGATOR CRACKING L 332.00 SqFt Comments:
41 ALLIGATOR CRACKING M 33.00 SqFt Comments:
48 LONGITUDINAL/TRANSVERSE CRACKING L 45.00 Ft Comments:
48 LONGITUDINAL/TRANSVERSE CRACKING M 65.00 Ft Comments:
48 LONGITUDINAL/TRANSVERSE CRACKING H 8.00 Ft Comments:

41 ALLIGATOR CRACKING L 400.00 SqFt Comments:
48 LONGITUDINAL/TRANSVERSE CRACKING L 118.00 Ft Comments:
48 LONGITUDINAL/TRANSVERSE CRACKING M 45.00 Ft Comments:
53 RUTTING L 22.00 SqFt Comments:

41 ALLIGATOR CRACKING L 80.00 SqFt Comments:
48 LONGITUDINAL/TRANSVERSE CRACKING L 687.00 Ft Comments:
48 LONGITUDINAL/TRANSVERSE CRACKING M 50.00 Ft Comments:

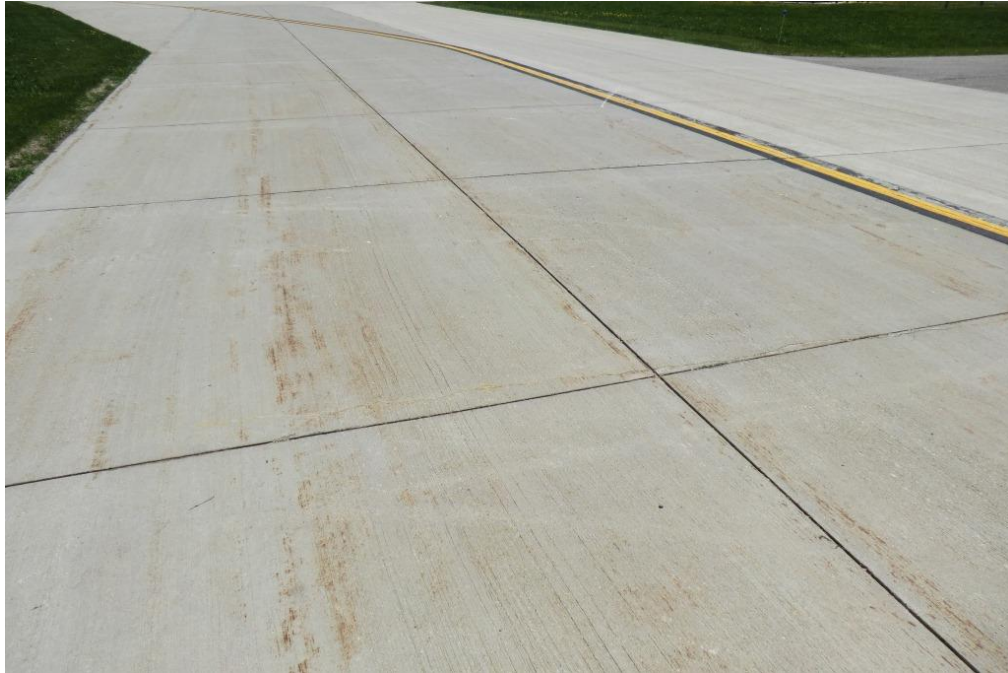
TOB TLB 001 (PCI = 98)

Conditions: PCI : 98
