Final Report

Pavement Condition Report

Elbow Lake Municipal Airport (Y63)

December 2014

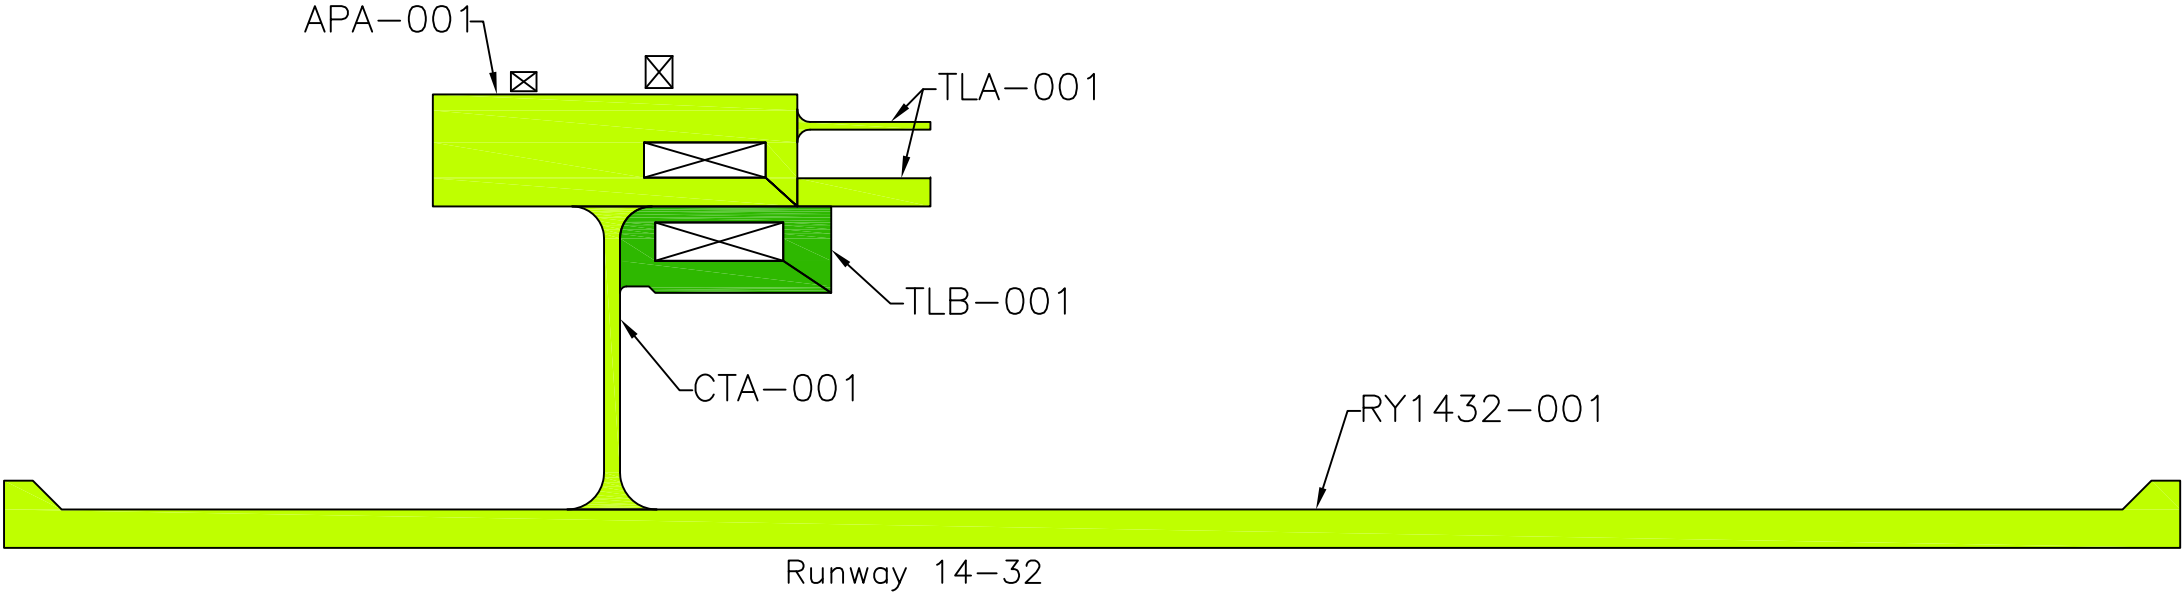
Figure 4. 2014 Pavement Condition Index Rating at Elbow Lake Municipal Airport (Y63).

Branch ID	Section ID	Surface type ¹	Section area (SF)	LCD ²	2011 PCI	2014 PCI	Drop in PCI/Yr ³	% Deduct due to		Distress types
								Load ⁴	Climate ⁵	
APA	1	AAC	89,300	2006	85	83	2.1	33	62	L&T cracking, rutting, swelling
CTA	1	AC	13,050	2006	82	76	3.0	0	100	L&T cracking
RY1432	1	AAC	210,075	2006	77	74	3.3	0	100	L&T cracking
TLA	1	AAC	13,000	2006	82	75	3.1	25	73	multiple
TLB	1	AC	32,350	2010	100	97	0.8	0	100	L&T cracking

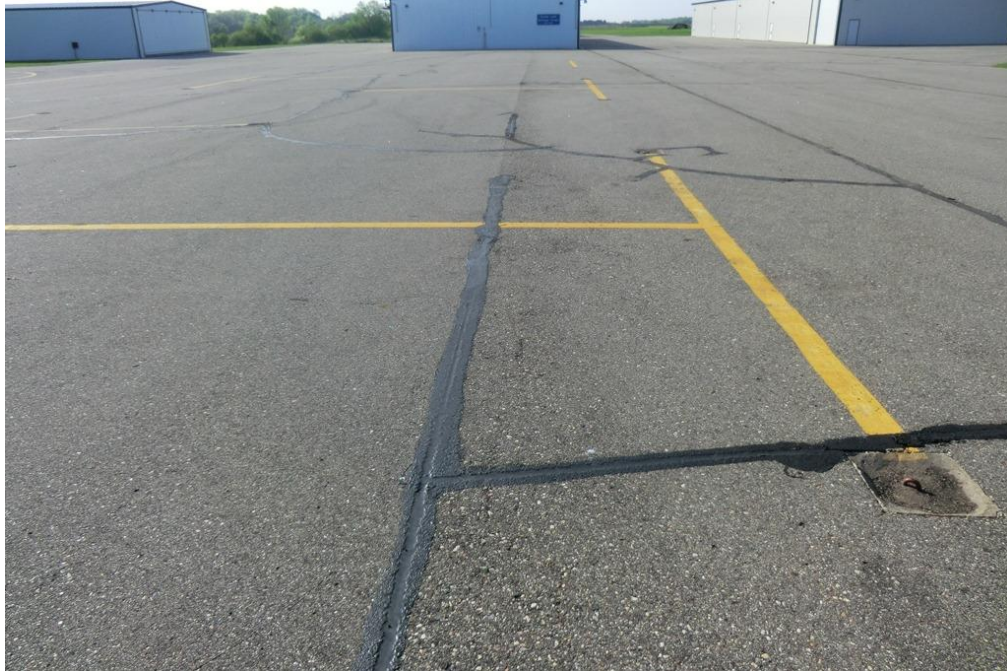
Y63 APA 001 (PCI = 83)

Conditions: PCI : 83

Sample Number: 302 Type: R Area: 5,000.00SqFt PCI = 70
Sample Comments:
48 LONGITUDINAL/TRANSVERSE CRACKING L 361.00 Ft Comments:
50 PATCHING L 45.00 SqFt Comments:
53 RUTTING L 25.00 SqFt Comments:
56 SWELLING L 36.00 SqFt Comments:

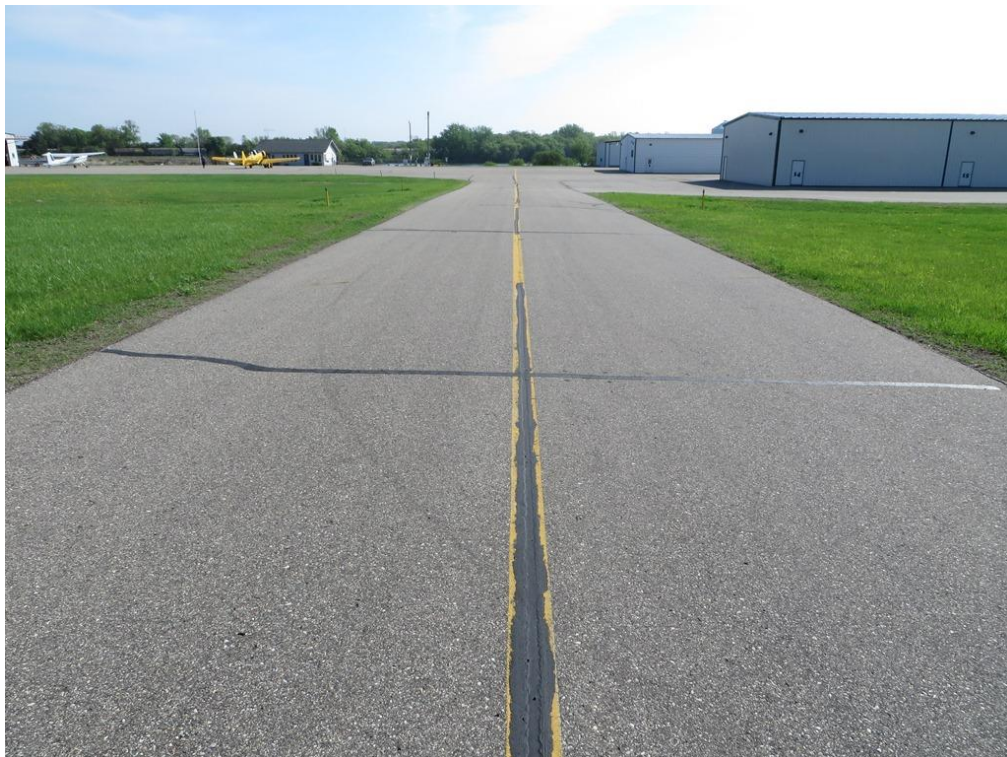
Y63 CTA 001 (PCI = 76)

Conditions: PCI : 76

48 LONGITUDINAL/TRANSVERSE CRACKING H 10.00 Ft Comments:

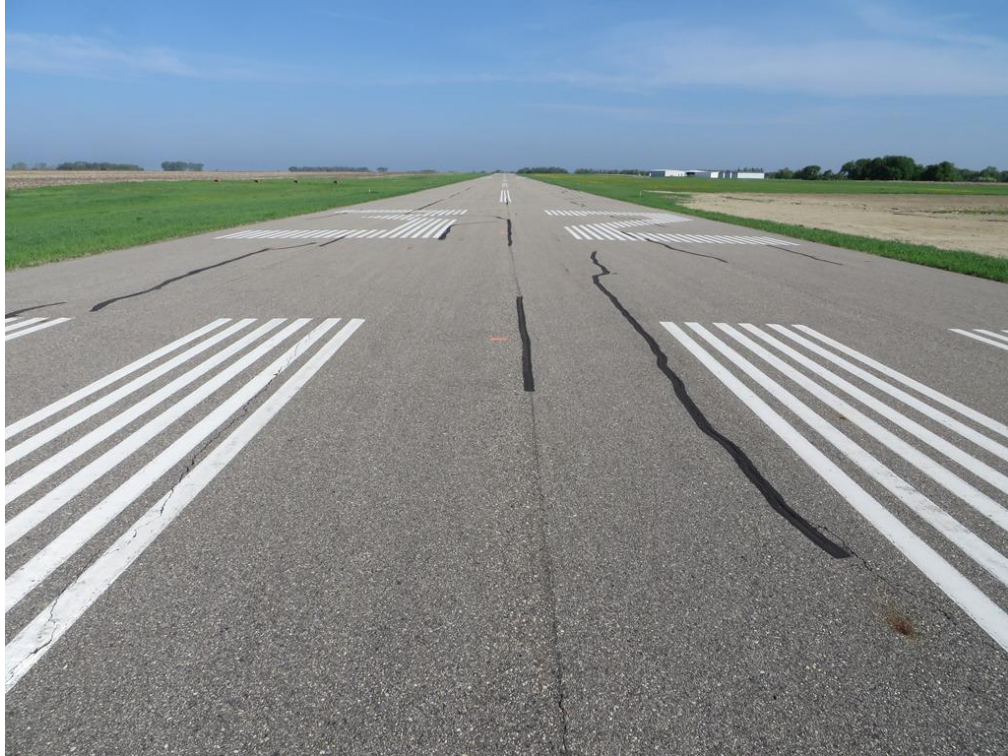
Y63 RY1432 001 (PCI = 74)

Conditions: PCI : 74

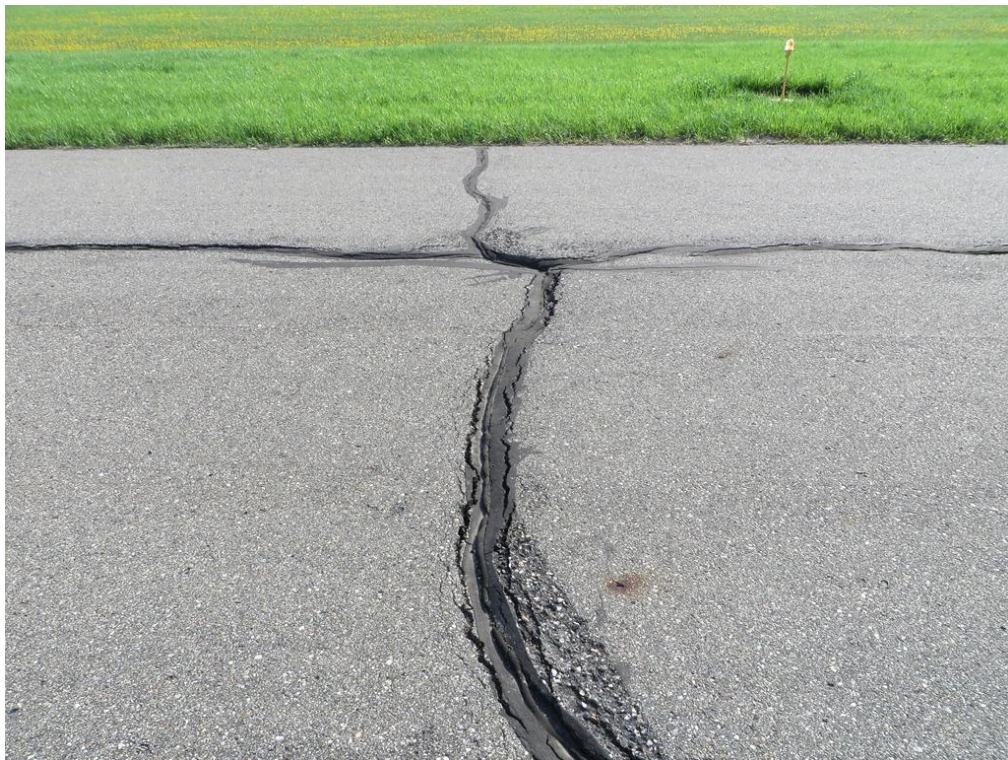
Y63 RY1432 001 (L&T Cracking with Subsidence)

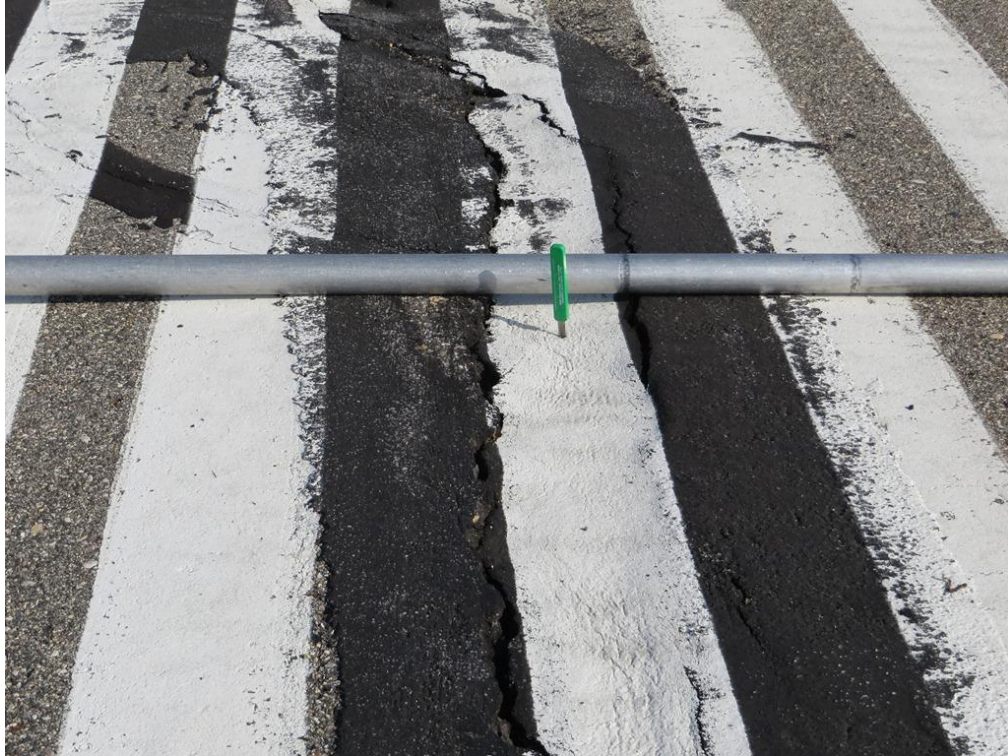
Y63 RY1432 001 (L&T Crack > 3 inches filled with sealant)

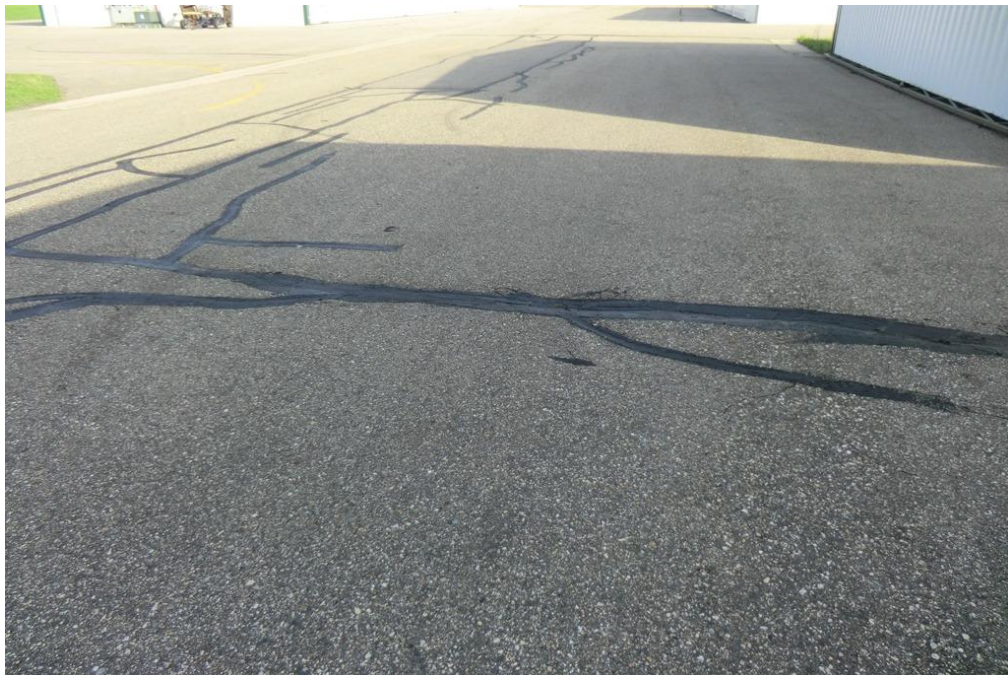
Y63 TLA 001 (PCI = 75)

Conditions: PCI : 75

41 ALLIGATOR CRACKING	M	5.00 SqFt	Comments:
45 DEPRESSION	L	20.00 SqFt	Comments:
48 LONGITUDINAL/TRANSVERSE CRACKING	L	344.00 Ft	Comments:
48 LONGITUDINAL/TRANSVERSE CRACKING	M	12.00 Ft	Comments:
50 PATCHING	L	368.00 SqFt	Comments:

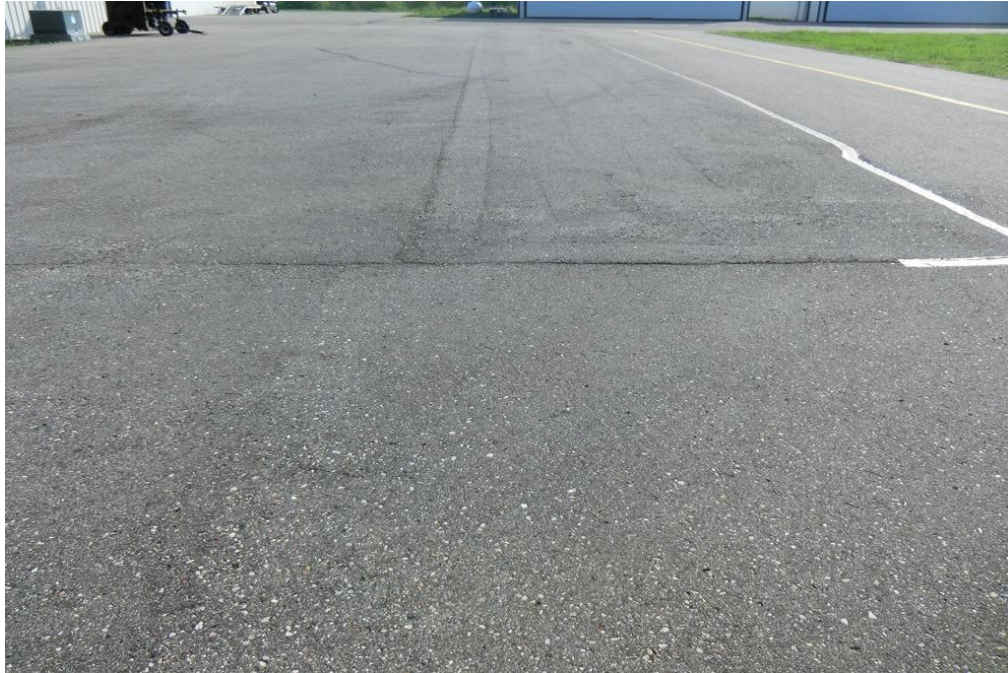
Y63 TLB 001 (PCI = 97)

Conditions: PCI : 97
