Pavement Condition Report

Hector Municipal Airport (1D6)

January 2016

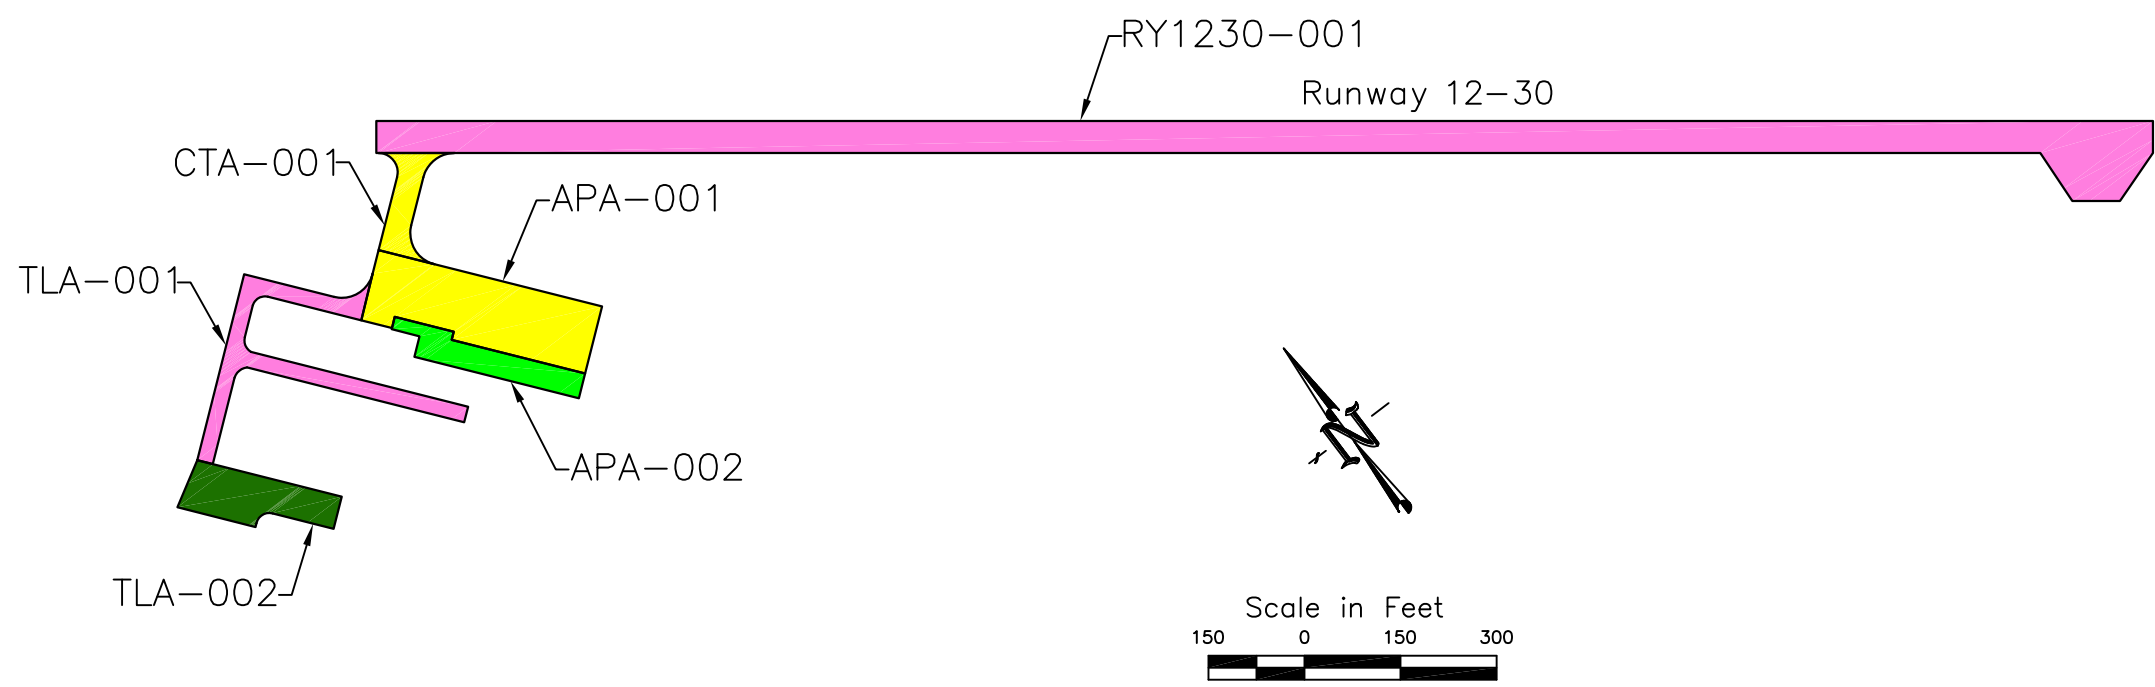
Figure 4. 2015 Pavement Condition Index Rating at Hector Municipal Airport (1D6).

Branch ID	Section ID	Surface type ¹	Section area (SF)	LCD ²	2012 PCI	2015 PCI	Drop in PCI/Yr ³	% Deduct due to		Distress types
								Load ⁴	Climate ⁵	
APA	001	AC	37,900	1985	67	61	1	22	78	Alligator Cracking, L&T, Ravelling
APA	002	AC	12,150	1986	77	73	1	0	100	L&T Cracking
CTA	001	AC	7,625	1985	60	56	1	0	100	L&T Cracking, Ravelling, Weathering
RY1230	001	AC	148,200	1985	60	53	2	15	85	Alligator, L&T Cracking, Ravelling, Weathering, Depression
TLA	001	AC	21,680	1985	57	51	2	27	73	Alligator, Block, L&T, Ravelling, Weathering
TLA	002	AC	15,750	2005	86	91	1	0	97	Depression, L&T Cracking

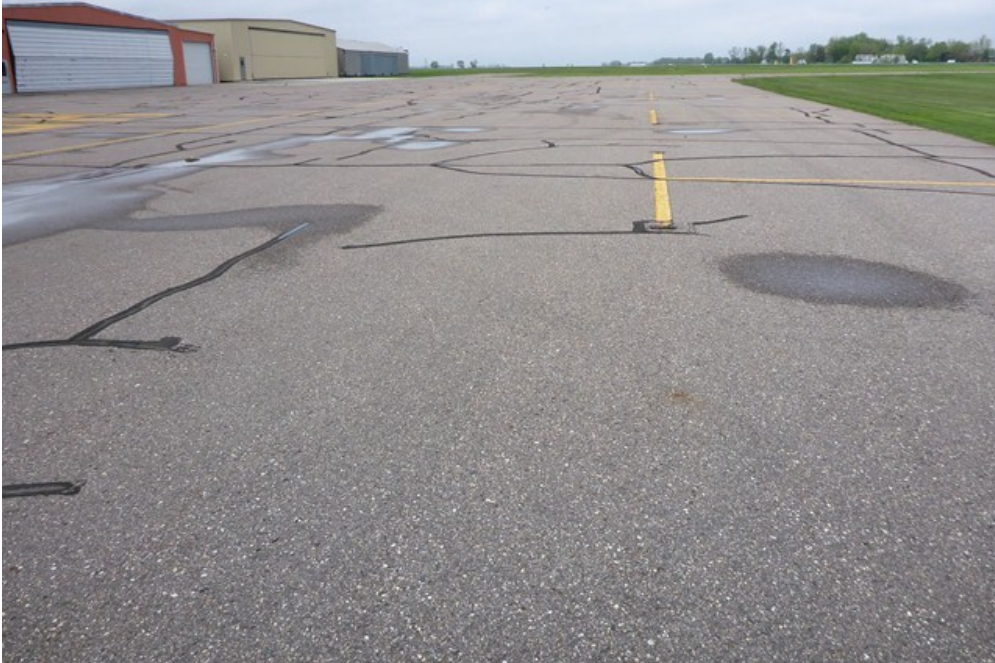
1D6 APA 001 (PCI = 61)

Conditions: PCI: 61

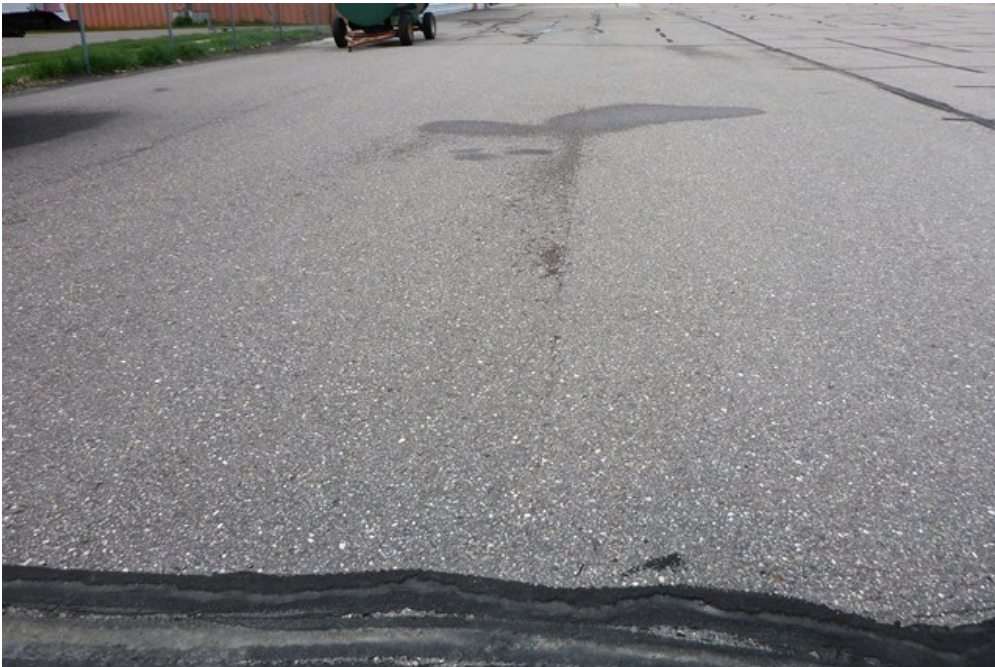
1D6 APA 002 (PCI = 73)

Network:	1D6	Name:	HECTOR						
Branch:	APA	Name:	APRON A	Use:	APRON	Area:	50,050 SqFt		
Section:	002	of 2	From:	200	To:	202	Last Const.:	9/30/1986	
Surface:	AC	Family:	MN2013 Asphalt Aprons	Zone:	S	Category:	2	Rank:	S
Area:	12,150 SqFt	Length:	310 Ft	Width:	40 Ft				
Slabs:	Slab Length:	Ft	Slab Width:	Ft	Joint Length:	Ft			
Shoulder:	Street Type:	Grade:	0	Lanes:	0				
Section Comments:									
Last Insp. Date:	5/16/2015	TotalSamples:	3	Surveyed:	1				
Conditions:	PCI: 73								
Inspection Comments:									
Sample Number:	201	Type:	R	Area:	4000.00 SqFt	PCI:	73		
Re-Inspection Report									
48	L & T CR	L	372.00 Ft	Comments:					
48	L & T CR	M	62.00 Ft	Comments:

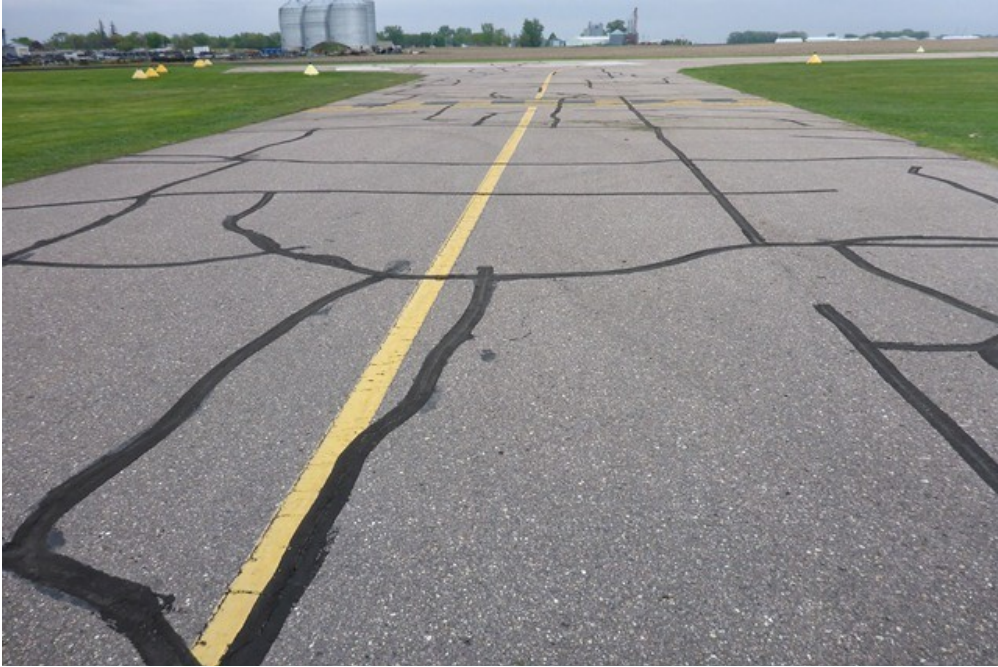
1D6 CTA 001 (PCI = 56)

Conditions: PCI: 56

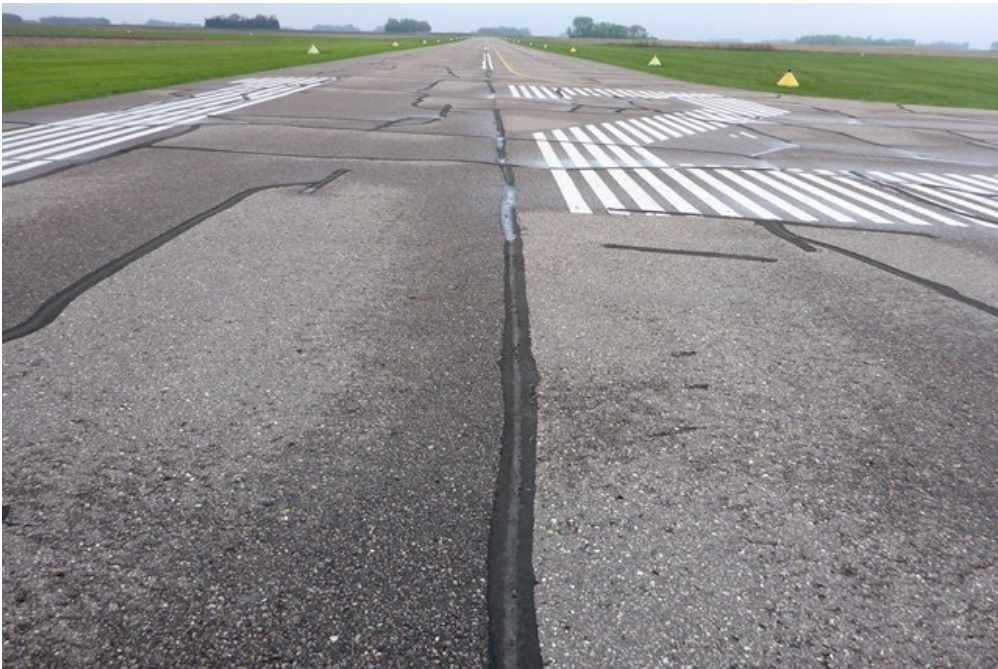
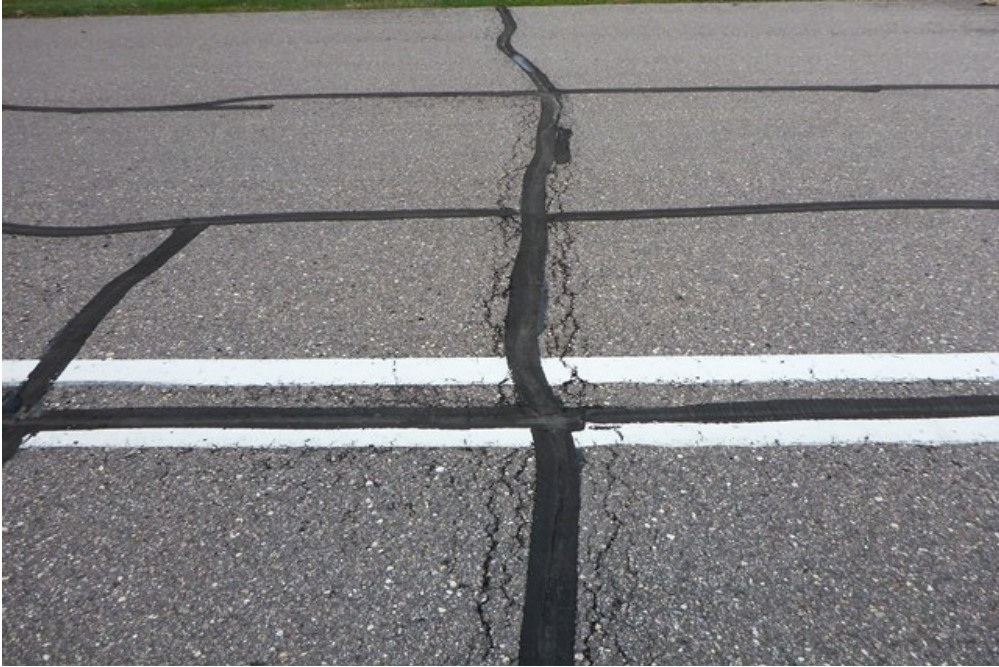
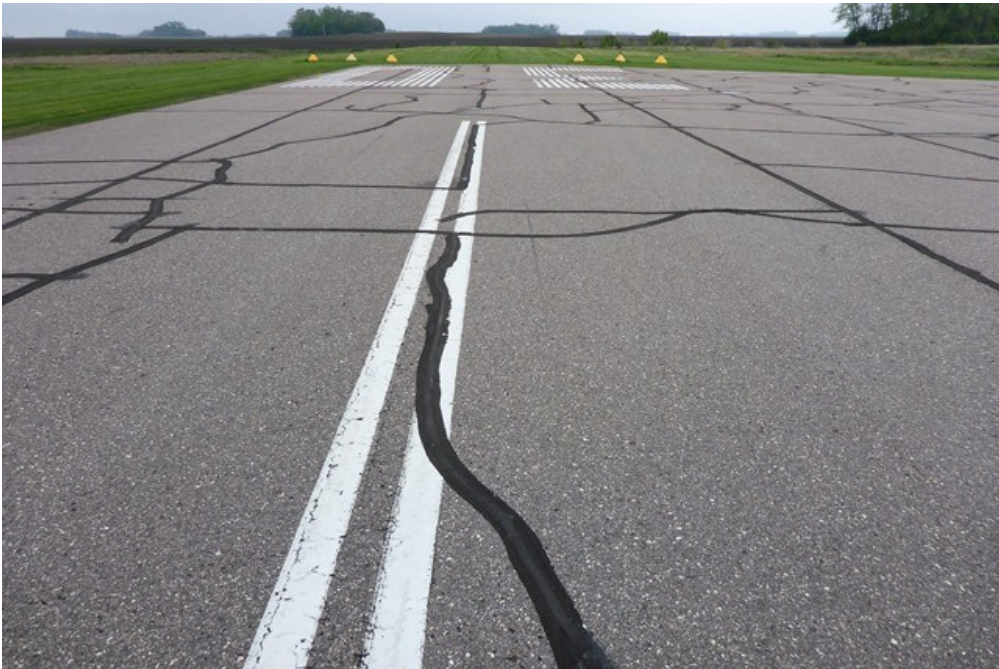
1D6 RY1230 001 (PCI = 53)

Network:	1D6	Name:	HECTOR						
Branch:	RY1230	Name:	RUNWAY 12-30	Use:	RUNWAY	Area:	148,200 SqFt		
Section:	001	of 1	From:	100	To:	127	Last Const.:	9/30/1985	
Surface:	AC	Family:	MN2013 Asphalt Runways	Zone:	S	Category:	2	Rank:	P
Area:	148,200 SqFt	Length:	2,776 Ft	Width:	50 Ft				
Slabs:		Slab Length:	Ft	Slab Width:	Ft	Joint Length:	Ft		
Shoulder:		Street Type:		Grade:	0	Lanes:	0		
Section Comments:									
Last Insp. Date:	5/16/2015	TotalSamples:	30	Surveyed:	4				
Conditions:	PCI: 53								
Inspection Comments:									
Sample Number:	101	Type:	R	Area:	5000.00 SqFt	PCI:	56		
Re-Inspection Report									
48	L & T CR	L	755.00 Ft	Comments:					
48	L & T CR	M	59.00 Ft	Comments:					
52	RAVELING	L	500.00 SqFt	Comments:					
57	WEATHERING	L	4000.00 SqFt	Comments:					
Sample Number:	109	Type:	R	Area:	5000.00 SqFt	PCI:	49		
Re-Inspection Report									
57	WEATHERING	L	4000.00 SqFt	Comments:					
41	ALLIGATOR CR	L	29.00 SqFt	Comments:

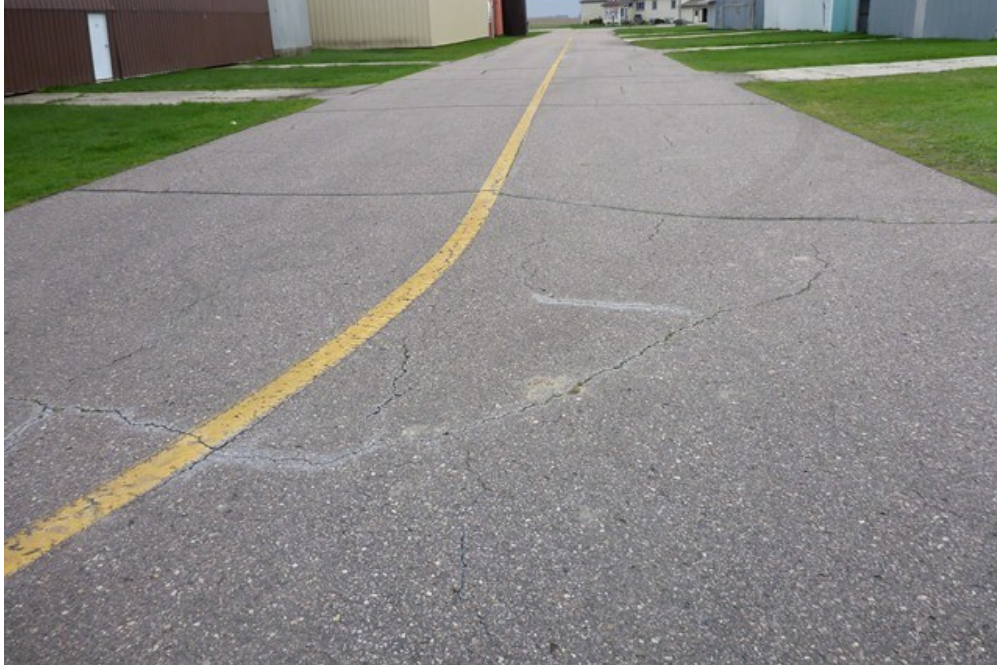
1D6 TLA 001 (PCI = 51)

Conditions: PCI: 51

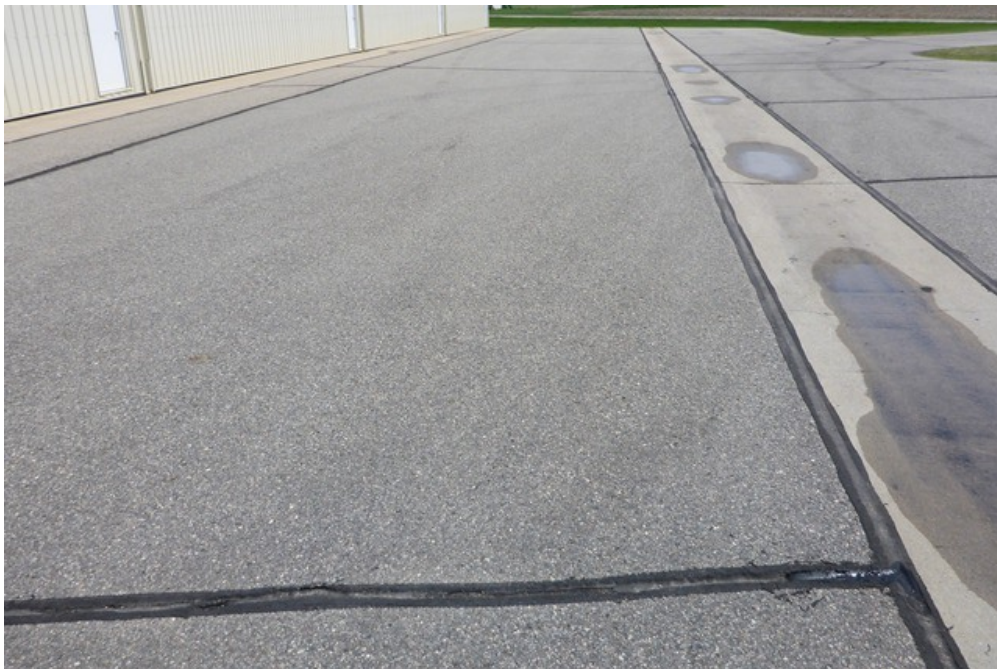
1D6 TLA 002 (PCI = 91)

Network:	1D6	Name:	HECTOR						
Branch:	TLA	Name:	Taxilane A	Use:	TAXILANE	Area:	37,430 SqFt		
Section:	002	of 2	From:	200	To:	202	Last Const.:	9/30/2005	
Surface:	AC	Family:	MN2013 Asphalt Taxilanes	Zone:	S	Category:	2	Rank:	T
Area:	15,750 SqFt	Length:	233 Ft	Width:	75 Ft				
Slabs:		Slab Length:	Ft	Slab Width:	Ft	Joint Length:	Ft		
Shoulder:		Street Type:		Grade:	0	Lanes:	0		
Section Comments:									
Last Insp. Date:	5/16/2015	TotalSamples:	3	Surveyed:	1				
Conditions:	PCI: 91								
Inspection Comments:									
Sample Number:	200	Type:	R	Area:	3750.00 SqFt	PCI:	91		
Re-Inspection Report									
45	DEPRESSION	L	2.00 SqFt	Comments:					
48	L & T CR	L	94.00 Ft	Comments:
