# Pavement Condition Report

## Rushford Municipal Airport (55Y)

**January 2016**

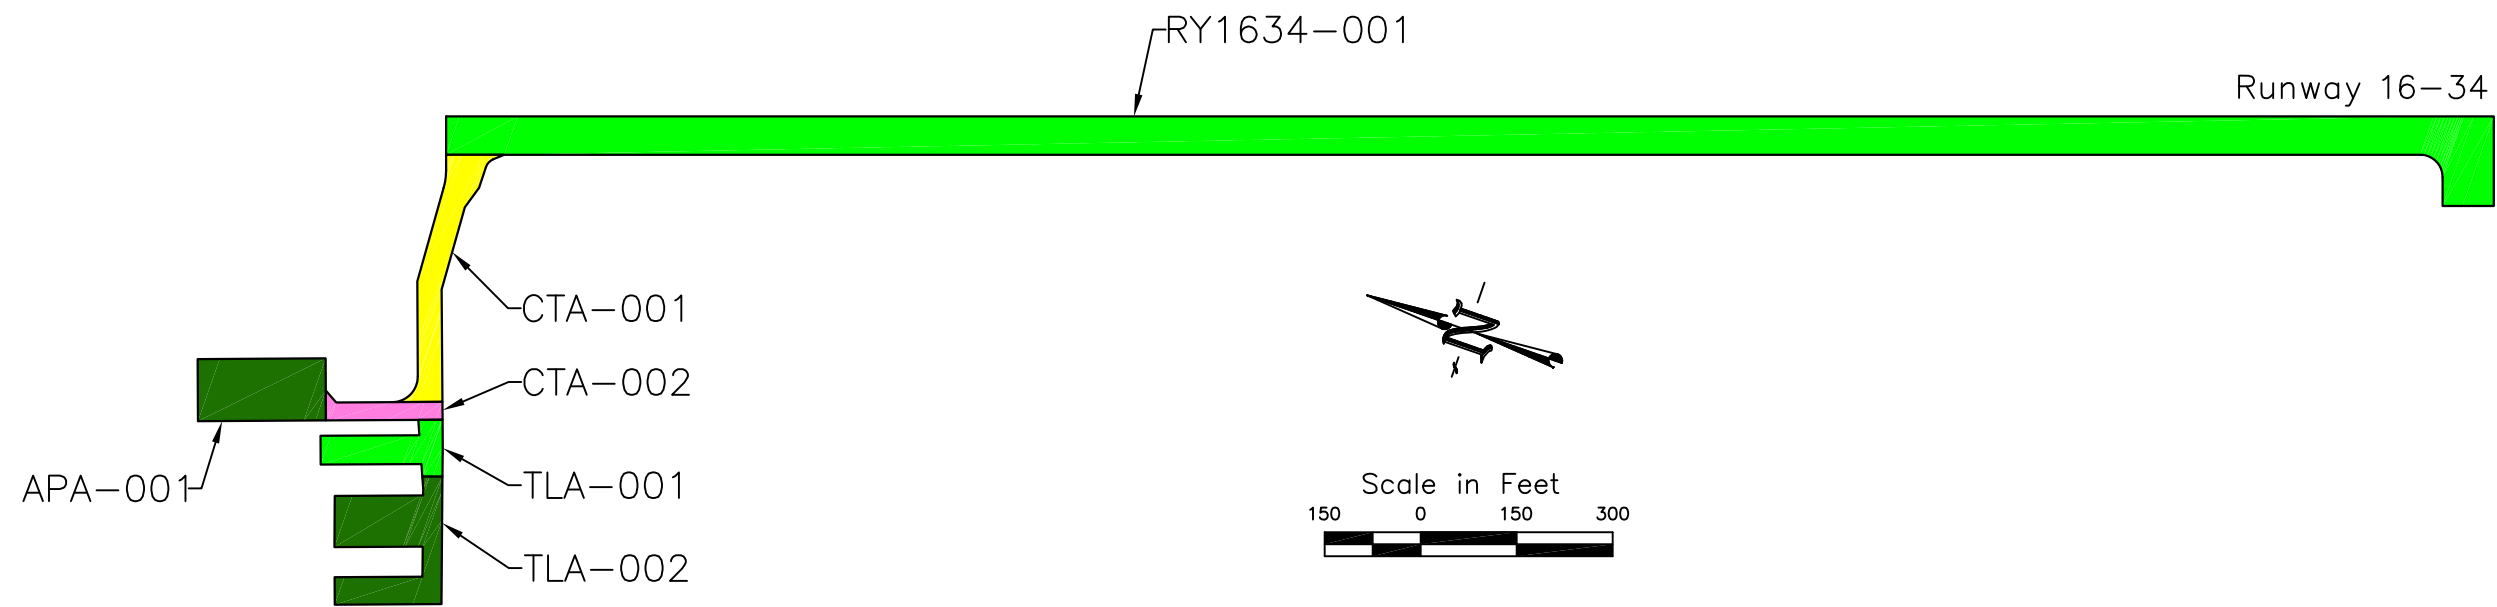
Figure 4. 2015 Pavement Condition Index Rating at Rushford Municipal Airport (55Y).

Branch ID	Section ID	Surface type <sup>1</sup>	Section area (SF)	LCD <sup>2</sup>	2012 PCI	2015 PCI	Drop in PCI/Yr <sup>3</sup>	% Deduct due to		Distress types
								Load <sup>4</sup>	Climate <sup>5</sup>	
APA	001	AC	19,400	2005	89	91	0.9	0	100	L&T Cracking
CTA	001	AC	17,095	2005	75	62	3.8	43	57	Alligator, L&T, Patching
CTA	002	AC	5,250	2005	89	55	4.5	59	41	Alligator, L&T, Patching
RY1634	001	AC	198,700	2005	89	82	1.8	0	100	L&T Cracking
TLA	001	AC	10,150	2005	91	85	1.5	0	100	L&T Cracking, Ravelling
TLA	002	AC	23,000	2011	100	95	1.3	0	100	L&T Cracking, Weathering

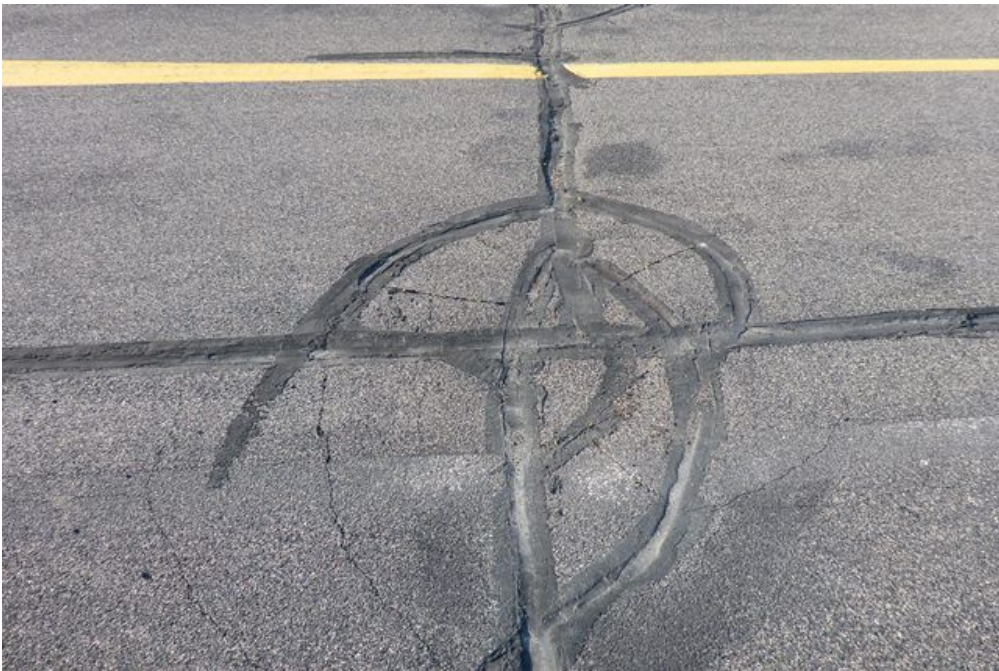
55Y CTA 001 (PCI = 62)

**Section Comments:** maint R&E (crack seal)

**Conditions:** PCI: 62

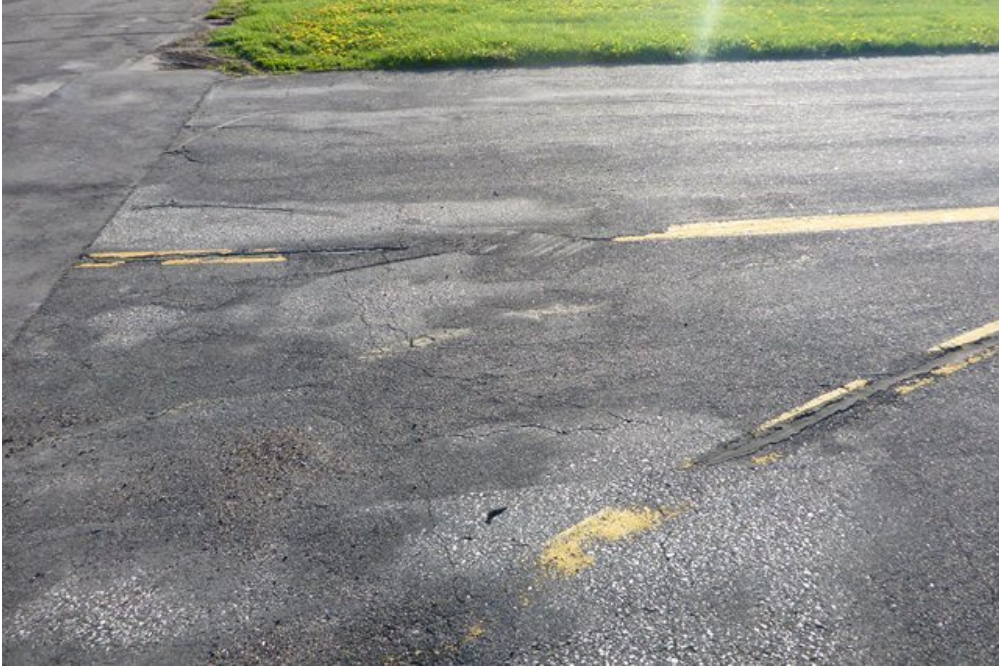
55Y CTA 002 (PCI = 55)

**Section Comments:** maint R&E (crack seal)

**Conditions:** PCI: 55

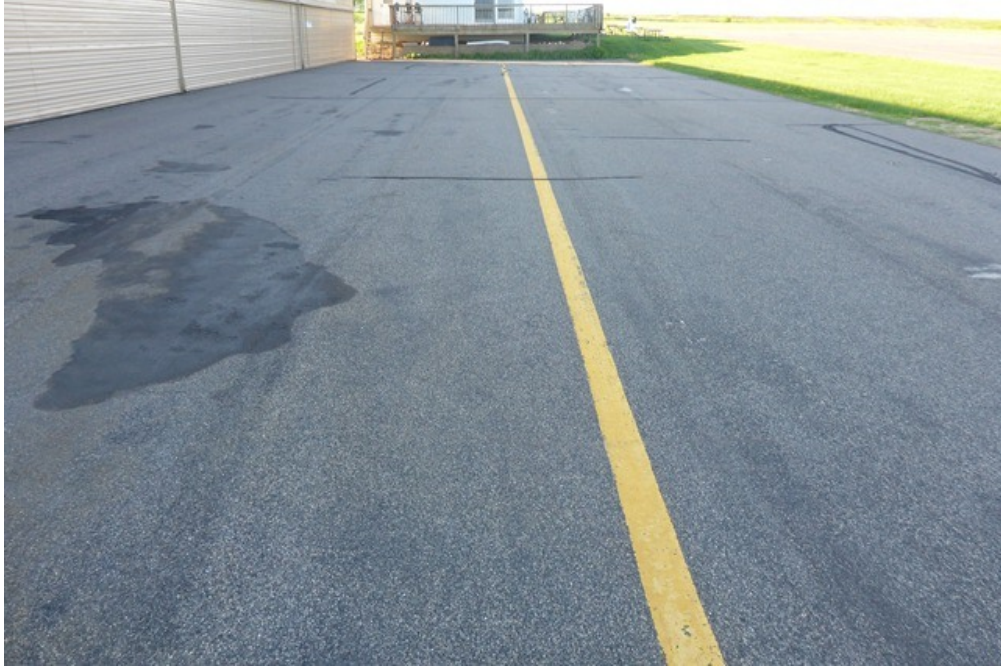
55Y TLA 001 (PCI = 85)

**Section Comments:** maint R&E (crack seal)

**Conditions:** PCI: 85

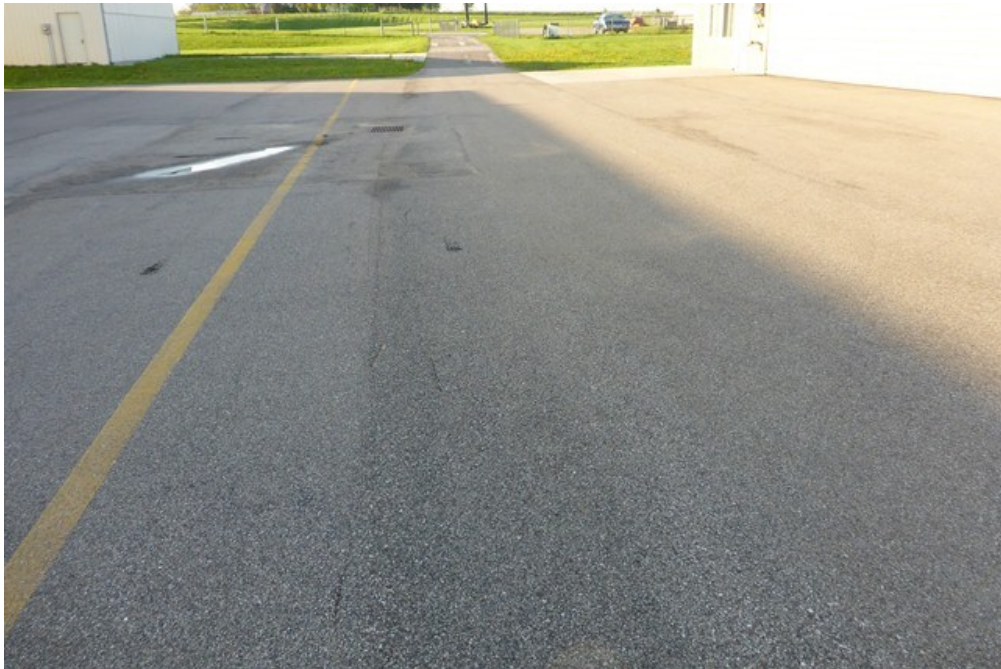
55Y TLA 002 (PCI = 95)

**Conditions:** PCI: 95
