# Pavement Condition Report

## Brooten Municipal Airport (6D1)

January 2016

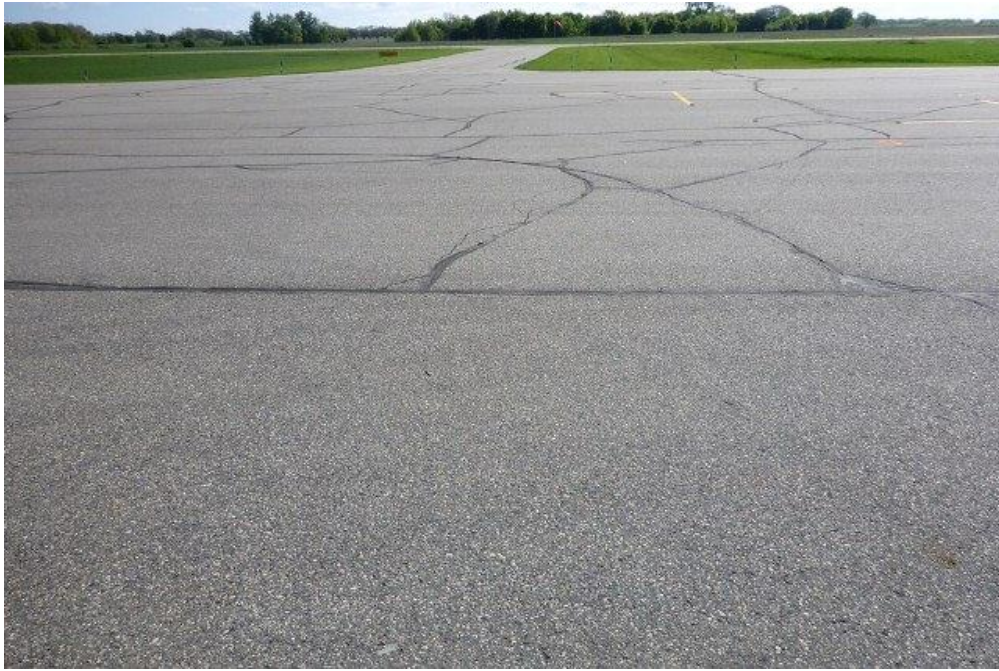
6D1 APA 001 (PCI = 65)

| <b>Section Comments:</b> | maint R&E (crack seal) | | | | | |

**Conditions:** PCI: 65

| Branch ID | Section ID | Distress Type | Severity | Treatment | Estimated Quantity | Unit | Cost |
|---|---|---|---|---|---|---|---|
| APA | 001 | ALLIGATOR CR | Low | Crack Sealing - AC | 10 | Ft | \$12 |
| APA | 001 | L & T CR | Medium | Crack Sealing - AC | 640 | Ft | \$769 |

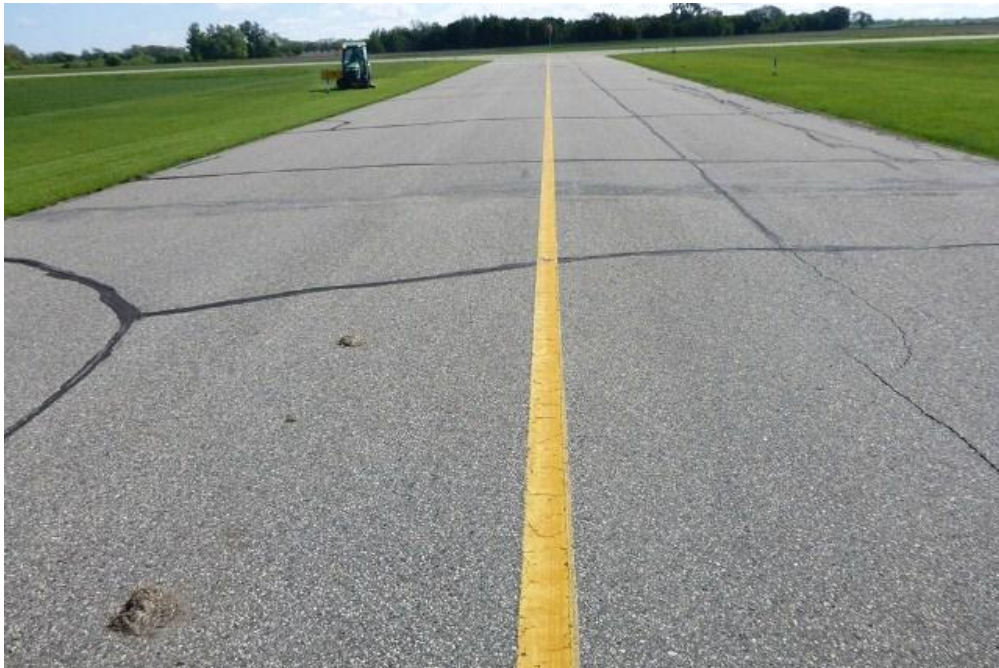
6D1 CTA 001 (PCI = 68)

| Section Comments: | maint R&E (crack seal) | | | | | | | | | |
| Conditions: | PCI: 68 | | | | | | | | | |

| Branch ID | Section ID | Distress Type | Severity | Treatment | Estimated Quantity | Unit | Cost |
|---|---|---|---|---|---|---|---|
| CTA | 001 | L & T CR | Medium | Crack Sealing - AC | 20 | Ft | \$24 |

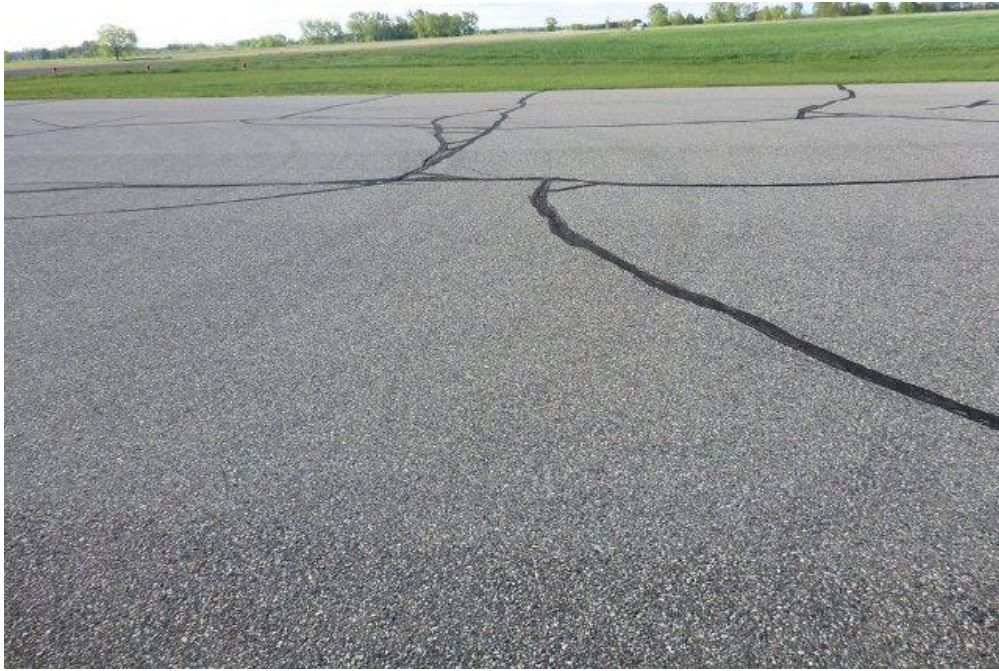
6D1 RTA 001 (PCI = 59)

| Section Comments: | maint R&E (crack seal) | | | | | | | | | |

| Branch ID | Section ID | Distress Type | Severity | Treatment | Estimated Quantity | Unit | Cost |
|---|---|---|---|---|---|---|---|
| RTA | 001 | L & T CR | Medium | Crack Sealing - AC | 17 | Ft | \$21 |

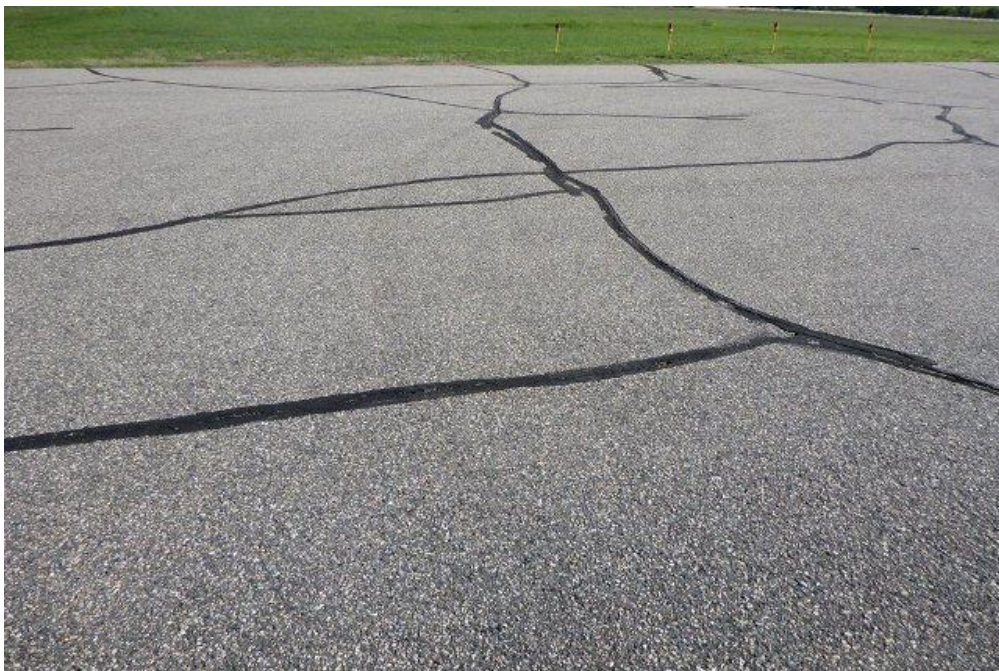
6D1 RTA 002 (PCI = 67)

| Conditions: | PCI: 67 | | | | | | | | | |

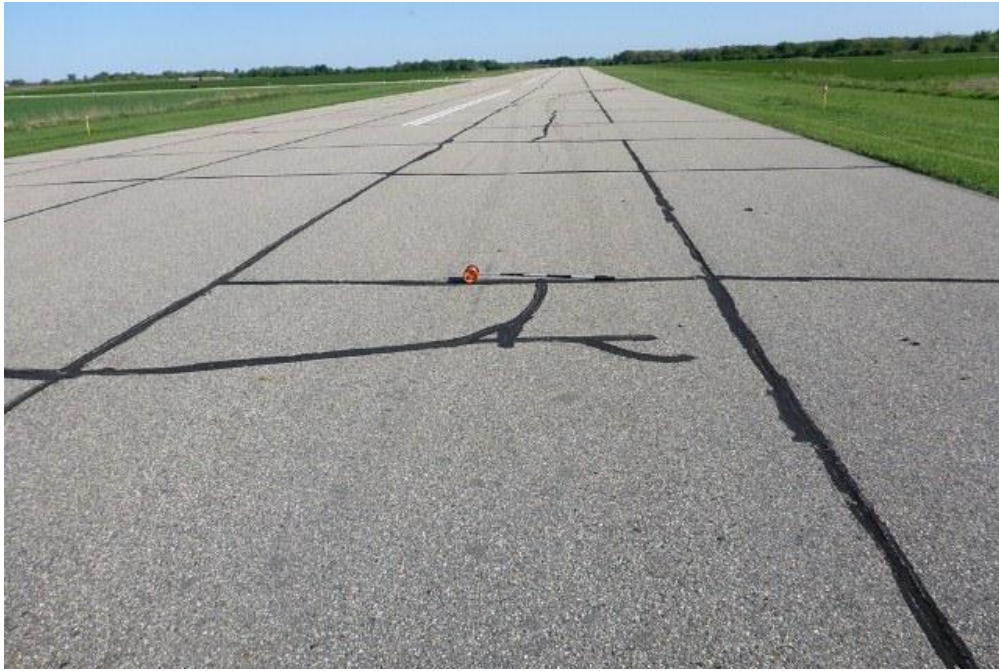
6D1 RY1533 001 (PCI = 59)

| Section Comments: | maint R&E (crack seal) | | | | | | | | | | | | |
| Conditions: | PCI: 59 | | | | | | | | | | | | |

| Branch ID | Section ID | Distress Type | Severity | Treatment | Estimated Quantity | Unit | Cost |
|---|---|---|---|---|---|---|---|
| RY1533 | 001 | L & T CR | Medium | Crack Sealing - AC | 460 | Ft | \$552 |

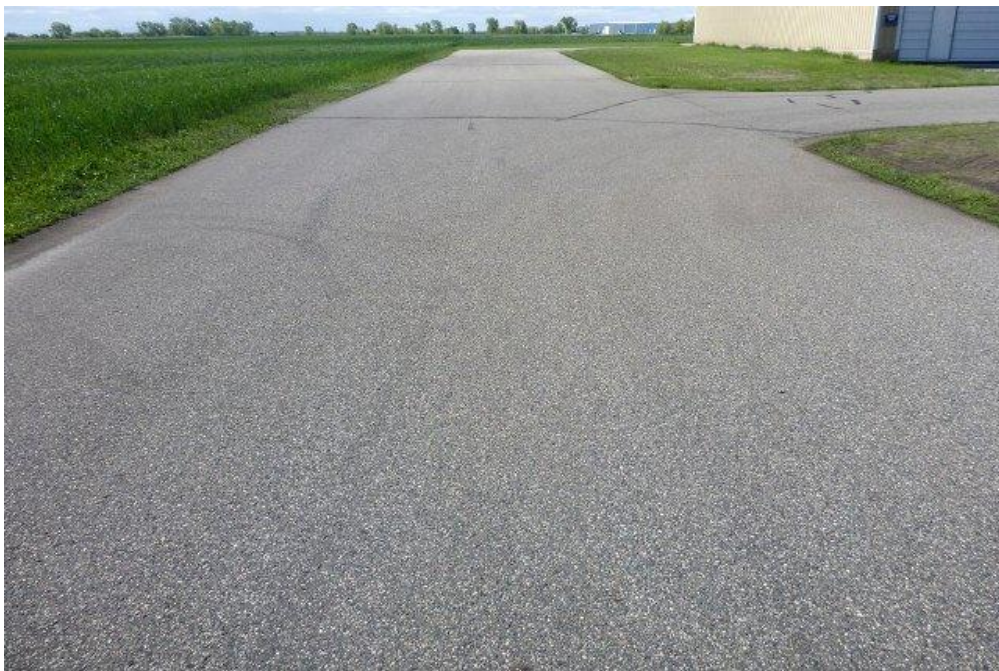
6D1 TLA 001 (PCI = 75)

| Section Comments: | | maint R&E (crack seal) | | | | | | | | | | | | | | | | | |
| Conditions: | | PCI: | | 75 | | | | | | | | | | | | | | | |

| Branch ID | Section ID | Distress Type | Severity | Treatment | Estimated Quantity | Unit | Cost |
|---|---|---|---|---|---|---|---|
| TLA | 001 | L & T CR | Medium | Crack Sealing - AC | 259 | Ft | \$311 |
