# Pavement Condition Report

## Appleton Municipal Airport (AQP)

**January 2016**

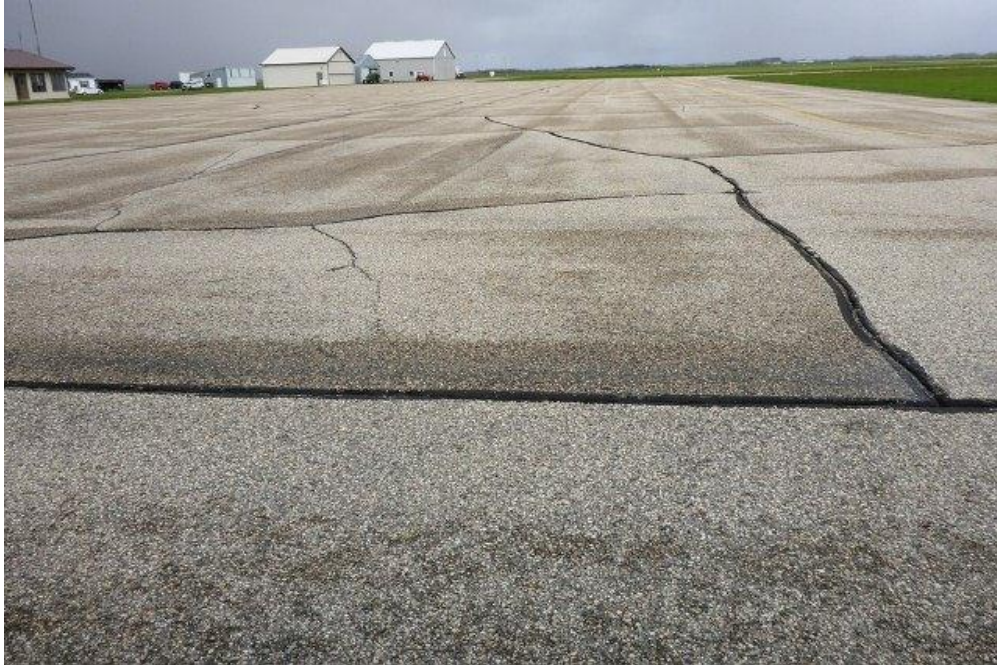
AQP APA 001 (PCI = 31)

Branch ID	Section ID	Surface type <sup>1</sup>	Section area (SF)	LCD <sup>2</sup>	2012 PCI	2015 PCI	Drop in PCI/Yr <sup>3</sup>	% Deduct due to		Distress types
								Load <sup>4</sup>	Climate <sup>5</sup>	
APA	001	AC	78,750	1991	31	31	2.9	0	100	L&T Cracking, Ravelling
CTA	001	AC	12,235	1991	33	33	2.8	0	100	L&T Cracking, Ravelling
CTB	001	AC	12,315	1991	18	15	3.5	10	90	Alligator, L&T Cracking, Ravelling
RTA	001	AC	17,000	2001	N/A	33	4.8	0	100	L&T Cracking, Ravelling
RY1331	001	AC	262,500	2013	27	77	11.5	0	100	L&T Cracking
TLA	001	AC	15,500	1991	23	20	3.3	0	100	L&T Cracking, Ravelling
