# Pavement Condition Report

## Benson Municipal Airport (BBB)

Applied Research Associates, Inc.  
6314 Odana Rd  
Madison, WI 53719  
(608) 274-6409

January 2016

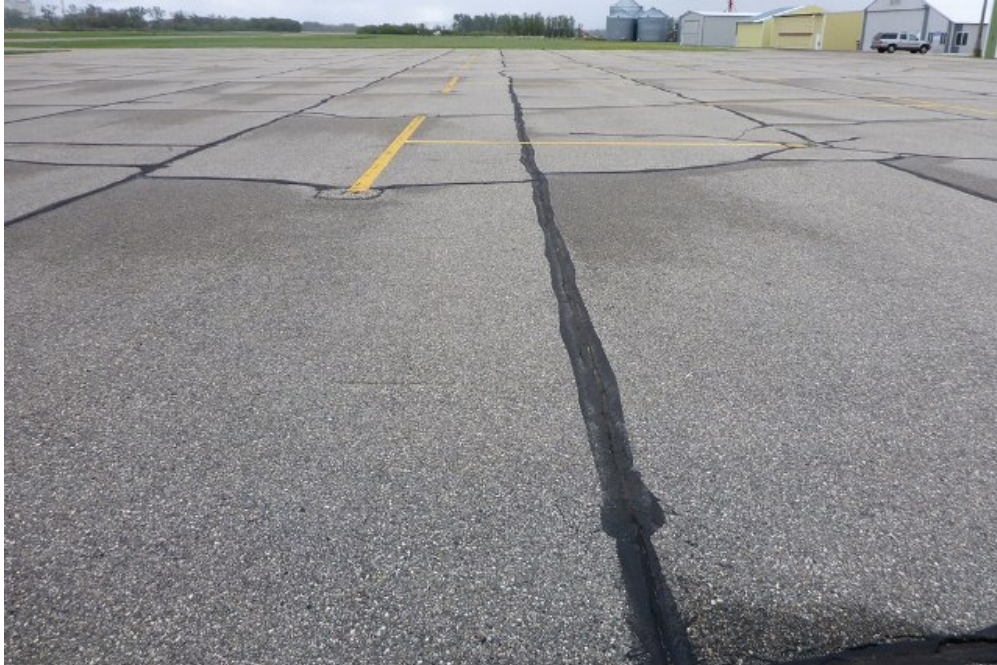
BBB APA 001 (PCI = 59)

| Section Comments: | maint R&E (crack seal 8/09) | | | | | | | | | | | | | |

**Conditions:** PCI: 59

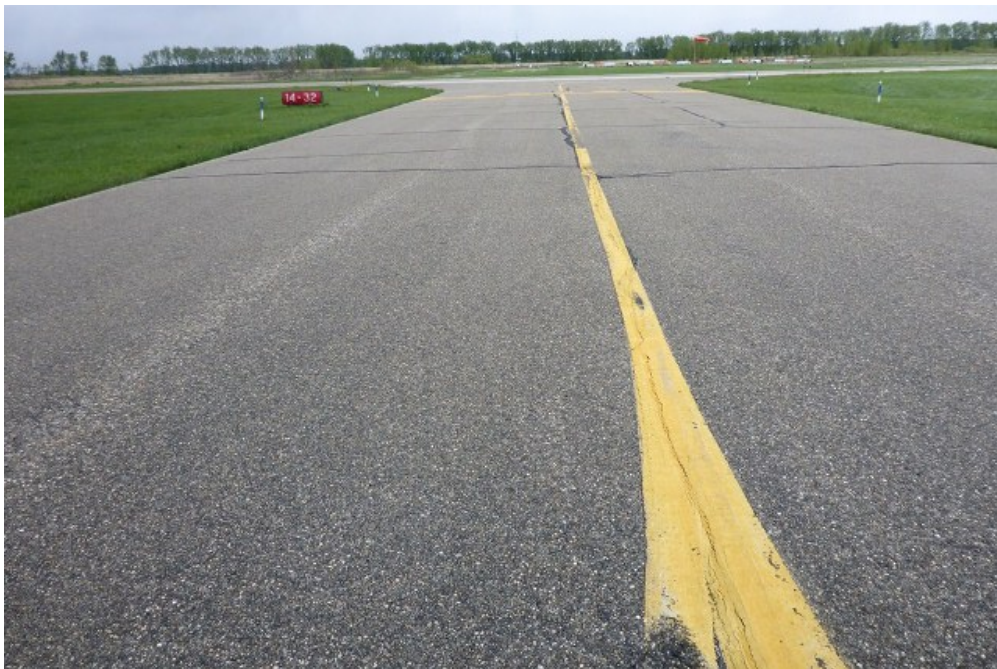
BBB CTA 001 (PCI = 69)

| Section Comments: | | maint R&E (crack seal 8/09) | | | | | | | | | | | | | | | | | |
| Conditions: | | PCI: | | 69 | | | | | | | | | | | | | | | |

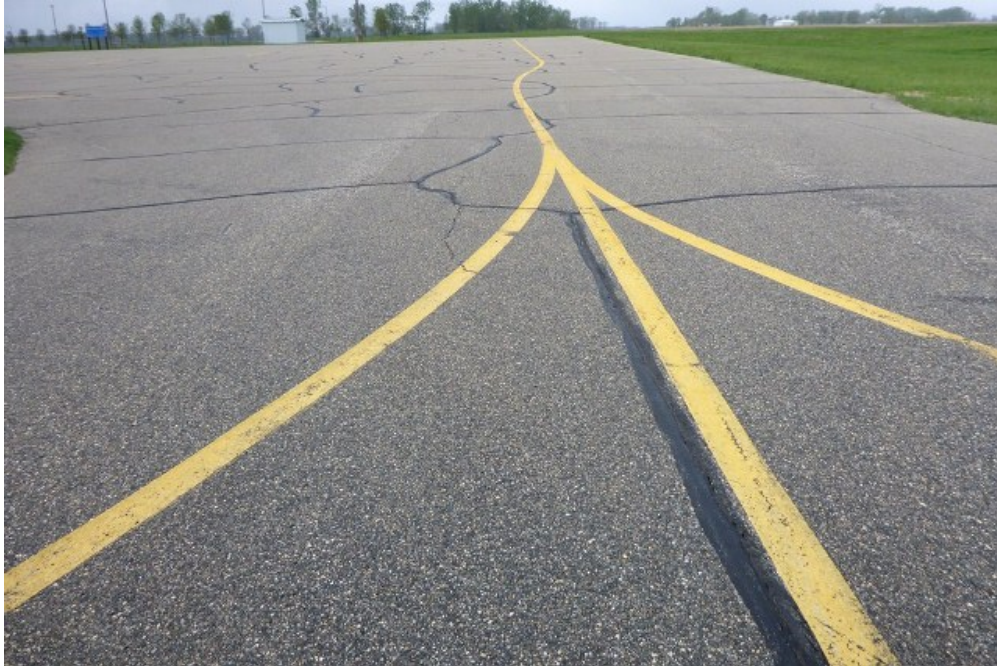
BBB CTAX 001 (PCI = 65)

| Section Comments: | | maint R&E (crack seal 8/09) | | | | | | | | | | | | | | | | | |
| Conditions: | | PCI: | | 65 | | | | | | | | | | | | | | | |

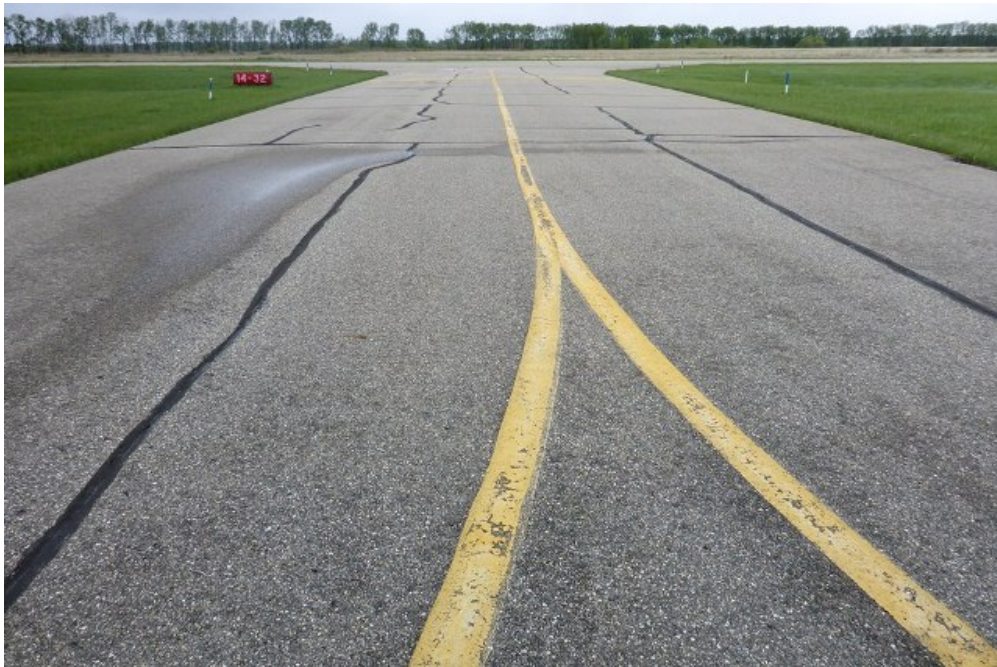
BBB CTB 001 (PCI = 52)

| Section Comments: | | maint R&E (crack seal 8/09) | | | | | | | | | | | | | | | | | |
| Conditions: | | PCI: 52 | | | | | | | | | | | | | | | | | |

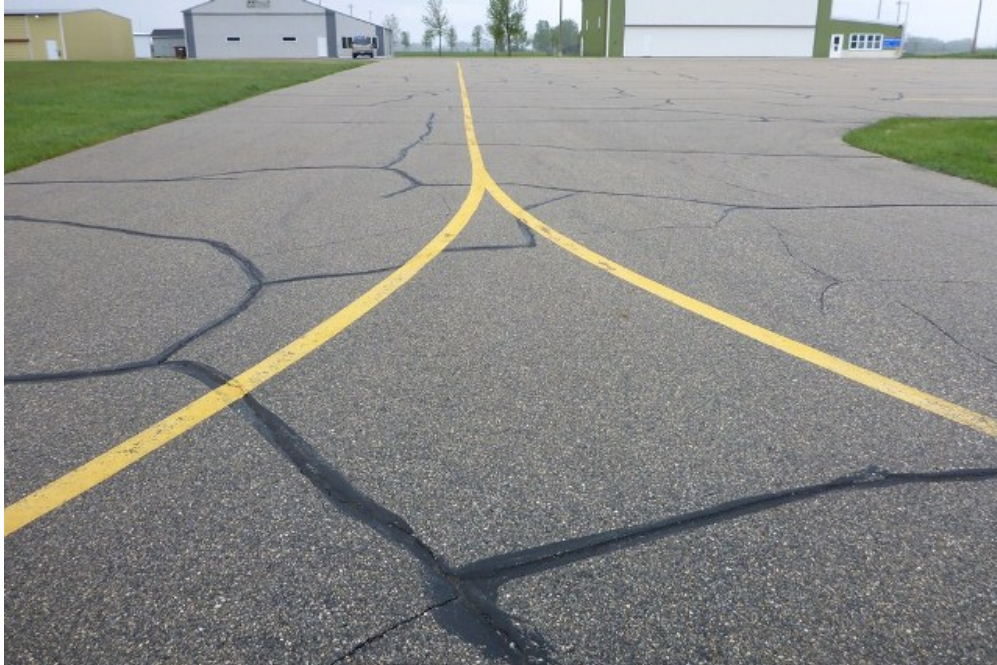
BBB CTC 001 (PCI = 64)

| Section Comments: | maint R&E (crack seal 8/09) | | | | | | | | | | | | | |
| Conditions: | PCI: 64 | | | | | | | | | | | | | |

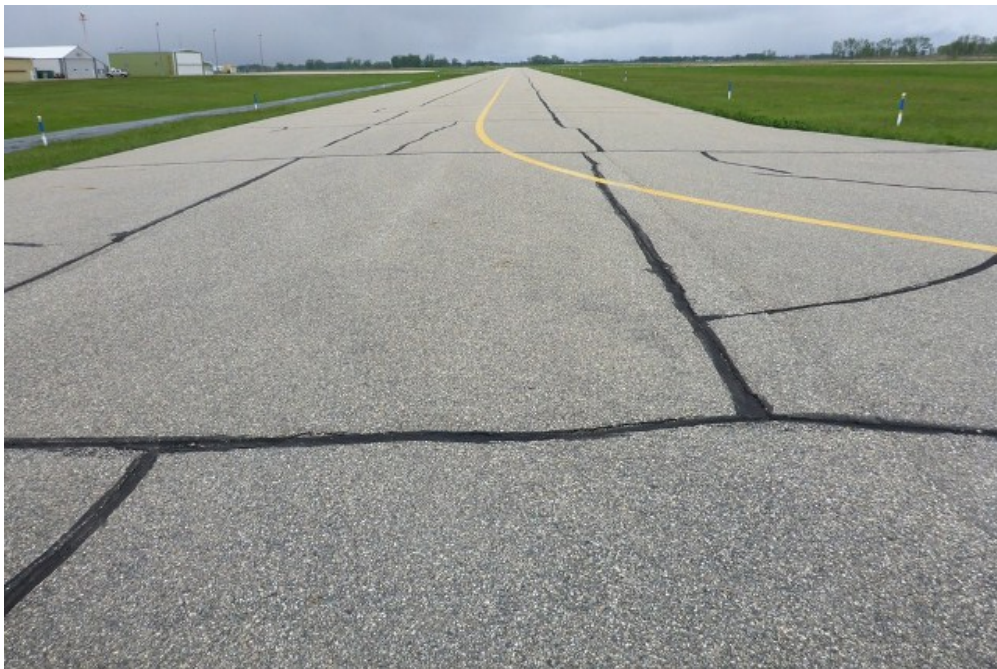
BBB PTA 001 (PCI = 67)

| Section Comments: | maint R&E (crack seal 8/09) | | | | | | | | | |
| Conditions: | PCI: 67 | | | | | | | | | |

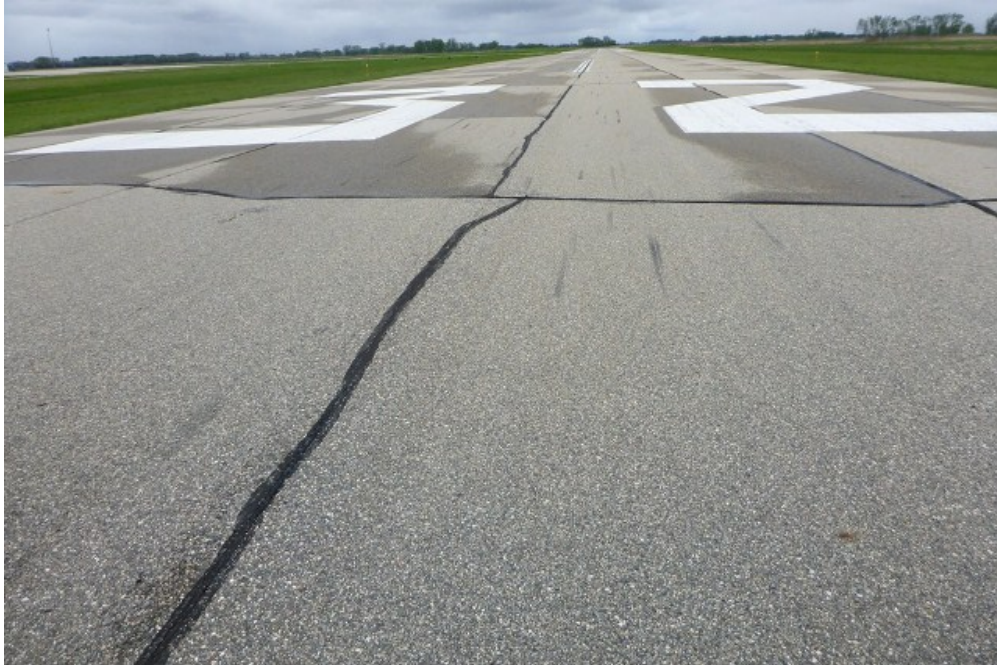
BBB RY1432 001 (PCI = 67)

| Section Comments: | | maint R&E (crack seal 8/09) | | | | | | | | | | | | | | | | | | | |
| Conditions: | | PCI: | | 67 | | | | | | | | | | | | | | | | | |

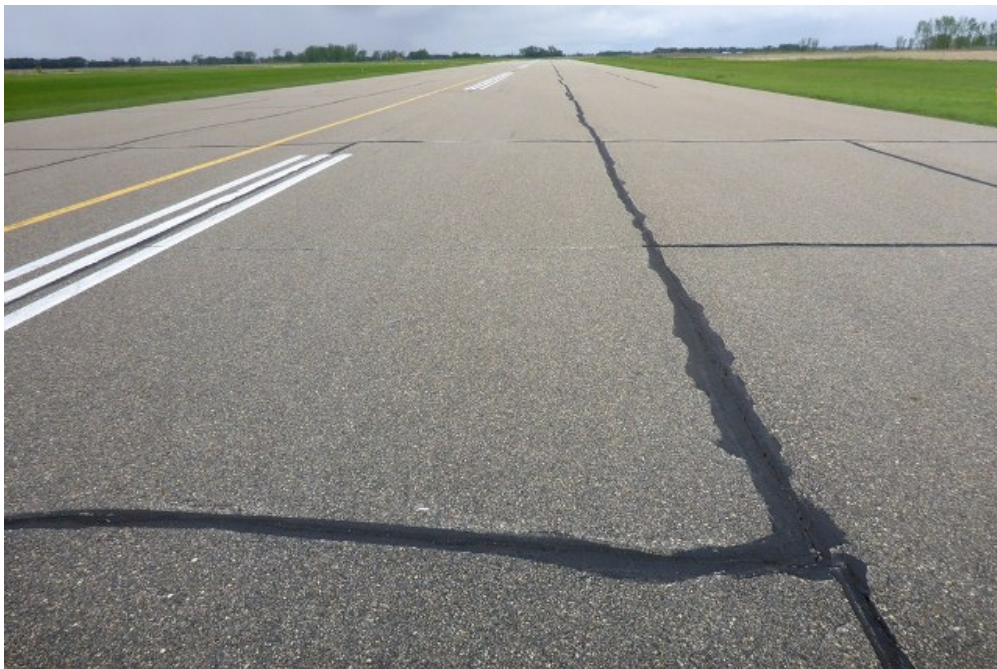
BBB RY1432 002 (PCI = 67)

| Section Comments: | maint R&E (crack seal 8/09) | | | | | | | | | | | |
| Conditions: | PCI: 67 | | | | | | | | | | | |

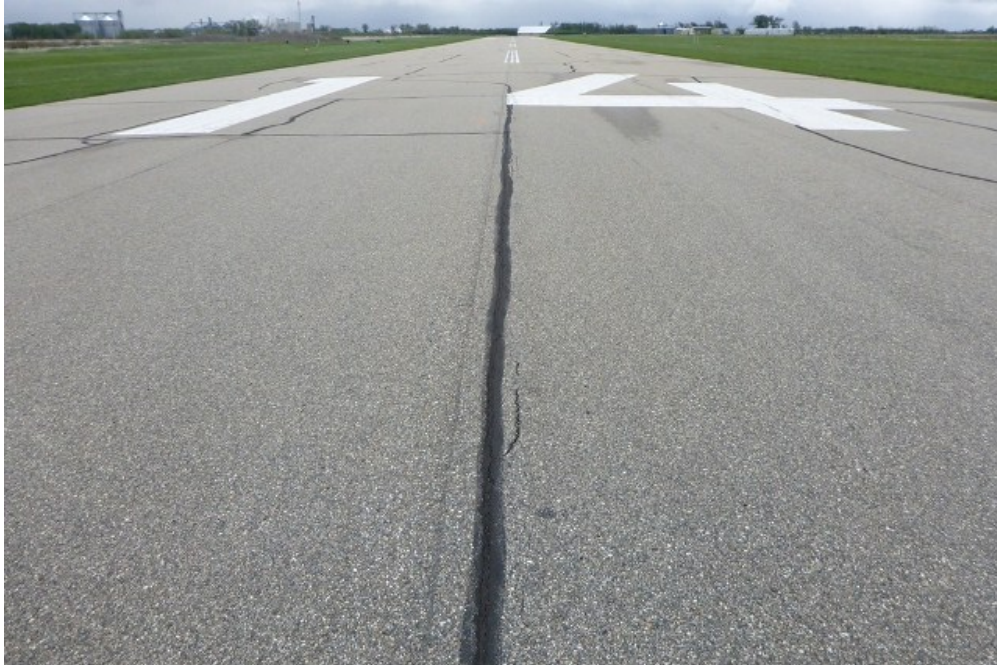
BBB RY1432 003 (PCI = 66)

| Section Comments: | maint R&E (crack seal 8/09) | | | | | | | | | | | |
| Conditions: | PCI: 66 | | | | | | | | | | | |

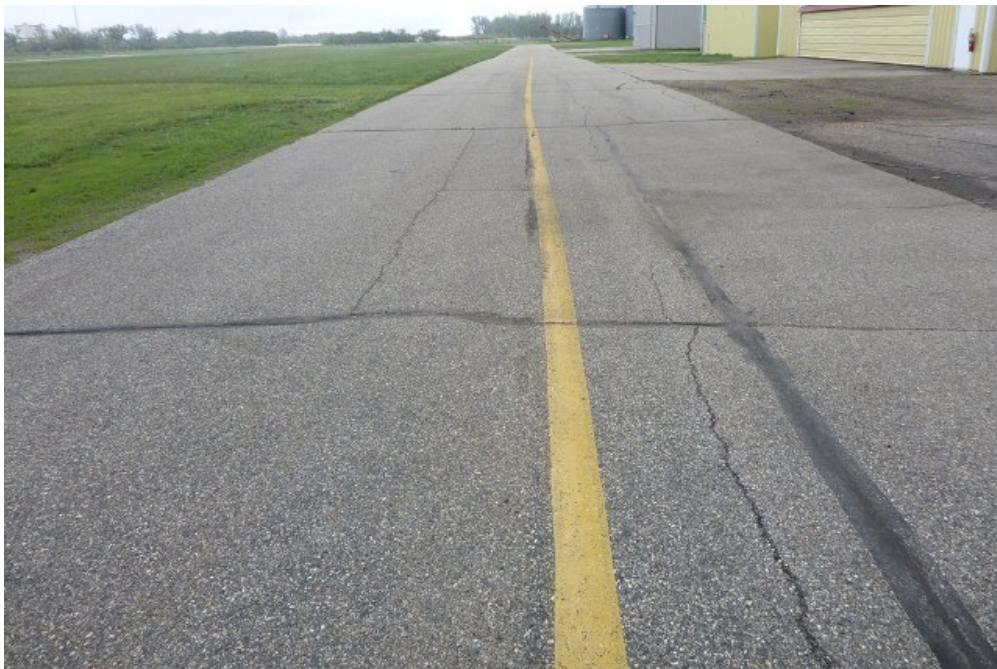
BBB TLA 001 (PCI = 67)

| Section Comments: | maint R&E (crack seal 8/09) | | | | | | | | | |
| Conditions: | PCI: | 67 | | | | | | | | |

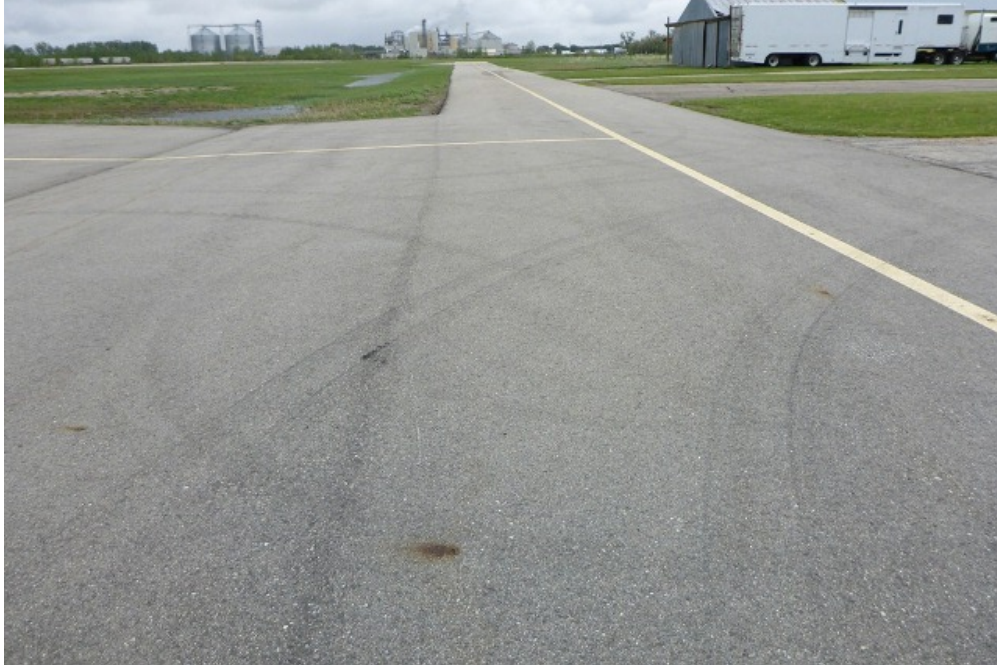
BBB TLB 001 (PCI = 95)

| Branch ID | Section ID | Surface type <sup>1</sup> | Section area (SF) | LCD <sup>2</sup> | 2012 PCI | 2015 PCI | Drop in PCI/Yr <sup>3</sup> | % Deduct due to | | Distress types |
|---|---|---|---|---|---|---|---|---|---|---|
| TLB | 001 | AC | 11,250 | 2013 | 53 | 95 | 2.5 | 0 | 100 | L&R Cracking |

| Section Comments: | | estimated LCD; maint R&E (crack seal 8/09) | | | | | | | | | | | | | | | | | |
| Conditions: | | PCI: 95 | | | | | | | | | | | | | | | | | |
