Pavement Condition Report

Silver Bay Municipal Airport (BFW)

January 2016

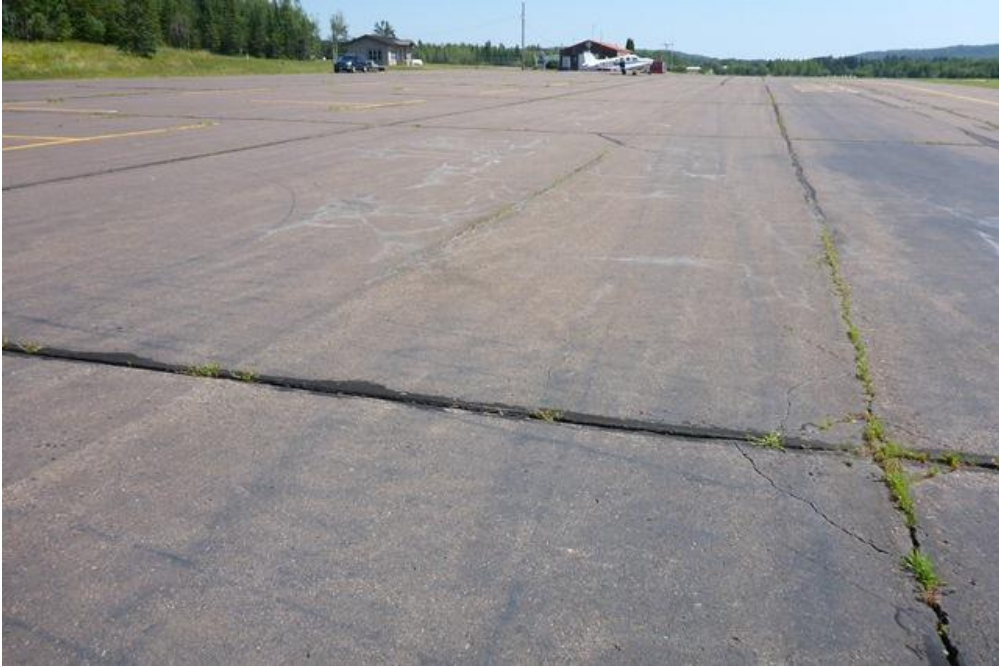
BFW APA 001 (PCI =50)

Branch ID	Section ID	Surface type ¹	Section area (SF)	LCD ²	2012 PCI	2015 PCI	Drop in PCI/Yr ³	% Deduct due to		Distress types
								Load ⁴	Climate ⁵	
APA	001	AC	57,420	2001	72	50	4.5	55	41	Alligator, Depression, L&T, Swelling
APA	002	AC	19,260	2006	75	58	7.0	29	46	Alligator, L&T, Swelling, Weathering
CTA	001	AC	24,400	2001	41	36	5.8	62	36	Alligator, L&T, Ravelling, Rutting, Swelling
CTB	001	AC	8,367	1982	49	33	2.2	54	31	Alligator, L&T, Rutting, Swelling
CTBX	001	AC	13,320	2001	69	69	2.8	0	100	L&T Cracking
RTA	001	AC	14,200	2001	57	47	4.8	50	45	Alligator, Depression, L&T
RY725	001	AC	240,000	2001	65	50	4.5	49	36	Alligator, Block, Depression, L&T, Ravelling, Rutting, Swelling
TLA	001	AC	60,660	1982	13	19	2.7	65	27	Alligator, Block, Depression, L&T, Patching, Ravelling, Rutting, Swelling

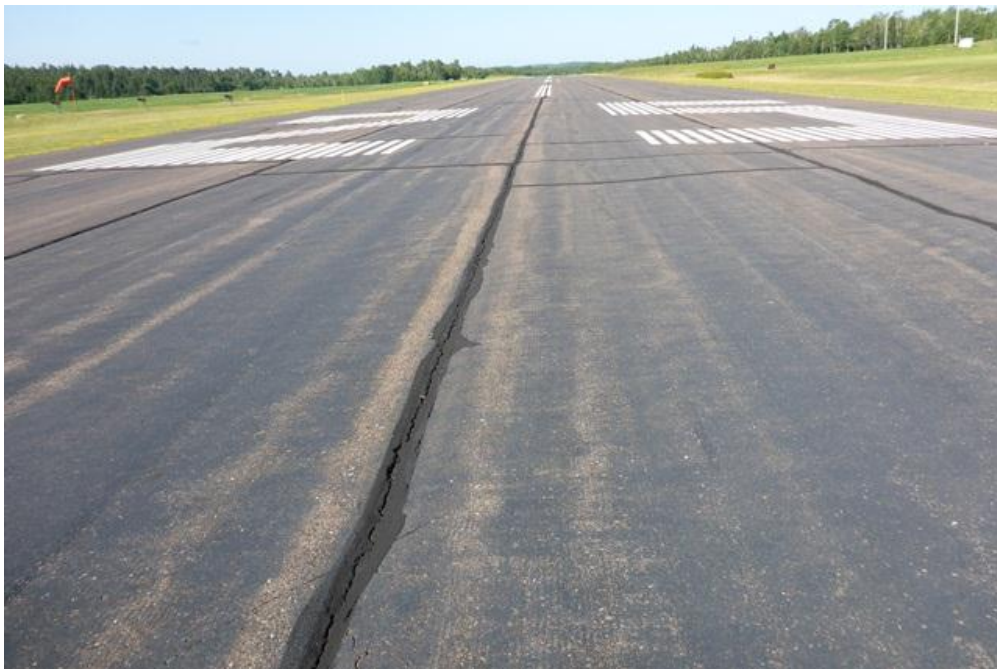
BFW RY725 001 (PCI =50)

Network:	BFW		Name:	SILVER BAY					
Branch:	RY725	Name:	RUNWAY 7-25	Use:	RUNWAY	Area:	240,000 SqFt		
Section:	001	of 1	From:	100	To:	163	Last Const.:	9/30/2001	
Surface:	AC	Family:	MN2013 Asphalt Runways	Zone:	N	Category:	2	Rank:	P
Area:	240,000 SqFt	Length:	3,200 Ft	Width:	75 Ft				
Slabs:		Slab Length:	Ft	Slab Width:	Ft	Joint Length:	Ft		
Shoulder:		Street Type:		Grade:	0	Lanes:	0		
Section Comments:									
Last Insp. Date:	7/26/2015		TotalSamples:	64	Surveyed:	10			
Conditions:	PCI:	50							
Inspection Comments:									
Sample Number:	100	Type:	R	Area:	3750.00 SqFt	PCI:	34		
Re-Inspection Report									
41	ALLIGATOR CR	M	277.00	SqFt	Comments:				
45	DEPRESSION	L	20.00	SqFt	Comments:				
52	RAVELING	L	378.00	SqFt	Comments:				
52	RAVELING	M	69.00	SqFt	Comments:				
Sample Number:	104	Type:	R	Area:	3750.00 SqFt	PCI:	66		
Re-Inspection Report									
48	L & T CR	L	325.00	Ft	Comments:				
48	L & T CR	M	54.00	Ft	Comments:
