Pavement Condition Report

Grand Marais – Cook County Airport (CKC)

January 2016

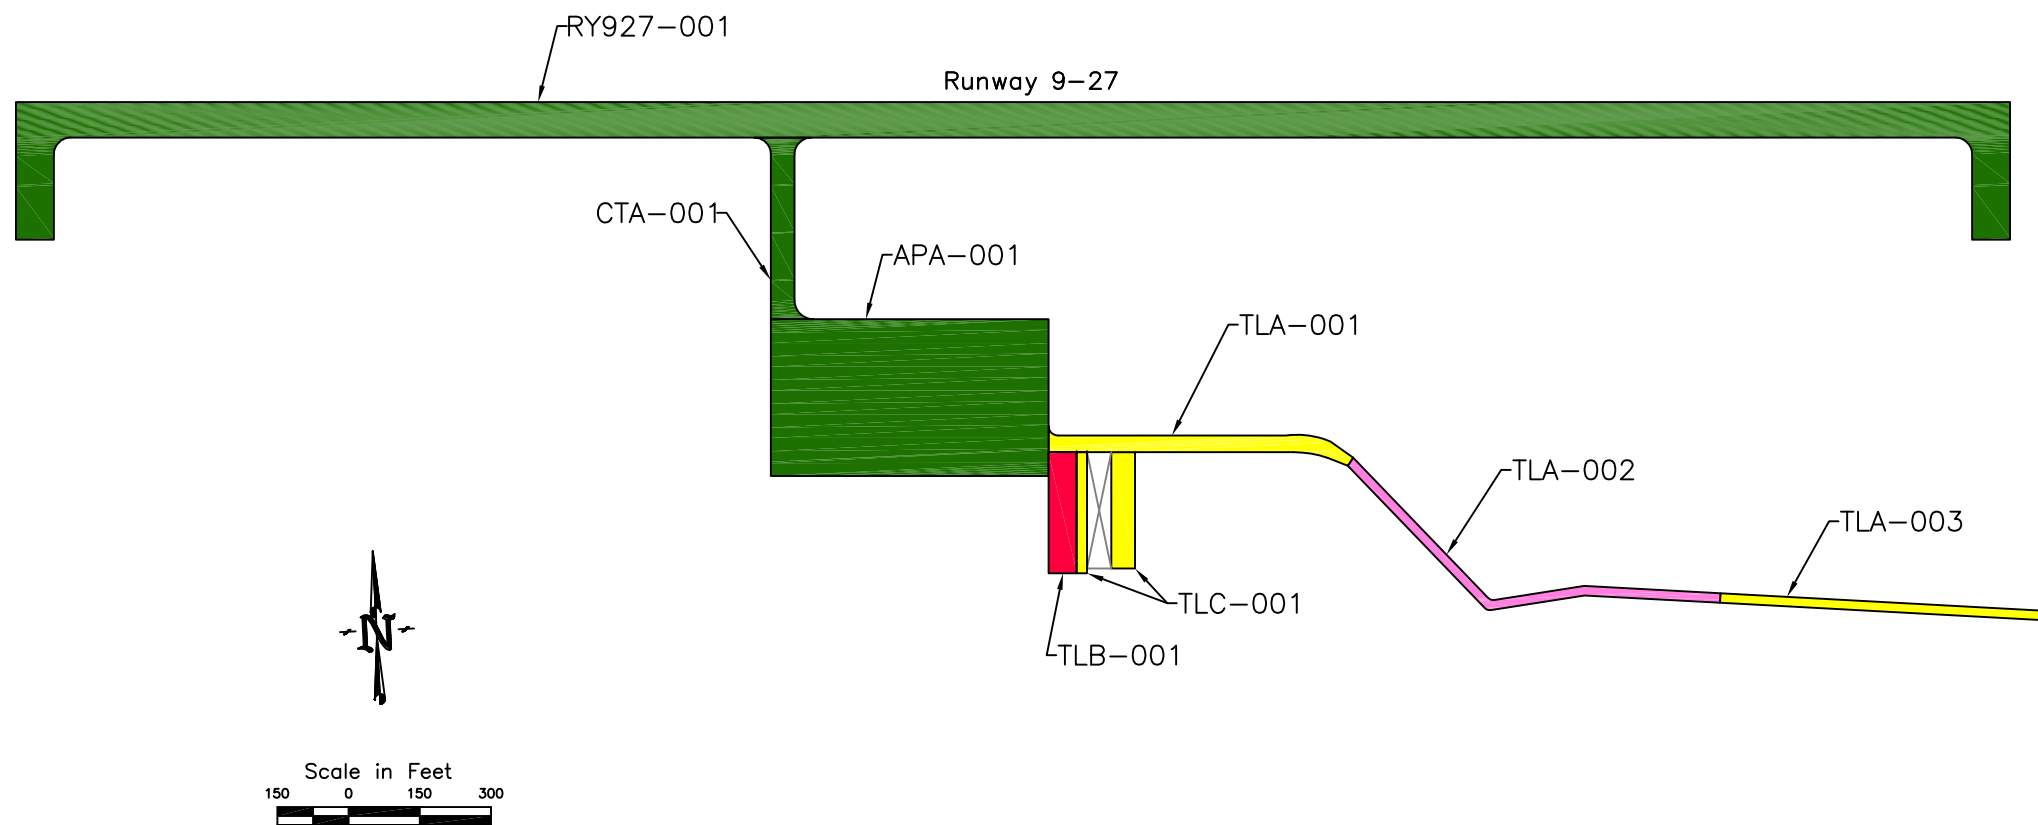
Figure 4. 2015 Pavement Condition Index Rating at Grand Marais-Cook County Airport (CKC).

Branch ID	Section ID	Surface type ¹	Section area (SF)	LCD ²	2012 PCI	2015 PCI	Drop in PCI/Yr ³	% Deduct due to		Distress types
								Load ⁴	Climate ⁵	
APA	001	AC	193,050	2012	100	91	3.0	0	100	L&T Cracking
CTA	001	AC	19,850	2012	100	98	0.7	0	100	L&T Cracking
RY927	001	AC	349,400	2012	100	89	3.7	0	100	L&T Cracking
TLA	001	AC	22,575	1993	73	66	1.5	0	100	L&T Cracking, Ravelling, Weathering
TLA	002	AC	18,200	1993	66	55	2.0	0	100	L&T Cracking, Weathering
TLA	003	AC	14,000	1993	79	67	1.5	0	100	L&T Cracking
TLB	001	AC	15,045	1993	47	35	3.0	0	100	Block Cracking, L&T, Ravelling, Weathering
TLC	001	AC	17,640	2007	80	68	4.0	0	100	L&T Cracking

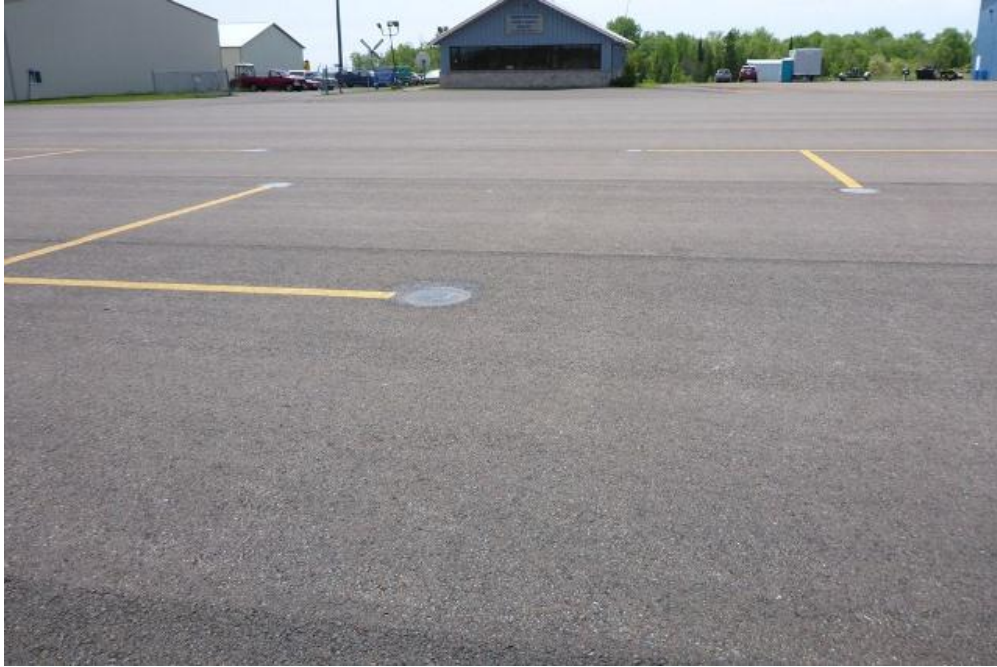
CKC APA 001 (PCI = 91)

Conditions: PCI: 91

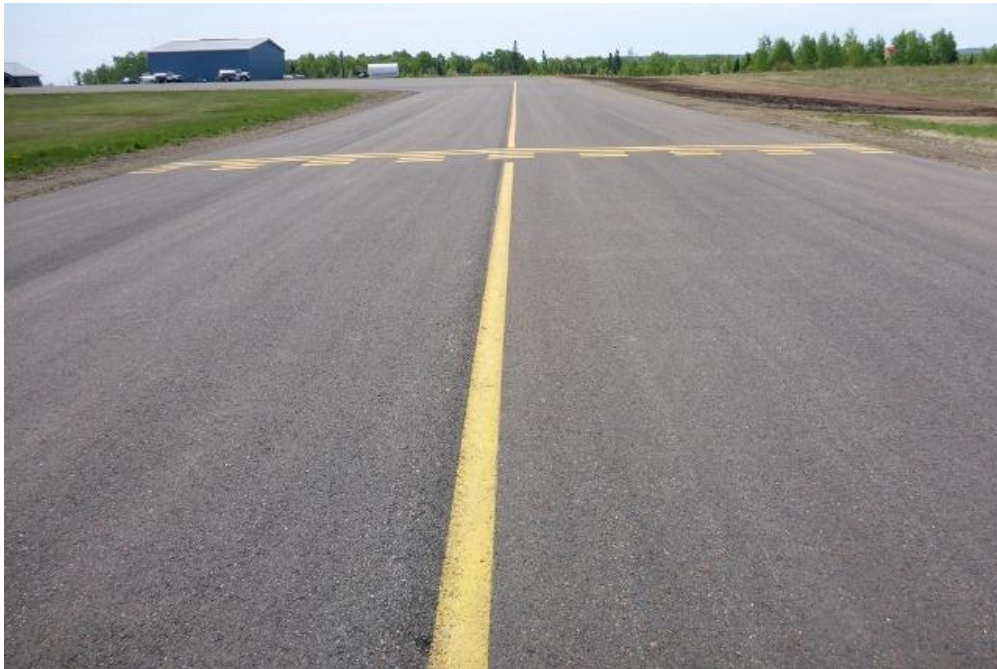
CKC CTA 001 (PCI = 98)

Network:	CKC	Name:	GRAND MARAIS						
Branch:	CTA	Name:	CONNECTING TAXIWAY A	Use:	TAXIWAY	Area:	19,850 SqFt		
Section:	001	of 1	From:	100	To:	103	Last Const.:	10/1/2012	
Surface:	AC	Family:	MN2013 Asphalt Taxiways	Zone:	N	Category:	2	Rank:	P
Area:	19,850 SqFt	Length:	380 Ft	Width:	50 Ft				
Slabs:		Slab Length:	Ft	Slab Width:	Ft	Joint Length:	Ft		
Shoulder:		Street Type:		Grade:	0	Lanes:	0		
Section Comments:	mill/replace 5" in Oct 2012 (PCI = 55)								
Last Insp. Date:	6/3/2015	TotalSamples:	4	Surveyed:	2				
Conditions:	PCI: 98								
Inspection Comments:									
Sample Number:	101	Type:	R	Area:	5000.00 SqFt	PCI:	100		
Re-Inspection Report									
<No Distress>				Comments:					
Sample Number:	102	Type:	R	Area:	5000.00 SqFt	PCI:	97		
Re-Inspection Report									
48	L & T CR	L	12.00 Ft	Comments:

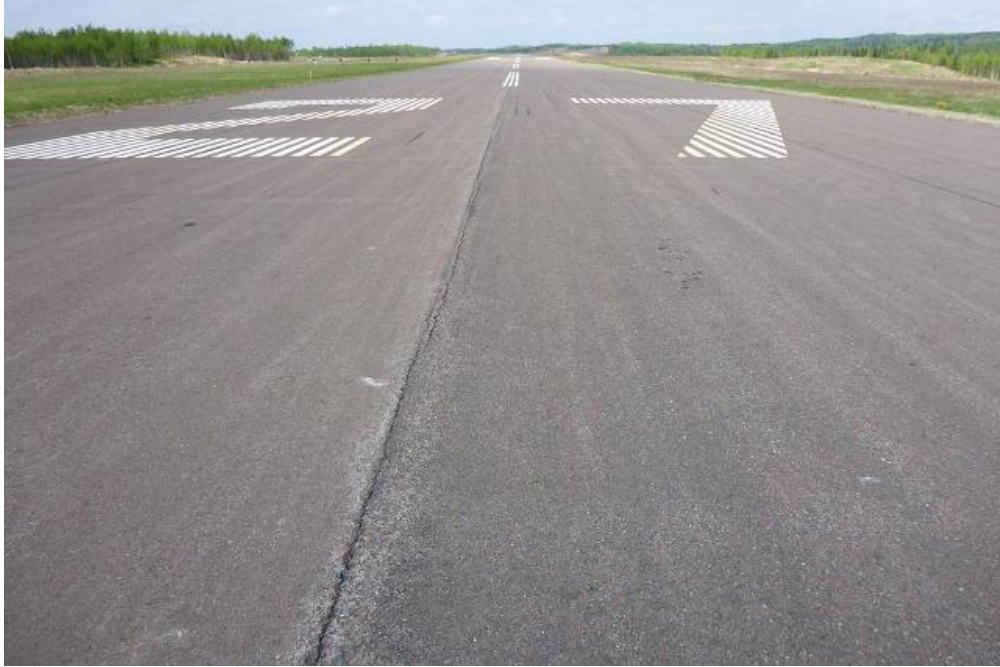
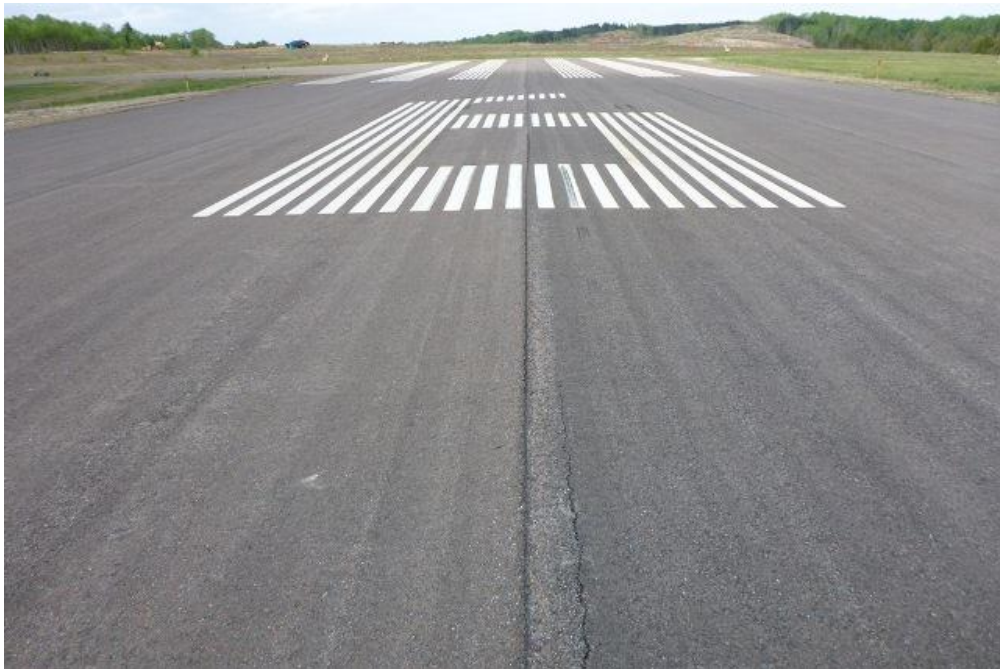
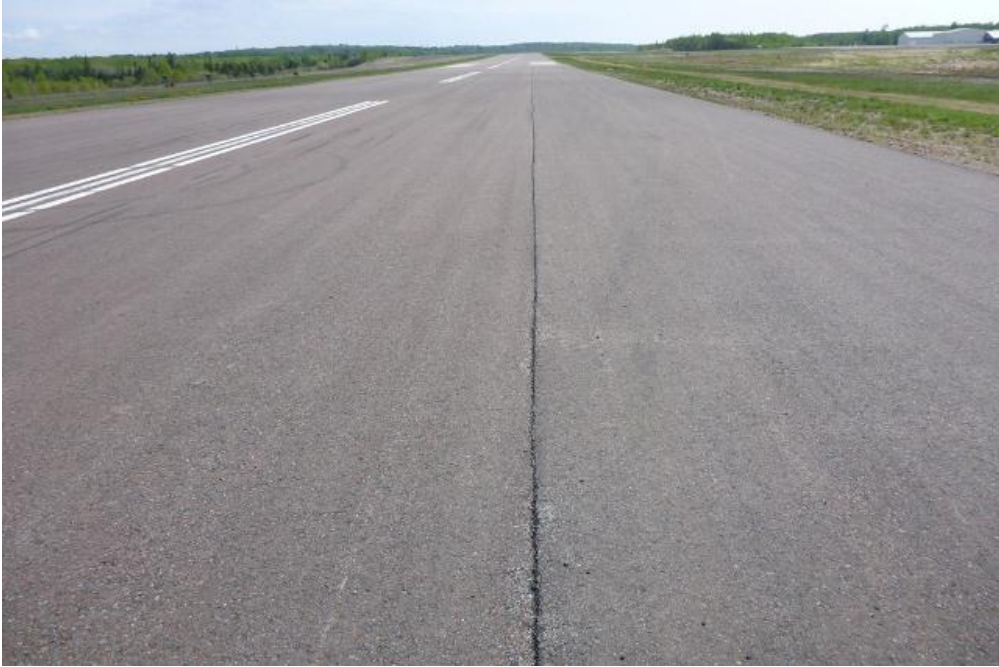
CKC RY927 001 (PCI = 89)

Network:	CKC	Name:	GRAND MARAIS						
Branch:	RY927	Name:	RUNWAY 9-27	Use:	RUNWAY	Area:	349,400 SqFt		
Section:	001	of 1	From:	100	To:	183+(100,101,200,201)	Last Const.:	10/1/2012	
Surface:	AC	Family:	MN2013 Asphalt Runways	Zone:	N	Category:	2	Rank:	P
Area:	349,400 SqFt	Length:	4,200 Ft	Width:	75 Ft				
Slabs:		Slab Length:	Ft	Slab Width:	Ft	Joint Length:	Ft		
Shoulder:		Street Type:		Grade:	0	Lanes:	0		
Section Comments:	mill/replace 5" in Oct 2012 (PCI = 49)								
Last Insp. Date:	6/3/2015	TotalSamples:	88	Surveyed:	8				
Conditions:	PCI: 89								
Inspection Comments:									
Sample Number:	104	Type:	R	Area:	3750.00 SqFt	PCI:	89		
Re-Inspection Report									
48	L & T CR	L	127.00	Ft	Comments:				
Sample Number:	114	Type:	R	Area:	3750.00 SqFt	PCI:	87		
Re-Inspection Report									
48	L & T CR	L	150.00	Ft	Comments:				
Sample Number:	124	Type:	R	Area:	3750.00 SqFt	PCI:	88		
Re-Inspection Report

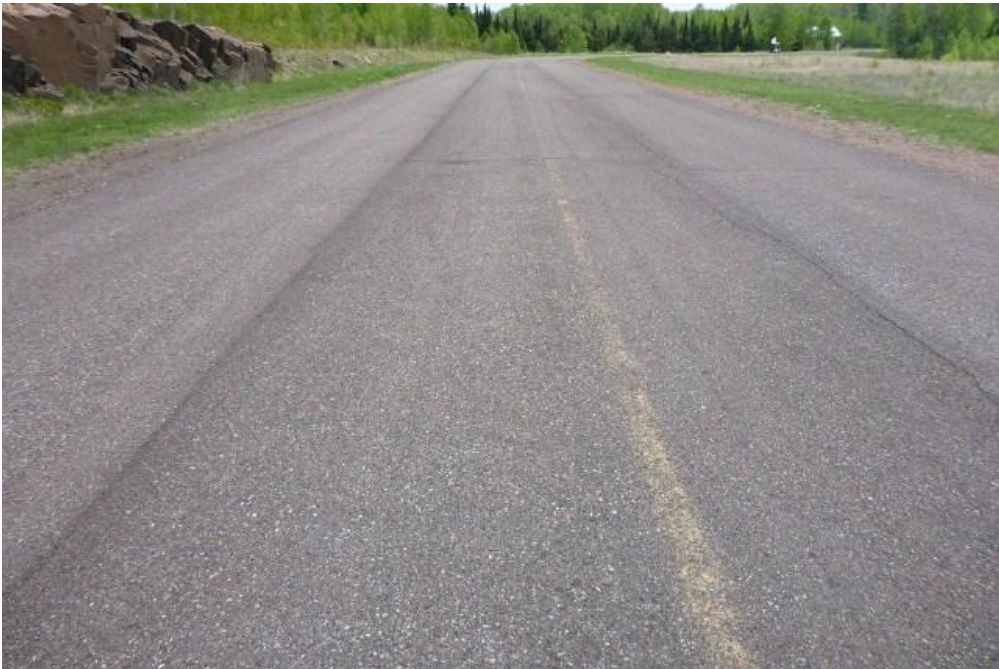
CKC TLA 001 (PCI = 66)

Conditions: PCI: 66

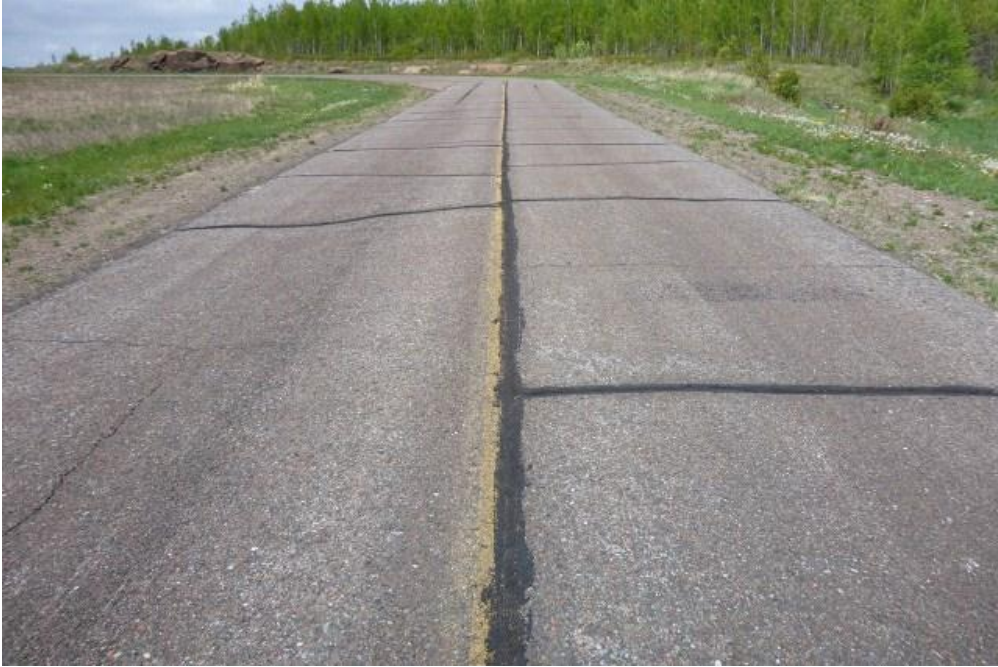
CKC TLA 002 (PCI = 55)

Conditions: PCI: 55

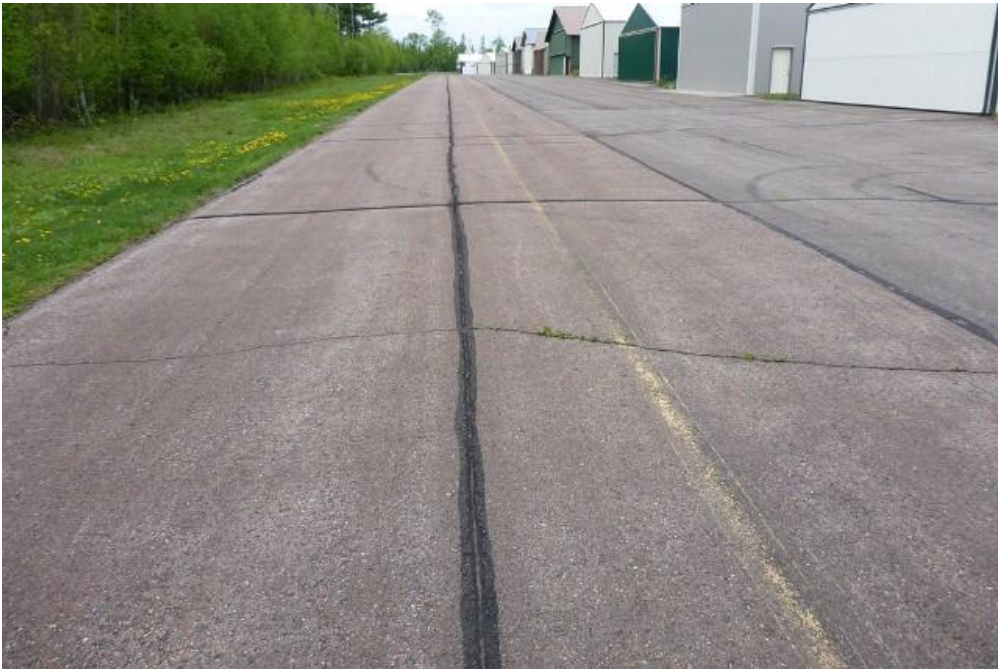
CKC TLA 003 (PCI = 67)

Conditions: PCI: 67

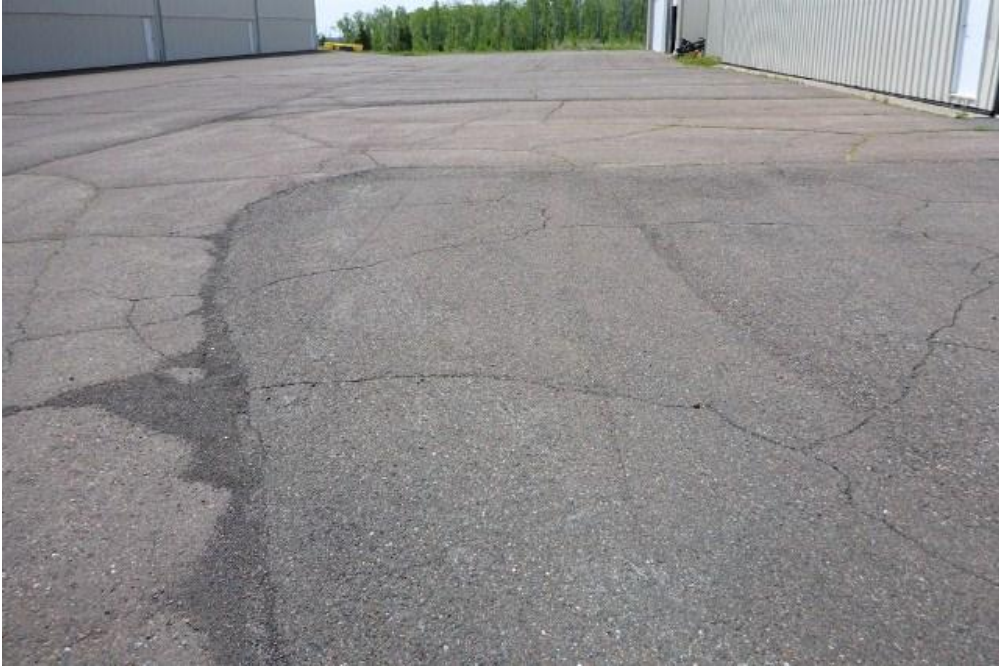
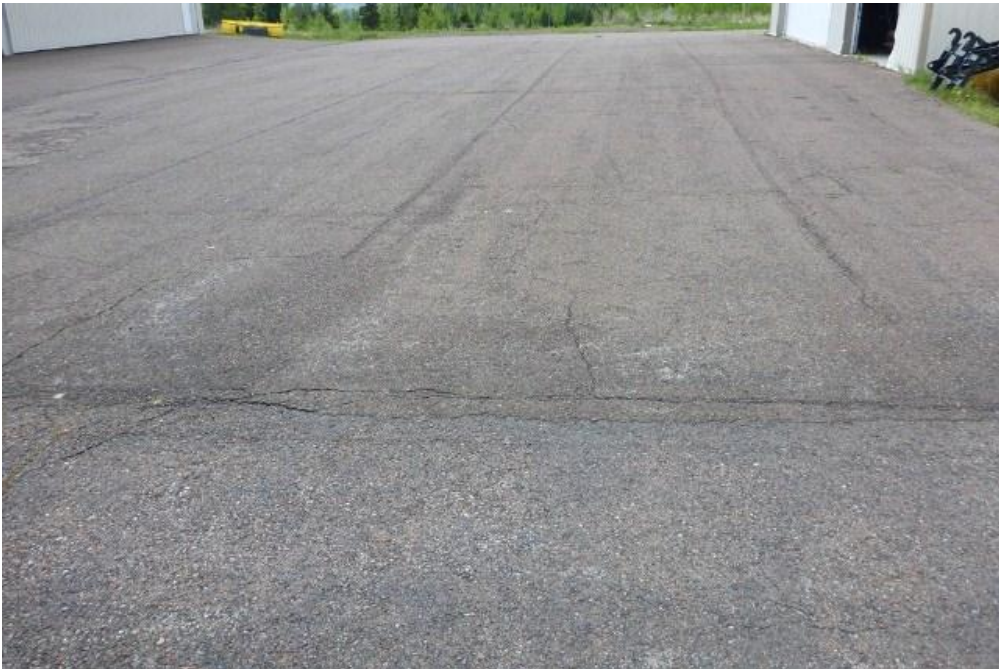
CKC TLB 001 (PCI = 35)

Conditions: PCI: 35

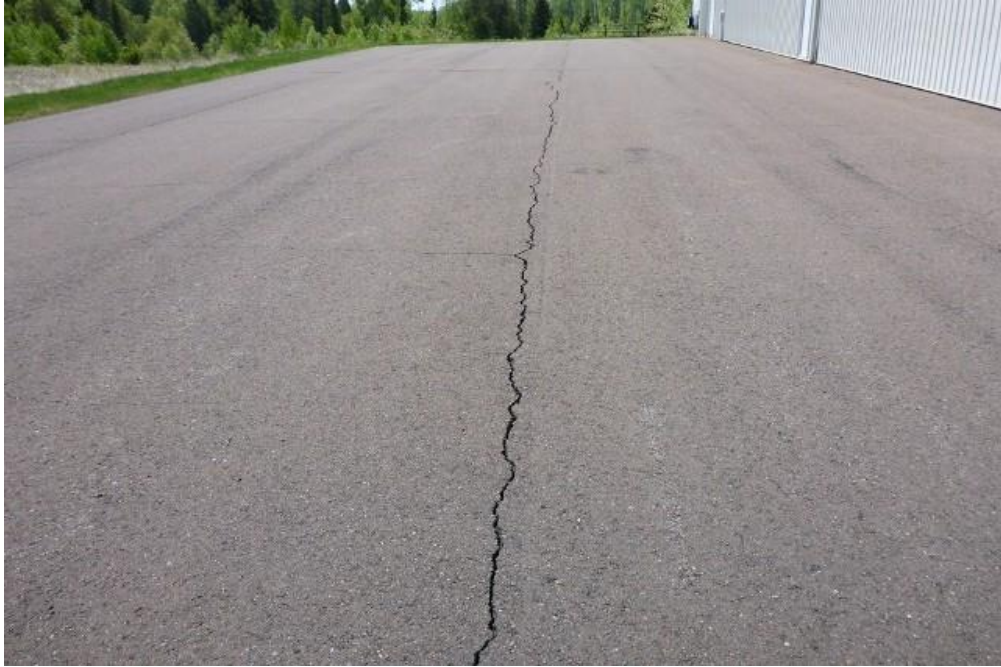
CKC TLC 001 (PCI = 68)

Conditions: PCI: 68
