Pavement Condition Report

Crookston Municipal Airport (CKN)

January 2016

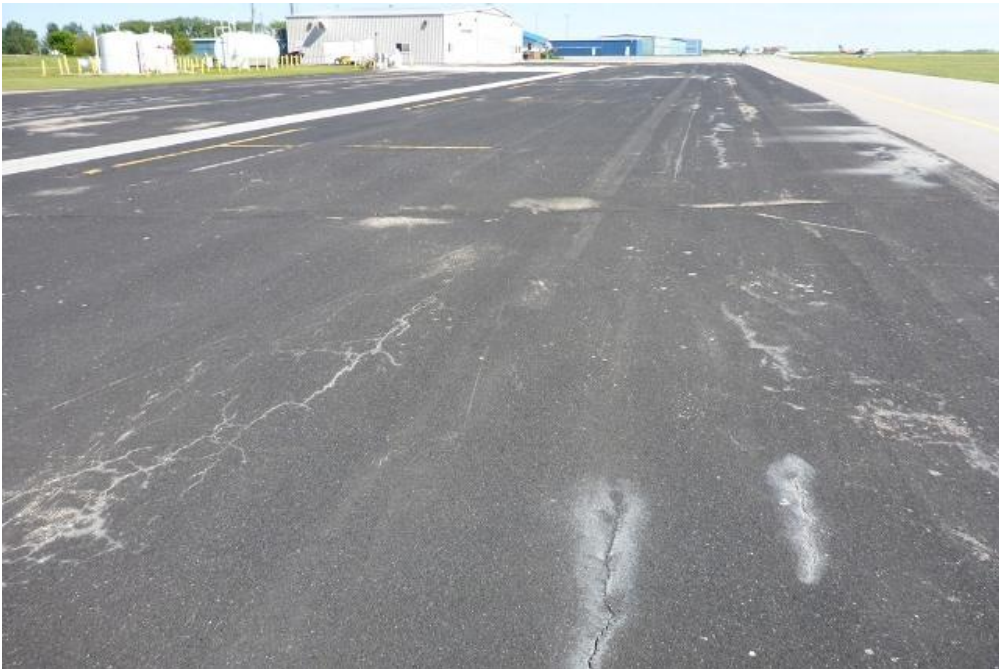
CKN APA 002 (PCI =42)

Conditions: PCI: 42

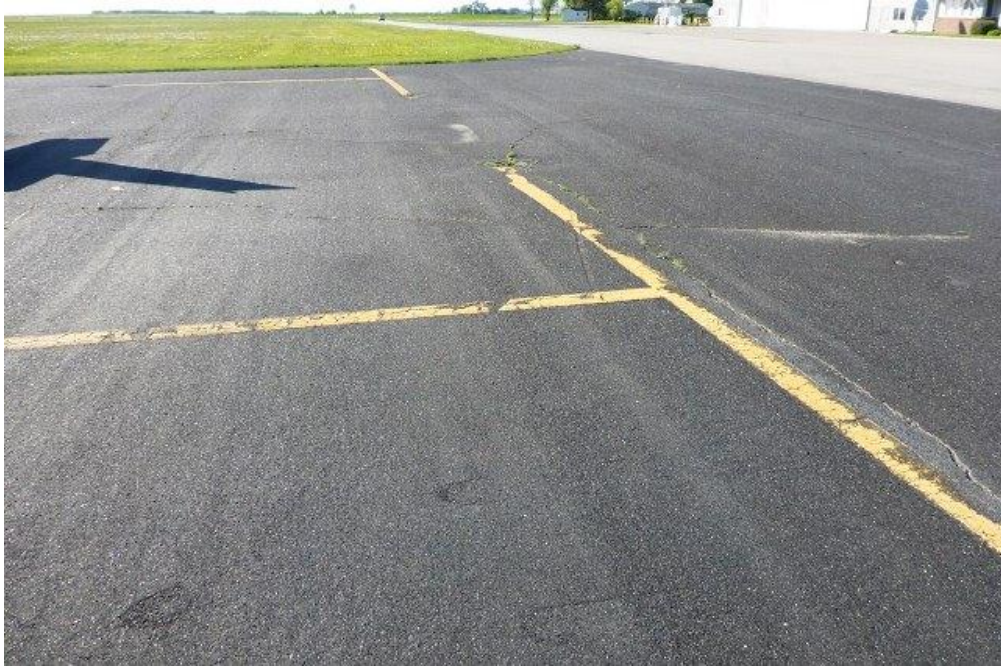
CKN APA 003 (PCI =57)

Conditions: PCI: 57

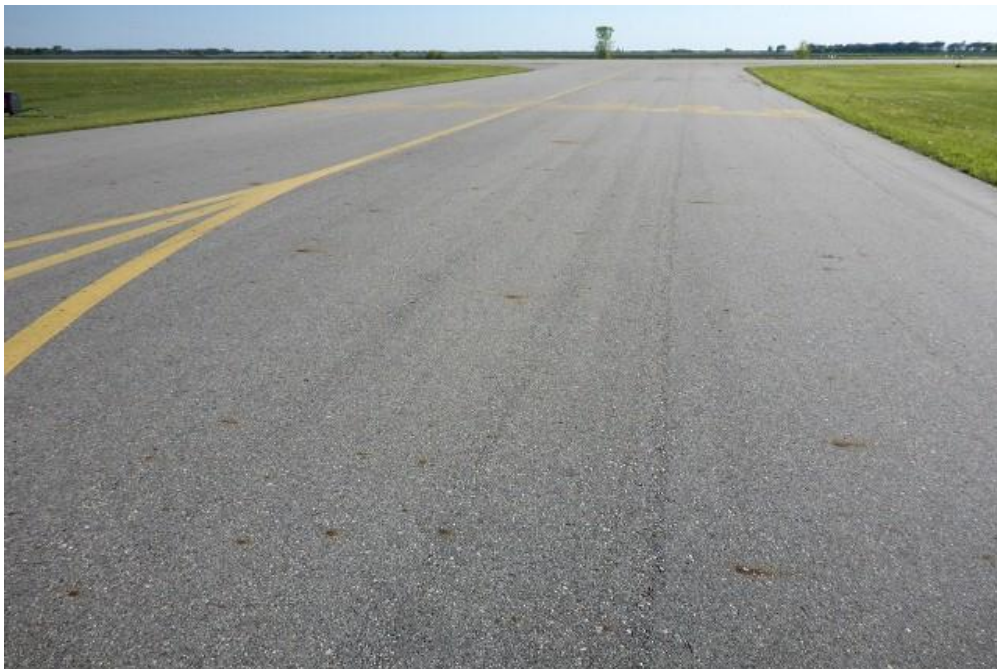
CKN CTA2 001 (PCI =95)

Network:	CKN	Name:	CROOKSTON						
Branch:	CTA2	Name:	CONNECTING TAXIWAY A2	Use:	TAXIWAY	Area:	33,113 SqFt		
Section:	001	of 2	From:	100	To:	102	Last Const.:	12/1/2013	
Surface:	AAC	Family:	MN2013 Asphalt Taxiways	Zone:	N	Category:	2	Rank:	P
Area:	12,005 SqFt	Length:	250 Ft	Width:	40 Ft				
Slabs:		Slab Length:	Ft	Slab Width:	Ft	Joint Length:	Ft		
Shoulder:		Street Type:		Grade:	0	Lanes:	0		
Section Comments:									
Last Insp. Date:	5/30/2015	TotalSamples:	3	Surveyed:	1				
Conditions:	PCI: 95								
Inspection Comments:									
Sample Number:	101	Type:	R	Area:	4000.00 SqFt	PCI:	95		
Re-Inspection Report									
48	L & T CR	L	40.00 Ft	Comments:

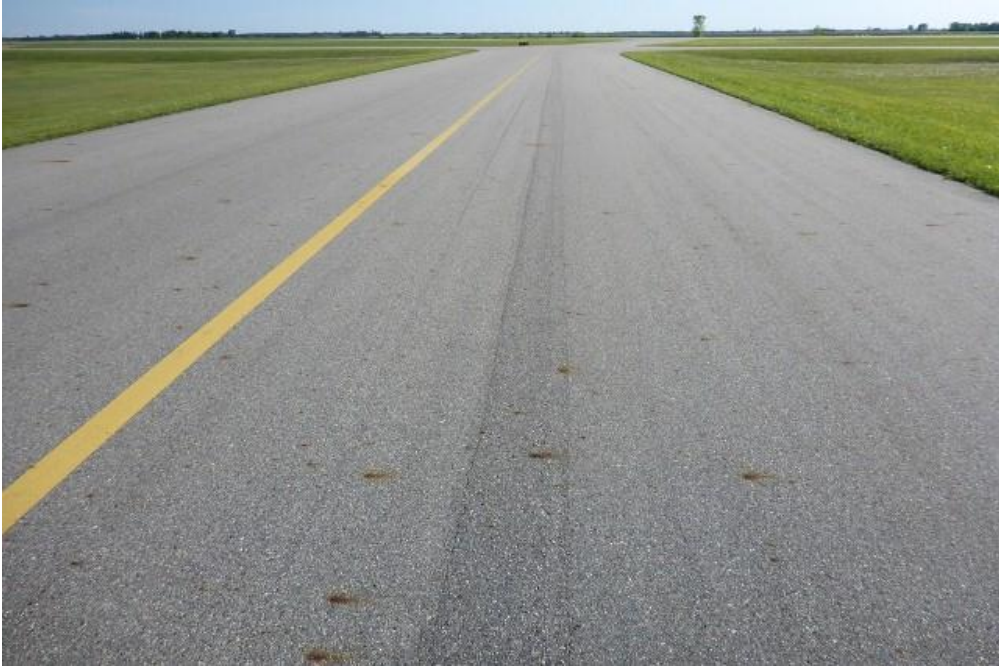
CKN CTA2 002 (PCI =98)

Network:	CKN		Name:	CROOKSTON					
Branch:	CTA2	Name:	CONNECTING TAXIWAY A2	Use:	TAXIWAY	Area:	33,113 SqFt		
Section:	002	of 2	From:	103	To:	107	Last Const.:	12/1/2013	
Surface:	AAC	Family:	MN2013 Asphalt Taxiways	Zone:	N	Category:	2	Rank:	P
Area:	21,108 SqFt	Length:	480 Ft	Width:	40 Ft				
Slabs:		Slab Length:	Ft	Slab Width:	Ft	Joint Length:	Ft		
Shoulder:		Street Type:		Grade:	0	Lanes:	0		
Section Comments:									
Last Insp. Date:	5/30/2015	TotalSamples:	5	Surveyed:	1				
Conditions:	PCI: 98								
Inspection Comments:									
Sample Number:	105	Type:	R	Area:	4000.00 SqFt	PCI:	98		
Re-Inspection Report									
48	L & T CR	L	3.00 Ft	Comments:

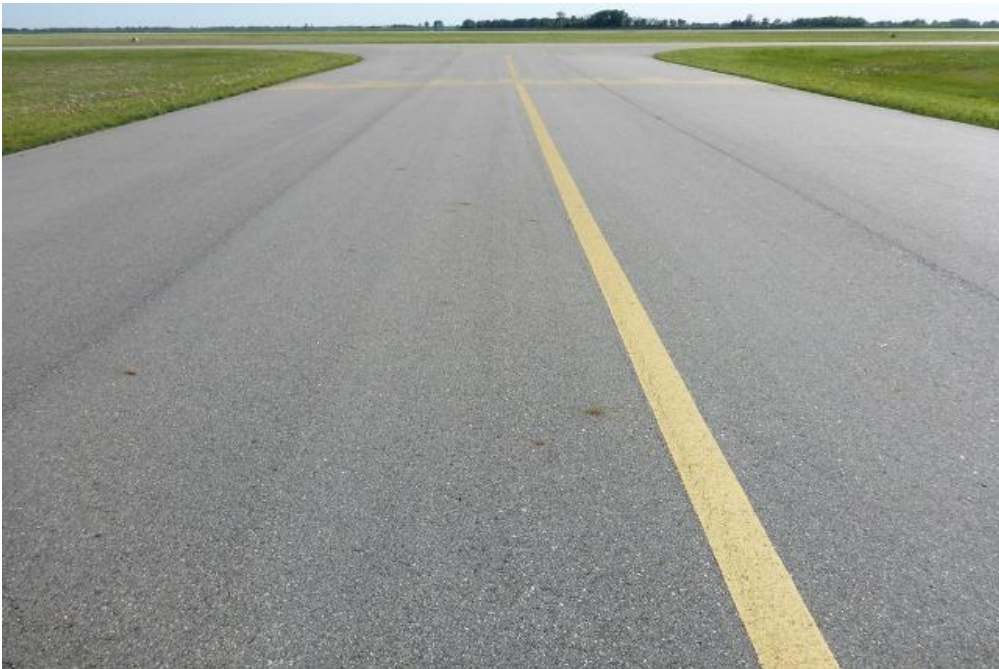
CKN CTA3 001 (PCI =100)

Network:	CKN		Name:	CROOKSTON					
Branch:	CTA3	Name:	CONNECTING TAXIWAY A3	Use:	TAXIWAY	Area:	18,232 SqFt		
Section:	001	of 1	From:	300	To:	303+20	Last Const.:	12/1/2013	
Surface:	AC	Family:	MN2013 Asphalt Taxiways	Zone:	N	Category:	2	Rank:	S
Area:	18,232 SqFt	Length:	420 Ft	Width:	40 Ft				
Slabs:		Slab Length:	Ft	Slab Width:	Ft	Joint Length:	Ft		
Shoulder:		Street Type:		Grade:	0	Lanes:	0		
Section Comments:	Spring 2013 rehab planned								
Last Insp. Date:	5/30/2015	TotalSamples:	4	Surveyed:	1				
Conditions:	PCI: 100								
Inspection Comments:									
Sample Number:	302	Type:	R	Area:	4000.00 SqFt	PCI:	100

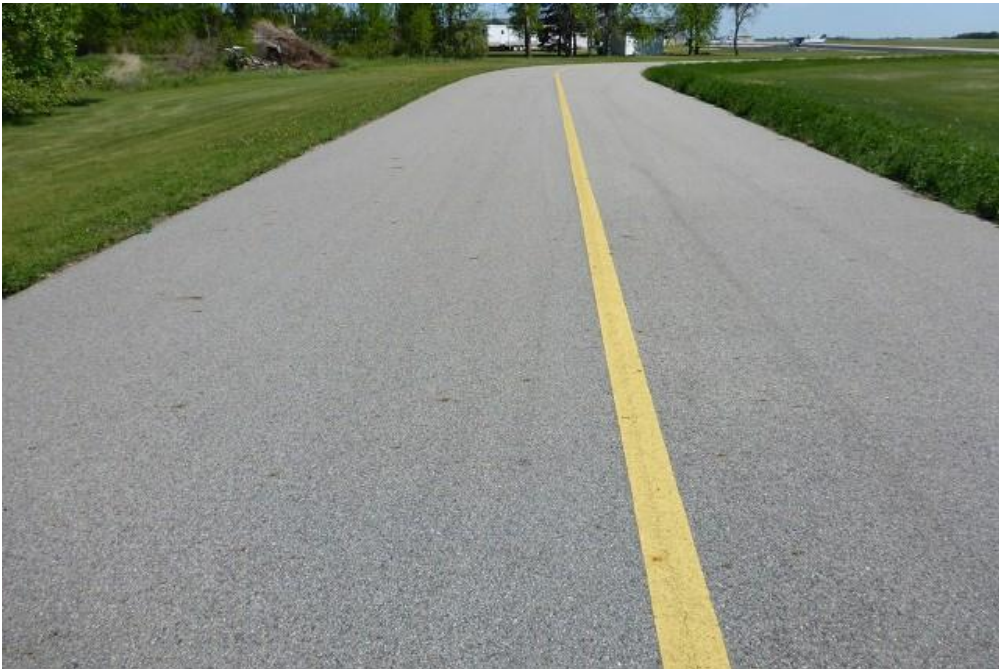
CKN CTB 001 (PCI =96)

Network:	CKN		Name:	CROOKSTON					
Branch:	CTB	Name:	CONNECTOR TAXIWAY B	Use:	TAXIWAY	Area:	15,507 SqFt		
Section:	001	of 1	From:	100	To:	102	Last Const.:	12/1/2013	
Surface:	AC	Family:	MN2013 Asphalt Taxiways	Zone:	N	Category:	2	Rank:	T
Area:	15,507 SqFt	Length:	600 Ft	Width:	23 Ft				
Slabs:		Slab Length:	Ft	Slab Width:	Ft	Joint Length:	Ft		
Shoulder:		Street Type:		Grade:	0	Lanes:	0		
Section Comments:									
Last Insp. Date:	5/30/2015		TotalSamples:	6		Surveyed:	2		
Conditions:	PCI:	96							
Inspection Comments:									
Sample Number:	101	Type:	R	Area:	2500.00 SqFt	PCI:	100		
Re-Inspection Report									
<No Distress>				Comments:					
Sample Number:	103	Type:	R	Area:	2500.00 SqFt	PCI:	93		
Re-Inspection Report									
48	L & T CR	L	47.00 Ft	Comments:

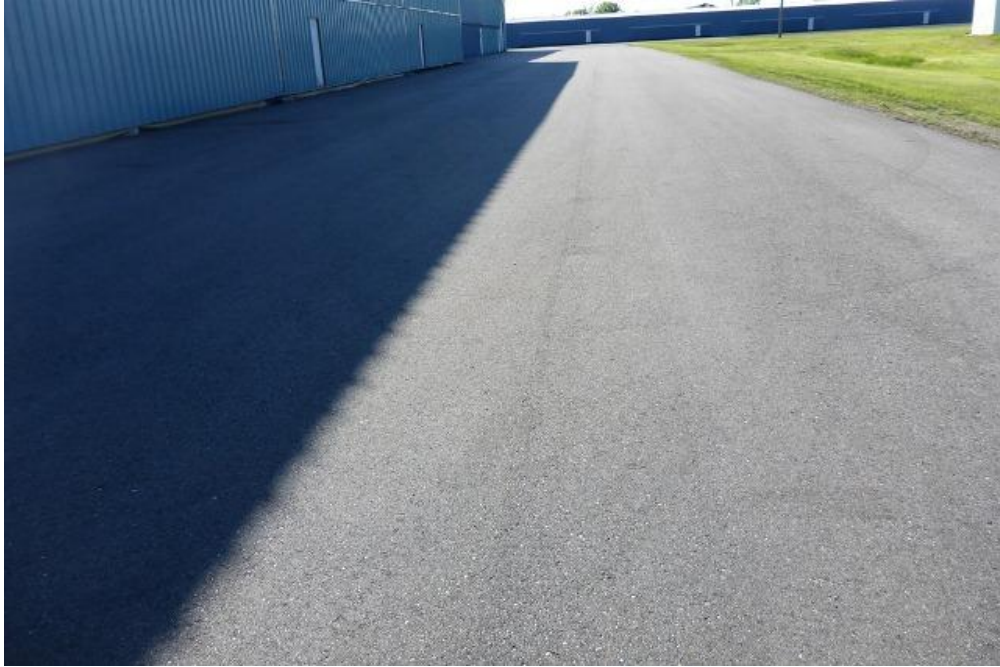
CKN TLA 002 (PCI =99)

Network:	CKN		Name:	CROOKSTON					
Branch:	TLA	Name:	Taxilane A	Use:	TAXILANE	Area:	162,628 SqFt		
Section:	002	of 3	From:	700	To:	704	Last Const.:	12/1/2013	
Surface:	AAC	Family:	MN2013 Asphalt Taxilanes	Zone:		Category:		Rank:	T
Area:	22,060 SqFt	Length:	450 Ft	Width:	40 Ft				
Slabs:		Slab Length:	Ft	Slab Width:	Ft	Joint Length:		Ft	
Shoulder:		Street Type:		Grade:	0	Lanes:	0		
Section Comments:									
Last Insp. Date:	5/30/2015		TotalSamples:	6		Surveyed:	2		
Conditions:	PCI: 99								
Inspection Comments:									
Sample Number:	401	Type:	R	Area:	1350.00 SqFt	PCI:	95		
Re-Inspection Report									
48	L & T CR	L	14.00 Ft	Comments:					
Sample Number:	702	Type:	R	Area:	4608.00 SqFt	PCI:	100		
Re-Inspection Report									
<No Distress>				Comments:
