# Pavement Condition Report

## Ada/Twin Valley Airport (D00)

Office of Aeronautics  
Minnesota Department of Transportation  
222 East Plato Boulevard  
Saint Paul, MN 55107  
(800) 657-3922

January 2016

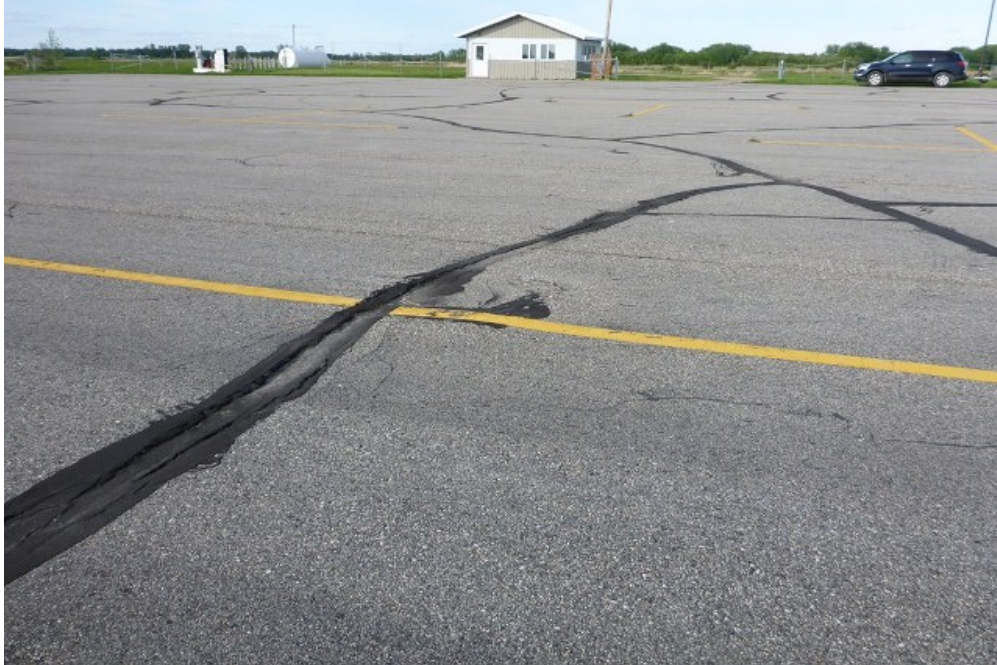
D00 APA 001 (PCI = 69)

**Conditions:** PCI: 69

| BranchID | SectionID | Distress Type | Severity | Treatment | Work Qty | Work Unit | Work Cost (\$) |
|---|---|---|---|---|---|---|---|
| APA | 001 | Alligator Cracking | Medium | Patching - AC Deep | 52 | SqFt | \$585 |
| APA | 001 | L & T Cracking | Medium | Crack Sealing - AC | 449 | Ft | \$539 |

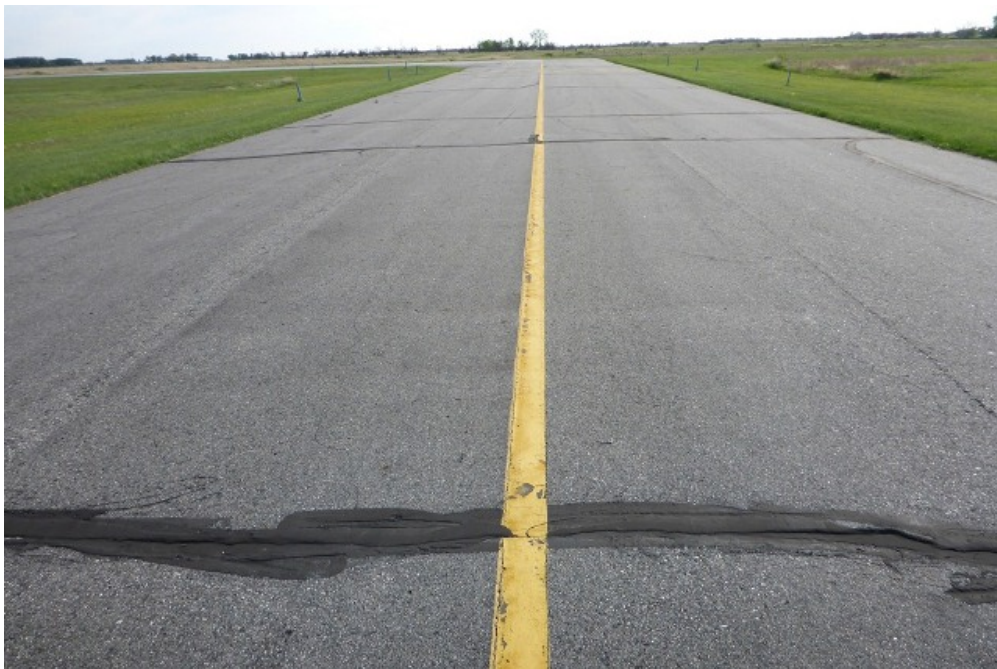
D00 CTA 001 (PCI = 75)

| Conditions: | PCI: | 75 | | | | | | | | | | |
| Re-Inspection Report | Crack seal OK | | | | | | | | | | | |

| BranchID | SectionID | Distress Type | Severity | Treatment | Work Qty | Work Unit | Work Cost (\$) |
|---|---|---|---|---|---|---|---|
| CTA | 001 | L & T Cracking | Medium | Crack Sealing - AC | 275 | Ft | \$329 |

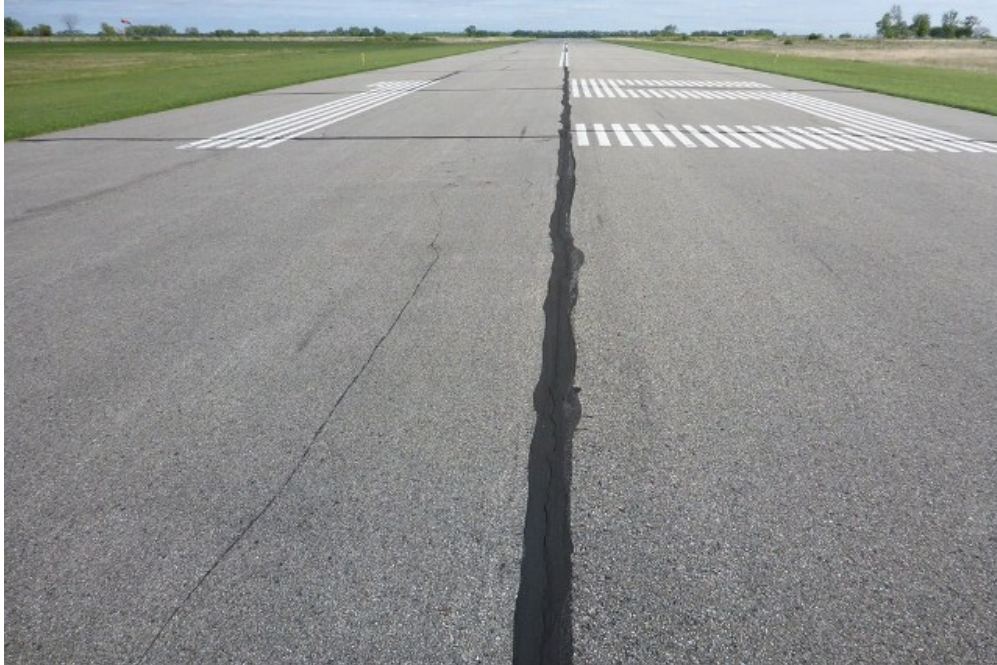
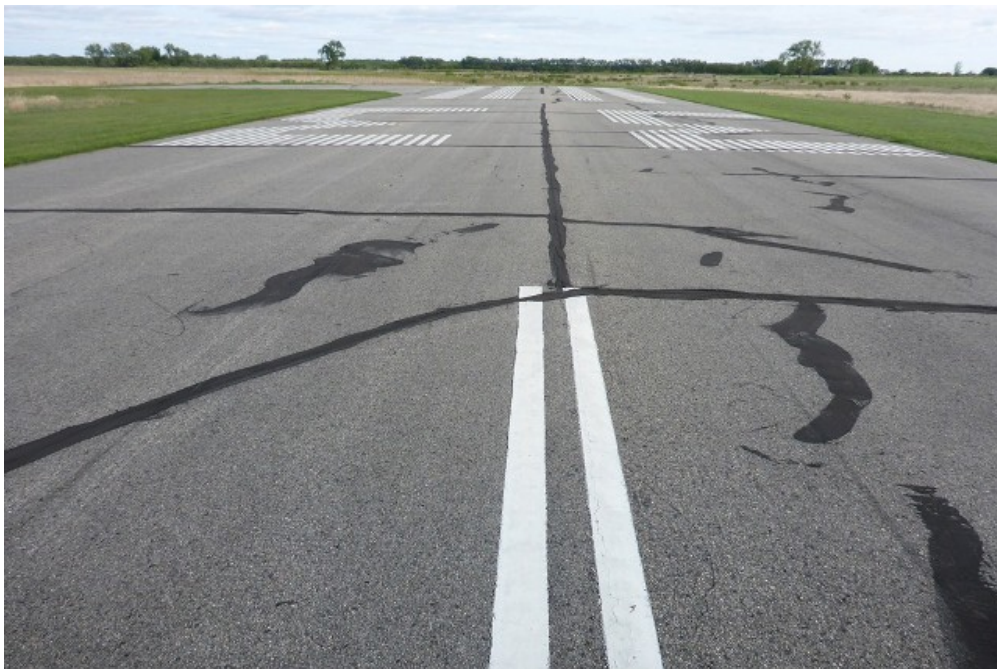
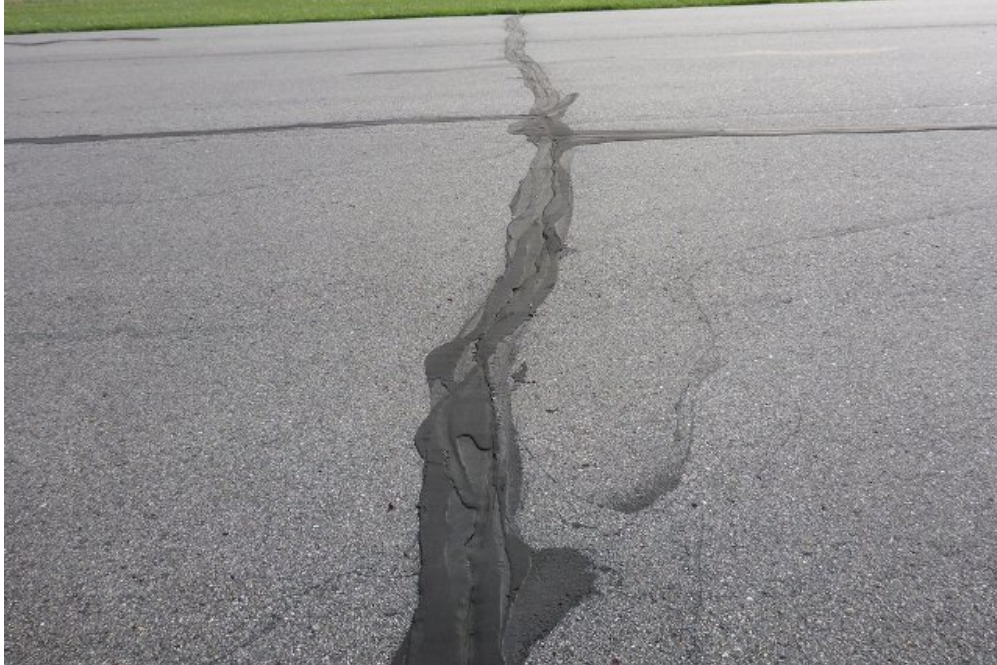
D00 RY1533 001 (PCI = 77)

| Branch ID | Section ID | Surface type <sup>1</sup> | Section area (SF) | LCD <sup>2</sup> | 2012 PCI | 2015 PCI | Drop in PCI/Yr <sup>3</sup> | % Deduct due to | | Distress types |
|---|---|---|---|---|---|---|---|---|---|---|
| RY1533 | 001 | AAC | 196,550 | 2003 | 80 | 77 | 1.9 | 0 | 96 | L&T Cracking |

| Conditions: | PCI: | 77 | | | | | | | | | | | |
| Inspection Comments: | Crack seal OK virtually all med cracks from secondary cracking | | | | | | | | | | | | |

| BranchID | SectionID | Distress Type | Severity | Treatment | Work Qty | Work Unit | Work Cost (\$) |
|---|---|---|---|---|---|---|---|
| RY1533 | 001 | L & T Cracking | Medium | Crack Sealing - AC | 1,078 | Ft | \$1,293 |

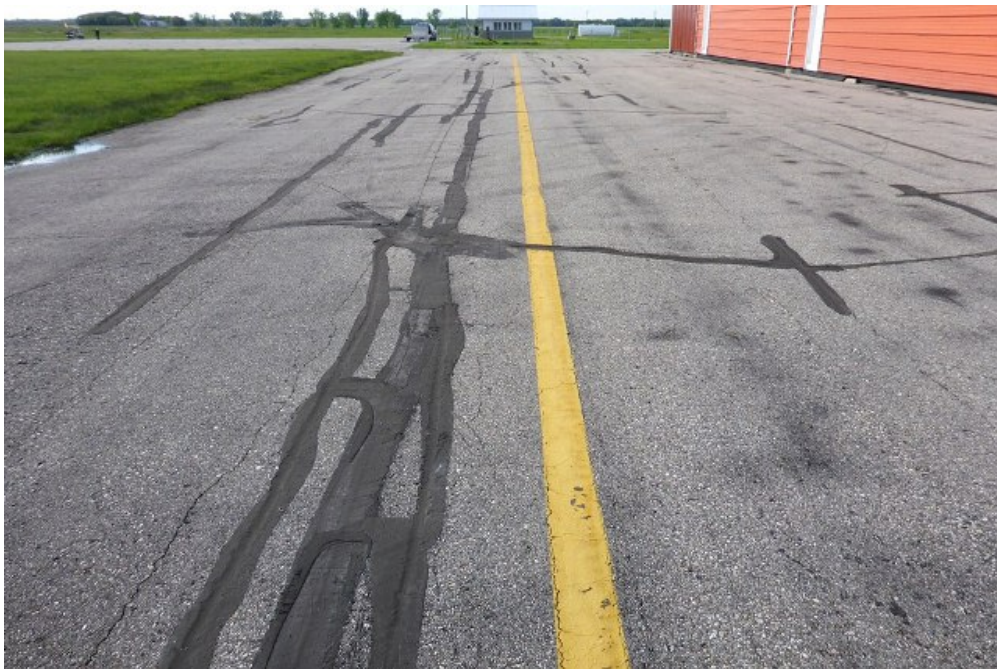
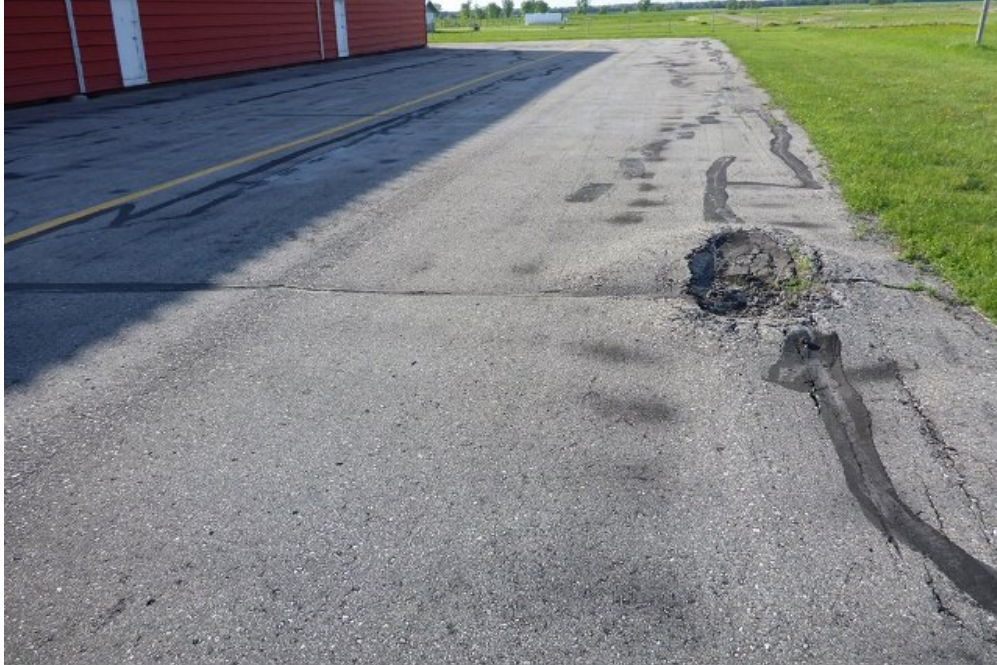
D00 TLA 001(PCI = 43)

| Conditions: | PCI: | 43 | | | | | | | |

| BranchID | SectionID | Distress Type | Severity | Treatment | Work Qty | Work Unit | Work Cost (\$) |
|---|---|---|---|---|---|---|---|
| TLA | 001 | Alligator Cracking | Low | Crack Sealing - AC | 76 | Ft | \$91 |
| TLA | 001 | Alligator Cracking | Medium | Patching - AC Deep | 97 | SqFt | \$1,083 |
| TLA | 001 | Alligator Cracking | High | Patching - AC Deep | 59 | SqFt | \$663 |
| TLA | 001 | L & T Cracking | Medium | Crack Sealing - AC | 203 | Ft | \$244 |
