# Pavement Condition Report

## Fertile Municipal Airport (D14)

**January 2016**

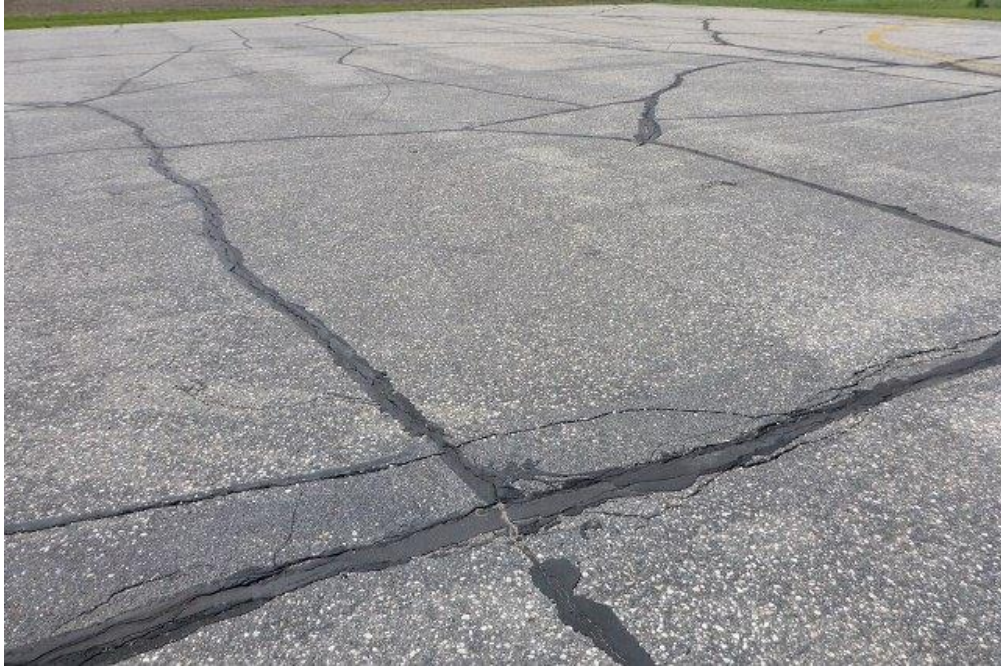
D14 APA 001 (PCI = 47)

**Section Comments:** maint. R&E (crack seal); w/r to w only

**Conditions:** PCI: 47

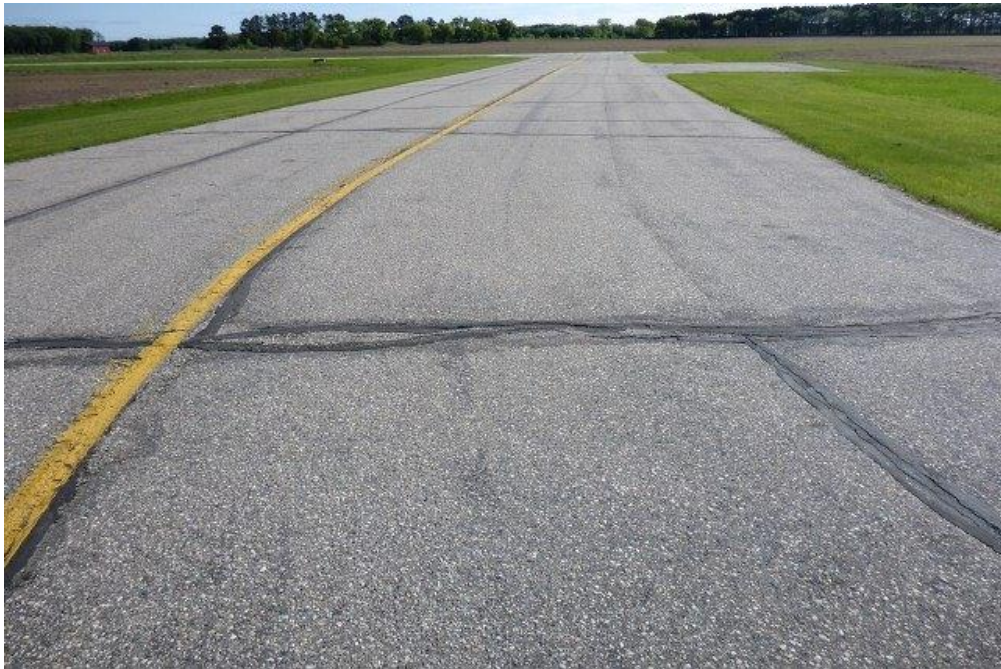
D14 CTA 001 (PCI = 63)

**Section Comments:** maint. R&E (crack seal); w/r to w only

**Conditions:** PCI: 63

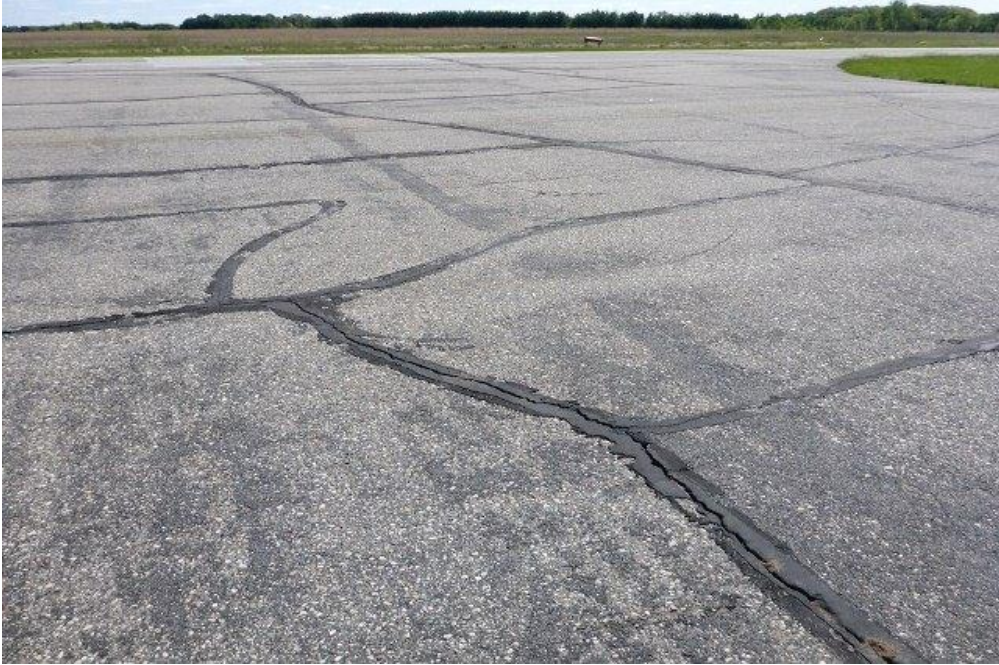
D14 RTA 001 (PCI = 62)

**Section Comments:** maint. R&E (crack seal); w/r to w only

**Conditions:** PCI: 62

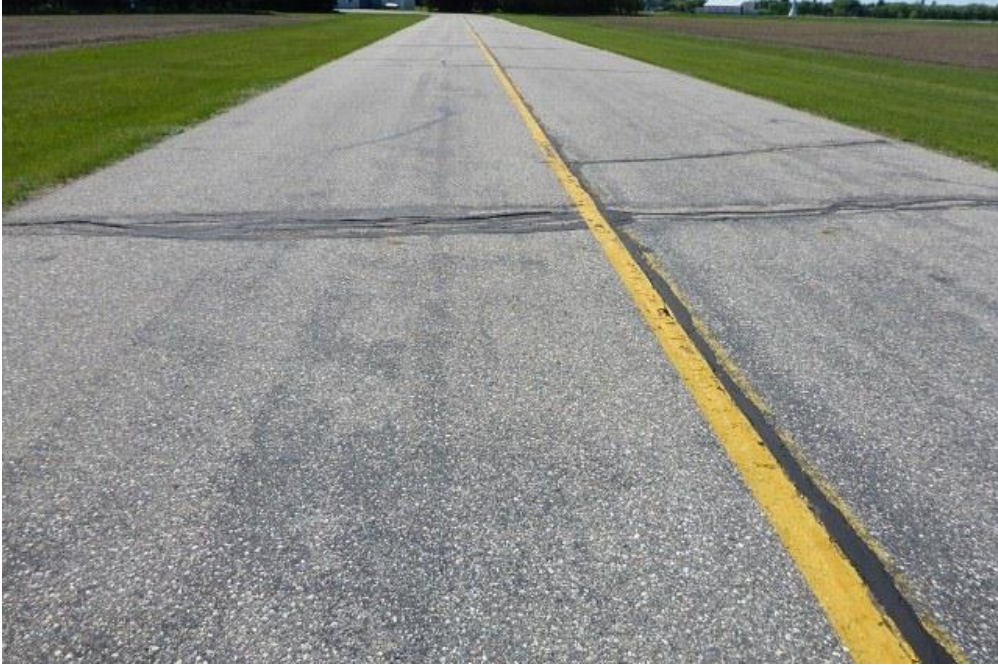
D14 TLA 001 (PCI = 60)

**Section Comments:** maint. R&E (crack seal); w/r to w only

**Conditions:** PCI: 60
