# Pavement Condition Report

## Warren Municipal Airport (D37)

January 2016

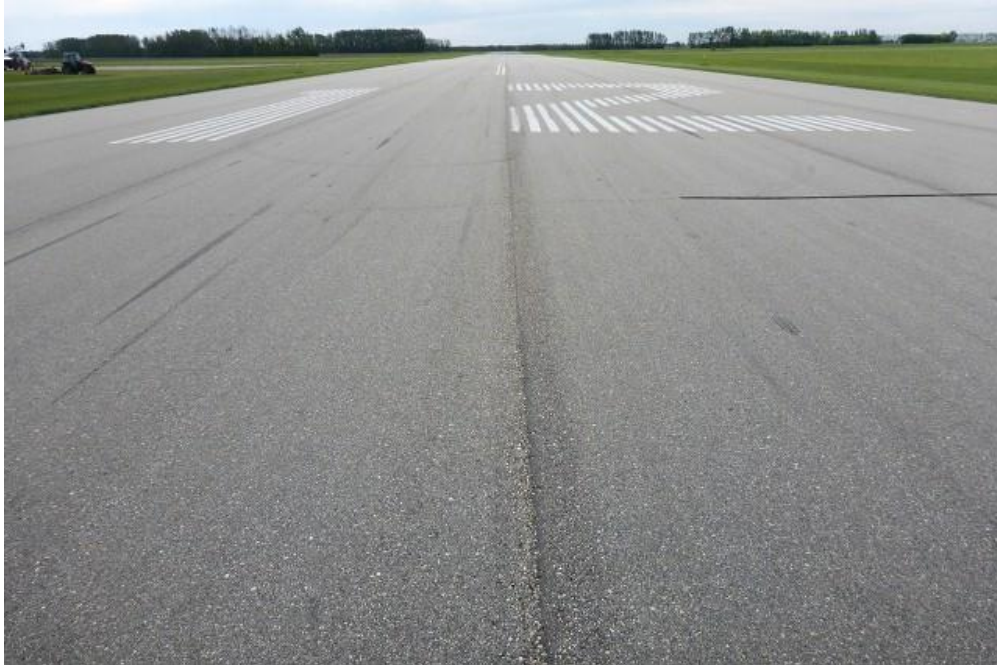
D37 RY1230 001 (PCI =95)

| Branch ID | Section ID | Surface type <sup>1</sup> | Section area (SF) | LCD <sup>2</sup> | 2012 PCI | 2015 PCI | Drop in PCI/Yr <sup>3</sup> | % Deduct due to | | Distress types |
|---|---|---|---|---|---|---|---|---|---|---|
| RY1230 | 001 | AC | 257,000 | 2012 | 100 | 95 | 1.7 | 0 | 100 | L&T Cracking |

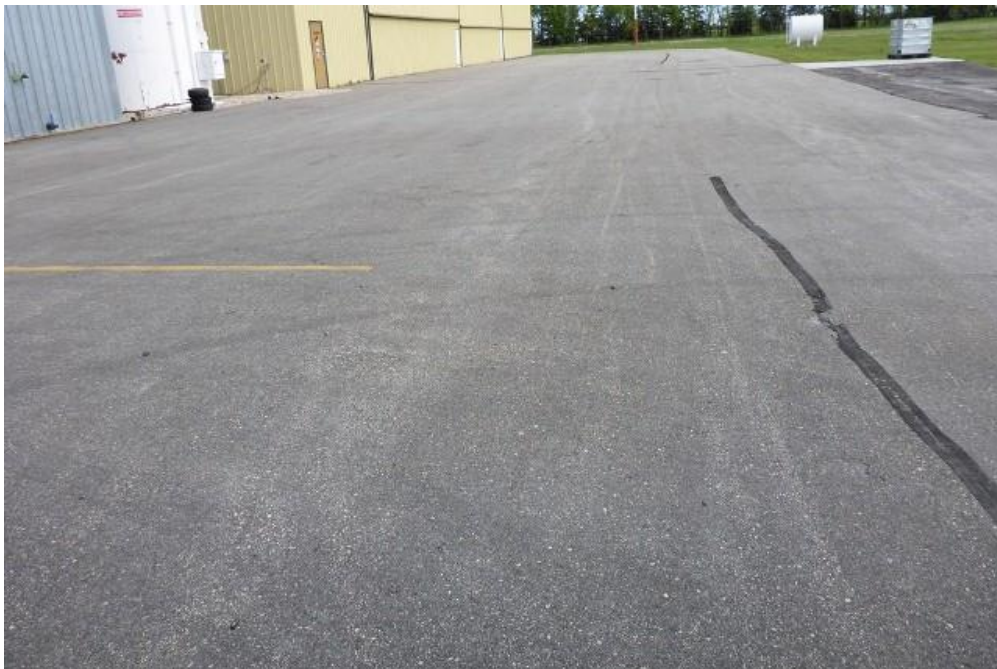
D37 TLA 002 (PCI =86)

| Branch ID | Section ID | Surface type <sup>1</sup> | Section area (SF) | LCD <sup>2</sup> | 2012 PCI | 2015 PCI | Drop in PCI/Yr <sup>3</sup> | % Deduct due to | | Distress types |
|---|---|---|---|---|---|---|---|---|---|---|
| TLA | 002 | AAC | 11,450 | 2012 | 100 | 86 | 4.7 | 0 | 100 | L&T Cracking |

| BranchID | SectionID | Distress Type | Severity | Treatment | Work Qty | Work Unit | Work Cost (\$) |
|---|---|---|---|---|---|---|---|
| TLA | 002 | L & T CR | Medium | Crack Sealing - AC | 62 | Ft | 74 |
