# Pavement Condition Report

## Duluth International Airport (DLH)

**January 2016**

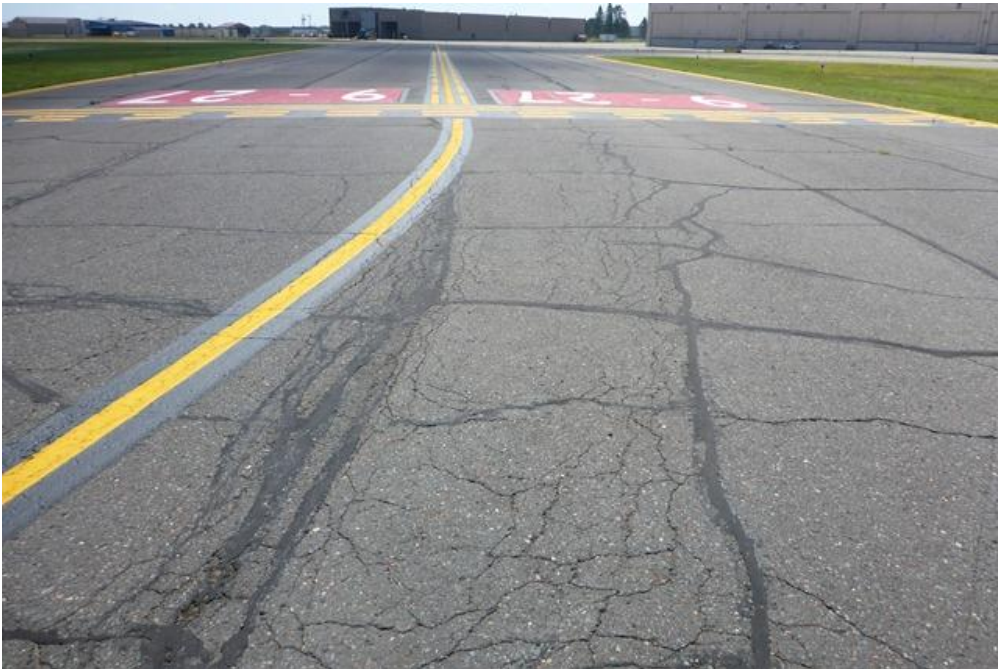
DLH CTA2 002 (PCI =33)

CTA2	002	AC	24,600	1981	-	33	2.0	37	61	Alligator, Block, Ravelling, Weathering, L&T, Patching, Swelling
CTA3	001	AC	19,500	1963	65	78	0.4	0	94	L&T, Depression, Weathering
CTA3	002	AC	20,600	1963	-	39	1.2	8	69	L&T, Ravelling, Swelling, Weathering
CTA3	003	AC	15,100	1963	-	60	0.8	0	100	L&T, Weathering
CTA5	001	AC	44,800	1974	63	55	1.1	0	100	Weathering, Block, L&T
CTB	001	PCC	345,200	1994	76	90	0.5	57	38	Joint Seal Damage, Corner Spall, Linear Crack, Corner Break, Small Patch
CTC1	001	AC	5,200	2009	-	92	1.3	0	63	L&T, Swelling
CTD	001	AC	114,000	1974	13	32	1.7	0	100	Block, Weathering, Patching, L&T, Ravelling
CTD	002	AC	25,300	1974	-	81	0.5	0	100	L&T, Weathering
PTA	001	AC	165,300	1992	34	33	2.9	29	71	Alligator, Block, L&T, Patching, Ravelling, Weathering, Bleeding
PTA	002	AC	493,800	1985	41	37	2.1	34	64	Alligator, L&T, Patching, Ravelling,

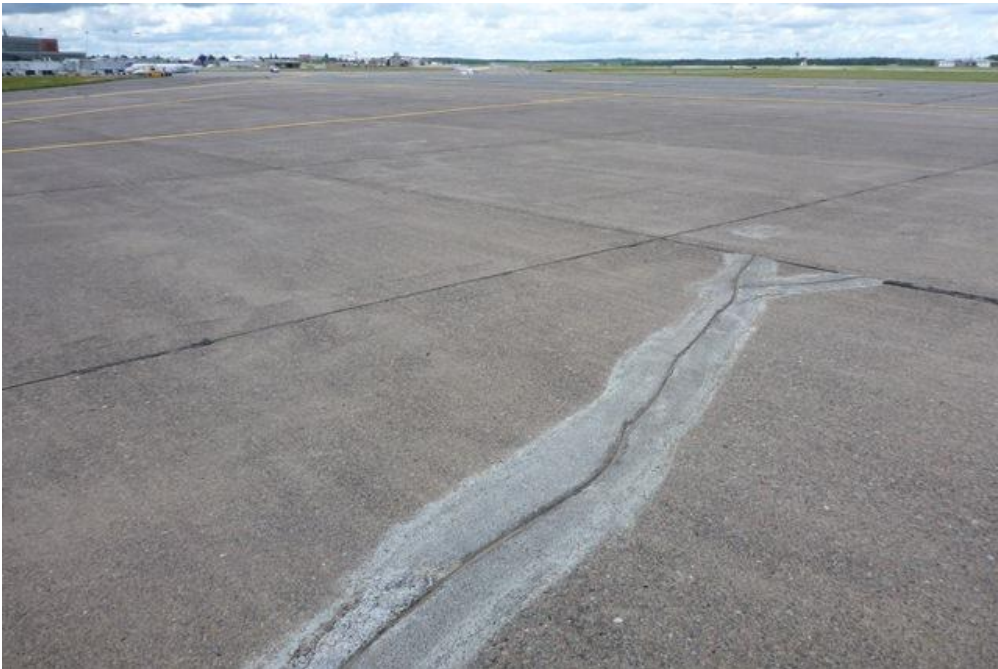
DLH RPE 001 (PCI =61)

RPA1	001	PCC	24,300	1978	96	87	0.4	35	65	Linear Crack, Joint Seal Damage, Joint Spall
RPE	001	PCC	28,000	1964	82	61	0.8	85	0	Linear Crack, Small Patch, Large Patch
RPW	001	PCC	105,000	1992	78	59	1.8	33	17	Joint Seal Damage, Small Patch, Large Patch, Joint Spall, Corner Spall, Linear Crack, Durability Crack, Faulting, Shrinkage Crack
RY321	001	AC	70,000	2009	100	93	1.2	0	100	L&T, Weathering
RY321	002	AC	35,000	2009	100	88	2.0	0	100	L&T, Weathering
RY321	004	AC	100,000	2009	100	89	1.8	0	100	L&T, Weathering
RY321	005	AC	50,000	2009	100	87	2.2	0	100	L&T, Weathering
RY321	007	AC	383,700	2009	100	87	2.2	0	100	L&T, Weathering
RY321	008	AC	191,800	2009	100	86	2.3	0	100	L&T Cracking
RY927	001	PCC	138,800	1968	48	57	0.9	46	13	Linear Crack, Joint Seal Damage, Small Patch, Large Patch

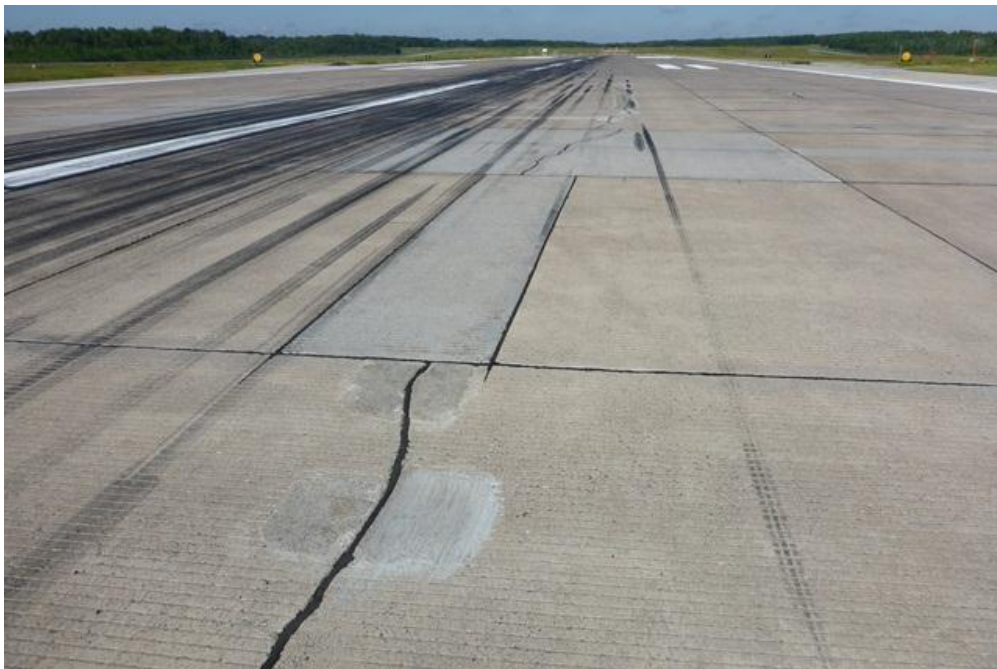
DLH RY927 002 (PCI =51)

Branch ID	Section ID	Surface type <sup>1</sup>	Section area (SF)	LCD <sup>2</sup>	2010 PCI	2015 PCI	Drop in PCI/Yr <sup>3</sup>	% Deduct due to		Distress types
								Load <sup>4</sup>	Climate <sup>5</sup>	
RY927	002	PCC	181,500	1968	47	51	1.0	56	3	Linear Crack, Joint Seal Damage, Small Patch, Large Patch, Shattered Slab, Joint Spall
RY927	004	PCC	799,300	1958	85	87	0.2	0	39	Joint Seal Damage, Small Patch, Large patch, Joint Spall
RY927	005	PCC	399,700	1958	78	79	0.4	4	7	Small Patch, Large Patch, Joint Seal Damage, Corner Spall, Joint Spall
RY927	007	PCC	100,000	1958	71	70	0.5	5	22	Linear Crack, Joint Seal Damage, Small Patch, Large Patch, Corner Break
RY927	008	PCC	50,000	1958	48	69	0.5	7	20	Joint Seal Damage, Small Patch, Large patch, Corner Break, Linear Crack
TLA	001	PCC	63,500	2008	-	100	-	0	0	-
TLA	002	AC	17,300	2008	-	96	0.6	47	53	Alligator, Bleeding, L&T
TLA	003	AC	14,000	2008	-	96	0.6	0	100	L&T, Weathering
