# Pavement Condition Report

## Eveleth - Virginia Municipal Airport (EVM)

**January 2016**

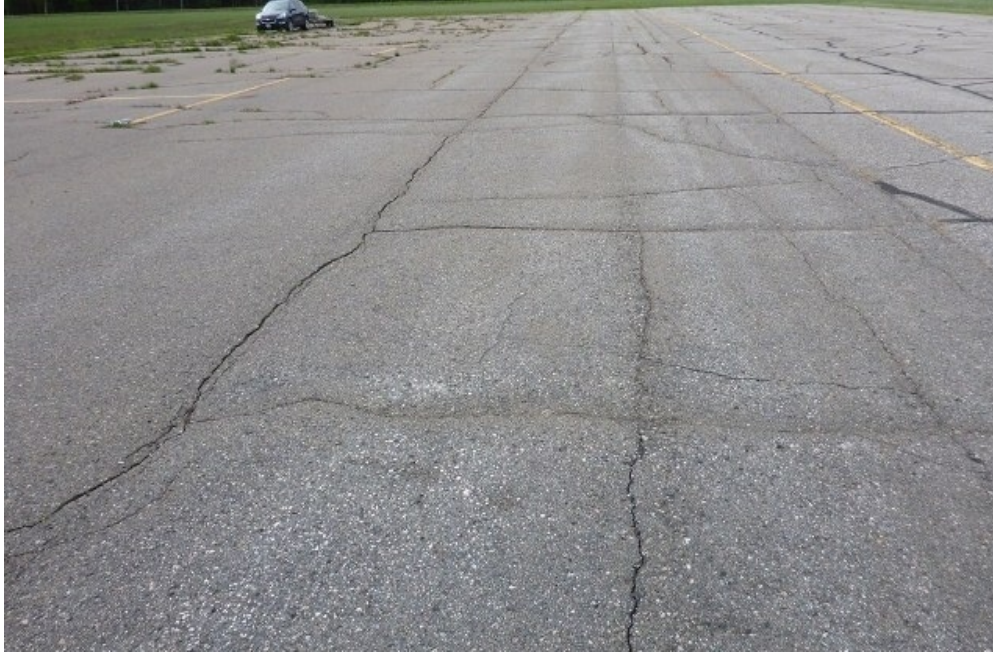
EVM APA 002 (PCI=42)

**Conditions:** PCI: 42

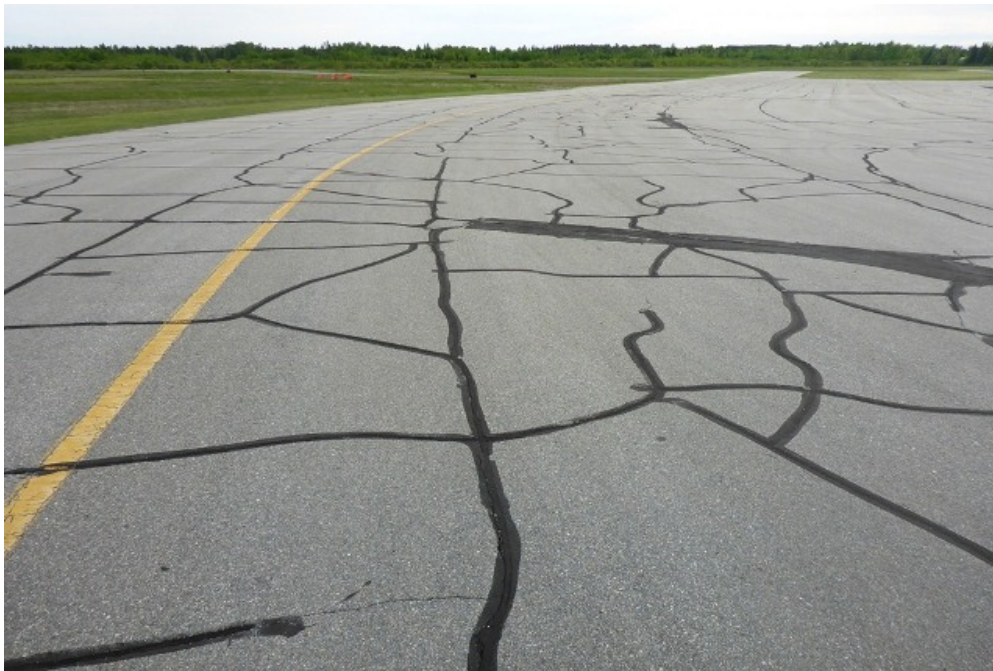
EVM CTA 001 (PCI =52)

**Conditions:** PCI: 52

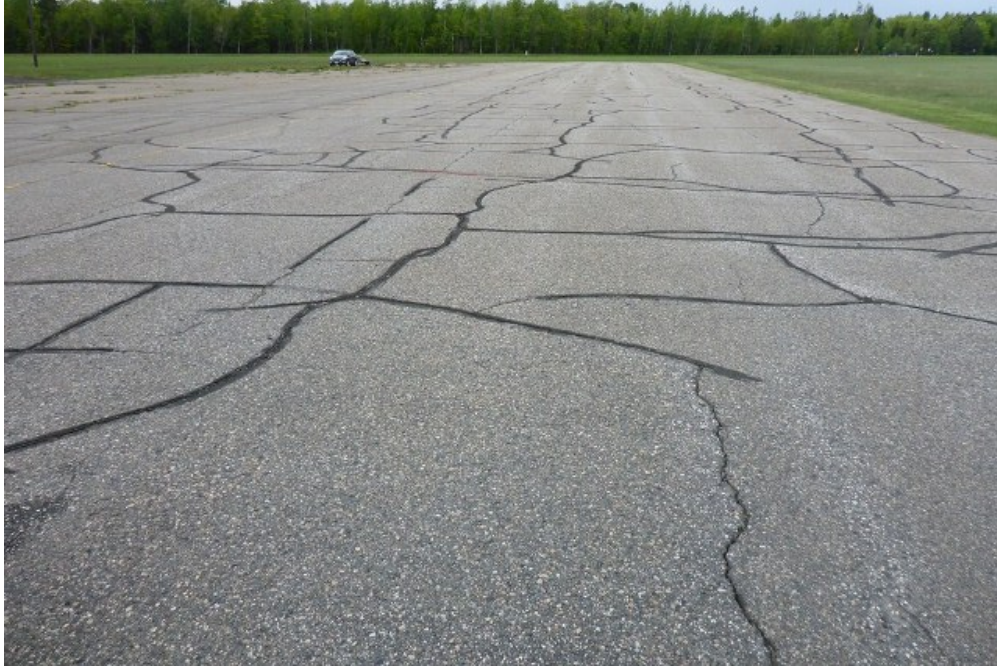
EVM CTA 002 (PCI =41)

**Conditions:** PCI: 41

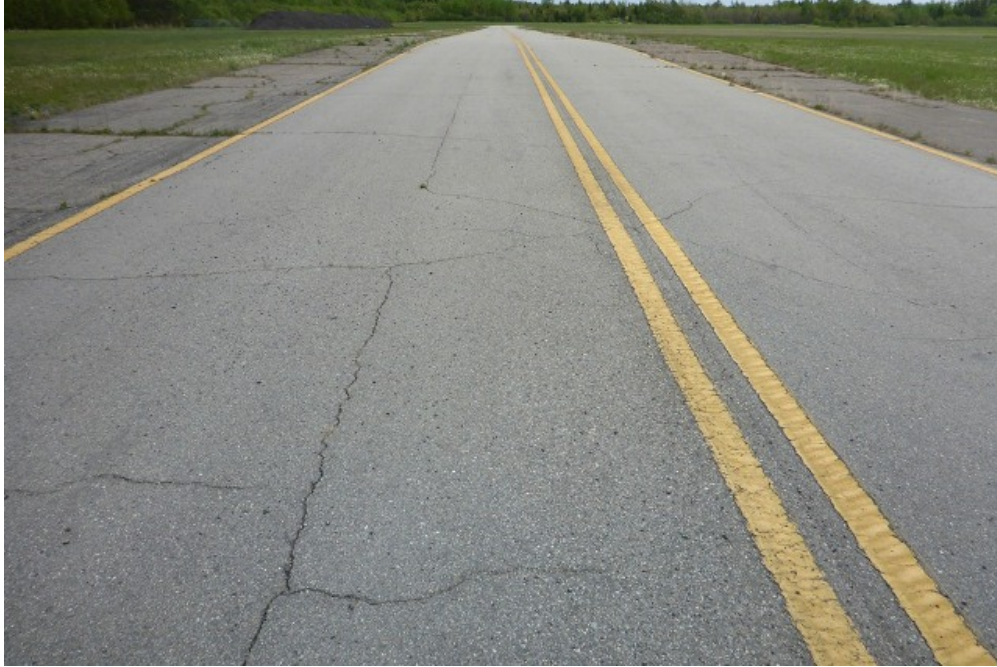
EVM CTC 002 (PCI =54)

**Conditions:** PCI: 54

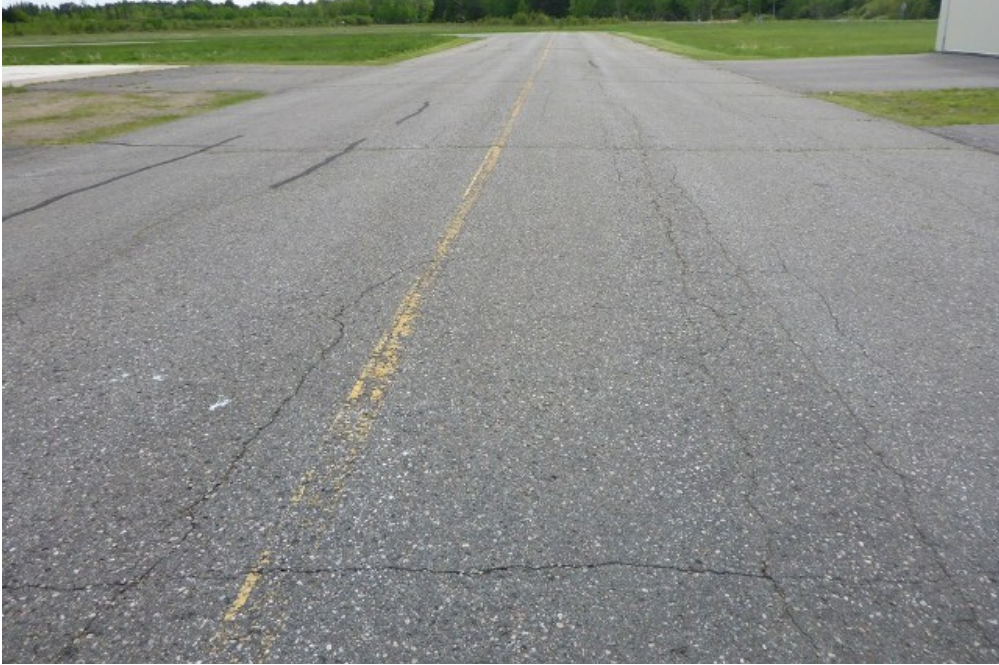
EVM TLA 001 (PCI=36)

**Conditions:** PCI: 36

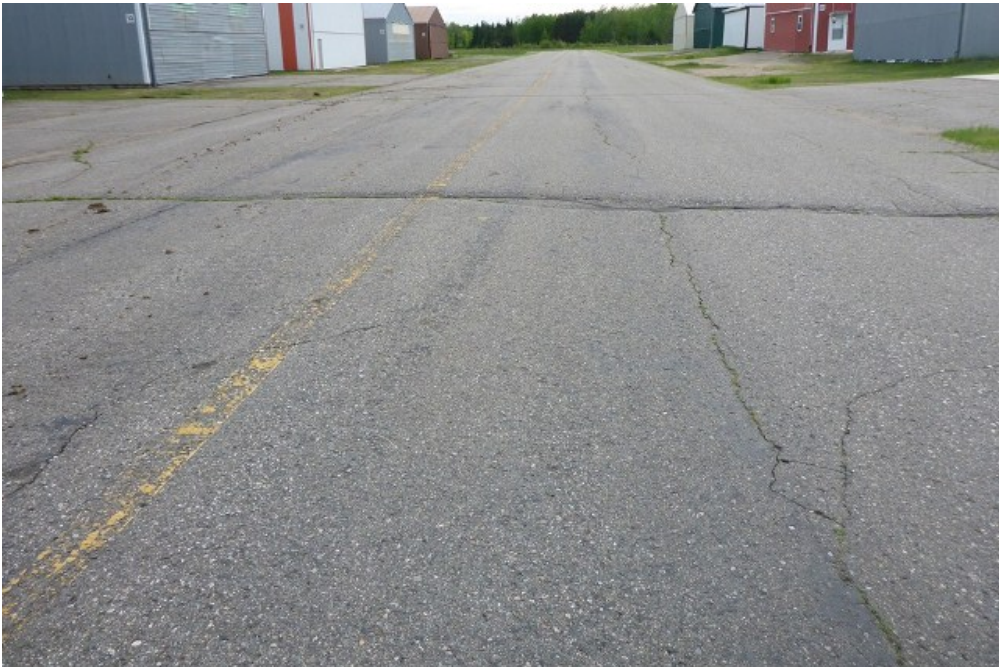
EVM TLA 002 (PCI =50)

**Conditions:** PCI: 50

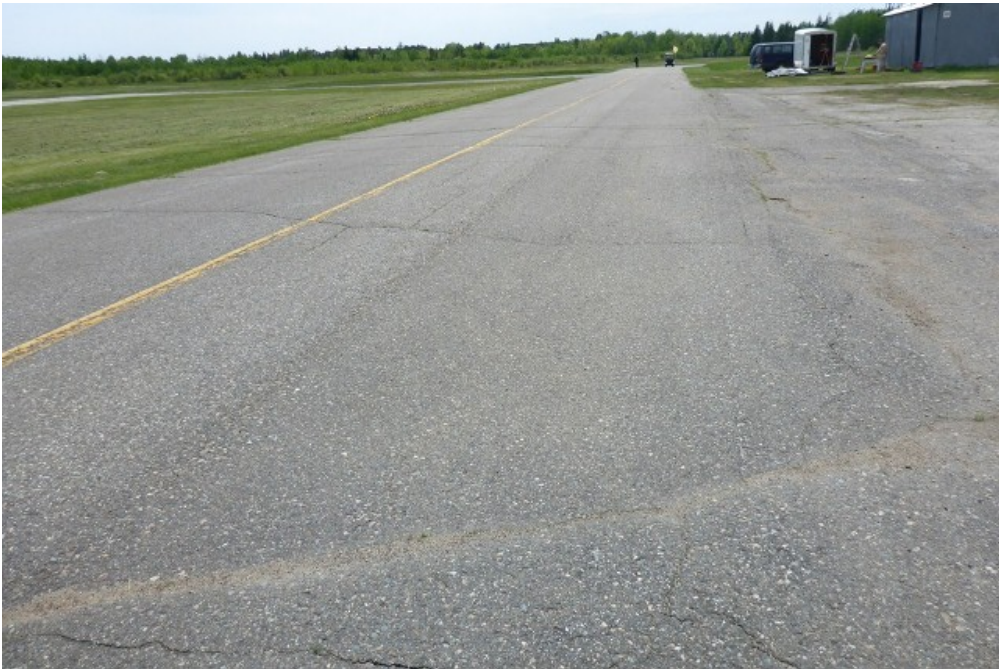
EVM TLB 001 (PCI =51)

**Conditions:** PCI: 51
