Pavement Condition Report

Fergus Falls Municipal Airport (FFM)

January 2016

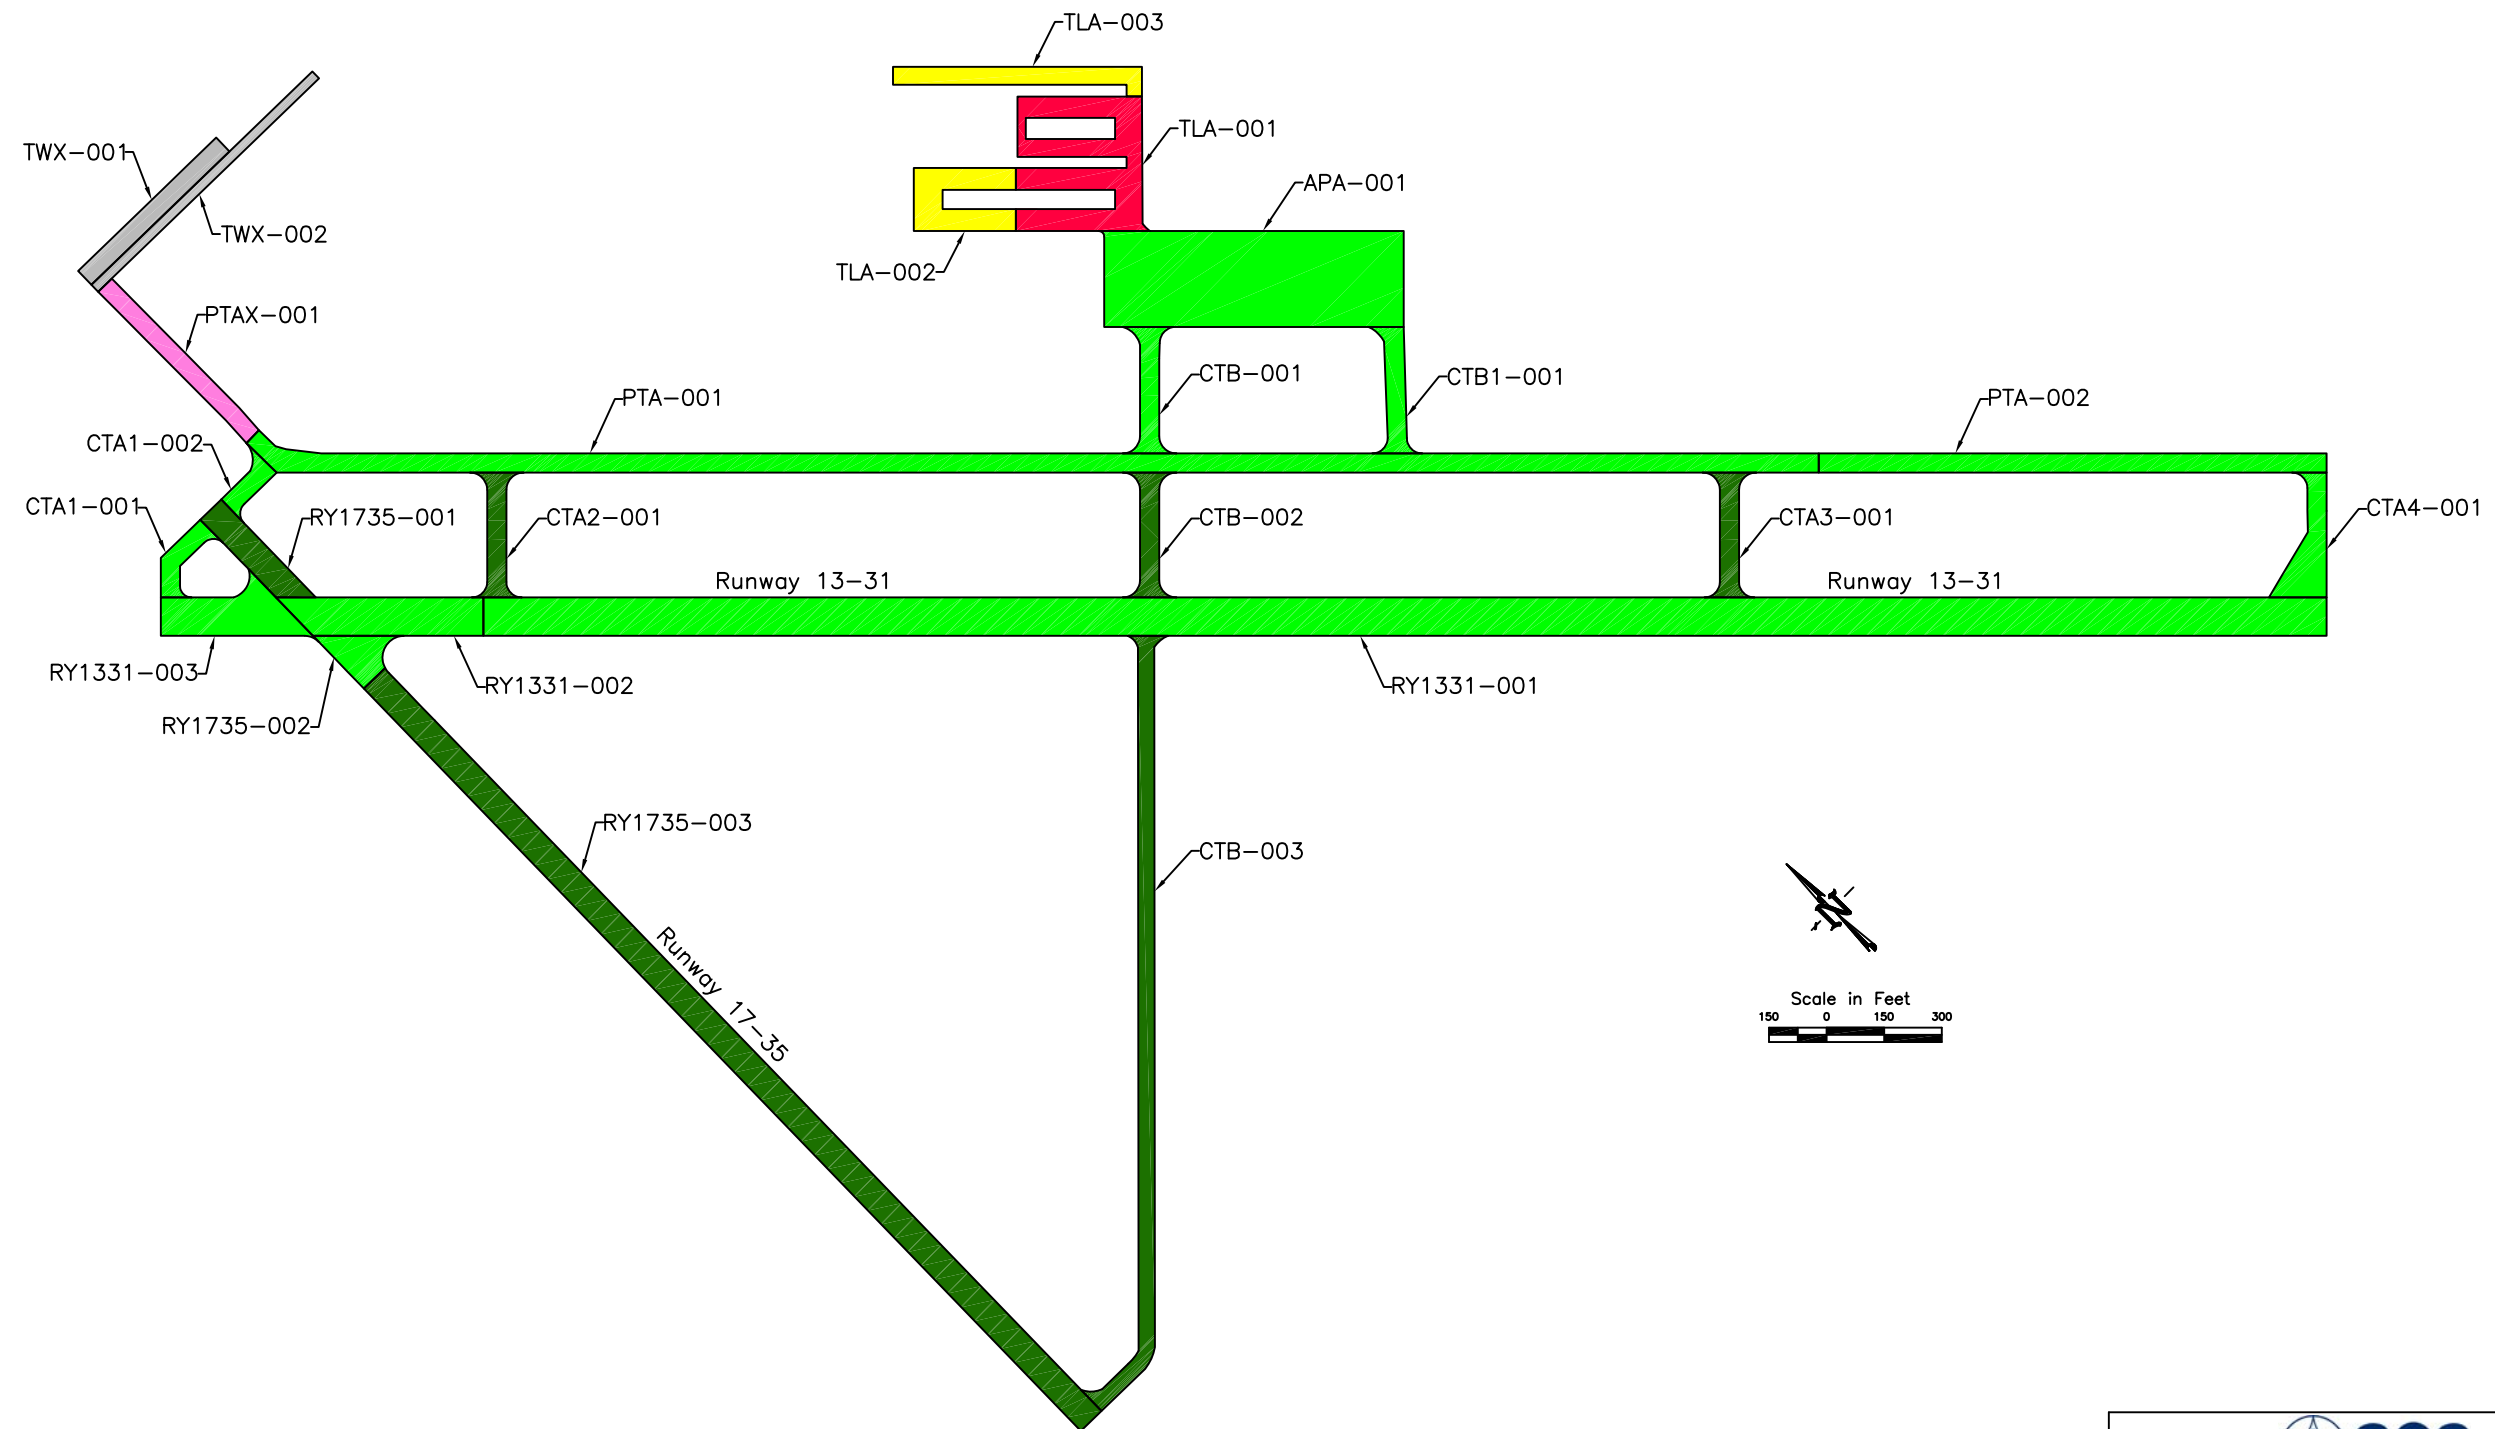
Figure 4. 2015 Pavement Condition Index Rating at Fergus Falls Municipal Airport (FFM).

Figures 5 and 6 present the overall PCI for FFM by area distribution and pavement use, respectively. Table 3 presents the PCI summary for each section at FFM, including the drop in PCI per year. Generally, pavement sections will deteriorate between 1 and 3 PCI points per year. Sections deteriorating at higher rates may need maintenance above the normal application rates and should be closely monitored in case major repairs become necessary earlier than expected.

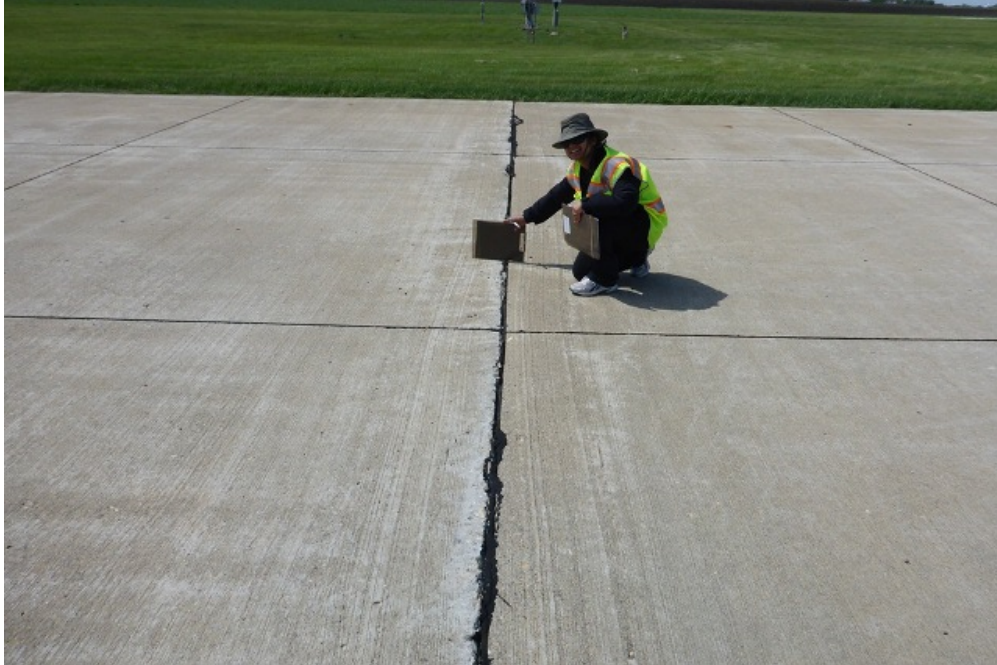
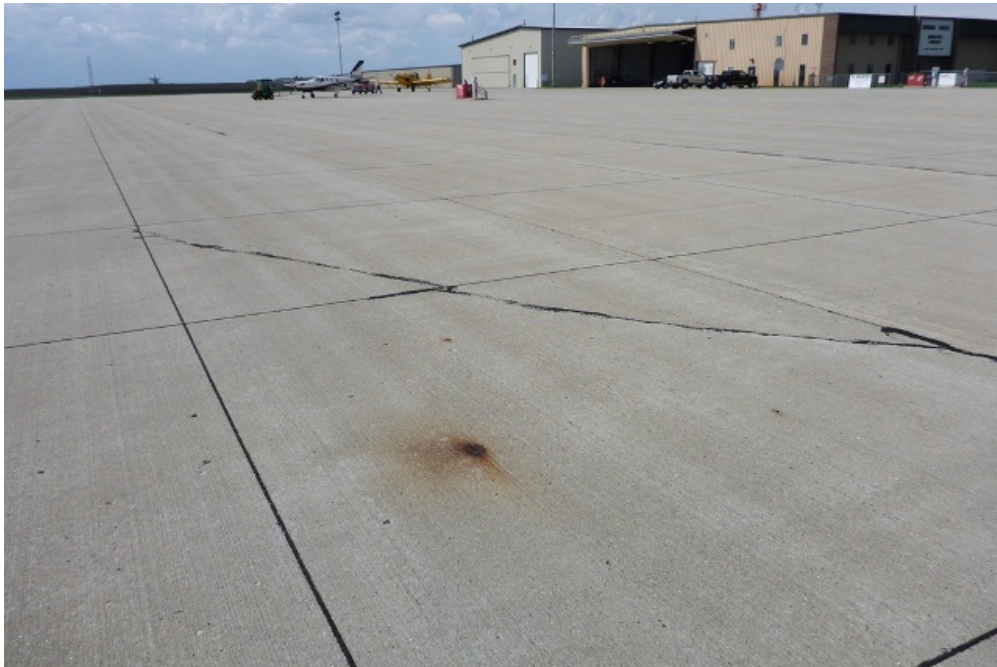
FFM APA 001 (PCI = 84)

Conditions: PCI: 84

65	JT SEAL DMG	M	20.00 Slabs	Comments:
74	JOINT SPALL	L	1.00 Slabs	Comments:

62	CORNER BREAK	H	1.00 Slabs	Comments:
63	LINEAR CR	M	1.00 Slabs	Comments:
65	JT SEAL DMG	M	20.00 Slabs	Comments:
74	JOINT SPALL	L	1.00 Slabs	Comments:

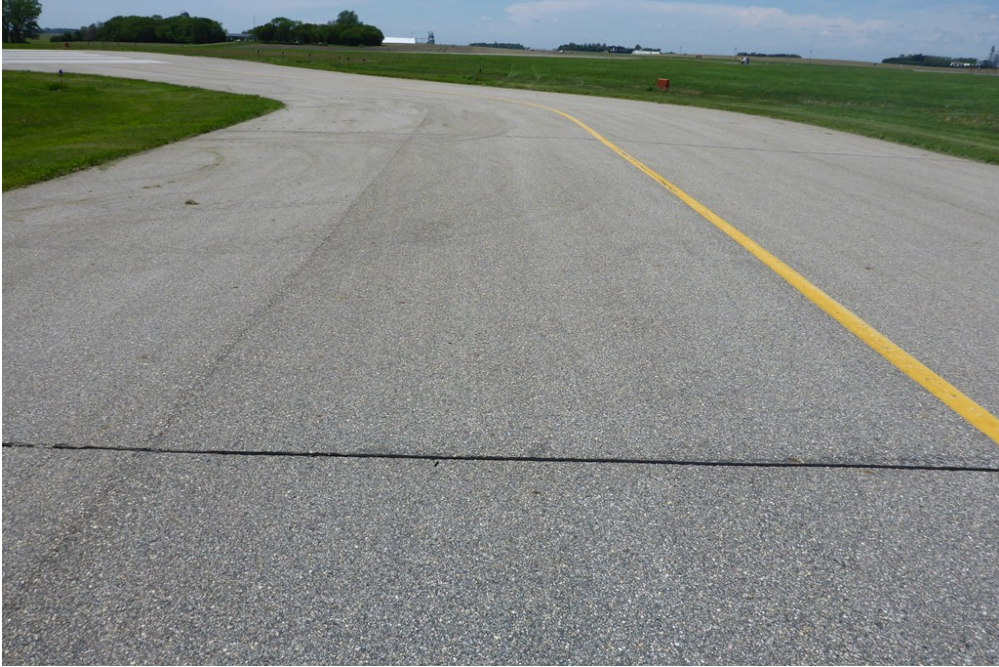
FFM CTA1 001 (PCI = 84)

Conditions: PCI: 84

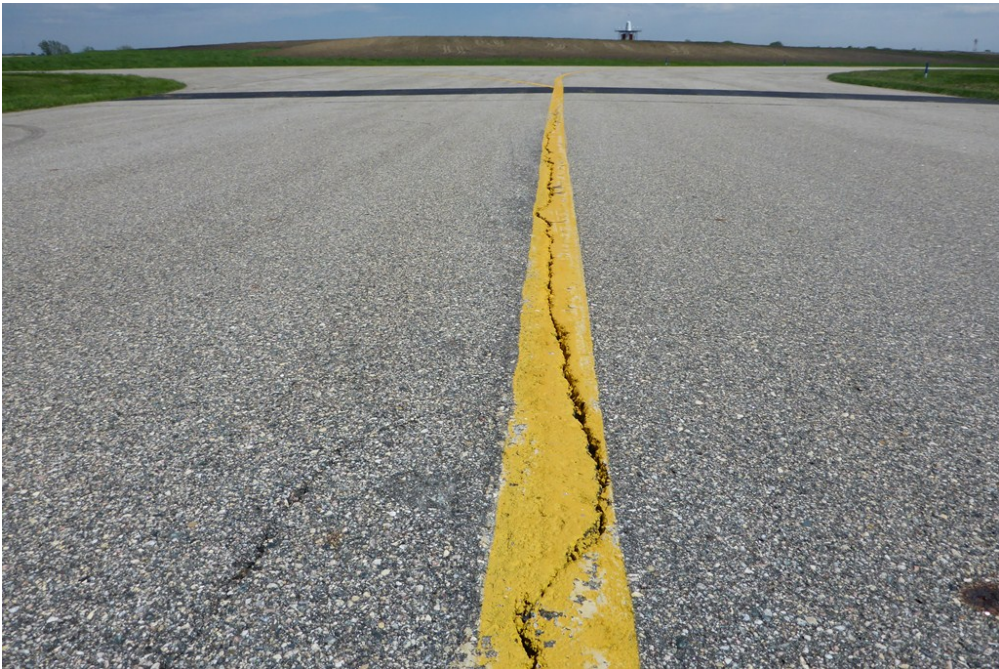
FFM CTA1 002 (PCI = 81)

Conditions: PCI: 81

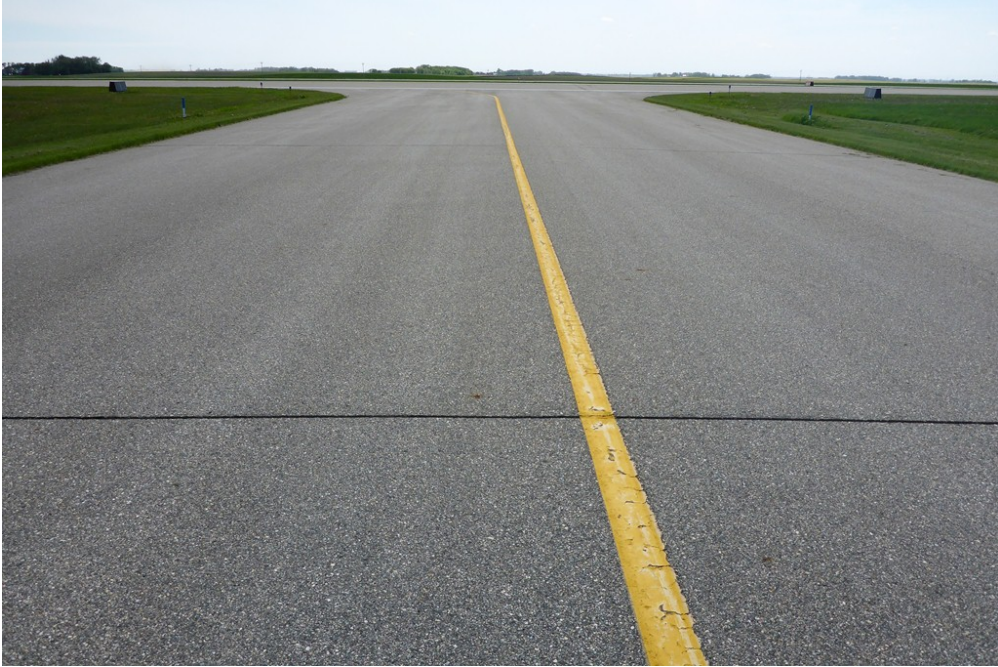
FFM CTA2 001 (PCI = 92)

Network:	FFM		Name:	FERGUS FALLS					
Branch:	CTA2	Name:	CONNECTING TAXIWAY A2	Use:	TAXIWAY	Area:	17,800 SqFt		
Section:	001	of 1	From:	300	To:	302	Last Const.:	12/15/2001	
Surface:	AC	Family:	MN2013 Asphalt Taxiways	Zone:	W	Category:	2	Rank:	S
Area:	17,800 SqFt	Length:	325 Ft	Width:	50 Ft				
Slabs:		Slab Length:	Ft	Slab Width:	Ft	Joint Length:	Ft		
Shoulder:		Street Type:		Grade:	0	Lanes:	0		
Section Comments:									
Last Insp. Date:	5/28/2015	TotalSamples:	3	Surveyed:	1				
Conditions:	PCI: 92								
Inspection Comments:									
Sample Number:	401	Type:	R	Area:	5000.00 SqFt	PCI:	92		
Re-Inspection Report									
48	L & T CR	L	111.00 Ft	Comments:

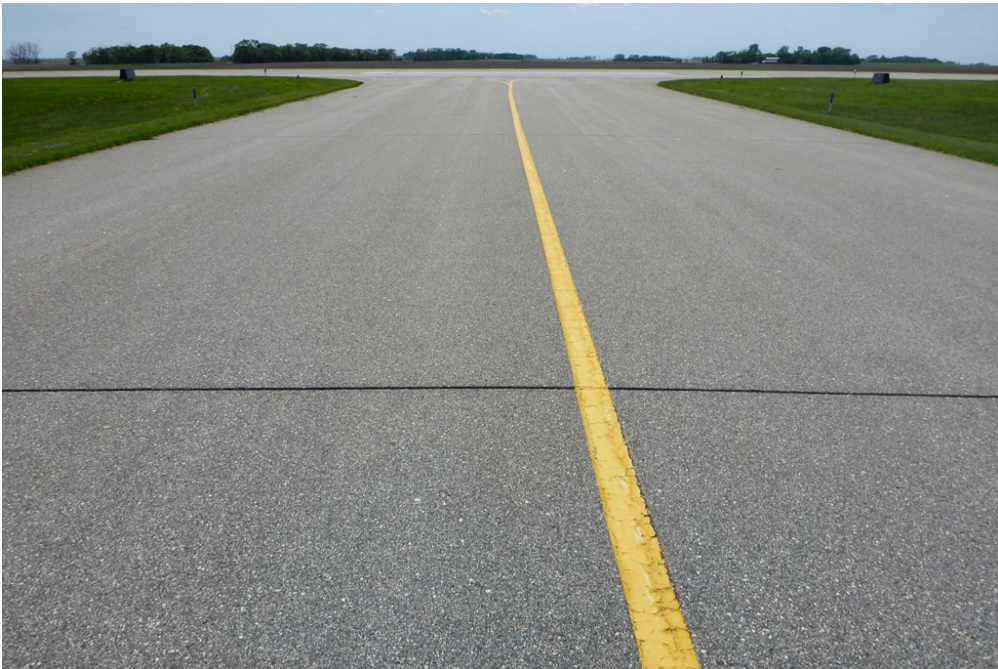
FFM CTA3 001 (PCI = 88)

Conditions: PCI: 88

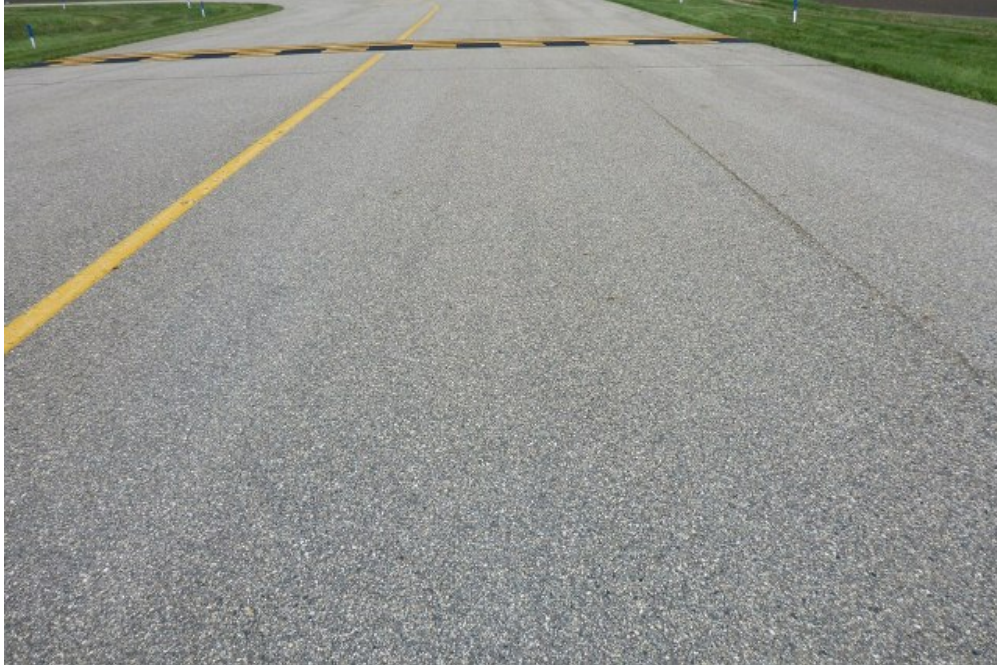
FFM CTA4 001 (PCI = 77)

Conditions: PCI: 77

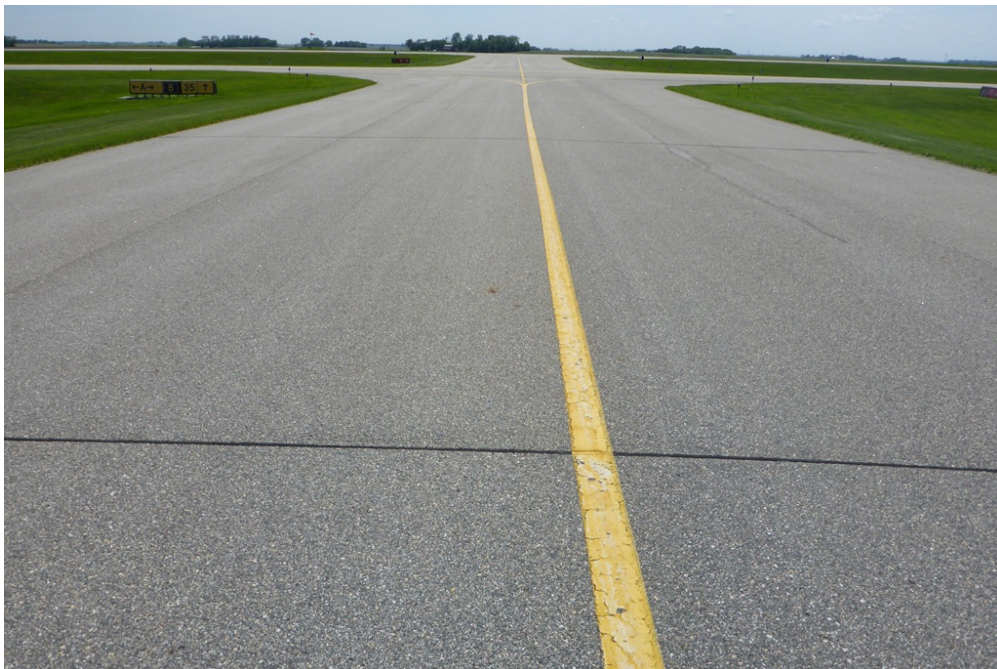
FFM CTB 001(PCI = 85)

Conditions: PCI: 85

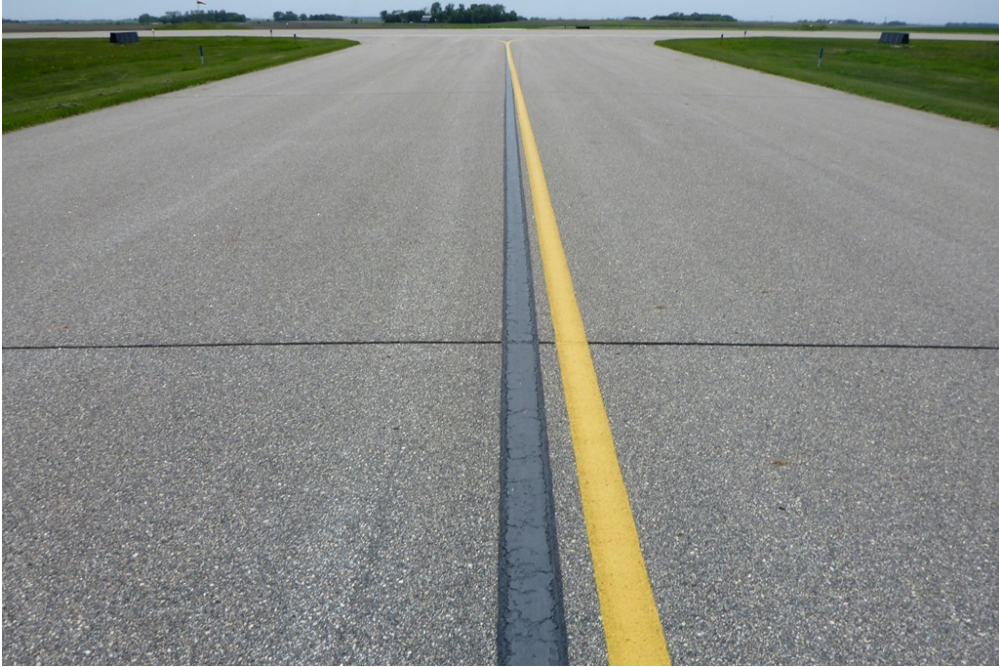
FFM CTB 002 (PCI = 88)

Network:	FFM	Name:	FERGUS FALLS						
Branch:	CTB	Name:	CONNECTING TAXIWAY B	Use:	TAXIWAY	Area:	124,700 SqFt		
Section:	002	of 3	From:	400	To:	402+20	Last Const.:	12/15/2001	
Surface:	AC	Family:	MN2013 Asphalt Taxiways	Zone:	W	Category:	2	Rank:	P
Area:	18,000 SqFt	Length:	320 Ft	Width:	50 Ft				
Slabs:		Slab Length:	Ft	Slab Width:	Ft	Joint Length:	Ft		
Shoulder:		Street Type:		Grade:	0	Lanes:	0		
Section Comments:									
Last Insp. Date:	5/28/2015	TotalSamples:	3	Surveyed:	1				
Conditions:	PCI: 88								
Inspection Comments:									
Sample Number:	201	Type:	R	Area:	5000.00 SqFt	PCI:	88		
Re-Inspection Report									
48	L & T CR	L	101.00 Ft	Comments:					
52	RAVELING	H	3.00 SqFt	Comments:

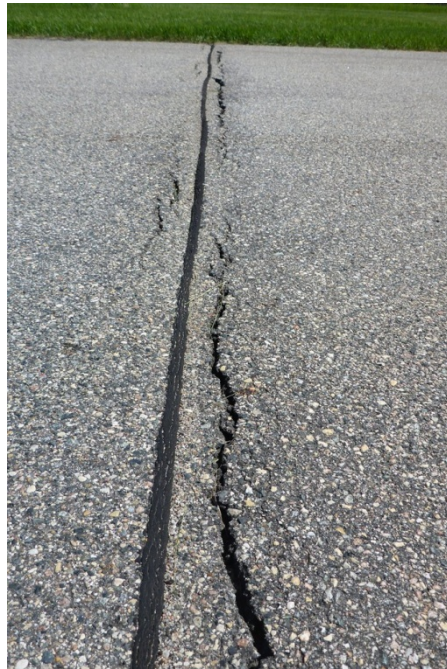
FFM CTB1 001(PCI = 78)

Conditions: PCI: 78

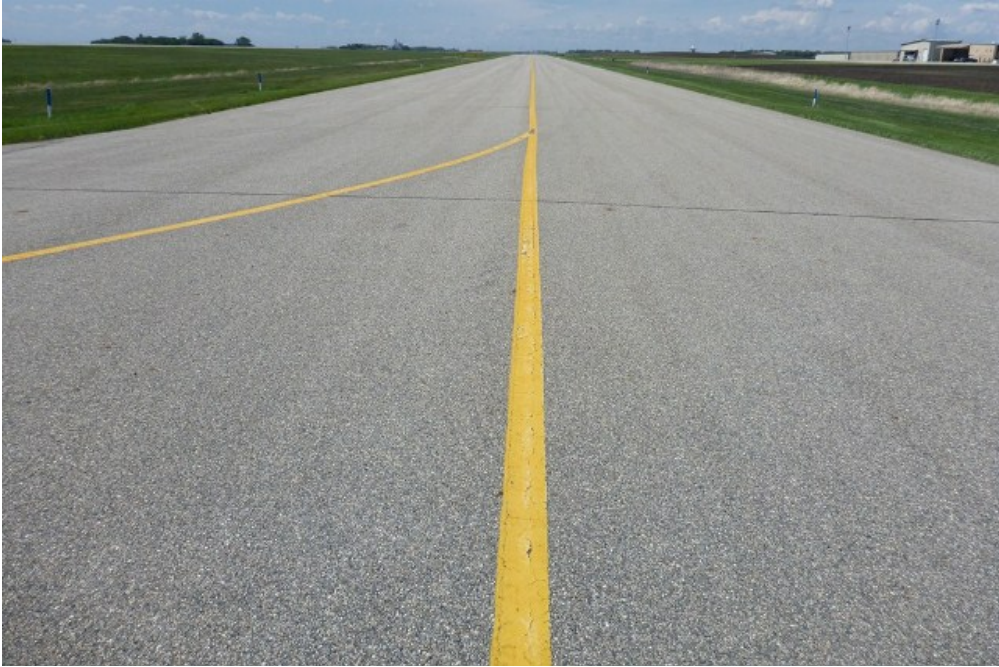
FFM PTA 001 (PCI = 82)

Network:	FFM		Name:	FERGUS FALLS		
Branch:	PTA	Name:	PARALLEL TAXIWAY A	Use:	TAXIWAY	Area: 271,825 SqFt
Section:	001	of 2	From: 106	To: 145	Last Const.: 12/15/2001	
Surface:	AC	Family: MN2013 Asphalt Taxiways	Zone: W	Category: 2	Rank: P	
Area:	205,700 SqFt	Length:	4,000 Ft	Width:	50 Ft	
Slabs:		Slab Length:	Ft	Slab Width:	Ft	Joint Length: Ft
Shoulder:		Street Type:		Grade: 0	Lanes: 0	
Section Comments:						
Last Insp. Date:	5/28/2015		TotalSamples: 40	Surveyed: 4		
Conditions:	PCI: 82					
Inspection Comments:						
Sample Number:	110	Type:	R	Area:	5000.00 SqFt	PCI: 79
Re-Inspection Report						
48	L & T CR	L	110.00 Ft	Comments:		
48	L & T CR	M	105.00 Ft	Comments:		
Sample Number:	120	Type:	R	Area:	5000.00 SqFt	PCI: 81
Re-Inspection Report						
48	L & T CR	M	51.00 Ft	Comments:		
57	WEATHERING	L	1200.00 SqFt	Comments:		
48	L & T CR	L	56.00 Ft	Comments:		
Sample Number:	130	Type:	R	Area:	5000.00 SqFt	PCI: 84

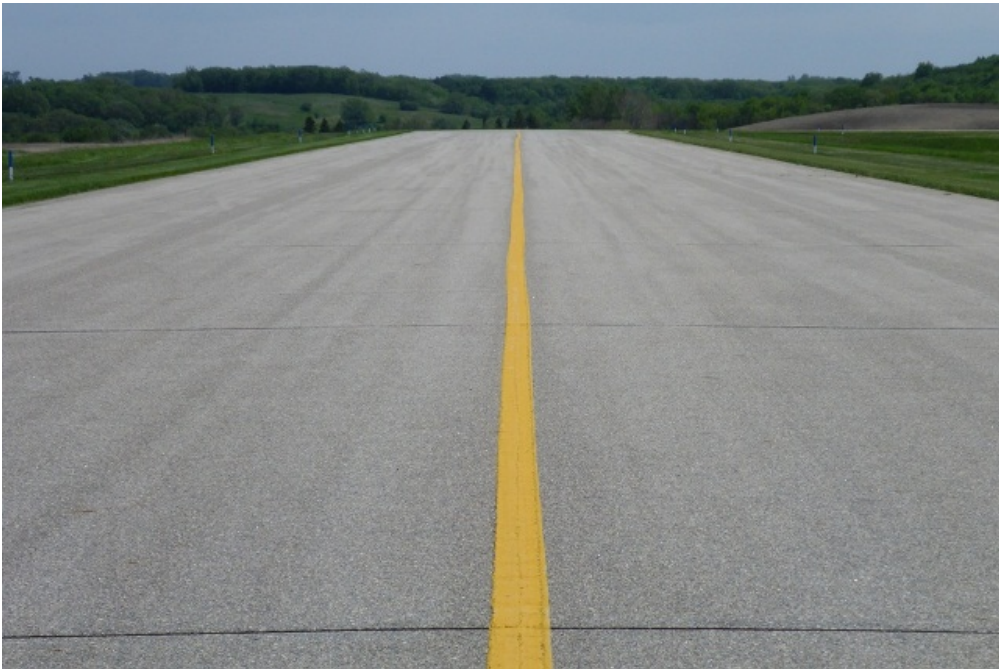
FFM PTA 002 (PCI = 82)

Network:	FFM	Name:	FERGUS FALLS						
Branch:	PTA	Name:	PARALLEL TAXIWAY A	Use:	TAXIWAY	Area:	271,825 SqFt		
Section:	002	of 2	From:	146	To:	159	Last Const.:	12/15/2001	
Surface:	AC	Family:	MN2013 Asphalt Taxiways	Zone:	W	Category:	2	Rank:	P
Area:	66,125 SqFt	Length:	1,420 Ft	Width:	50 Ft				
Slabs:		Slab Length:	Ft	Slab Width:	Ft	Joint Length:	Ft		
Shoulder:		Street Type:		Grade:	0	Lanes:	0		
Section Comments:									
Last Insp. Date:	5/28/2015	TotalSamples:	14	Surveyed:	3				
Conditions:	PCI: 82								
Inspection Comments:									
Sample Number:	149	Type:	R	Area:	5000.00 SqFt	PCI:	81		
Re-Inspection Report									
48	L & T CR	L	28.00 Ft	Comments:					
48	L & T CR	M	77.00 Ft	Comments:					
57	WEATHERING	L	900.00 SqFt	Comments:					
Sample Number:	153	Type:	R	Area:	5000.00 SqFt	PCI:	90		
Re-Inspection Report									
48	L & T CR	L	35.00 Ft	Comments:					
48	L & T CR	L	69.00 Ft	Comments:					
57	WEATHERING	L	900.00 SqFt	Comments:

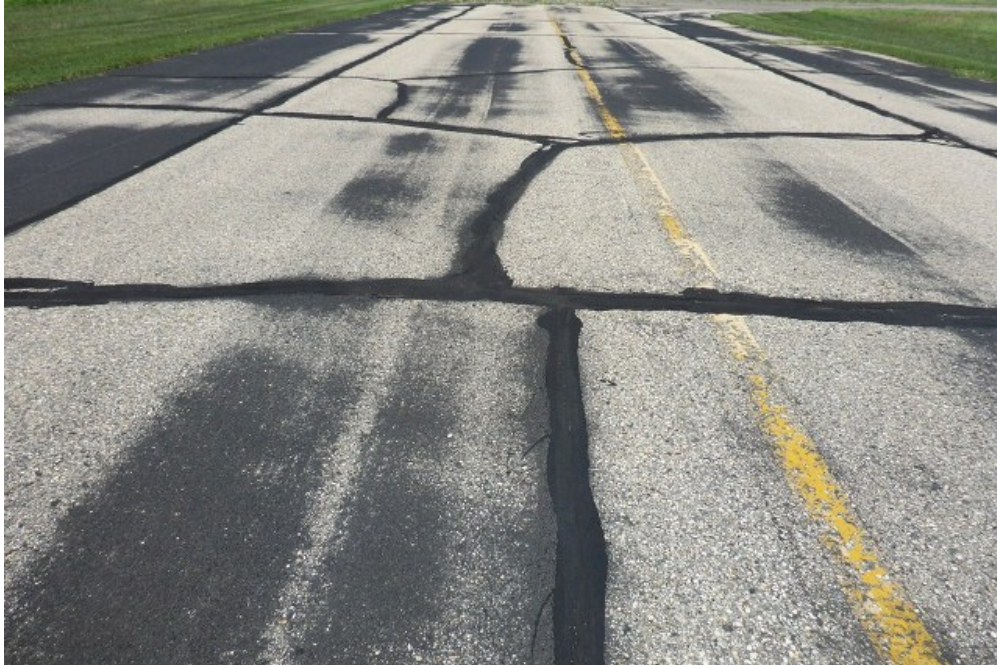
FFM PTAX 001 (PCI = 47)

PTAX	001	AC	26,700	1979	50	47	1.5	26	67	Alligator, Depression, L&T, Ravelling, Weathering
RY1331	001	AC	480,000	2001	81	76	1.7	0	100	L&T, Ravelling
RY1331	002	AC	49,200	2001	79	78	1.6	0	100	L&T, Ravelling
RY1331	003	AC	37,950	2001	81	78	1.6	0	100	L&T, Ravelling
RY1735	001	AC	23,900	2001	94	88	0.9	0	100	L&T Cracking
RY1735	002	AC	15,400	2001	81	80	1.4	0	100	L&T Cracking, Weathering, Ravelling
RY1735	003	AC	201,600	2012	100	86	4.7	0	100	L&T Cracking
TLA	001	AC	80,600	1979	26	28	2.0	10	90	Alligator, Block, Ravelling, Weathering, Patching
TLA	002	AC	34,125	2004	70	58	3.8	0	100	L&T, Ravelling, Weathering
TLA	003	AC	31,656	2004	71	66	3.1	0	100	L&T, Ravelling, Weathering
TWX	001	AC	25,000	1970	0	7	2.1	37	63	Alligator, Block, Ravelling, Patching
TWX	002	AC	20,000	1970	0	6	2.1	23	77	Alligator, Block, Ravelling, Patching

Conditions: PCI: 47

Inspection Comments: New crack sral OK

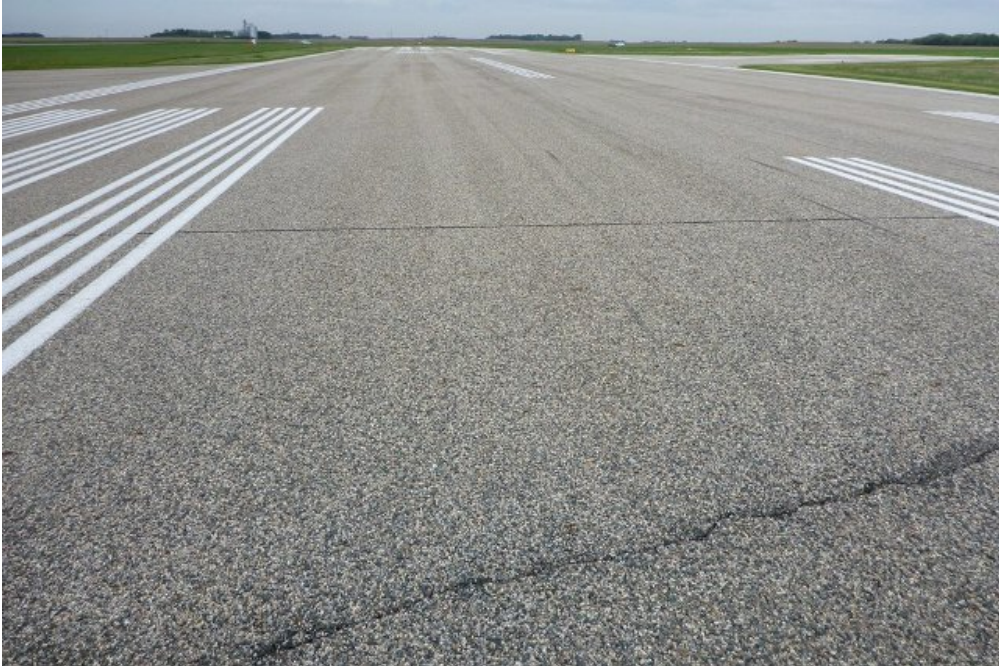
FFM RY1331 002 (PCI = 78)

Conditions: PCI: 78

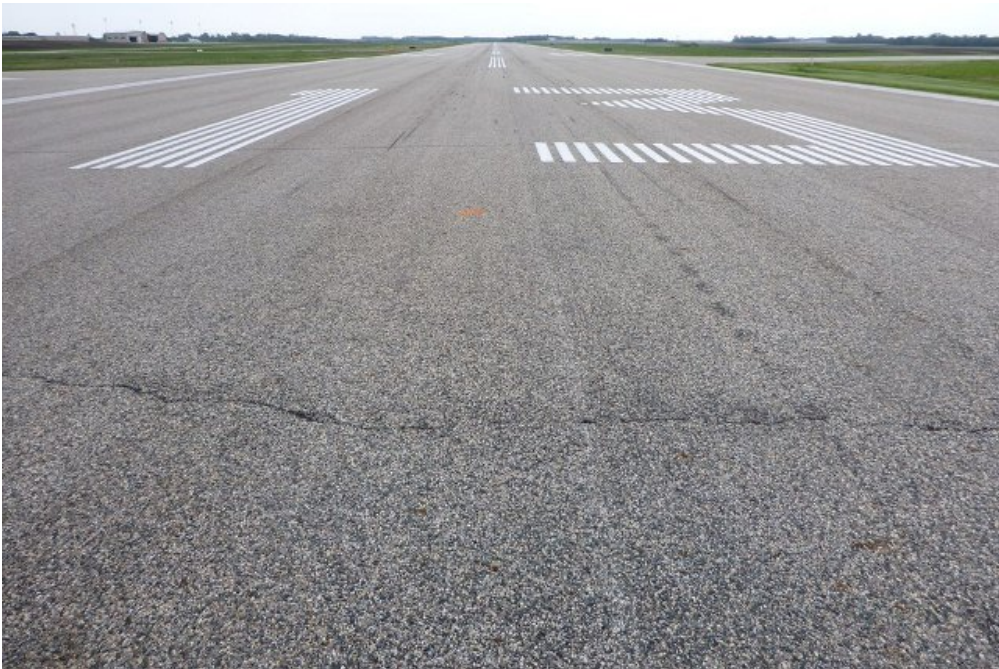
FFM RY1331 003(PCI = 78)

Conditions: PCI: 78

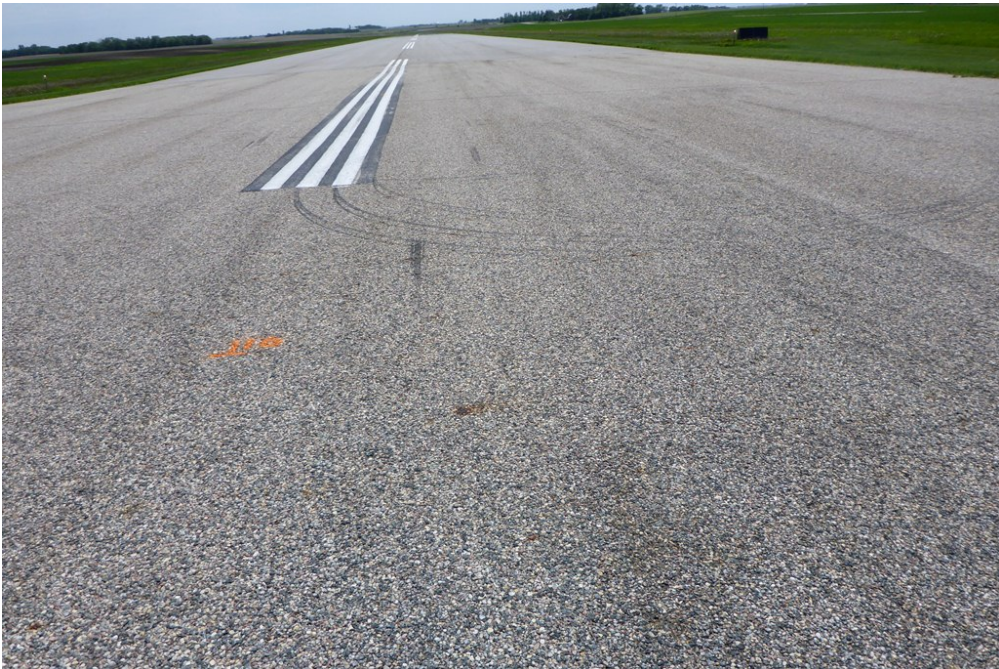
FFM RY1735 002(PCI = 80)

Conditions: PCI: 80

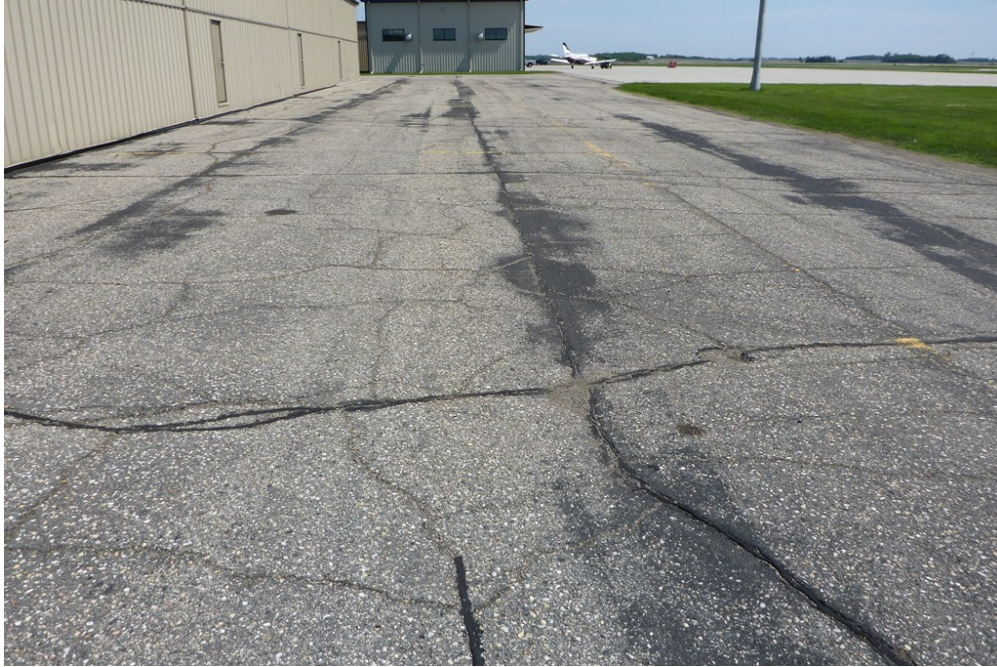
FFM TLA 002 (PCI = 58)

Conditions: PCI: 58

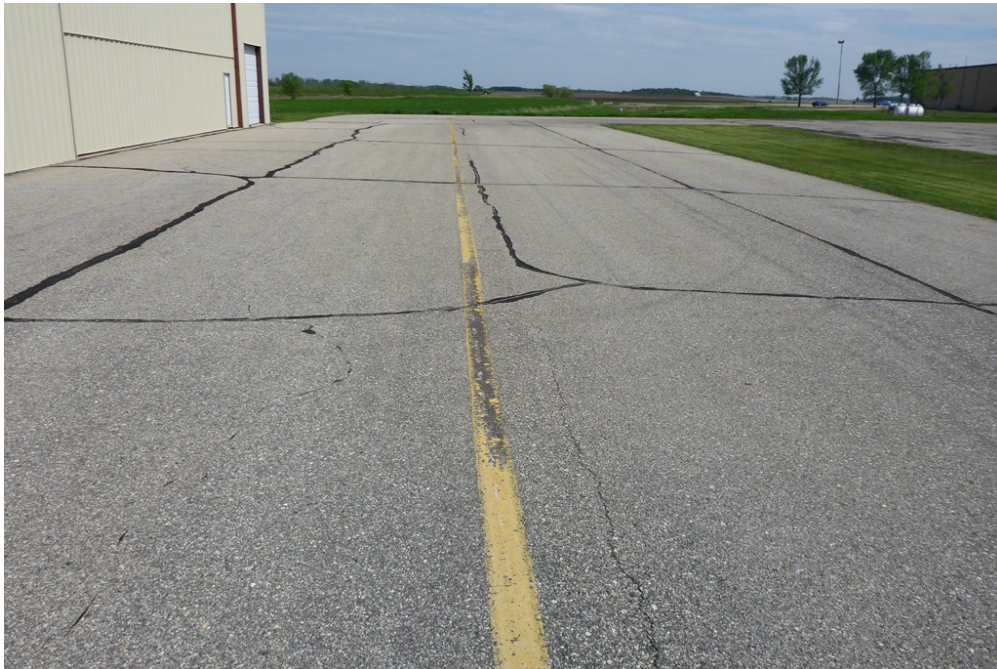
FFM TLA 003(PCI = 66)

Conditions: PCI: 66
