Pavement Condition Report

McGregor – Isedor Iverson Airport (HZX)

January 2016

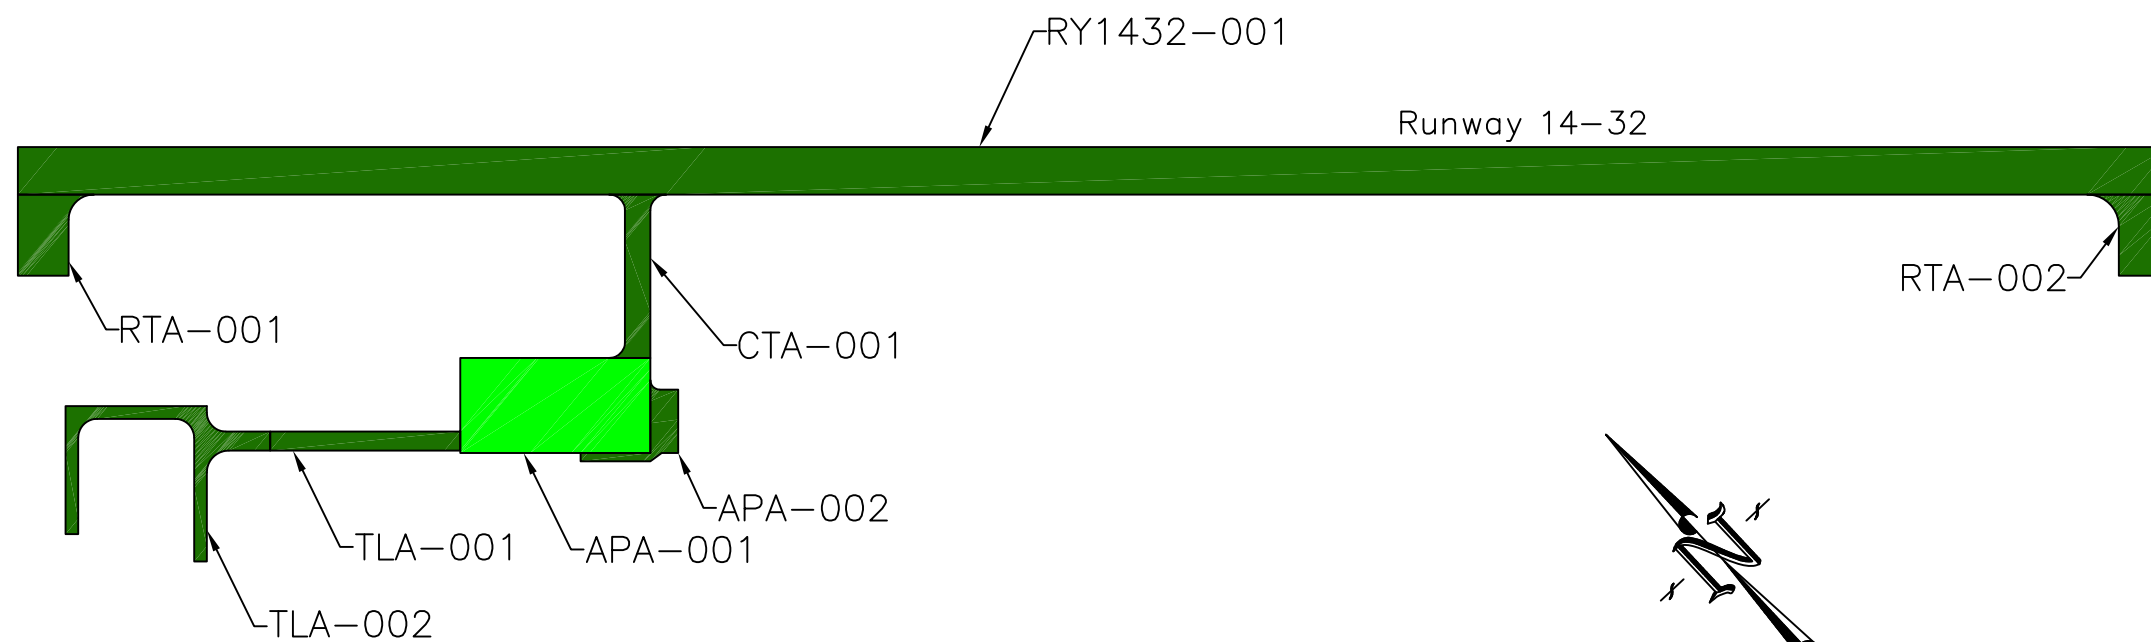
Figure 4. 2015 Pavement Condition Index Rating at McGregor-Isedor Iverson Airport (HZX).

Branch ID	Section ID	Surface type ¹	Section area (SF)	LCD ²	2012 PCI	2015 PCI	Drop in PCI/Yr ³	% Deduct due to		Distress types
								Load ⁴	Climate ⁵	
APA	001	AAC	45,000	2012	100	84	5.3	0	100	L&T Cracking, Ravelling
APA	002	AAC	5,200	2012	100	90	3.3	0	100	L&T Cracking, Ravelling
CTA	001	AAC	10,320	2012	100	92	2.7	0	100	L&T Cracking
RTA	001	AC	10,736	2012	100	96	1.3	0	100	L&T Cracking
RTA	002	AC	10,925	2012	100	100	-	0	0	-
RY1432	001	AC	255,000	2012	100	94	2.0	0	100	L&T Cracking
TLA	001	AAC	9,000	2012	100	87	4.3	0	100	L&T Cracking
TLA	002	AC	15,500	2008	97	94	0.9	0	100	L&T Cracking
