# Pavement Condition Report

## Moorhead Municipal Airport (JKJ)

January 2016

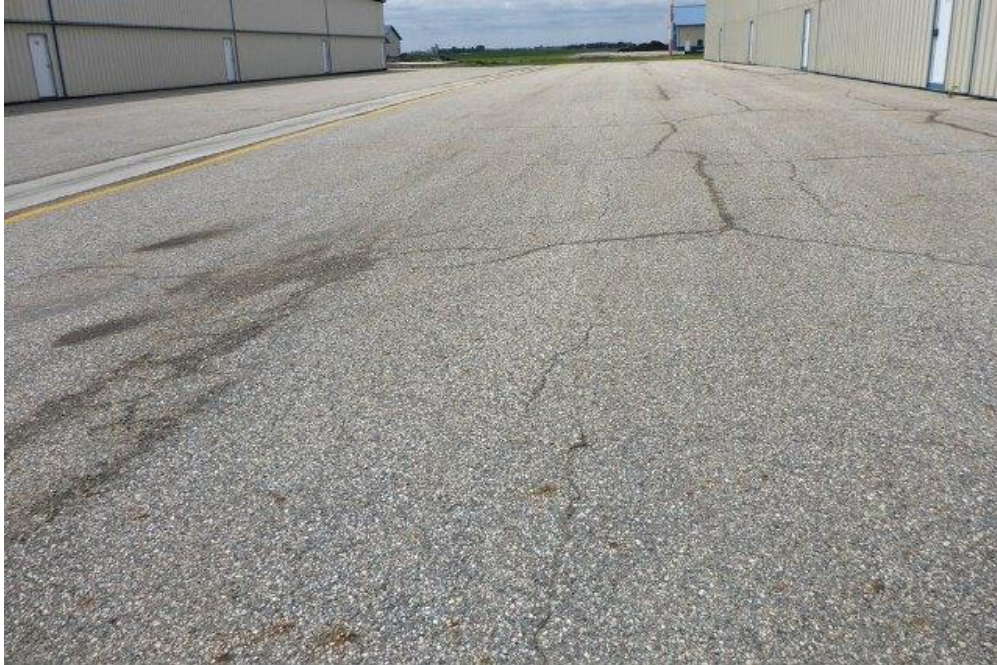
JKJ TLA 001 (PCI = 66)

TLA	001	AC	101,000	2002	66	50	3.8	31	68	Alligator, Block, Depression, L&T, Patching, Ravelling, Rutting, Weathering
TLA	002	AC	10,320	2004	69	51	4.5	18	82	L&T, Ravelling, Rutting, Weathering
TLA	003	AC	22,030	2012	100	91	3.0	0	35	L&T Cracking, Shoving
TLB	001	AC	4,460	2006	98	85	1.7	0	100	L&T Cracking
TLC	001	AC	13,325	2015		100		0	0	No Distress
