Pavement Condition Report

Luverne - Quentin Aanenson Field Airport (LYV)

January 2016

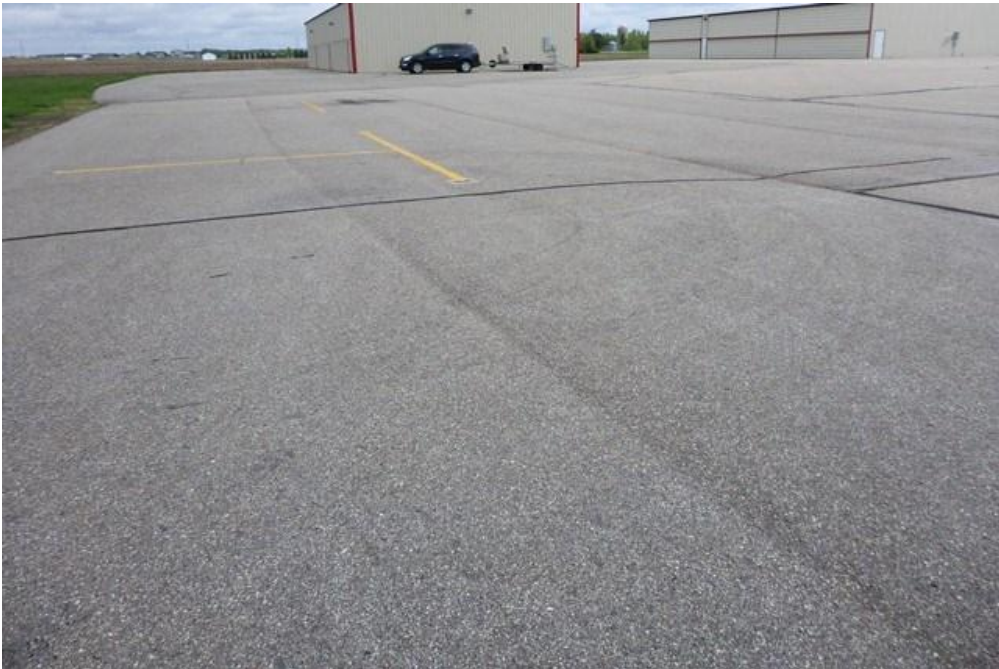
LYV APA 002 (PCI = 85)

Network:	LYV	Name:	LUVERNE				
Branch:	APA	Name:	APRON A	Use:	APRON	Area:	64,426 SqFt
Section:	002	of 3	From:	-	To:	-	Last Const.: 6/1/2009
Surface:	AC	Family:	MN2013 Asphalt Aprons	Zone:		Category:	Rank: S
Area:	8,224 SqFt	Length:	160 Ft	Width:	33 Ft		
Slabs:		Slab Length:	Ft	Slab Width:	Ft	Joint Length:	Ft
Shoulder:		Street Type:		Grade:	0	Lanes:	0
Section Comments:							
Last Insp. Date:	5/15/2015	TotalSamples:	2	Surveyed:	1		
Conditions:	PCI: 85						
Inspection Comments:							
Sample Number:	200	Type:	R	Area:	3300.00 SqFt	PCI:	85
Re-Inspection Report							
48	L & T CR	L	137.00 Ft	Comments:			
52	RAVELING	L	25.00 SqFt	Comments:

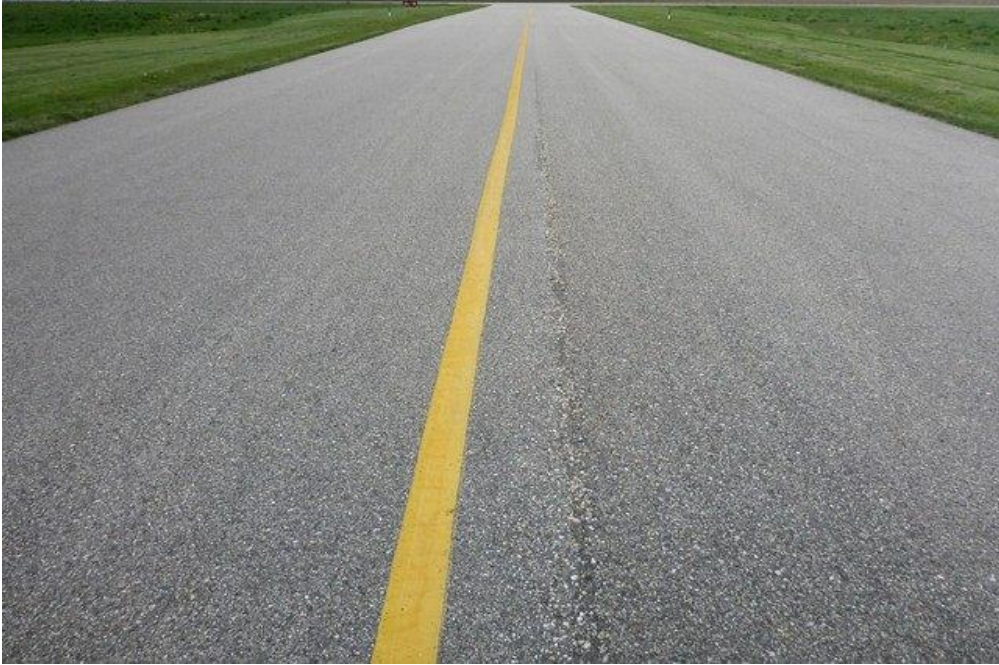
LYV CTB 001 (PCI = 98)

Network:	LYV	Name:	LUVERNE						
Branch:	CTB	Name:	Connecting Taxiway B	Use:	TAXIWAY	Area:	22,414 SqFt		
Section:	001	of 1	From:	100	To:	105	Last Const.:	6/30/2009	
Surface:	AC	Family:	MN2013 Asphalt Taxiways	Zone:	S	Category:	2	Rank:	P
Area:	22,414 SqFt	Length:	565 Ft	Width:	35 Ft				
Slabs:		Slab Length:	Ft	Slab Width:	Ft	Joint Length:	Ft		
Shoulder:		Street Type:		Grade:	0	Lanes:	0		
Section Comments:									
Last Insp. Date:	5/15/2015	TotalSamples:	6	Surveyed:	2				
Conditions:	PCI: 98								
Inspection Comments:									
Sample Number:	101	Type:	R	Area:	3500.00 SqFt	PCI:	100		
Re-Inspection Report									
<No Distress>				Comments:					
Sample Number:	103	Type:	R	Area:	3500.00 SqFt	PCI:	96		
Re-Inspection Report									
48	L & T CR	L	18.00 Ft	Comments:

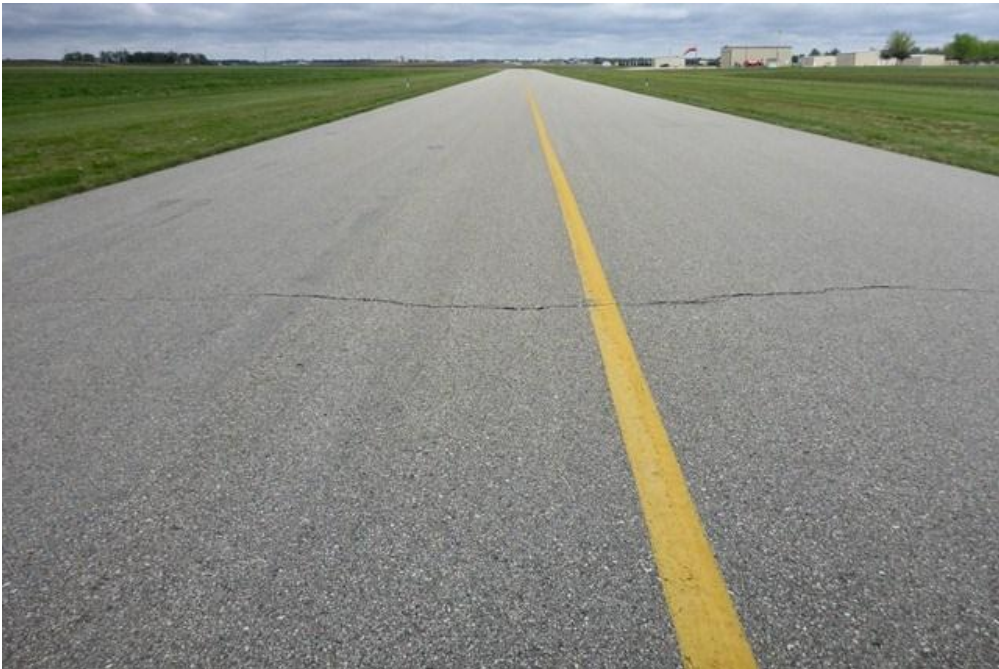
LYV PPTB 001 (PCI = 98)

Network:	LYV	Name:	LUVERNE						
Branch:	PPTB	Name:	Prt Parallel Taxiway B	Use:	TAXIWAY	Area:	52,558 SqFt		
Section:	001	of 1	From:	100	To:	113	Last Const.: 6/30/2009		
Surface:	AAC	Family:	MN2013 Asphalt Taxiways	Zone:	S	Category:	2	Rank:	P
Area:	52,558 SqFt	Length:	1,405 Ft	Width:	35 Ft				
Slabs:		Slab Length:	Ft	Slab Width:	Ft	Joint Length:	Ft		
Shoulder:		Street Type:		Grade:	0	Lanes:	0		
Section Comments:									
Last Insp. Date:	5/15/2015	TotalSamples:	14	Surveyed:	3				
Conditions:	PCI: 98								
Inspection Comments:									
Sample Number:	103	Type:	R	Area:	3500.00 SqFt	PCI:	98		
Re-Inspection Report									
48	L & T CR	L	3.00 Ft	Comments:					
Sample Number:	107	Type:	R	Area:	3500.00 SqFt	PCI:	100		
Re-Inspection Report									
<No Distress>				Comments:					
Sample Number:	111	Type:	R	Area:	3500.00 SqFt	PCI:	96		
Re-Inspection Report									
48	L & T CR	L	17.00 Ft	Comments:

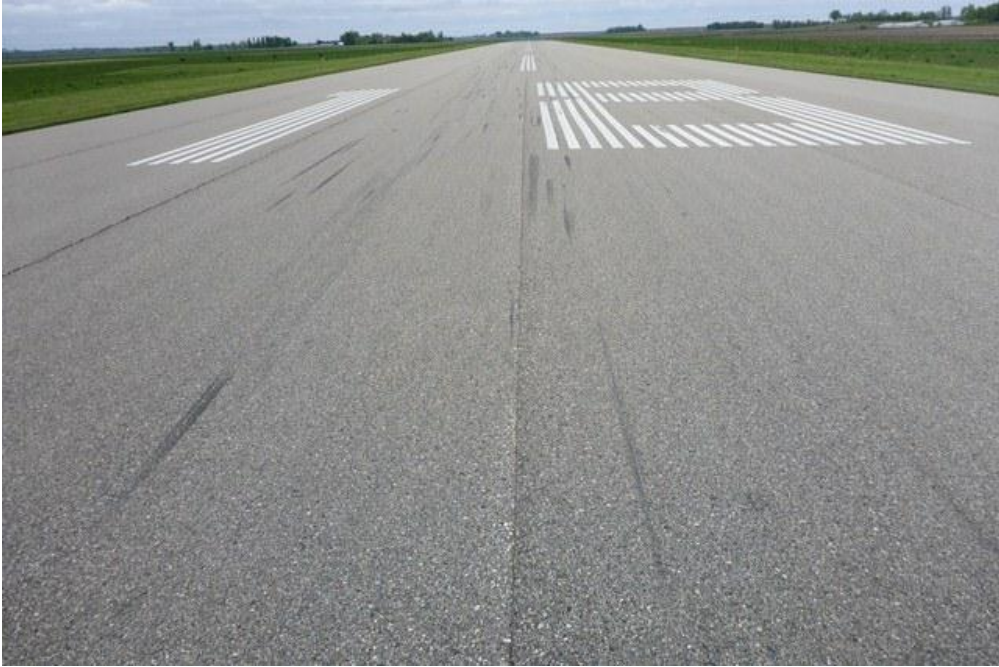
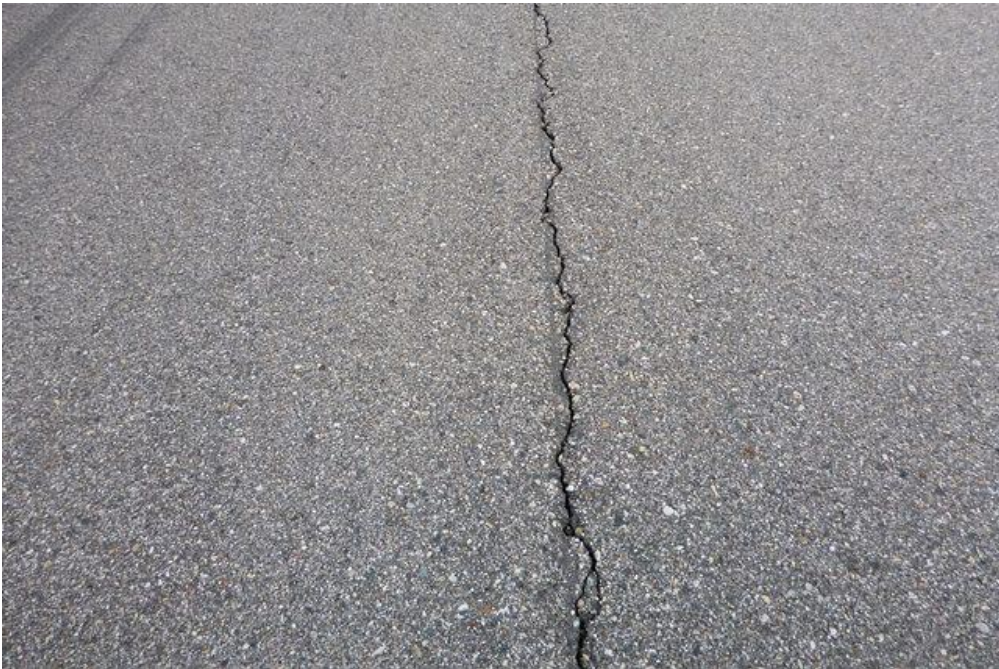
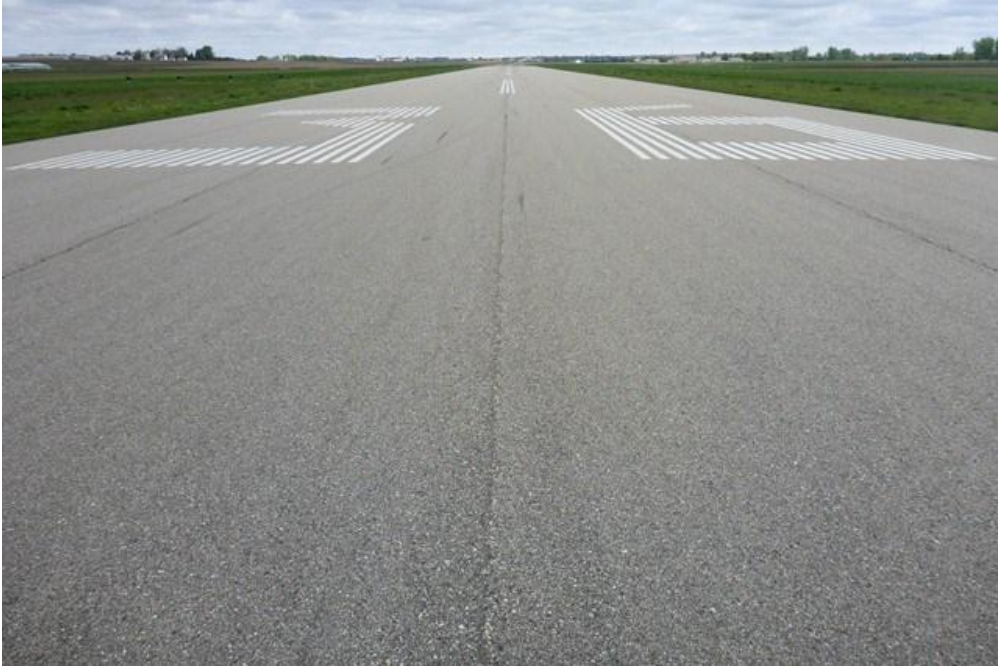
LYV RY1836 001 (PCI = 84)

Network:	LYV	Name:	LUVERNE						
Branch:	RY1836	Name:	Runway 18/36	Use:	RUNWAY	Area:	334,325 SqFt		
Section:	001	of 1	From:	100	To:	183	Last Const.: 6/30/2009		
Surface:	AC	Family:	MN2013 Asphalt Runways	Zone:	S	Category:	2	Rank:	P
Area:	334,325 SqFt	Length:	4,200 Ft	Width:	75 Ft				
Slabs:		Slab Length:	Ft	Slab Width:	Ft	Joint Length:	Ft		
Shoulder:		Street Type:		Grade:	0	Lanes:	0		
Section Comments:									
Last Insp. Date:	5/15/2015	TotalSamples:	84	Surveyed:	8				
Conditions:	PCI: 84								
Inspection Comments:									
Sample Number:	103	Type:	R	Area:	3750.00 SqFt	PCI:	85		
Re-Inspection Report									
48	L & T CR	L	94.00 Ft	Comments:					
48	L & T CR	M	26.00 Ft	Comments:					
Sample Number:	114	Type:	R	Area:	3750.00 SqFt	PCI:	82		
Re-Inspection Report									
48	L & T CR	L	100.00 Ft	Comments:					
48	L & T CR	M	50.00 Ft	Comments:					
Sample Number:	125	Type:	R	Area:	3750.00 SqFt	PCI:	82		
Re-Inspection Report

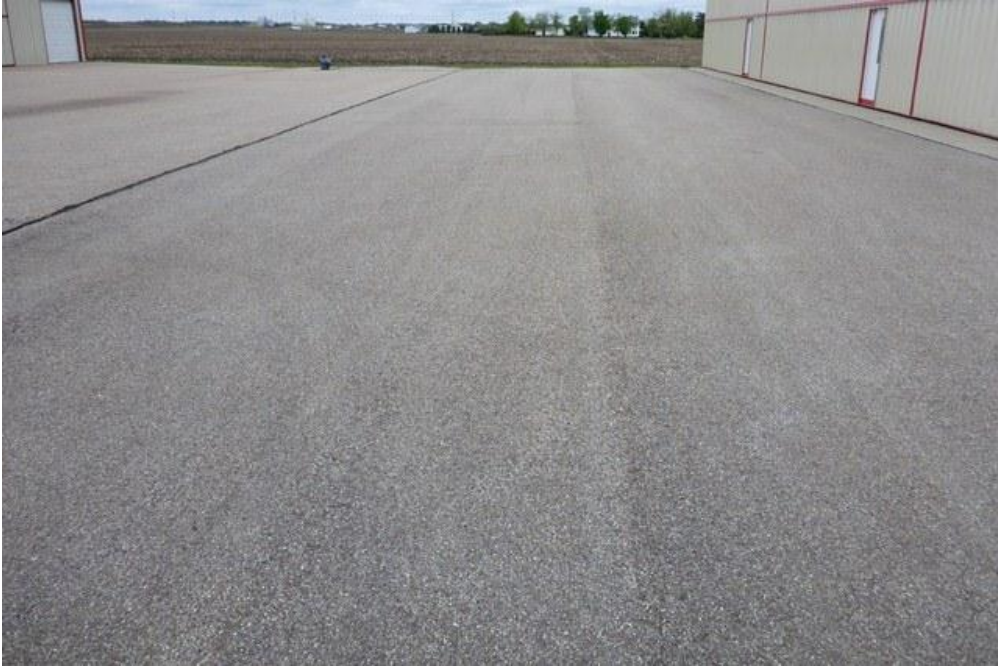
LYV TLA 004 (PCI = 92)

Network:	LYV	Name:	LUVERNE				
Branch:	TLA	Name:	Taxilane A	Use:	TAXILANE	Area:	113,294 SqFt
Section:	004	of 4	From:	-	To:	-	Last Const.: 6/1/2011
Surface:	AC	Family:	MN2013 Asphalt Taxilanes	Zone:		Category:	Rank: T
Area:	6,104 SqFt	Length:	190 Ft	Width:	32 Ft		
Slabs:		Slab Length:	Ft	Slab Width:	Ft	Joint Length:	Ft
Shoulder:		Street Type:		Grade:	0	Lanes:	0
Section Comments:							
Last Insp. Date:	5/15/2015	TotalSamples:	2	Surveyed:	1		
Conditions:	PCI: 92						
Inspection Comments:							
Sample Number:	100	Type:	R	Area:	3300.00 SqFt	PCI:	92
Re-Inspection Report							
47	JT REF. CR	L	100.00 Ft	Comments:
