Pavement Condition Report

Windom Municipal Airport (MWM)

January 2016

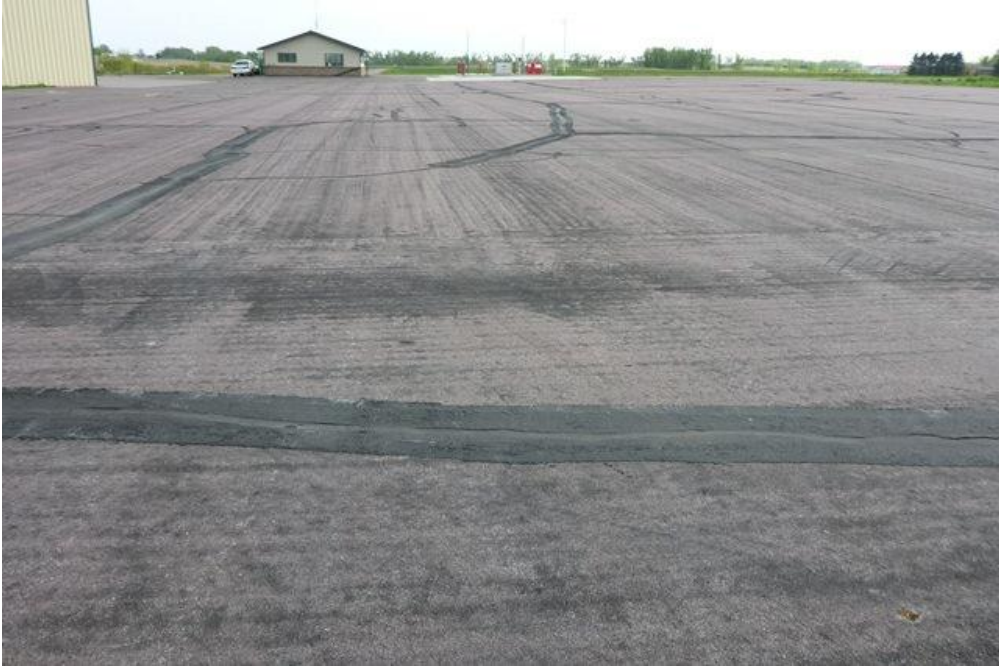
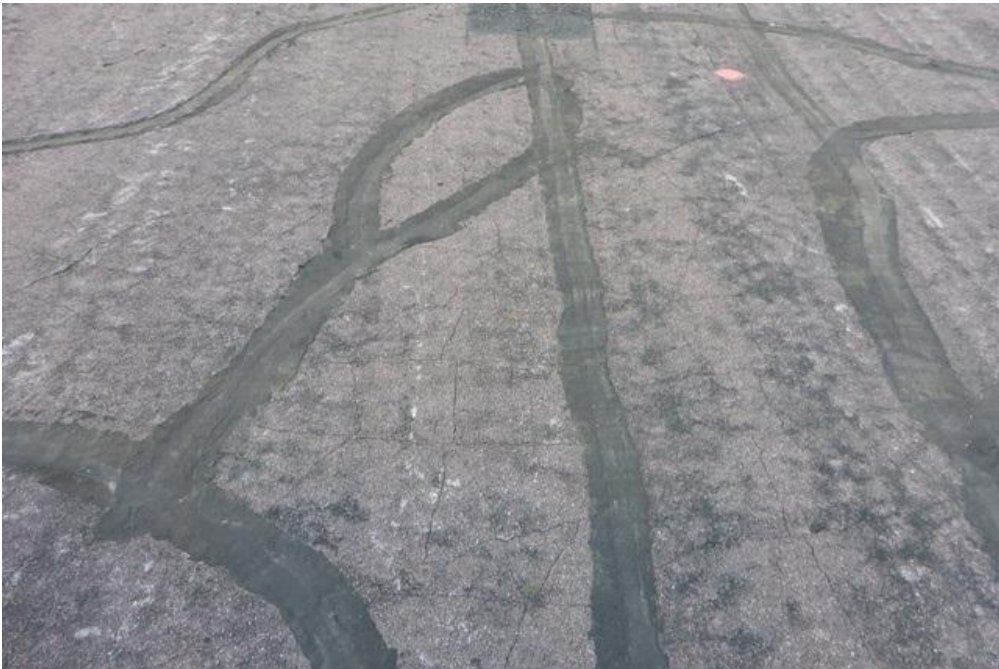
MWM APA 001 (PCI = 68)

Branch ID	Section ID	Surface type ¹	Section area (SF)	LCD ²	2012 PCI	2015 PCI	Drop in PCI/Yr ³	% Deduct due to		Distress types
								Load ⁴	Climate ⁵	
APA	001	AC	84,150	2005	80	68	3.2	68	32	Alligator Cracking, L&T
CTA	001	PCC	13,600	2009	100	100	-	0	0	No Distress
CTB	001	PCC	38,500	2009	100	100	-	0	0	No Distress
CTC	001	PCC	10,600	2009	99	99	0.2	0	0	Corner Spall
CTC	002	AC	2,400	2003	78	76	2.0	0	100	L&T Cracking
RY1735	001	PCC	280,350	2009	98	97	0.5	35	32	Corner Spall, Joint Seal Damage, Joint Spall, Linear Cracking
TLA	001	PCC	18,000	2009	99	99	0.2	0	0	L&T Cracking
TLA	002	AC	76,800	2005	87	84	1.6	0	100	Corner Spall, Joint Spall

Section Comments: maint. R&E (crack seal and fog seal)

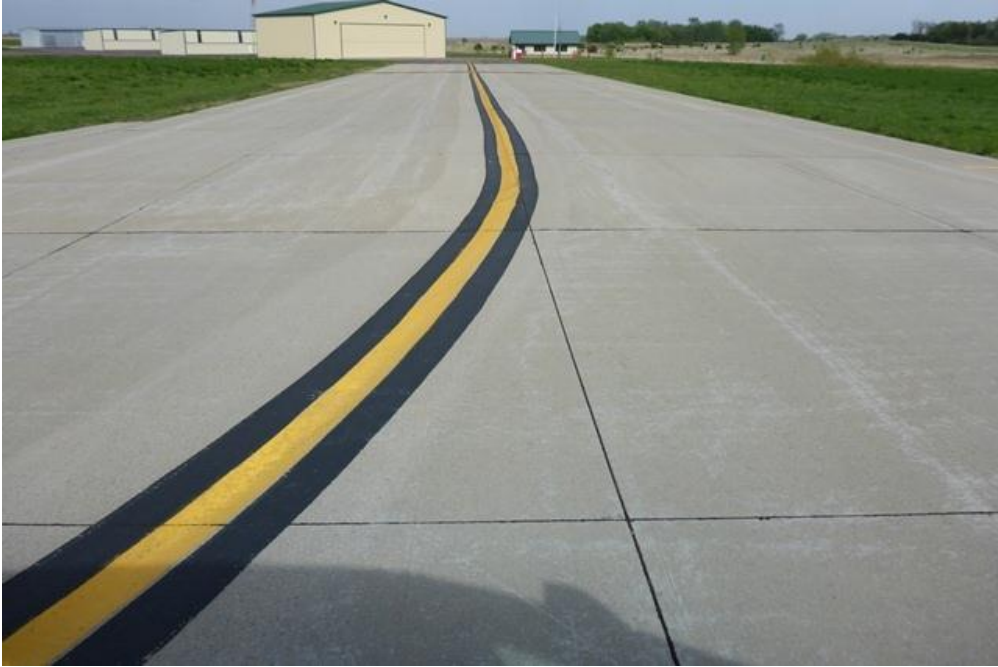
MWM CTC 001 (PCI = 99)

Network:	MWM	Name:	WINDOM						
Branch:	CTC	Name:	CONNECTING TAXIWAY C	Use:	TAXIWAY	Area:	13,000 SqFt		
Section:	001	of 2	From:	300	To:	300	Last Const.:	9/1/2009	
Surface:	PCC	Family:	MN2013 PCC	Zone:	S	Category:	2	Rank:	P
Area:	10,600 SqFt	Length:	242 Ft	Width:	40 Ft				
Slabs:	77	Slab Length:	13 Ft	Slab Width:	10 Ft	Joint Length:	1,460 Ft		
Shoulder:		Street Type:		Grade:	0	Lanes:	0		
Section Comments:									
Last Insp. Date:	5/13/2015	TotalSamples:	5	Surveyed:	2				
Conditions:	PCI: 99								
Inspection Comments:									
Sample Number:	300	Type:	R	Area:	20.00 Slabs	PCI:	98		
Re-Inspection Report									
75	CORNER SPALL	L	1.00 Slabs	Comments:					
Sample Number:	302	Type:	R	Area:	20.00 Slabs	PCI:	100		
Re-Inspection Report									
<No Distress>				Comments:

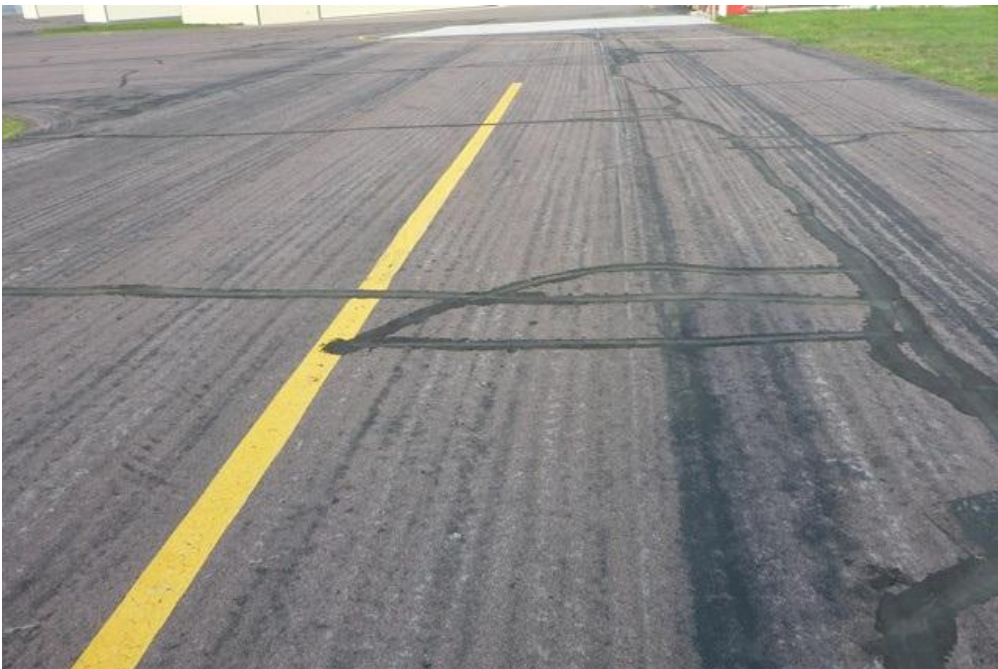
MWM CTC 002 (PCI = 76)

Network:	MWM	Name:	WINDOM						
Branch:	CTC	Name:	CONNECTING TAXIWAY C	Use:	TAXIWAY	Area:	13,000 SqFt		
Section:	002	of 2	From:	apron	To:	PCC	Last Const.: 6/1/2003		
Surface:	AC	Family:	MN2013 Asphalt Taxiways	Zone:	S	Category:	2	Rank:	P
Area:	2,400 SqFt	Length:	60 Ft	Width:	40 Ft				
Slabs:		Slab Length:	Ft	Slab Width:	Ft	Joint Length:	Ft		
Shoulder:		Street Type:		Grade:	0	Lanes:	0		
Section Comments:	maint. R&E (crack seal and fog seal)								
Last Insp. Date:	5/13/2015	TotalSamples:	1	Surveyed:	1				
Conditions:	PCI: 76								
Inspection Comments:									
Sample Number:	400	Type:	R	Area:	2400.00 SqFt	PCI:	76		
Re-Inspection Report									
48	L & T CR	L	260.00 Ft	Comments:

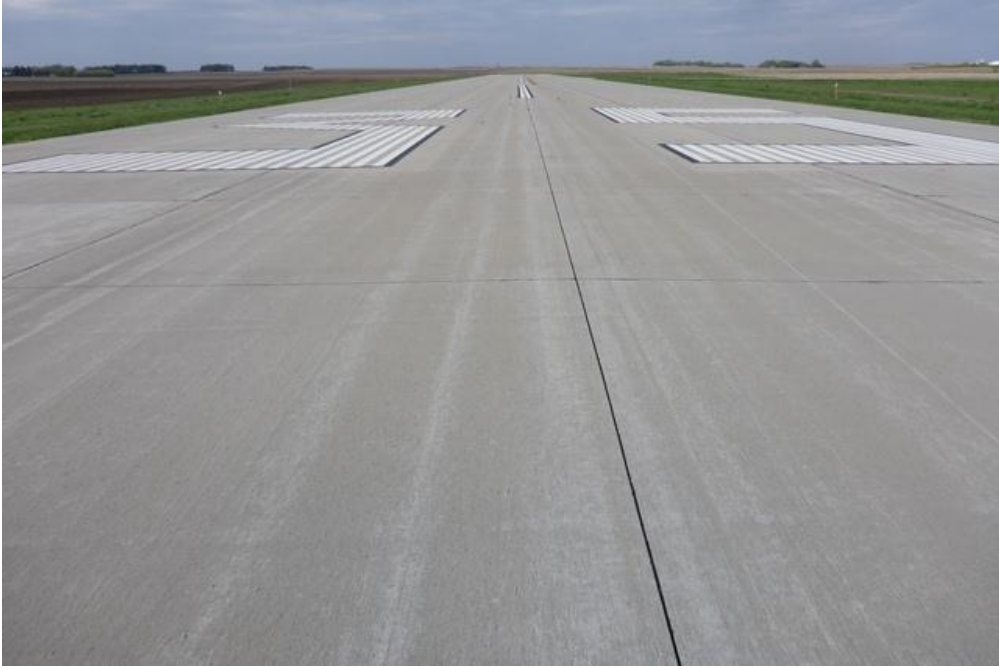
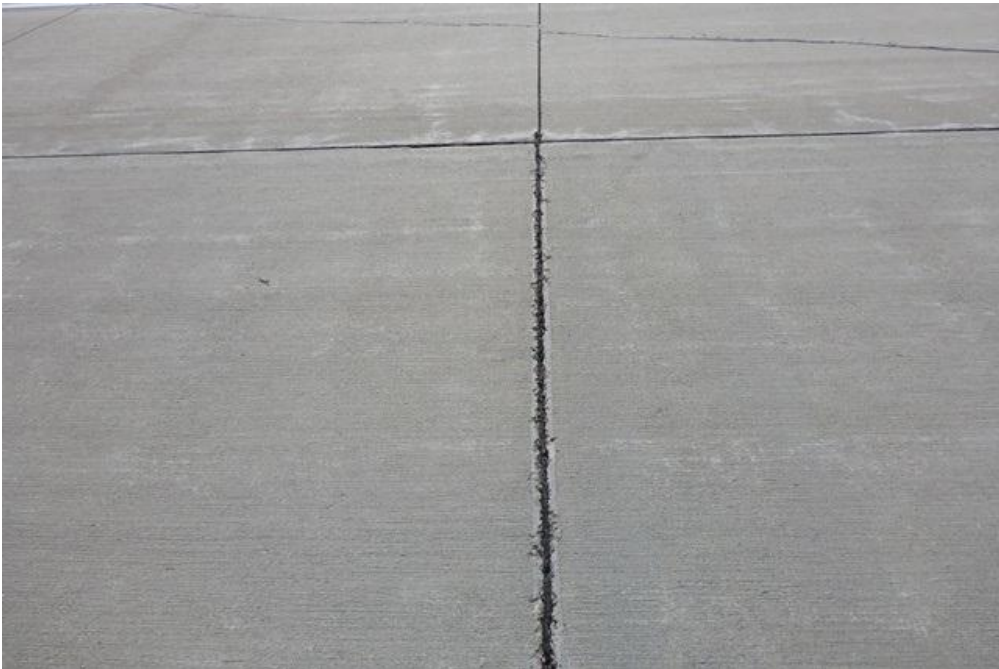
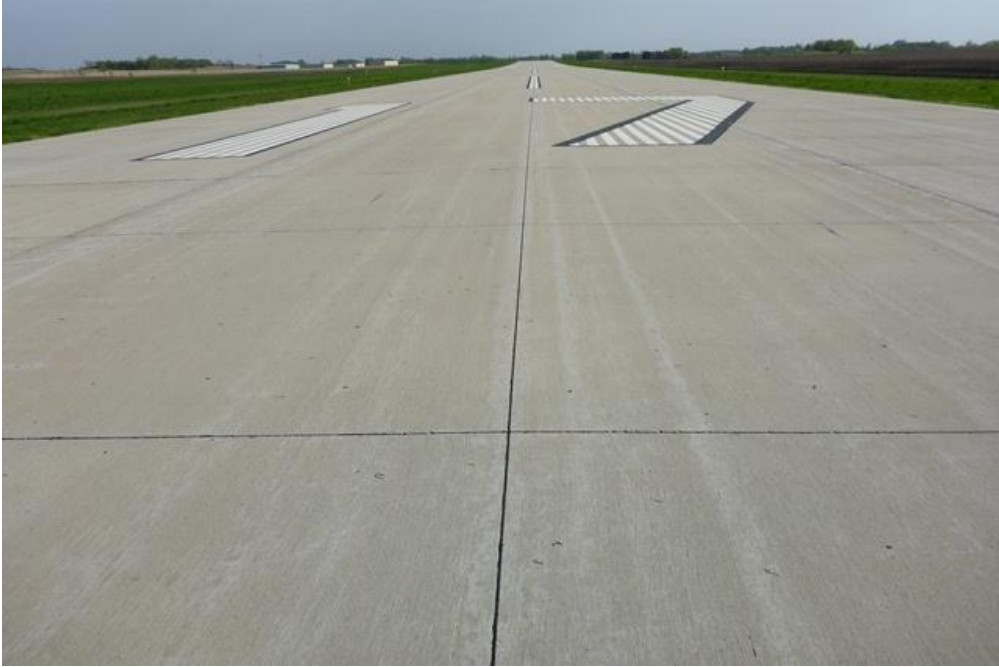
MWM RY1735 001 (PCI = 97)

Network:	MWM	Name:	WINDOM						
Branch:	RY1735	Name:	RUNWAY 17-35	Use:	RUNWAY	Area:	280,350 SqFt		
Section:	001	of 1	From:	100	To:	171	Last Const.: 9/1/2009		
Surface:	PCC	Family:	MN2013 PCC	Zone:	S	Category:	2	Rank:	P
Area:	280,350 SqFt	Length:	3,600 Ft	Width:	75 Ft				
Slabs:	1,805	Slab Length:	13 Ft	Slab Width:	13 Ft	Joint Length:	39,525 Ft		
Shoulder:		Street Type:		Grade:	0	Lanes:	0		
Section Comments:									
Last Insp. Date:	5/13/2015	TotalSamples:	75	Surveyed:	10				
Conditions:	PCI: 97								
Inspection Comments:									
Sample Number:	104	Type:	R	Area:	24.00 Slabs	PCI:	100		
Re-Inspection Report									
<No Distress>				Comments:					
Sample Number:	112	Type:	R	Area:	24.00 Slabs	PCI:	96		
Re-Inspection Report									
75	CORNER SPALL	H	1.00 Slabs	Comments:					
Sample Number:	120	Type:	R	Area:	24.00 Slabs	PCI:	100		
Re-Inspection Report									
<No Distress>				Comments:					
Sample Number:	128	Type:	R	Area:	24.00 Slabs	PCI:	87

Re-Inspection Report									
63	LINEAR CR	L	1.00 Slabs	Comments:					
75	CORNER SPALL	L	2.00 Slabs	Comments:

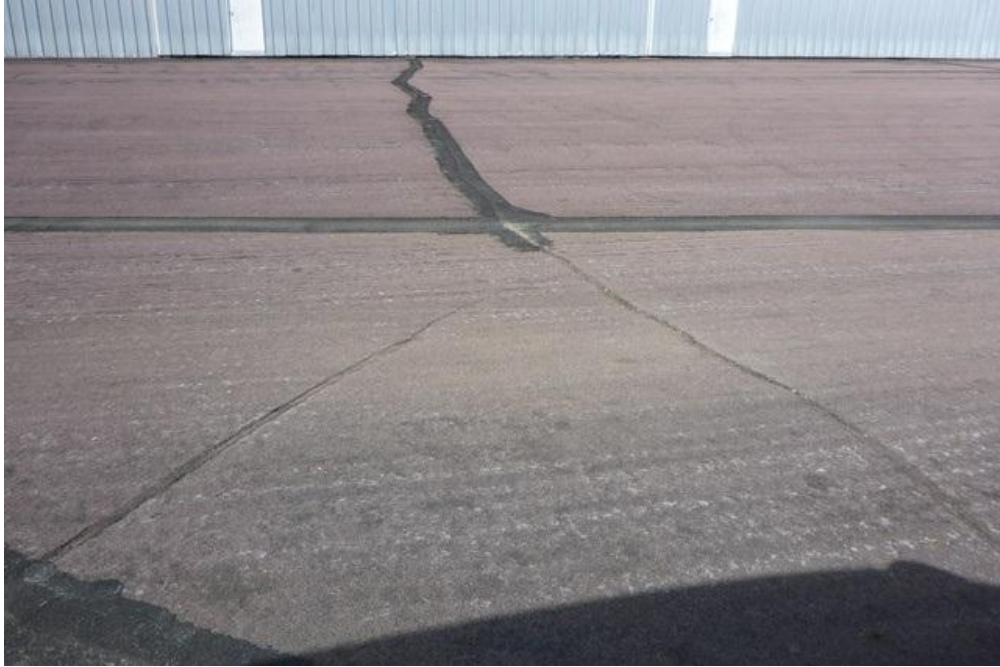
MWM TLA 002 (PCI = 84)

74 JOINT SPALL L 1.00 Slabs **Comments:**

75 CORNER SPALL L 1.00 Slabs **Comments:**

Section Comments: maint. R&E (crack seal and fog seal)
