Pavement Condition Report

Moose Lake - Carlton County Airport (MZH)

January 2016

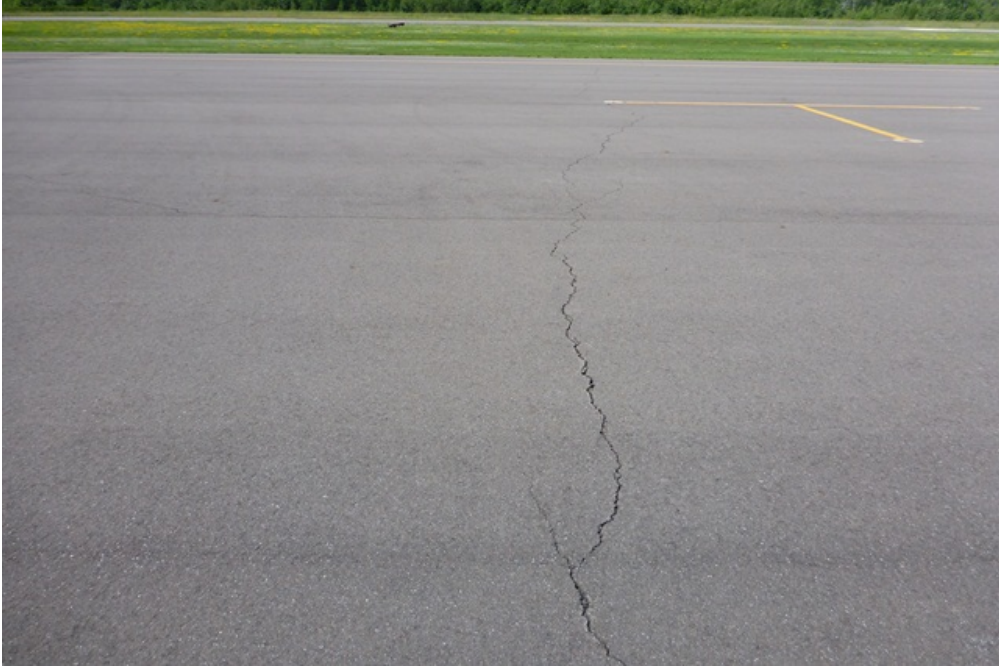
MZH APA 001 (PCI =88)

| Branch ID | Section ID | Surface type ¹ | Section area (SF) | LCD ² | 2012 PCI | 2015 PCI | Drop in PCI/Yr ³ | % Deduct due to | | Distress types |
|---|---|---|---|---|---|---|---|---|---|--|
| APA | 001 | AC | 38,250 | 2013 | 20 | 88 | 6.0 | 0 | 100 | L&T Cracking |

| BranchID | SectionID | Distress Type | Severity | Treatment | Work Qty | Work Unit | Work Cost (\$) |
|---|---|---|---|---|---|---|---|
| APA | 1 | L & T Cracking | Medium | Crack Sealing - AC | 27 | Ft | \$32 |

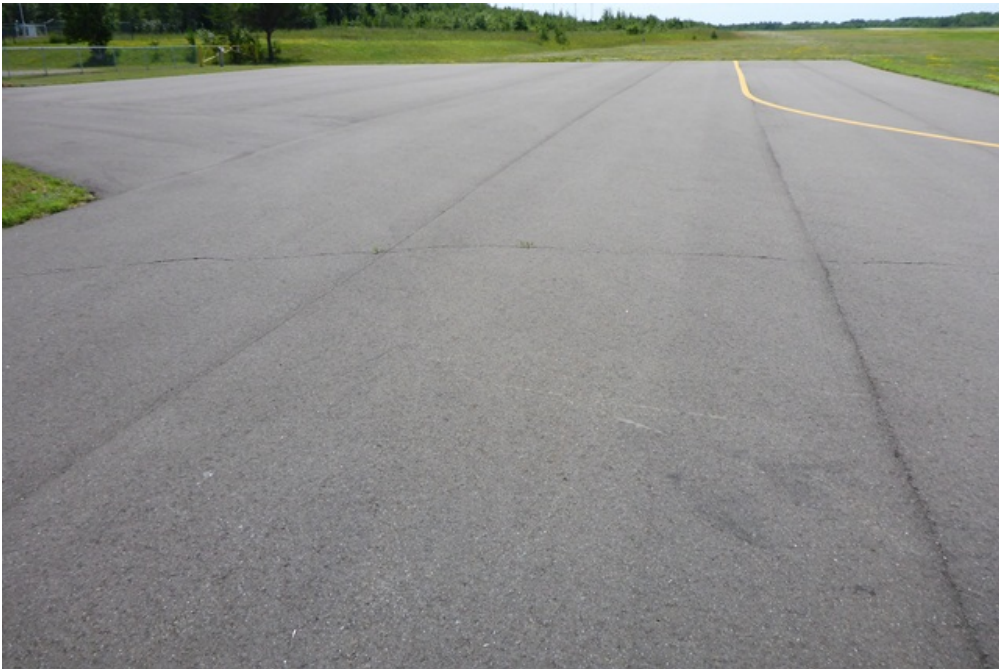
MZH APA 002 (PCI =89)

| Branch ID | Section ID | Surface type ¹ | Section area (SF) | LCD ² | 2012 PCI | 2015 PCI | Drop in PCI/Yr ³ | % Deduct due to | | Distress types |
|---|---|---|---|---|---|---|---|---|---|--|
| APA | 002 | AC | 28,100 | 2013 | 20 | 89 | 5.5 | 0 | 100 | L&T Cracking |

| BranchID | SectionID | Distress Type | Severity | Treatment | Work Qty | Work Unit | Work Cost (\$) |
|---|---|---|---|---|---|---|---|
| APA | 2 | L & T Cracking | Medium | Crack Sealing - AC | 21 | Ft | \$25 |

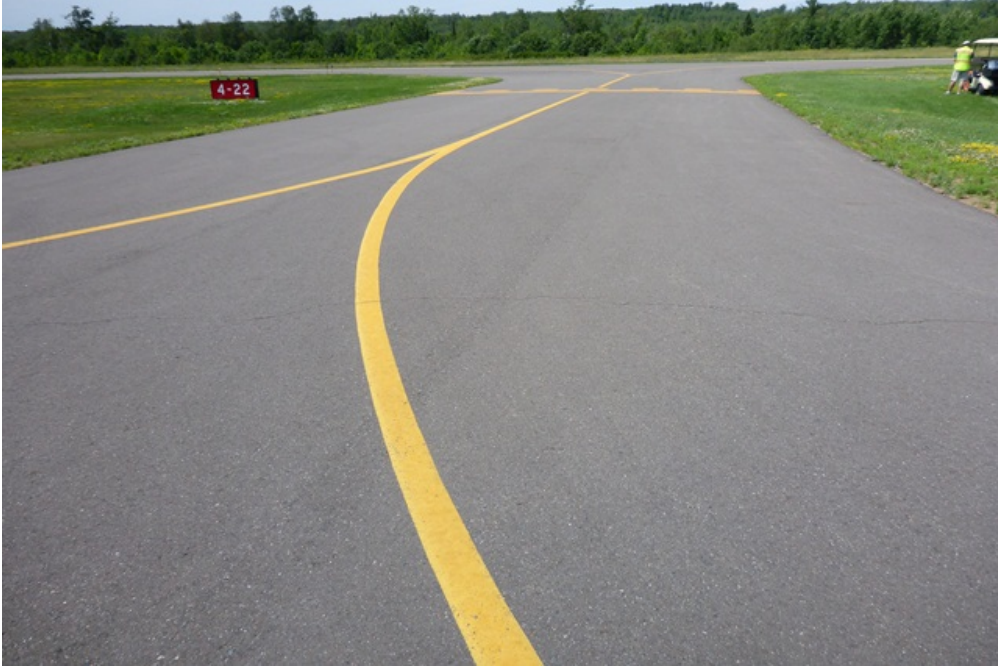
MZH CTA 001 (PCI =89)

| Branch ID | Section ID | Surface type ¹ | Section area (SF) | LCD ² | 2012 PCI | 2015 PCI | Drop in PCI/Yr ³ | % Deduct due to | | Distress types |
|---|---|---|---|---|---|---|---|---|---|--|
| CTA | 001 | AC | 8,900 | 2013 | 46 | 89 | 5.5 | 0 | 100 | L&T Cracking |

| BranchID | SectionID | Distress Type | Severity | Treatment | Work Qty | Work Unit | Work Cost (\$) |
|---|---|---|---|---|---|---|---|
| CTA | 1 | L & T Cracking | Medium | Crack Sealing - AC | 28 | Ft | \$34 |

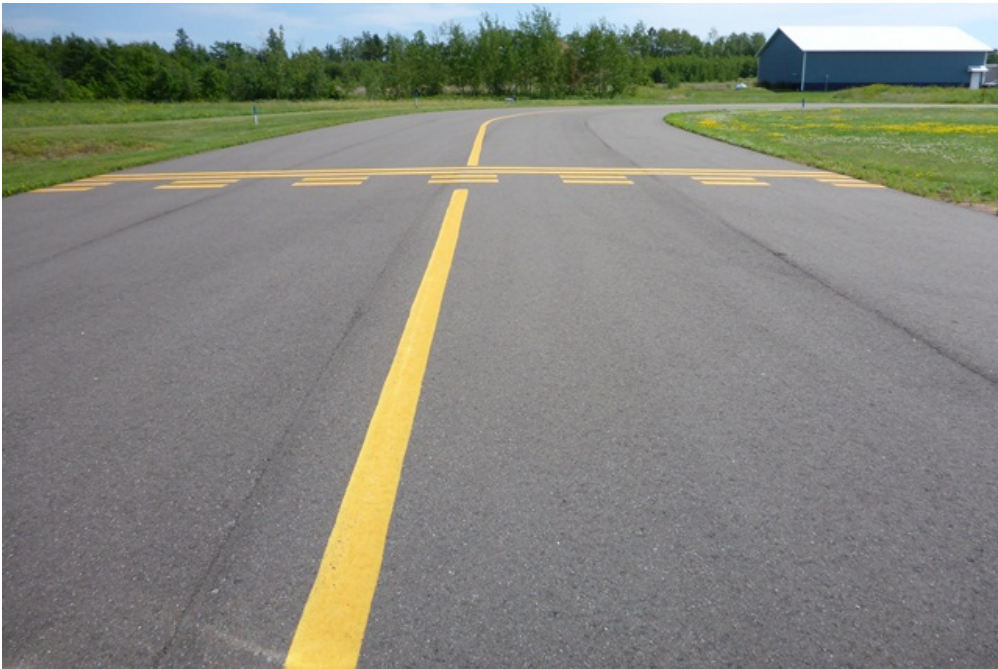
MZH CTB 001 (PCI =91)

| Branch ID | Section ID | Surface type ¹ | Section area (SF) | LCD ² | 2012 PCI | 2015 PCI | Drop in PCI/Yr ³ | % Deduct due to | | Distress types |
|---|---|---|---|---|---|---|---|---|---|--|
| CTB | 001 | AC | 18,850 | 2013 | 28 | 91 | 4.5 | 0 | 100 | L&T Cracking |

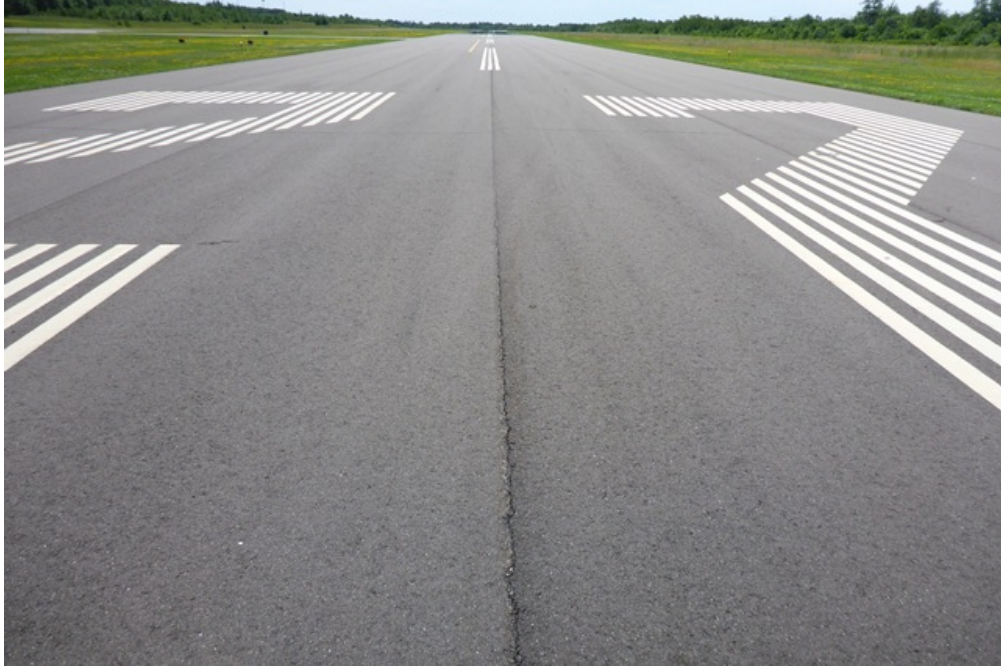
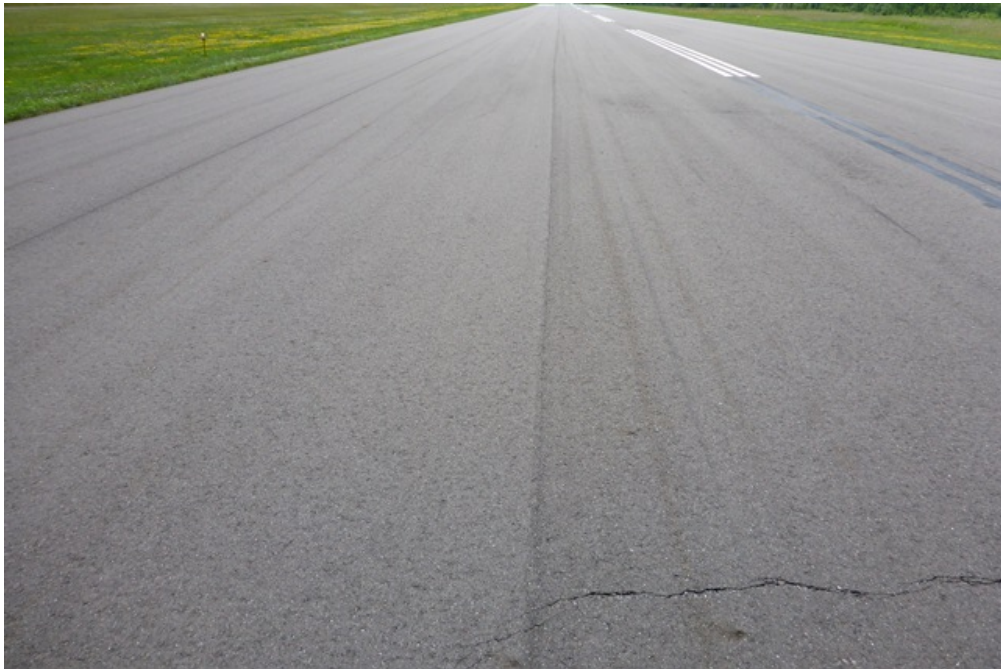
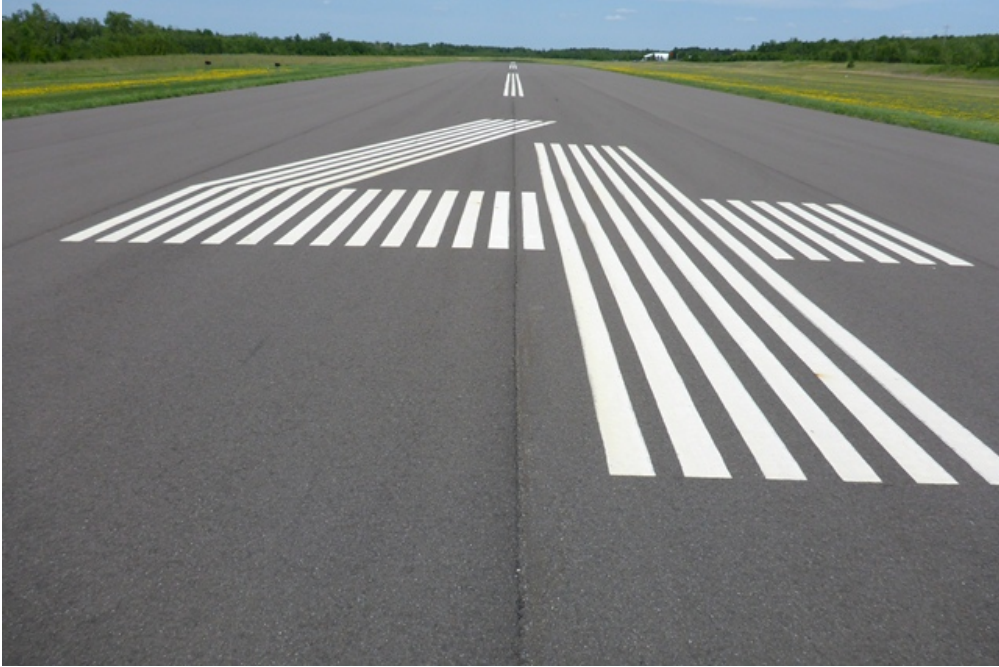
MZH RY422 001 (PCI =87)

| Branch ID | Section ID | Surface type ¹ | Section area (SF) | LCD ² | 2012 PCI | 2015 PCI | Drop in PCI/Yr ³ | % Deduct due to | | Distress types |
|---|---|---|---|---|---|---|---|---|---|--|
| RY422 | 001 | AC | 249,375 | 2013 | 48 | 87 | 6.5 | 0 | 100 | L&T Cracking |

| BranchID | SectionID | Distress Type | Severity | Treatment | Work Qty | Work Unit | Work Cost (\$) |
|---|---|---|---|---|---|---|---|
| RY422 | 1 | L & T Cracking | Medium | Crack Sealing - AC | 627 | Ft | \$752 |

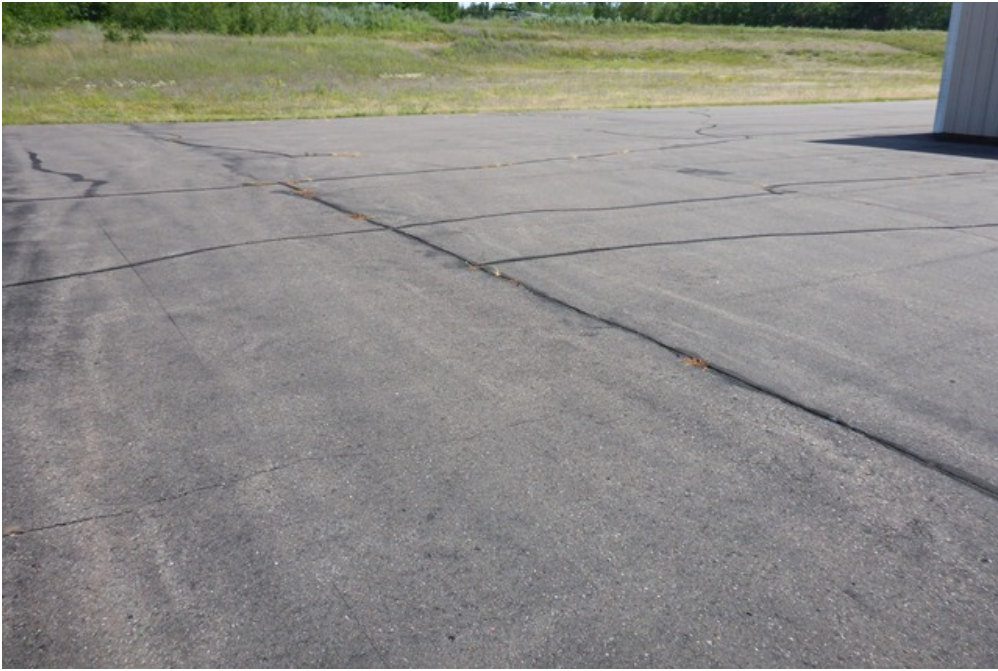
MZH TLA 002 (PCI =70)

| Branch ID | Section ID | Surface type ¹ | Section area (SF) | LCD ² | 2012 PCI | 2015 PCI | Drop in PCI/Yr ³ | % Deduct due to | | Distress types |
|---|---|---|---|---|---|---|---|---|---|--|
| TLA | 002 | AC | 20,500 | 1995 | 73 | 70 | 1.5 | 0 | 100 | L&T Cracking |
