Pavement Condition Report

Winona Municipal Airport (ONA)

January 2016

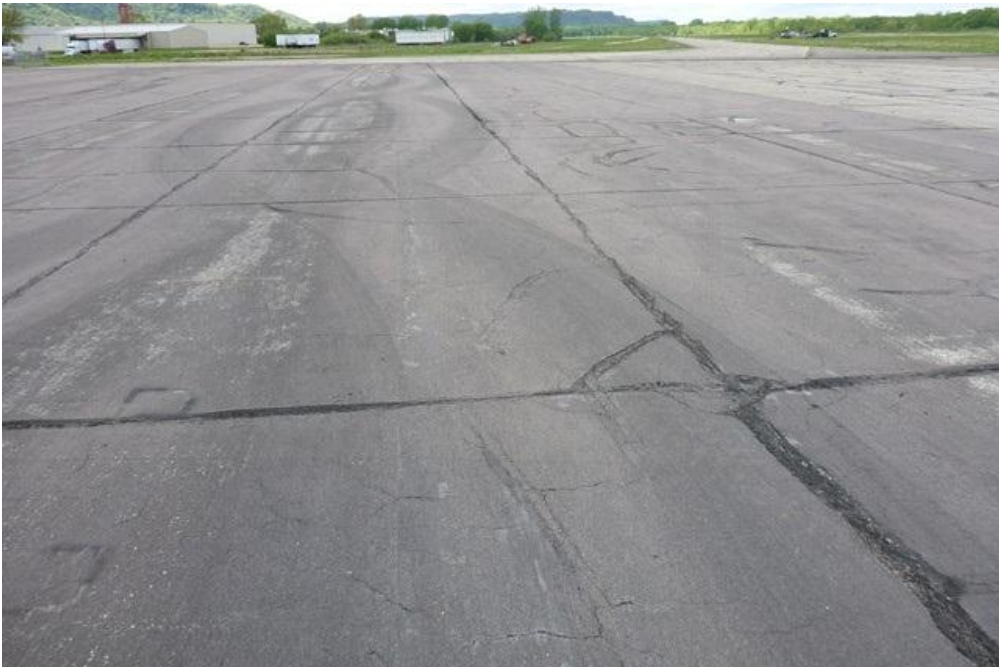
ONA APA 002 (PCI = 67)

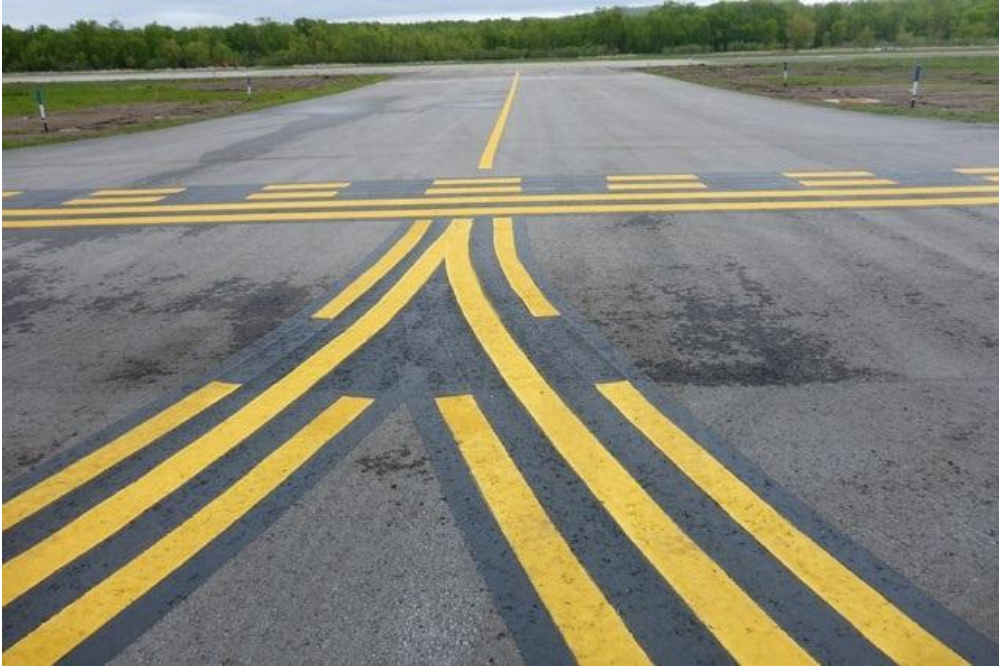
ONA CTA2 001 (PCI = 100)

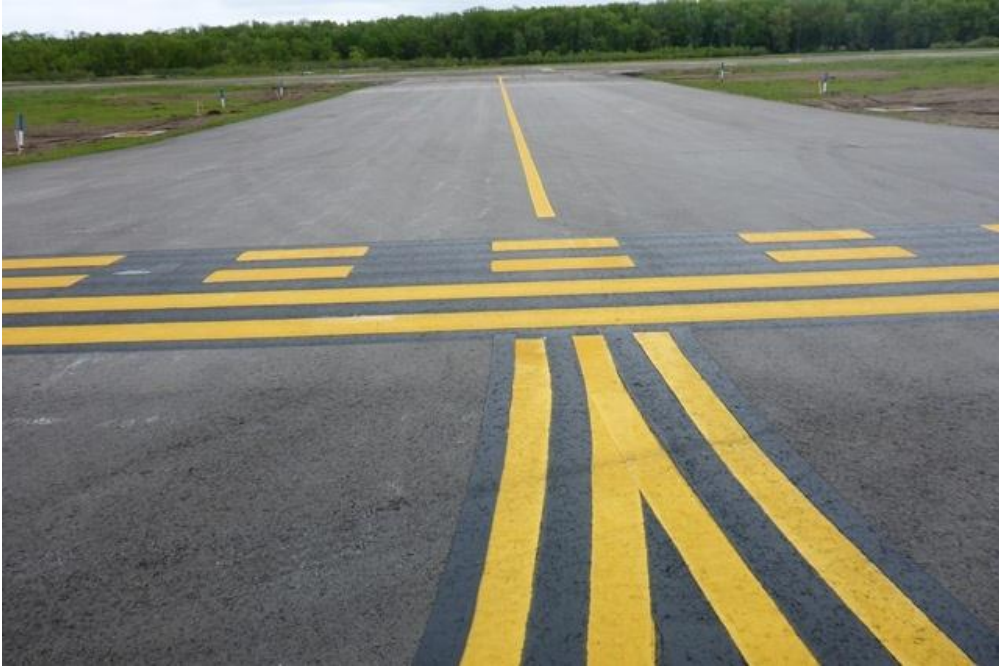
ONA CTA3 001 (PCI = 100)

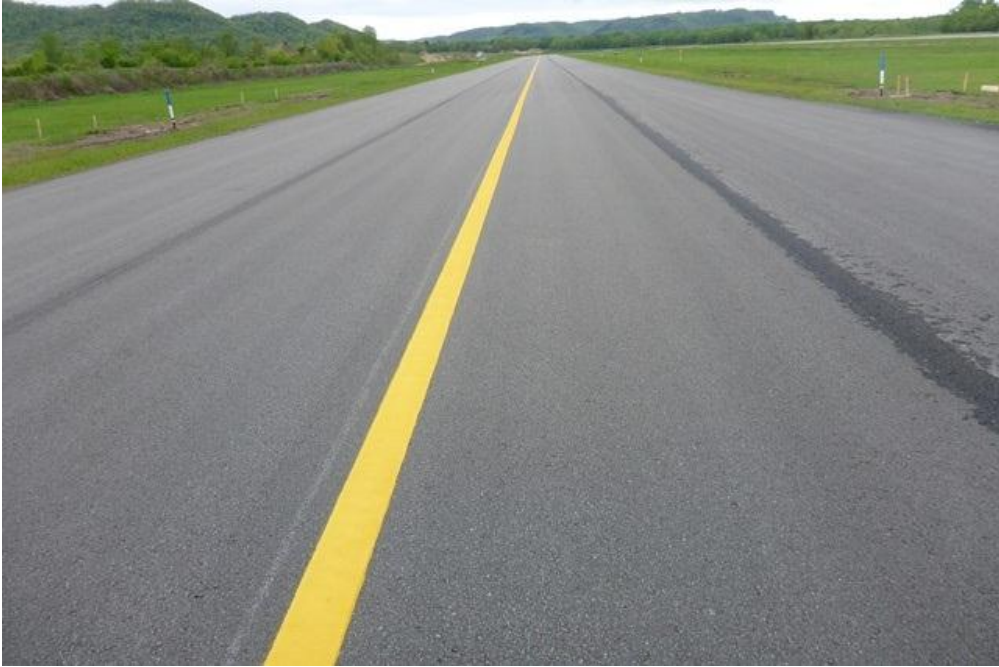
ONA PPTA 001 (PCI = 100)

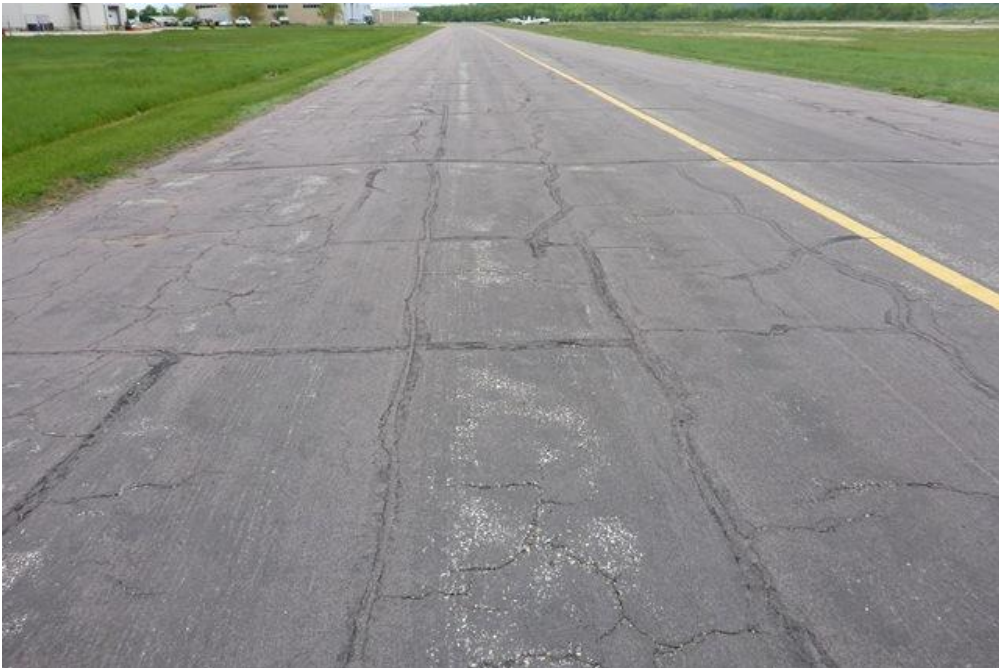
ONA PPTB 001 (PCI = 56)

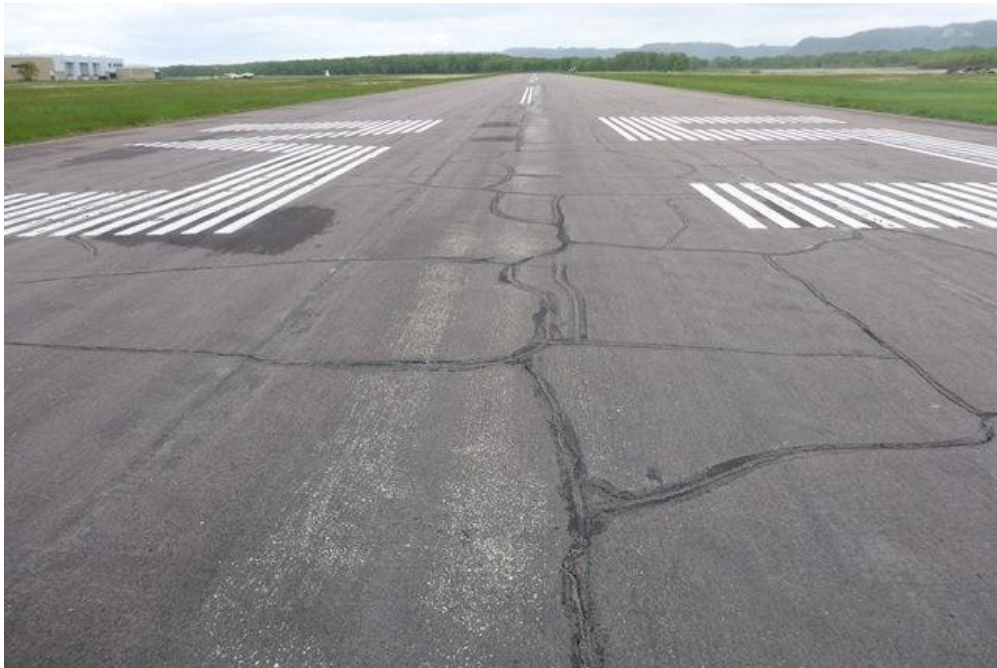
ONA RY1735 001 (PCI = 62)

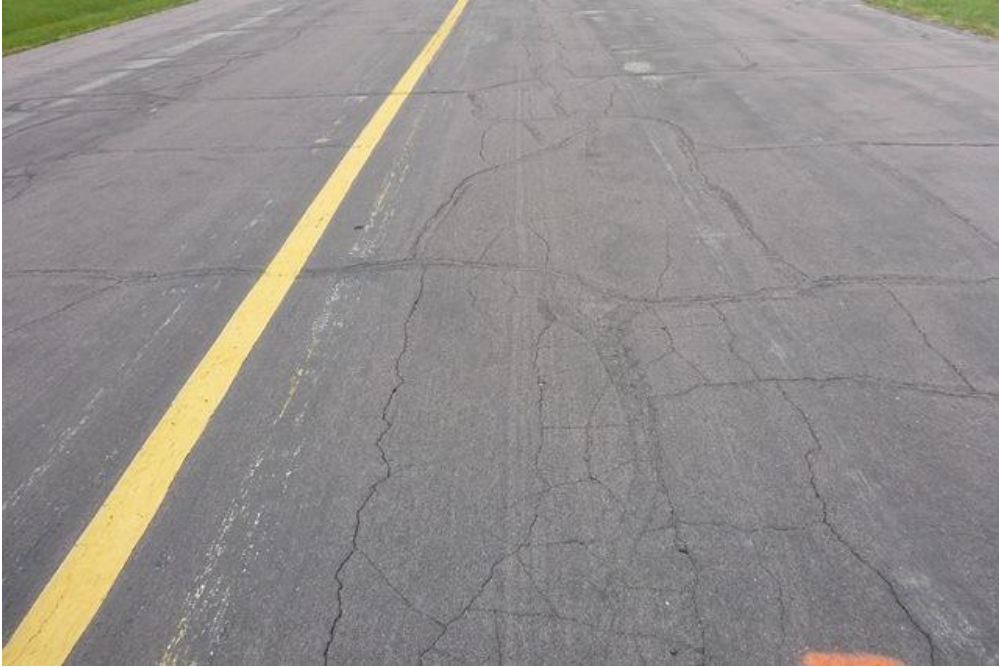
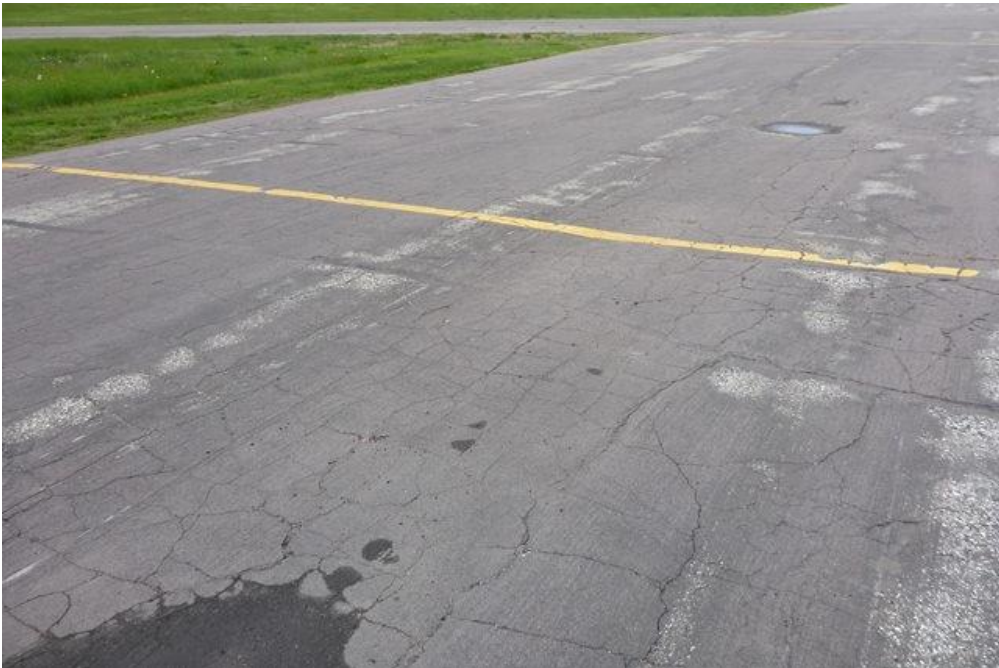
ONA TLA 001 (PCI = 22)

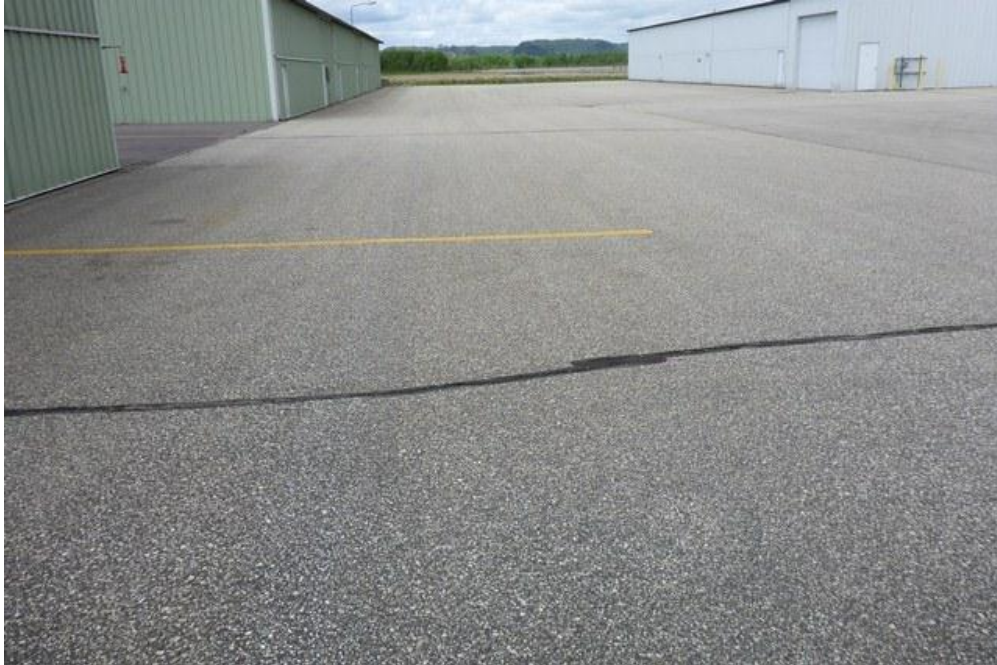
ONA TLA 002 (PCI = 85)

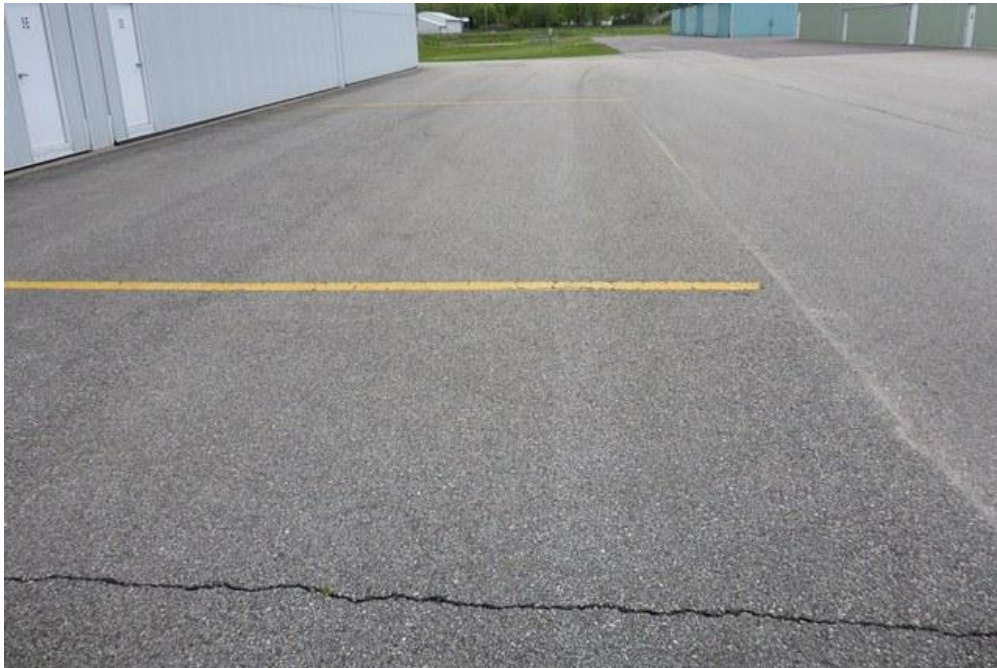
ONA TLA 003 (PCI = 82)
