# Pavement Condition Report

## Olivia Regional Airport (OVL)

**January 2016**

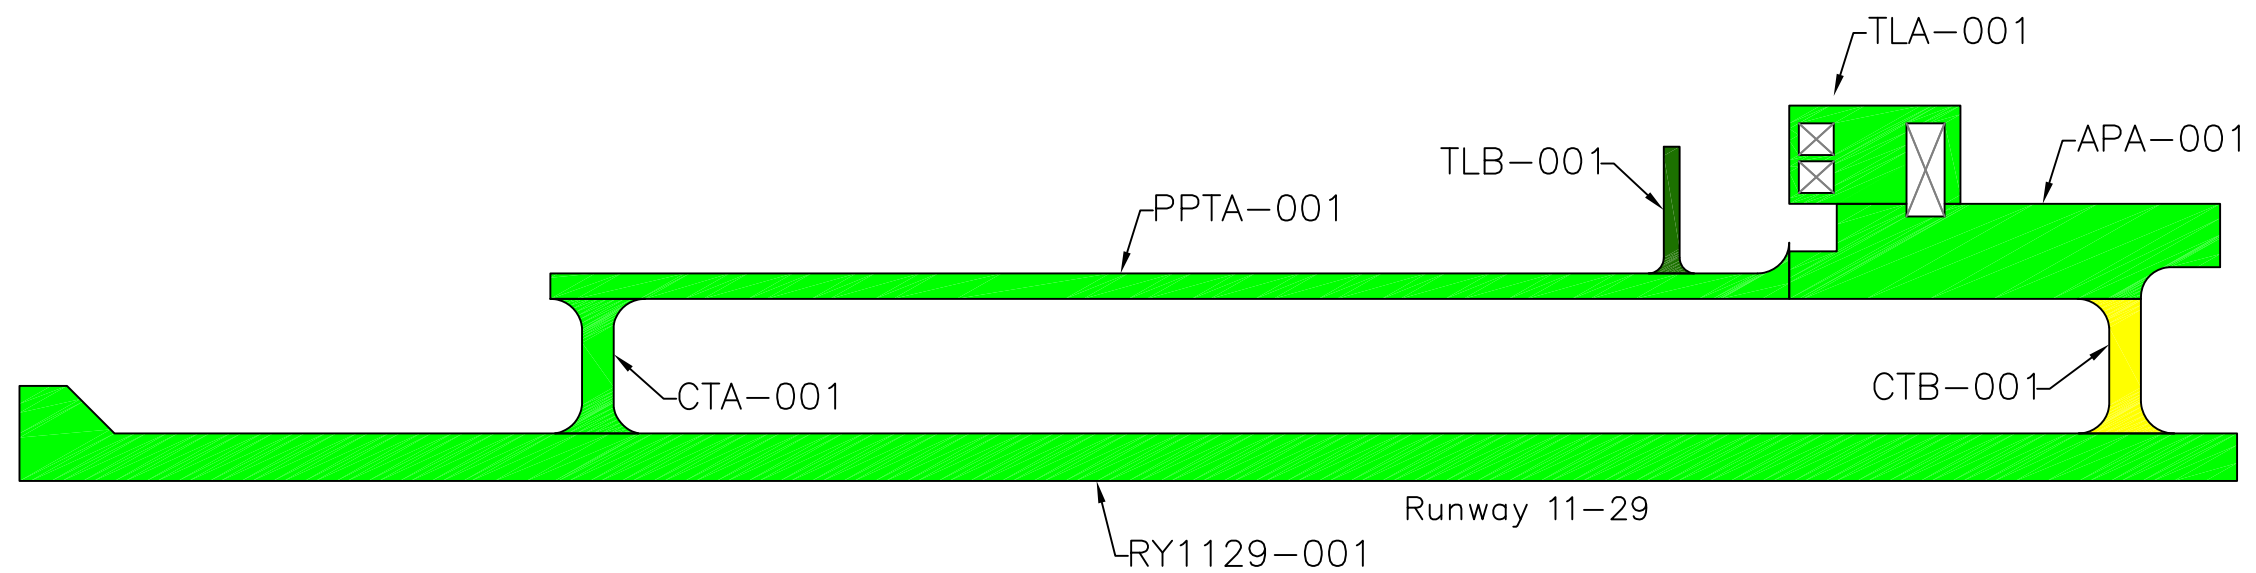
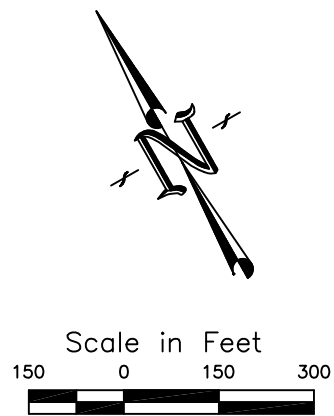
Figure 4. 2015 Pavement Condition Index Rating at Olivia Regional Airport (OVL).

Figures 5 and 6 present the overall PCI for OVL by area distribution and pavement use, respectively. Table 3 presents the PCI summary for each section at OVL, including the drop in PCI per year. Generally, pavement sections will deteriorate between 1 and 3 PCI points per year. Sections deteriorating at higher rates may need maintenance above the normal application rates and should be closely monitored in case major repairs become necessary earlier than expected.

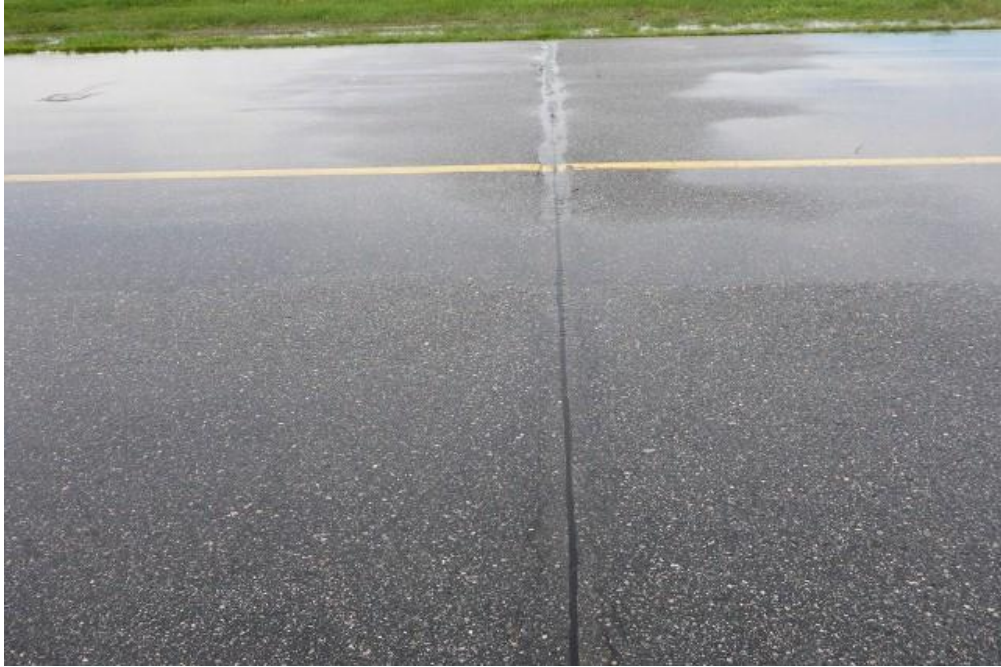
OVL APA 001 (PCI = 79)

**Conditions:** PCI: 79

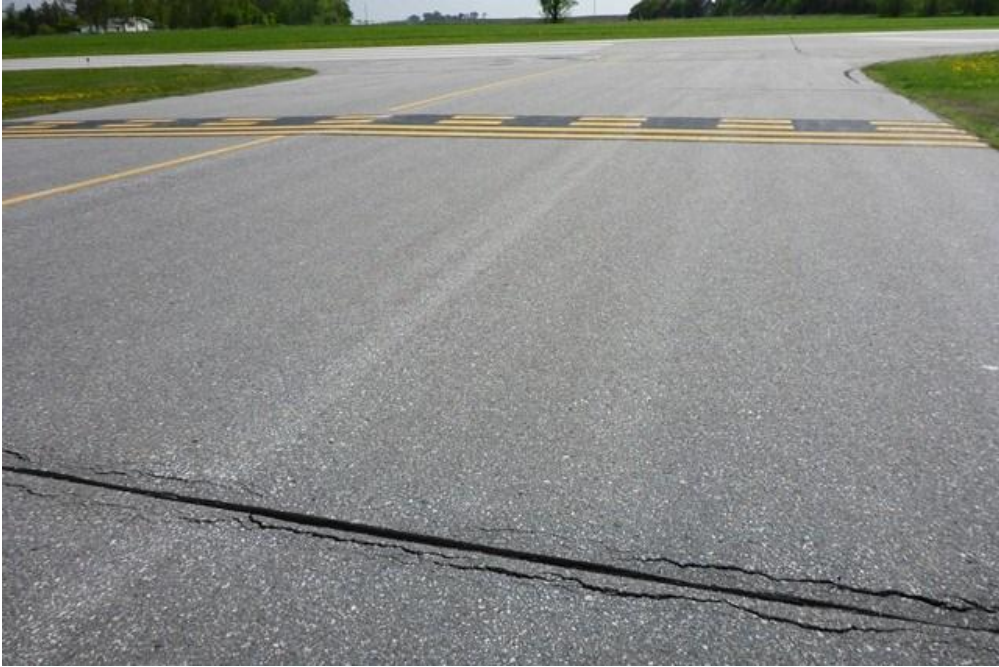
OVL CTB 001 (PCI = 65)

**Conditions:** PCI: 65
