# Pavement Condition Report

## Paynesville Municipal Airport (PEX)

January 2016

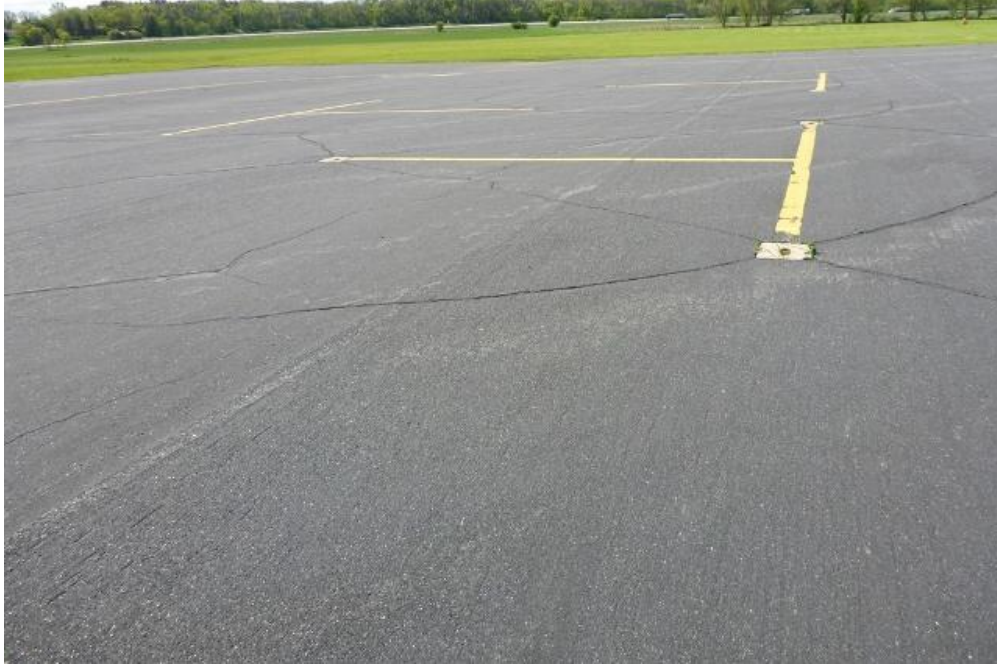
PEX APA 001 (PCI = 71)

**Conditions:** PCI: 71

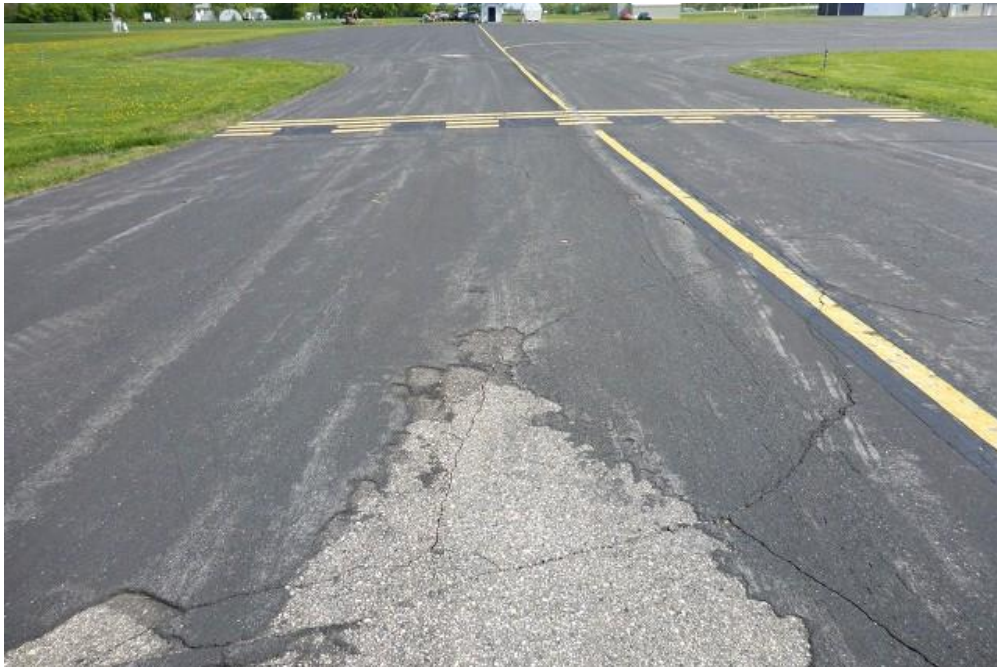
PEX CTA 001 (PCI = 60)

**Conditions:** PCI: 60

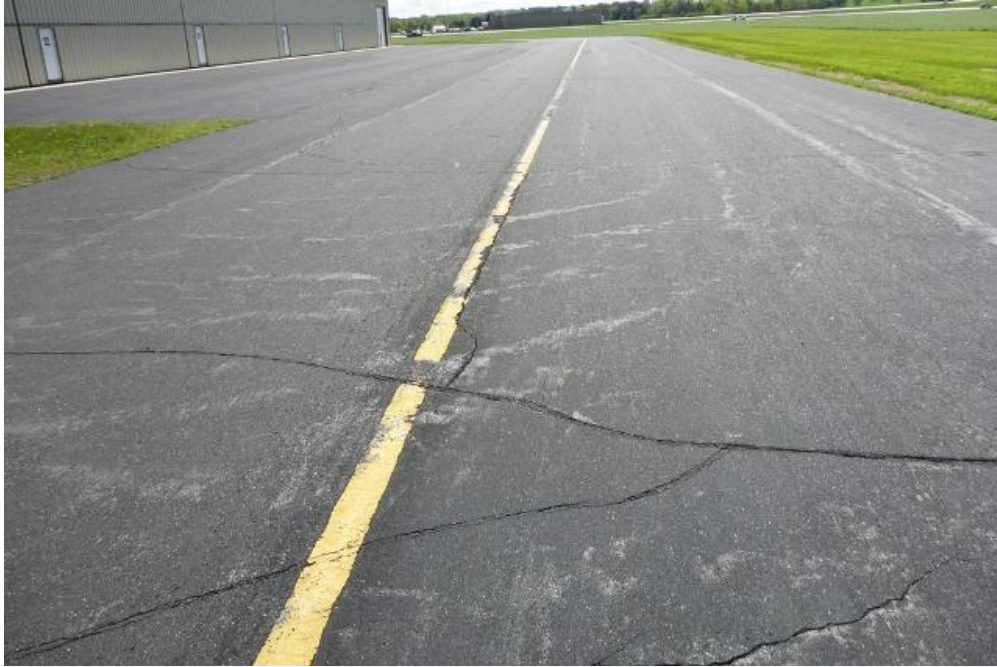
PEX TLA 001 (PCI = 72)

**Conditions:** PCI: 72

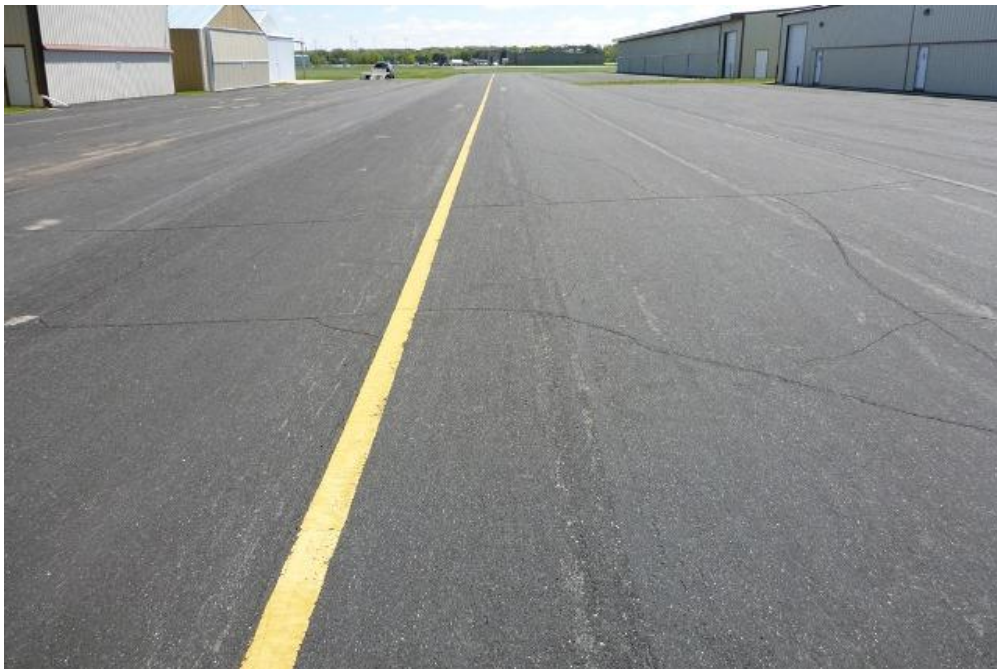
PEX TLB 001 (PCI = 62)

**Conditions:** PCI: 62
