# Pavement Condition Report

## Pipeston Municipal Airport (PQN)

Applied Research Associates, Inc.  
6314 Odana Rd  
Madison, WI 53719  
(608) 274-6409

January 2016

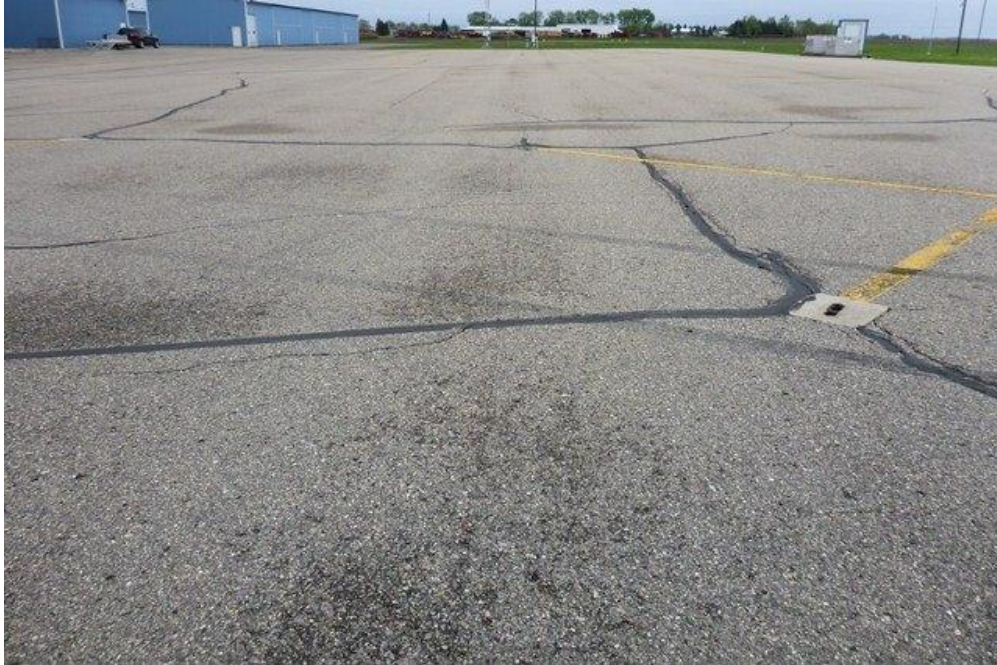
PQN APA 001 (PCI = 58)

**Conditions:** PCI: 58

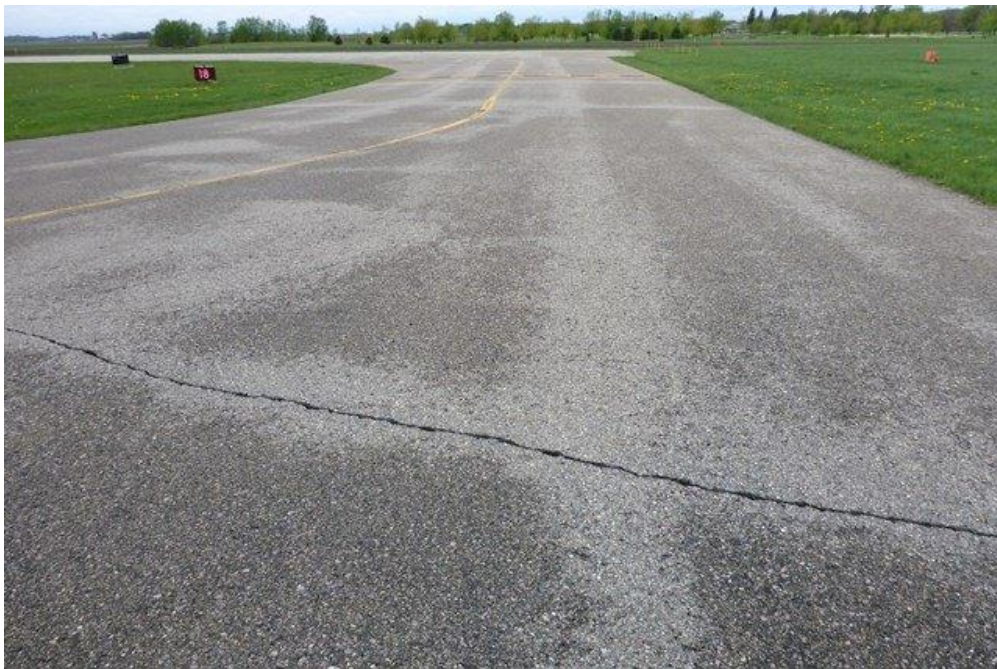
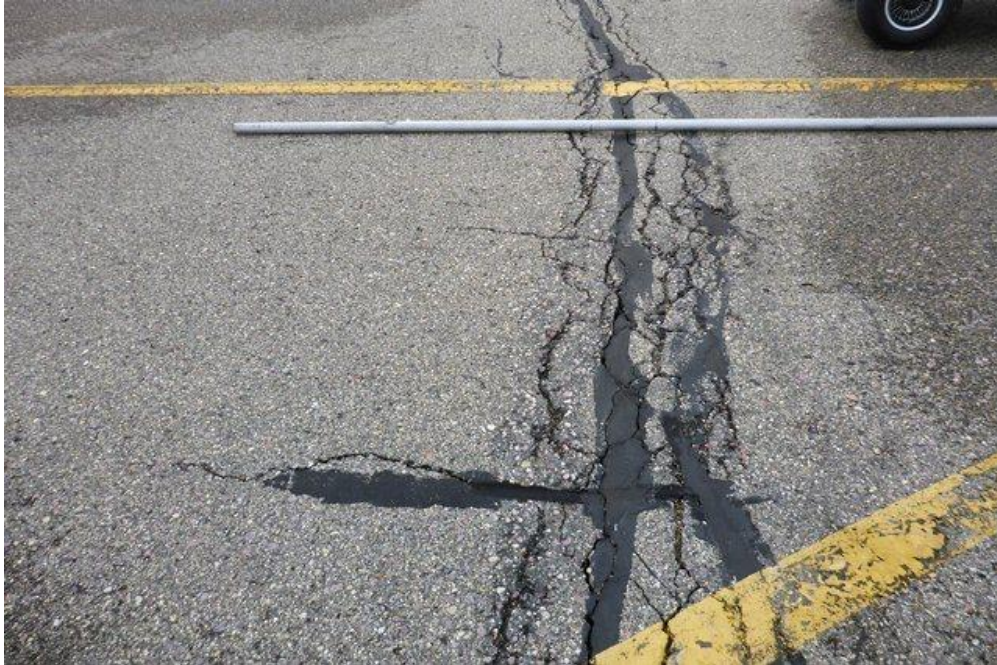
PQN CTA 001 (PCI = 76)

| Conditions: | PCI: 76 | | | | | | | | | |

| BranchID | SectionID | Distress Type | Severity | Treatment | Work Qty | Work Unit | Work Cost (\$) |
|---|---|---|---|---|---|---|---|
| CTA | 001 | L & T CR | High | Crack Sealing - AC | 18 | Ft | 22 |
| CTA | 001 | L & T CR | Medium | Crack Sealing - AC | 174 | Ft | 209 |

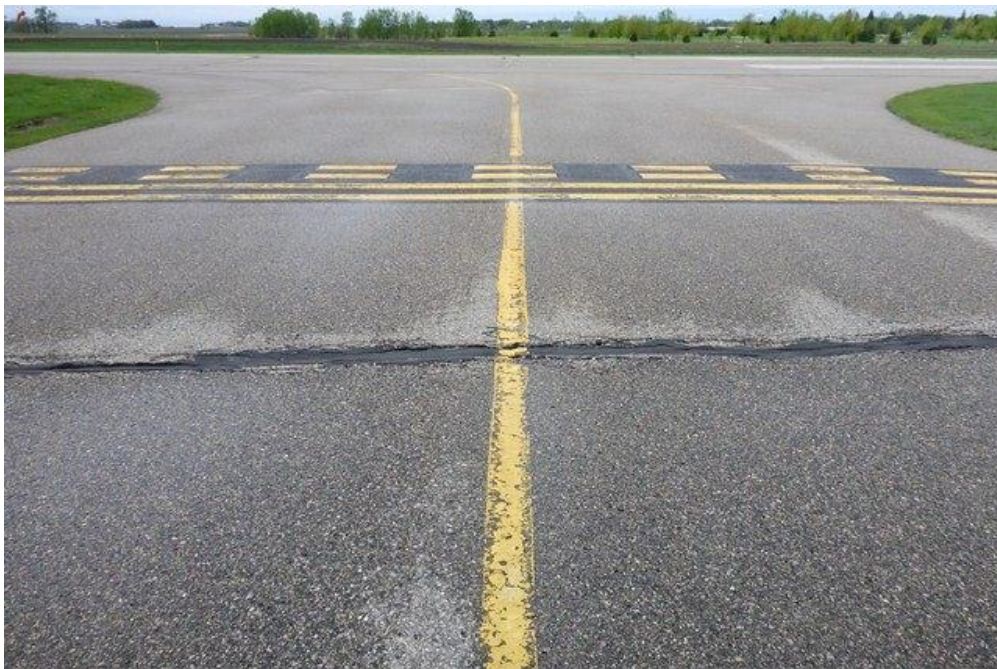
PQN CTB 001 (PCI = 75)

| Branch ID | Section ID | Surface type <sup>1</sup> | Section area (SF) | LCD <sup>2</sup> | 2012 PCI | 2015 PCI | Drop in PCI/Yr <sup>3</sup> | % Deduct due to | | Distress types |
|---|---|---|---|---|---|---|---|---|---|---|
| CTB | 001 | AC | 9,825 | 2003 | 80 | 75 | 2.1 | 0 | 100 | L&T Cracking |

| Conditions: | PCI: 75 | | | | | | | | |

| BranchID | SectionID | Distress Type | Severity | Treatment | Work Qty | Work Unit | Work Cost (\$) |
|---|---|---|---|---|---|---|---|
| CTB | 001 | L & T CR | Medium | Crack Sealing - AC | 46 | Ft | 55 |
| CTB | 001 | L & T CR | High | Crack Sealing - AC | 98 | Ft | 118 |

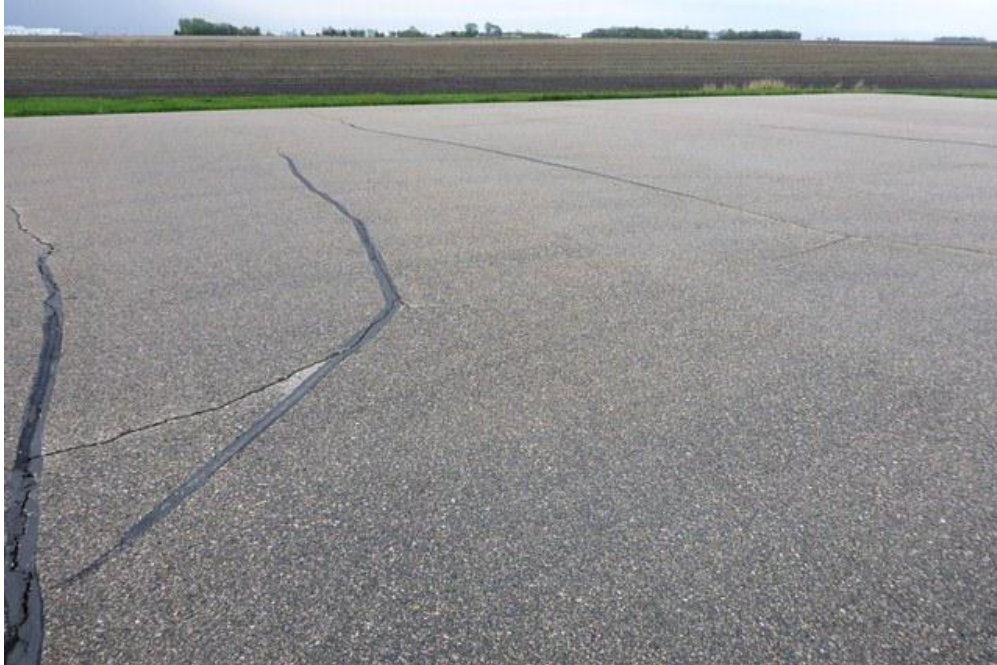
PQN RTA 001 (PCI = 70)

| Branch ID | Section ID | Surface type <sup>1</sup> | Section area (SF) | LCD <sup>2</sup> | 2012 PCI | 2015 PCI | Drop in PCI/Yr <sup>3</sup> | % Deduct due to | | Distress types |
|---|---|---|---|---|---|---|---|---|---|---|
| RTA | 001 | AC | 10,950 | 2003 | 82 | 70 | 2.5 | 0 | 100 | L&T Cracking, Ravelling |

| Conditions: | PCI: 70 | | | | | | | | |

| BranchID | SectionID | Distress Type | Severity | Treatment | Work Qty | Work Unit | Work Cost (\$) |
|---|---|---|---|---|---|---|---|
| RTA | 001 | L & T CR | Medium | Crack Sealing - AC | 355 | Ft | 426 |

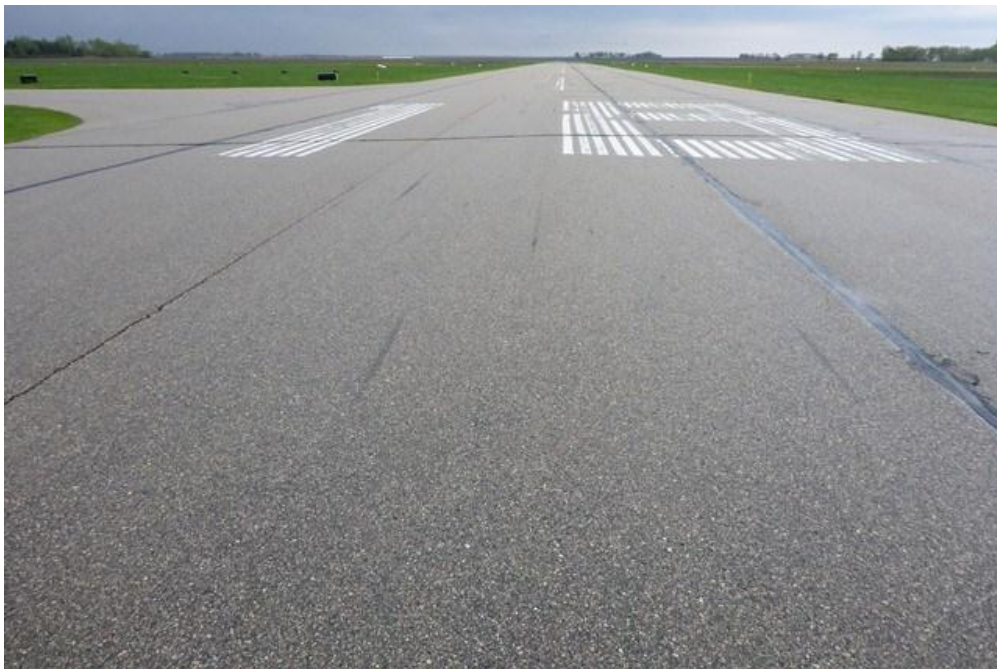
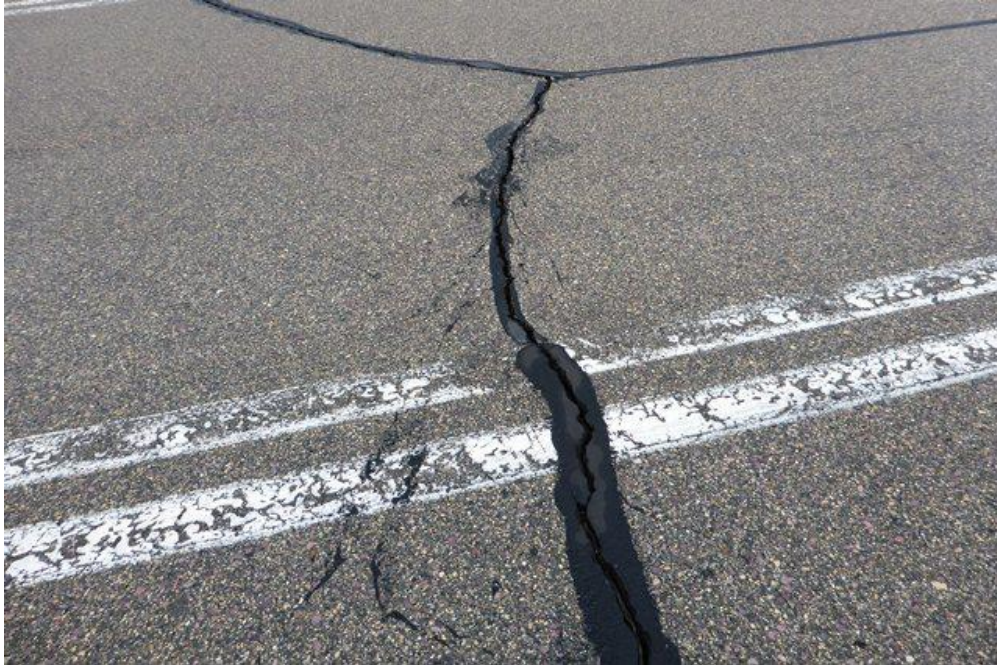
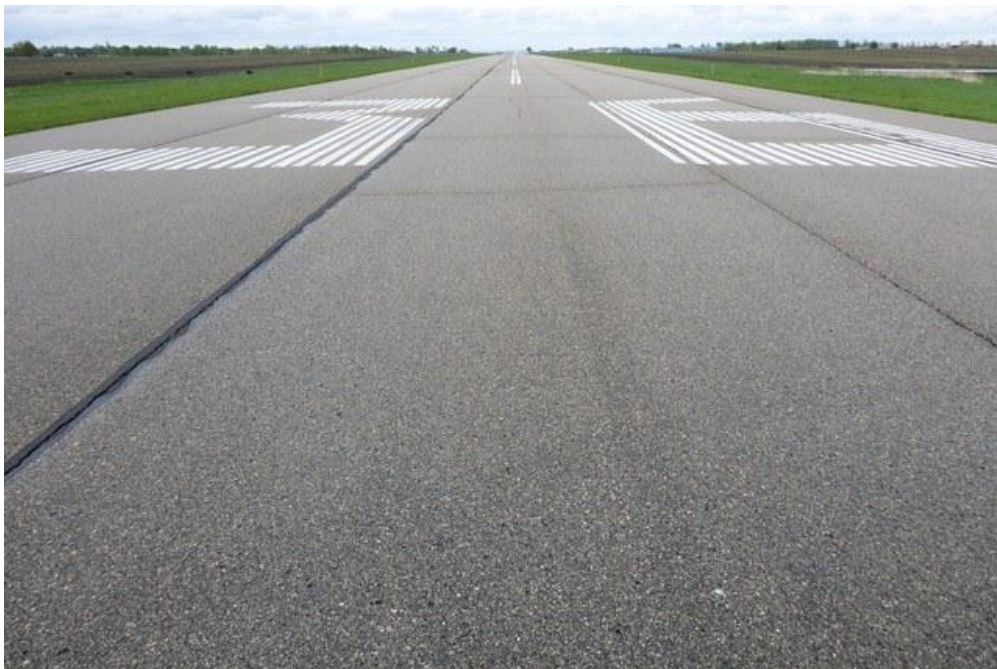
PQN RY1836 001 (PCI = 76)

| Branch ID | Section ID | Surface type <sup>1</sup> | Section area (SF) | LCD <sup>2</sup> | 2012 PCI | 2015 PCI | Drop in PCI/Yr <sup>3</sup> | % Deduct due to | | Distress types |
|---|---|---|---|---|---|---|---|---|---|---|
| RY1836 | 001 | AC | 322,650 | 2003 | 80 | 76 | 2.0 | 0 | 100 | L&T Cracking, Weathering |

| Conditions: | | PCI: | | 76 | | | | | | | | | | |

| BranchID | SectionID | Distress Type | Severity | Treatment | Work Qty | Work Unit | Work Cost (\$) |
|---|---|---|---|---|---|---|---|
| RY1836 | 001 | L & T CR | High | Crack Sealing - AC | 899 | Ft | 1,078 |
| RY1836 | 001 | L & T CR | Medium | Crack Sealing - AC | 7,074 | Ft | 8,489 |

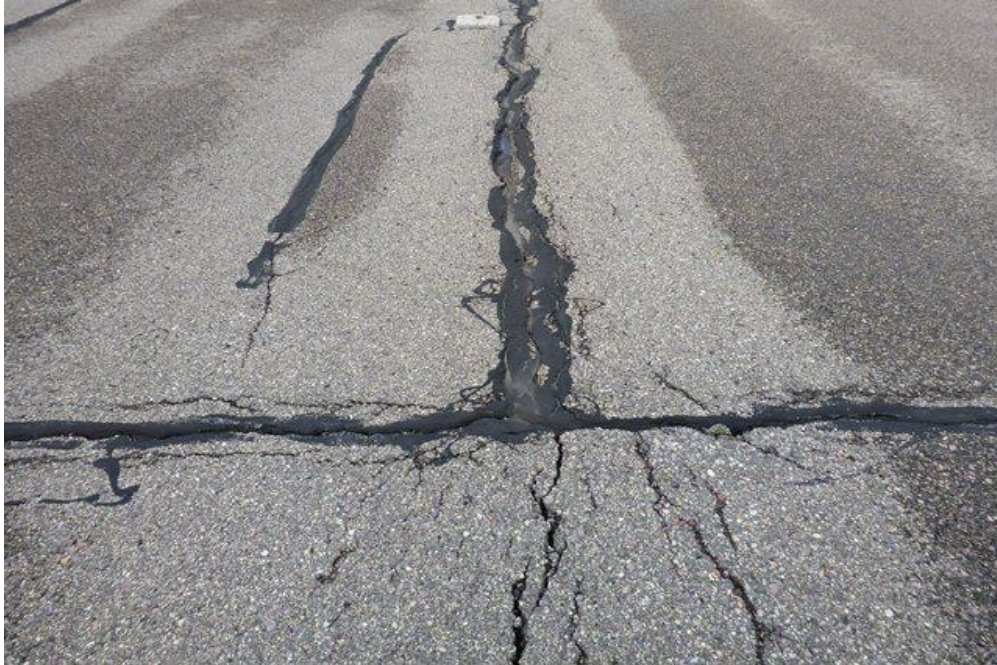
PQN TLA 001 (PCI = 45)

| Conditions: | | PCI: | | 45 | | | | | | | | | | | |

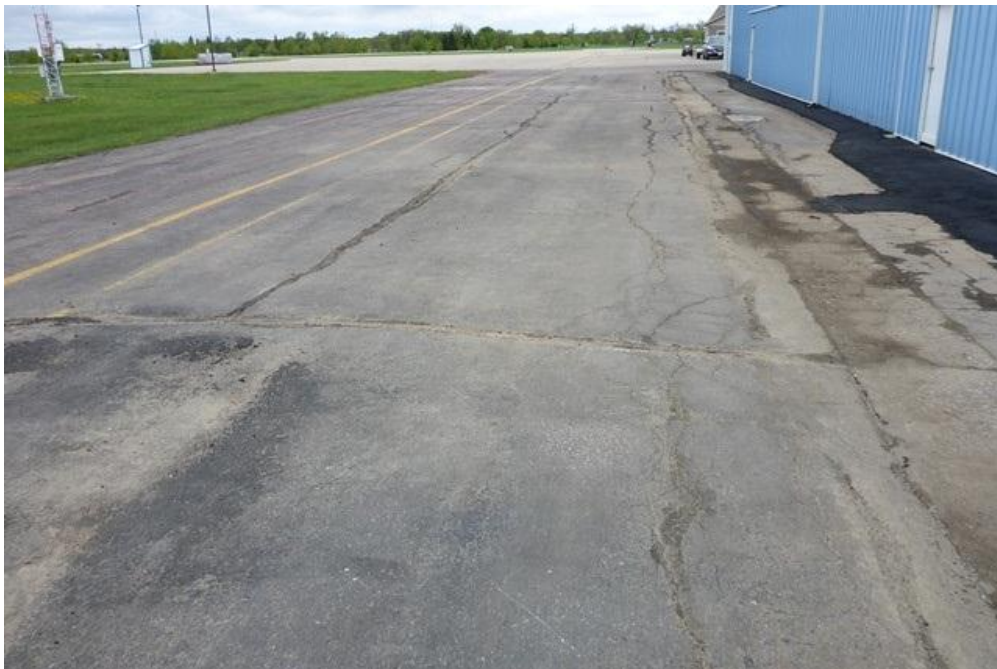
PQN TLB 001 (PCI = 28)

| Conditions: | | PCI: | | 28 | | | | | | | | | | | | | | | | | |

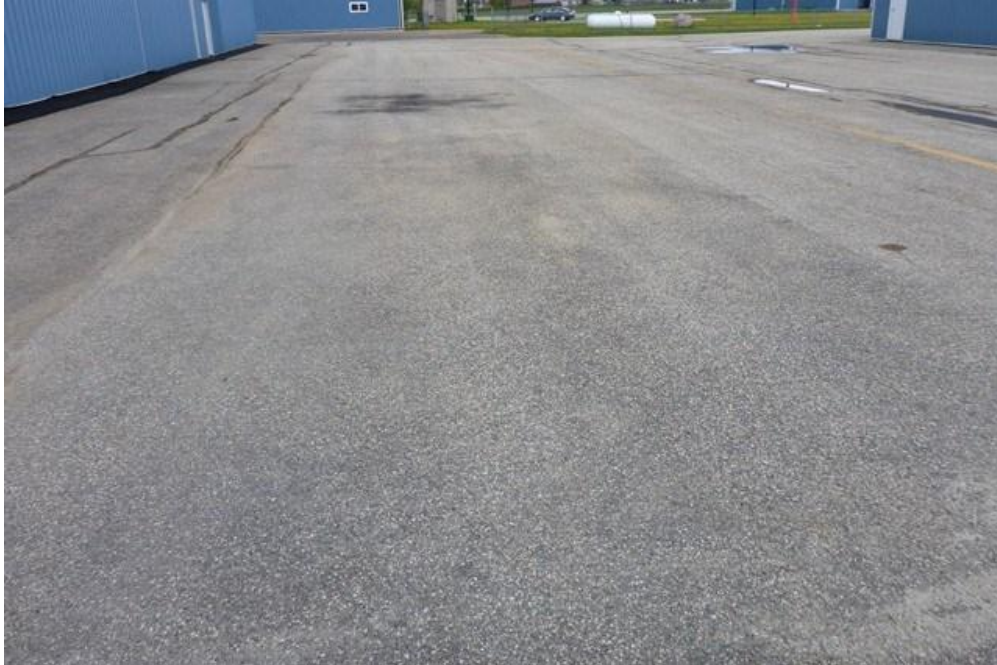
PQN TLB 002 (PCI = 58)

| Conditions: | PCI: | 58 | | | | | | | | | |
