# Pavement Condition Report

## Warroad International Memorial Airport (RRT)

January 2016

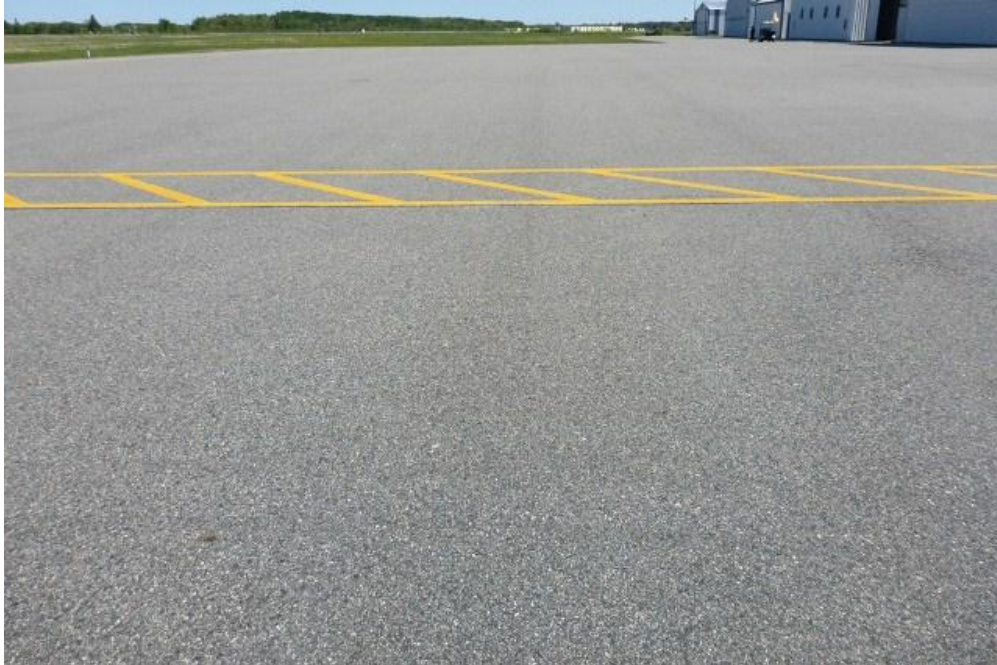
RRT APA 001 (PCI = 93)

| Branch ID | Section ID | Surface type <sup>1</sup> | Section area (SF) | LCD <sup>2</sup> | 2012 PCI | 2015 PCI | Drop in PCI/Yr <sup>3</sup> | % Deduct due to | | Distress types |
|---|---|---|---|---|---|---|---|---|---|---|
| APA | 001 | AAC | 50,000 | 2012 | 100 | 93 | 2.3 | 0 | 100 | L&T Cracking |

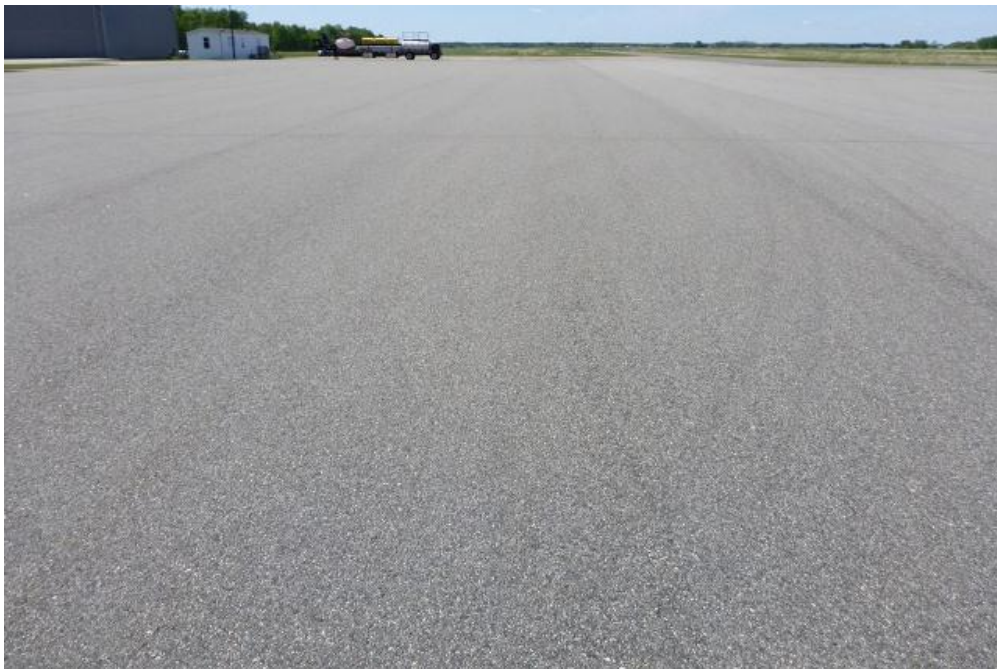
RRT APA 002 (PCI = 92)

| Branch ID | Section ID | Surface type <sup>1</sup> | Section area (SF) | LCD <sup>2</sup> | 2012 PCI | 2015 PCI | Drop in PCI/Yr <sup>3</sup> | % Deduct due to | | Distress types |
|---|---|---|---|---|---|---|---|---|---|---|
| APA | 002 | AAC | 73,750 | 2012 | 100 | 92 | 2.7 | 0 | 100 | L&T Cracking |

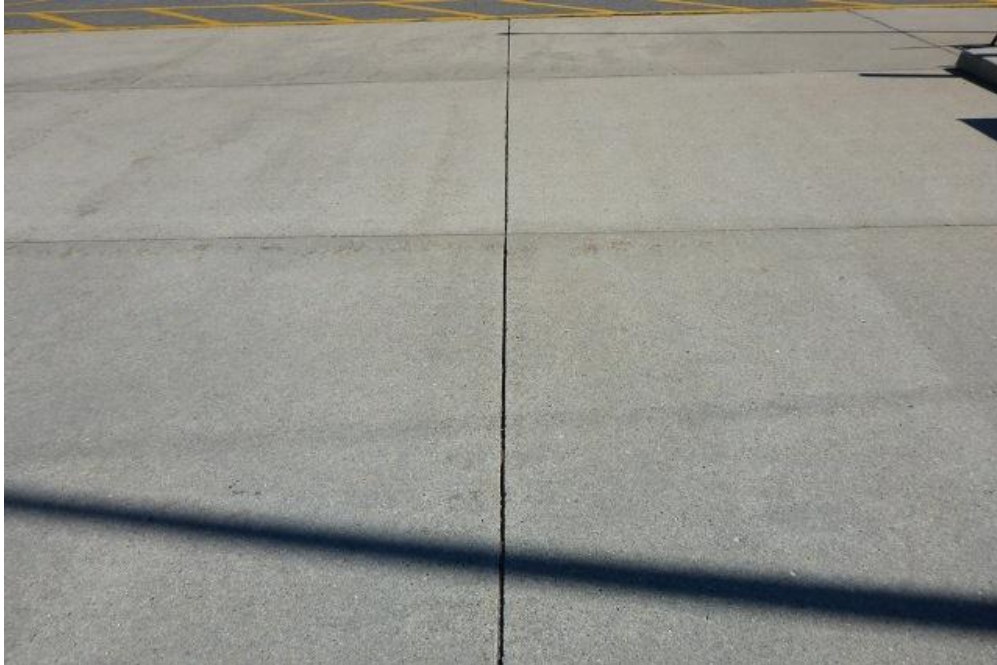
RRT APA 003 (PCI = 88)

| Branch ID | Section ID | Surface type <sup>1</sup> | Section area (SF) | LCD <sup>2</sup> | 2012 PCI | 2015 PCI | Drop in PCI/Yr <sup>3</sup> | % Deduct due to | | Distress types |
|---|---|---|---|---|---|---|---|---|---|---|
| APA | 003 | PCC | 2,700 | 1991 | 100 | 88 | 0.5 | 0 | 100 | Joint Seal Damage |

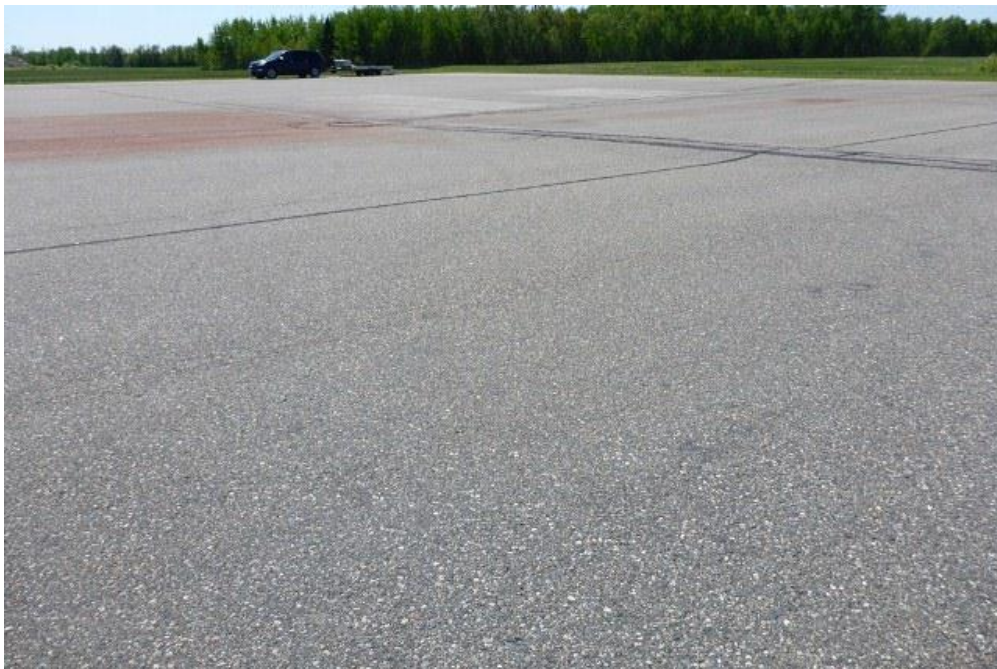
RRT APA 004 (PCI = 71)

| Branch ID | Section ID | Surface type <sup>1</sup> | Section area (SF) | LCD <sup>2</sup> | 2012 PCI | 2015 PCI | Drop in PCI/Yr <sup>3</sup> | % Deduct due to | | Distress types |
|---|---|---|---|---|---|---|---|---|---|---|
| APA | 004 | AC | 40,615 | 2004 | 74 | 71 | 2.6 | 8 | 41 | Alligator Cracking, L&T Cracking, Patching, Ravelling, Swelling |

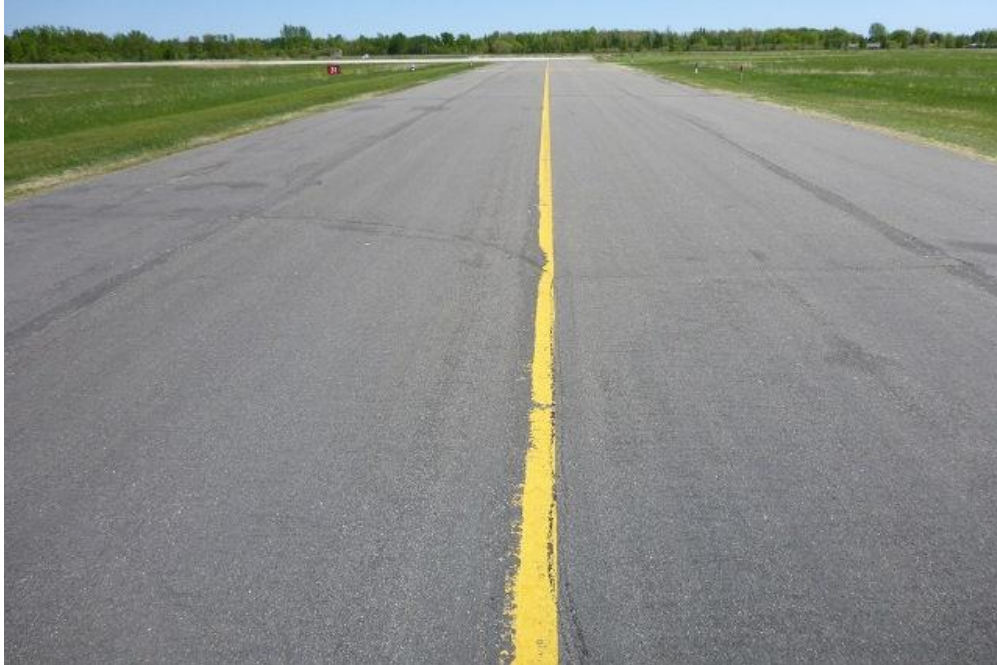
RRT CTA 001 (PCI = 74)

| Branch ID | Section ID | Surface type <sup>1</sup> | Section area (SF) | LCD <sup>2</sup> | 2012 PCI | 2015 PCI | Drop in PCI/Yr <sup>3</sup> | % Deduct due to | | Distress types |
|---|---|---|---|---|---|---|---|---|---|---|
| CTA | 001 | AC | 20,088 | 1991 | 67 | 74 | 1.1 | 0 | 96 | Depression, L&T Cracking, Patching |

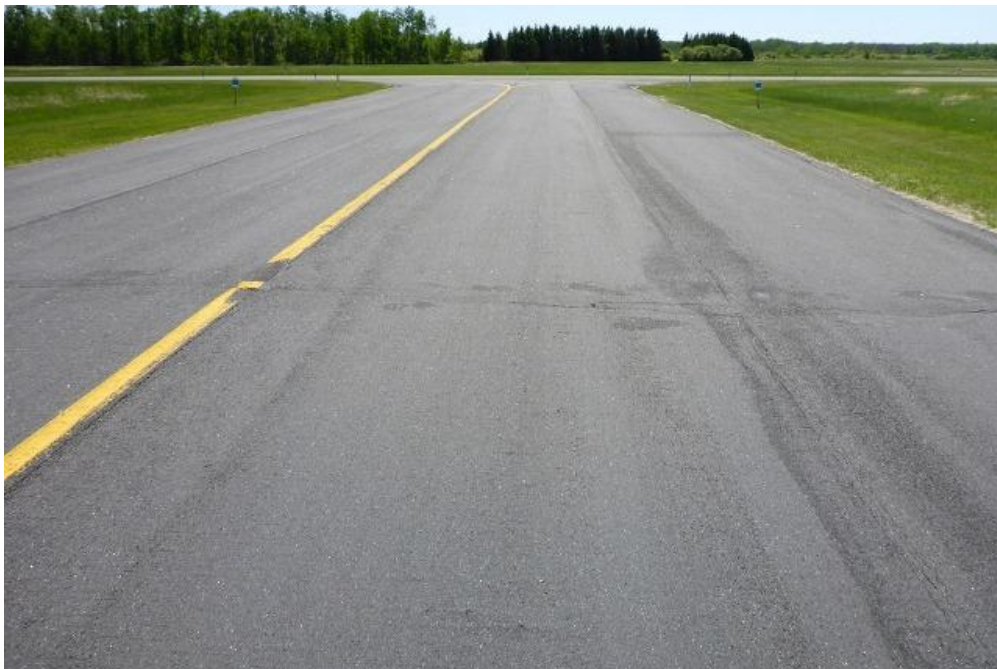
RRT CTB 001 (PCI = 69)

| Branch ID | Section ID | Surface type <sup>1</sup> | Section area (SF) | LCD <sup>2</sup> | 2012 PCI | 2015 PCI | Drop in PCI/Yr <sup>3</sup> | % Deduct due to | | Distress types |
|---|---|---|---|---|---|---|---|---|---|---|
| CTB | 001 | AC | 22,144 | 1991 | 47 | 69 | 1.3 | 0 | 77 | Depression, L&T Cracking, Swelling |

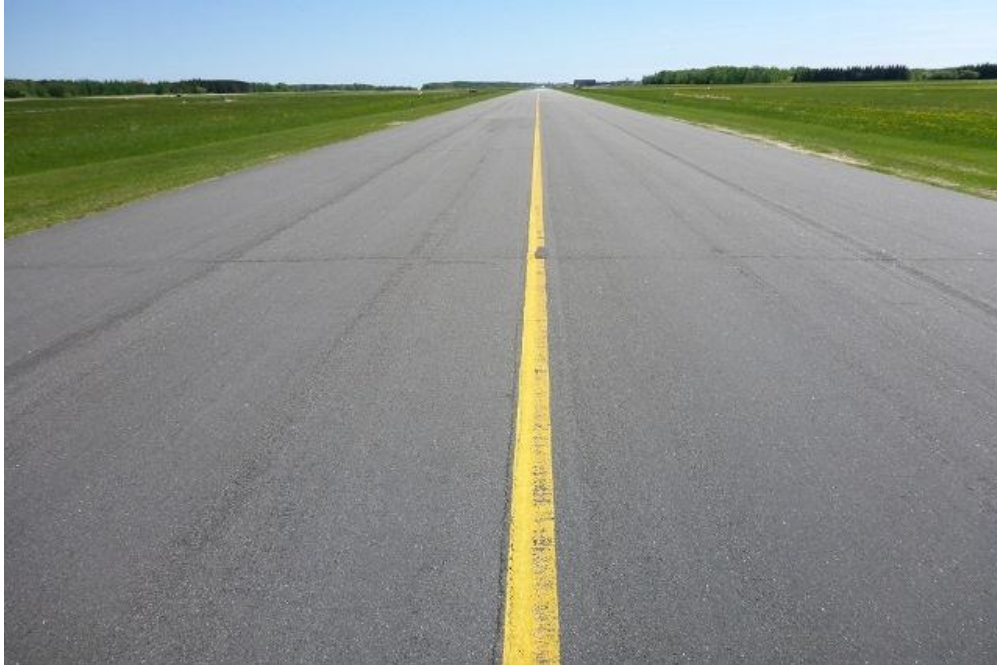
RRT PTA 001 (PCI = 71)

| Branch ID | Section ID | Surface type <sup>1</sup> | Section area (SF) | LCD <sup>2</sup> | 2012 PCI | 2015 PCI | Drop in PCI/Yr <sup>3</sup> | % Deduct due to | | Distress types |
|---|---|---|---|---|---|---|---|---|---|---|
| PTA | 001 | AC | 233,136 | 1991 | 65 | 71 | 1.2 | 0 | 97 | Depression, L&T Cracking |

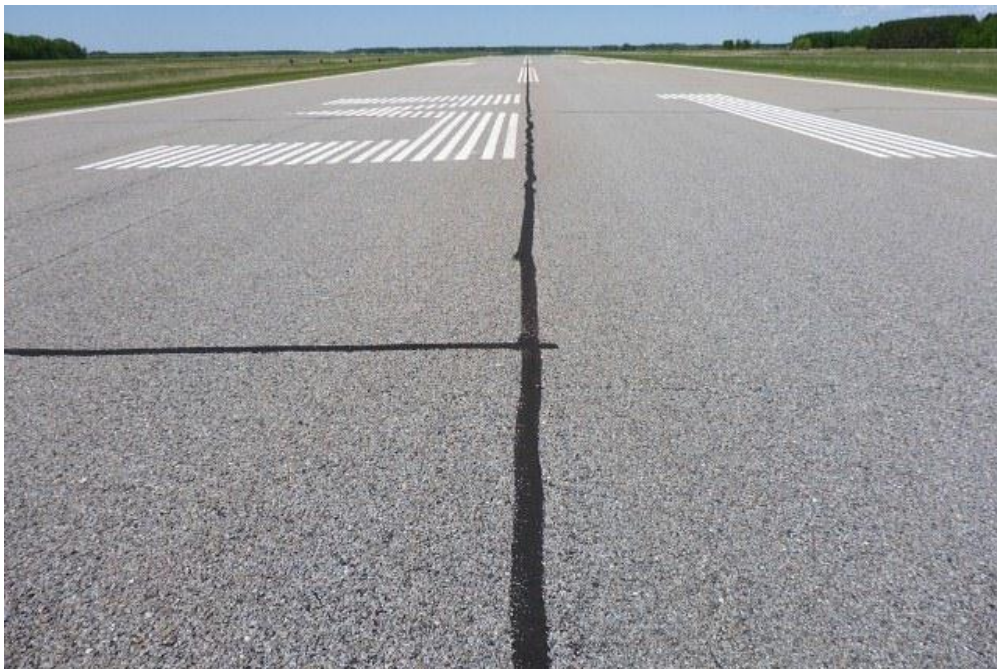
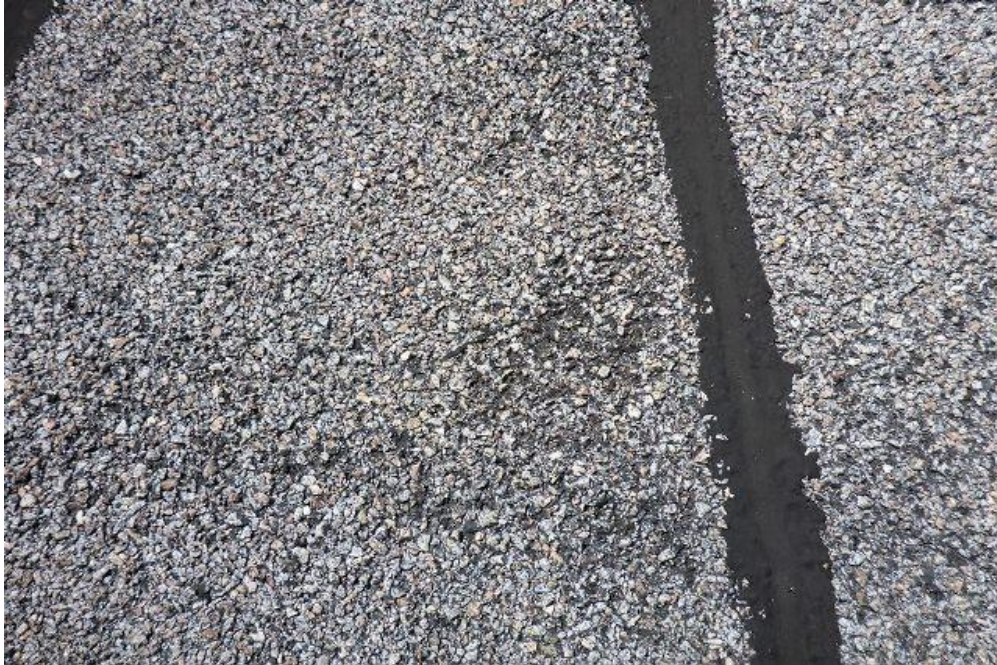
RRT RY1331 001 (PCI = 78)

| Branch ID | Section ID | Surface type <sup>1</sup> | Section area (SF) | LCD <sup>2</sup> | 2012 PCI | 2015 PCI | Drop in PCI/Yr <sup>3</sup> | % Deduct due to | | Distress types |
|---|---|---|---|---|---|---|---|---|---|---|
| RY1331 | 001 | AC | 385,000 | 2008 | 84 | 78 | 3.1 | 0 | 100 | L&T Cracking, Ravelling |

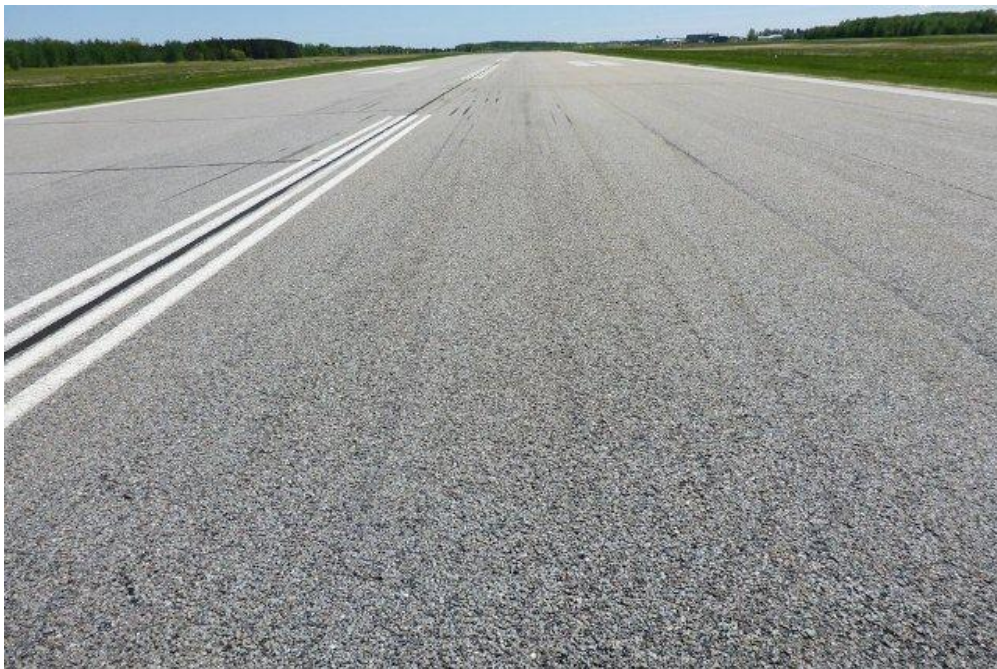
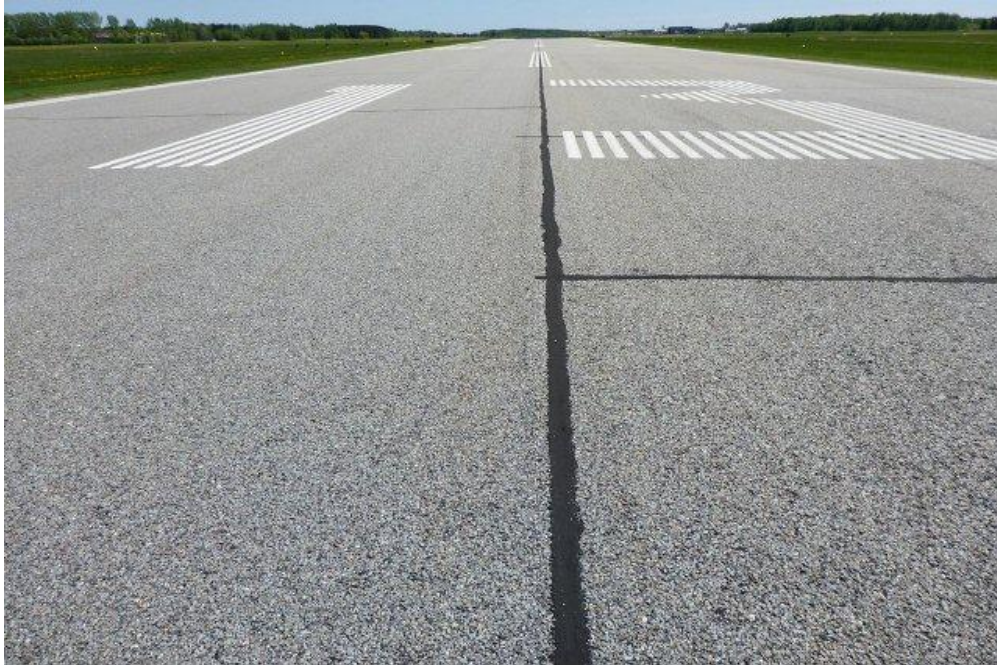
RRT RY1331 002 (PCI = 74)

| Branch ID | Section ID | Surface type <sup>1</sup> | Section area (SF) | LCD <sup>2</sup> | 2012 PCI | 2015 PCI | Drop in PCI/Yr <sup>3</sup> | % Deduct due to | | Distress types |
|---|---|---|---|---|---|---|---|---|---|---|
| RY1331 | 002 | AC | 155,000 | 2008 | 79 | 74 | 3.7 | 0 | 100 | L&T Cracking, Ravelling |

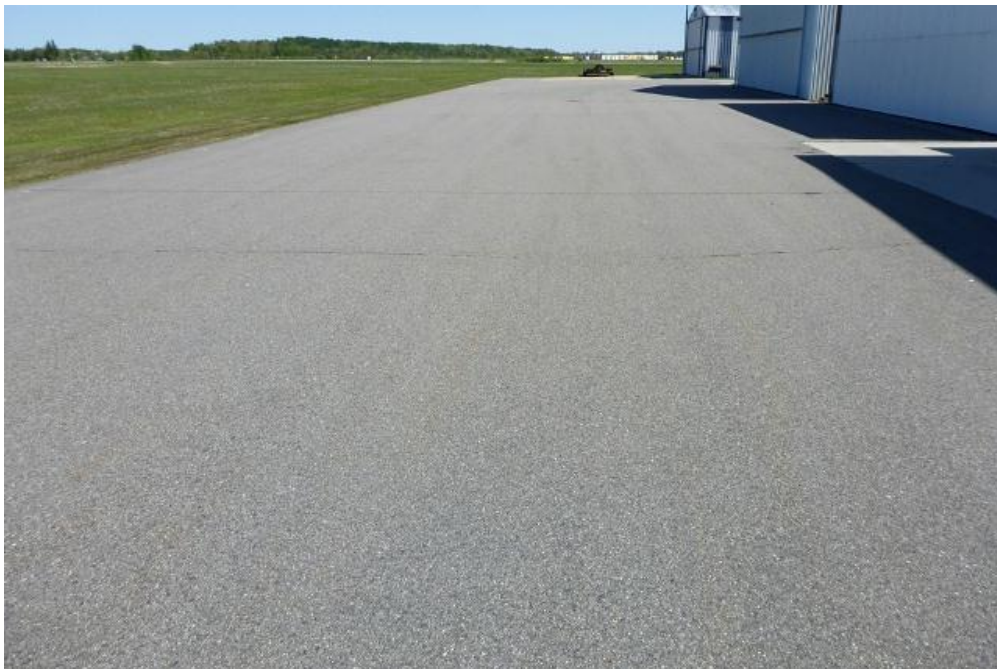
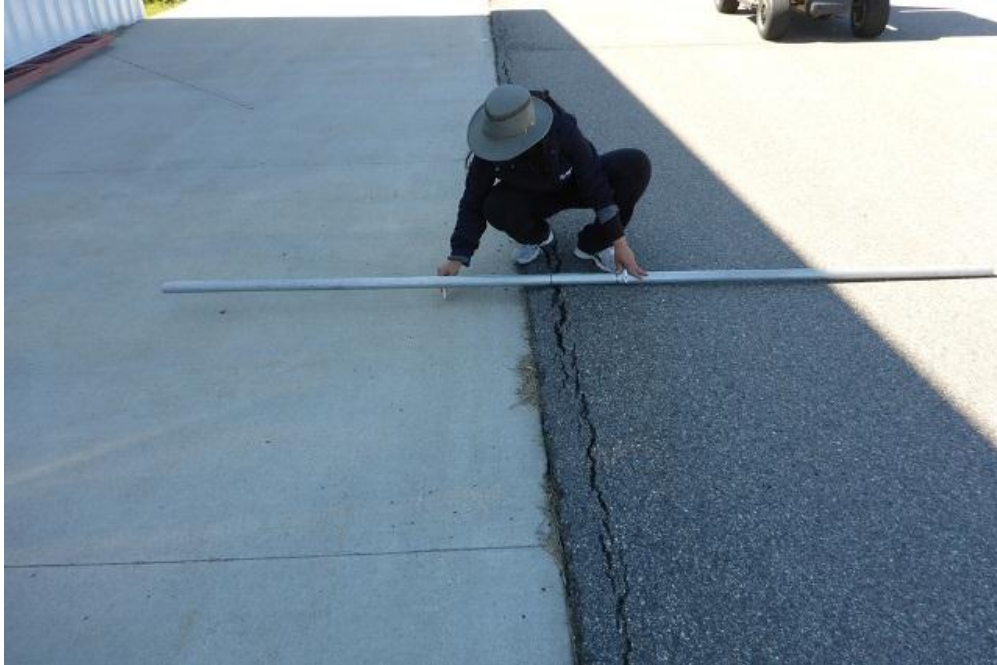
RRT TLA 001 (PCI = 88)

| Branch ID | Section ID | Surface type <sup>1</sup> | Section area (SF) | LCD <sup>2</sup> | 2012 PCI | 2015 PCI | Drop in PCI/Yr <sup>3</sup> | % Deduct due to | | Distress types |
|---|---|---|---|---|---|---|---|---|---|---|
| TLA | 001 | AAC | 7,200 | 2012 | 100 | 88 | 4.0 | 0 | 61 | L&T Cracking, Shoving |

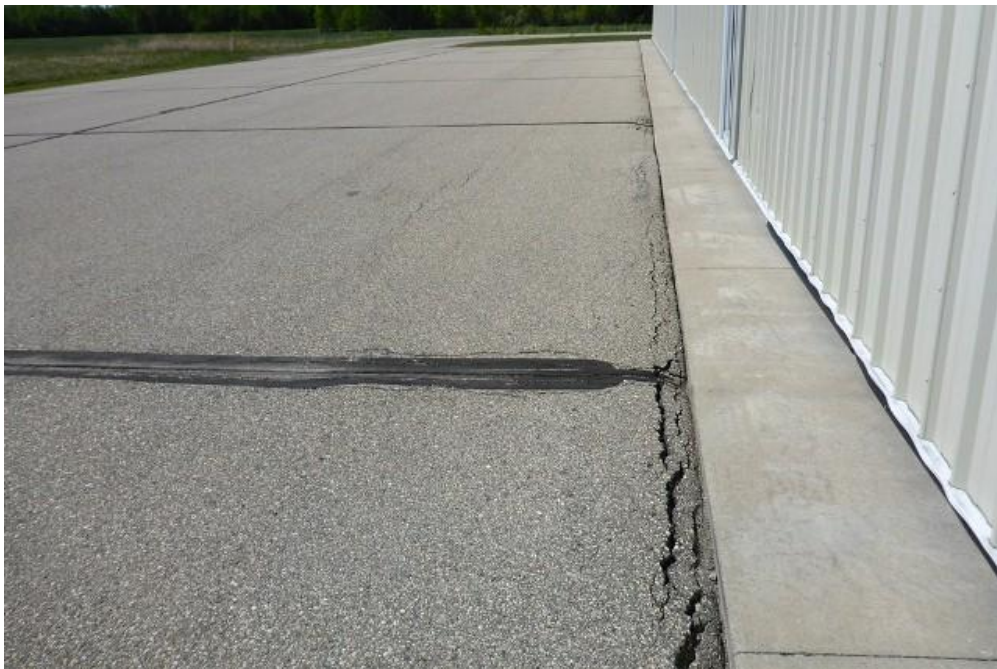
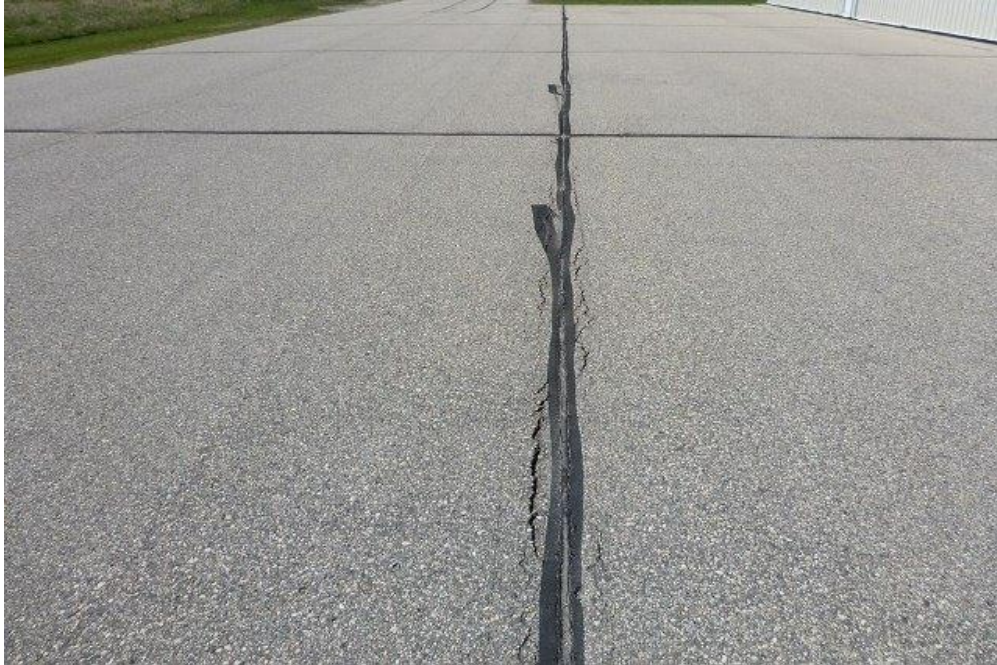
RRT TLB 001 (PCI = 69)

| Branch ID | Section ID | Surface type <sup>1</sup> | Section area (SF) | LCD <sup>2</sup> | 2012 PCI | 2015 PCI | Drop in PCI/Yr <sup>3</sup> | % Deduct due to | | Distress types |
|---|---|---|---|---|---|---|---|---|---|---|
| TLB | 001 | AC | 41,000 | 2003 | 81 | 69 | 2.6 | 0 | 100 | L&T Cracking, Weathering |
