Pavement Condition Report

Redwood Falls Municipal Airport (RWF)

January 2016

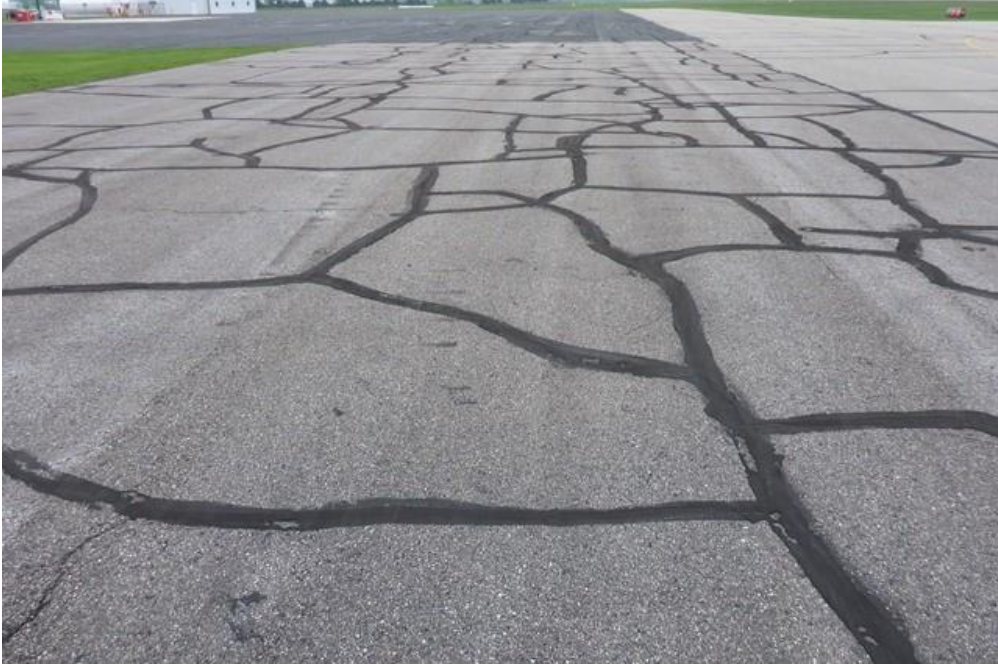
RWF APA 001 (PCI = 59)

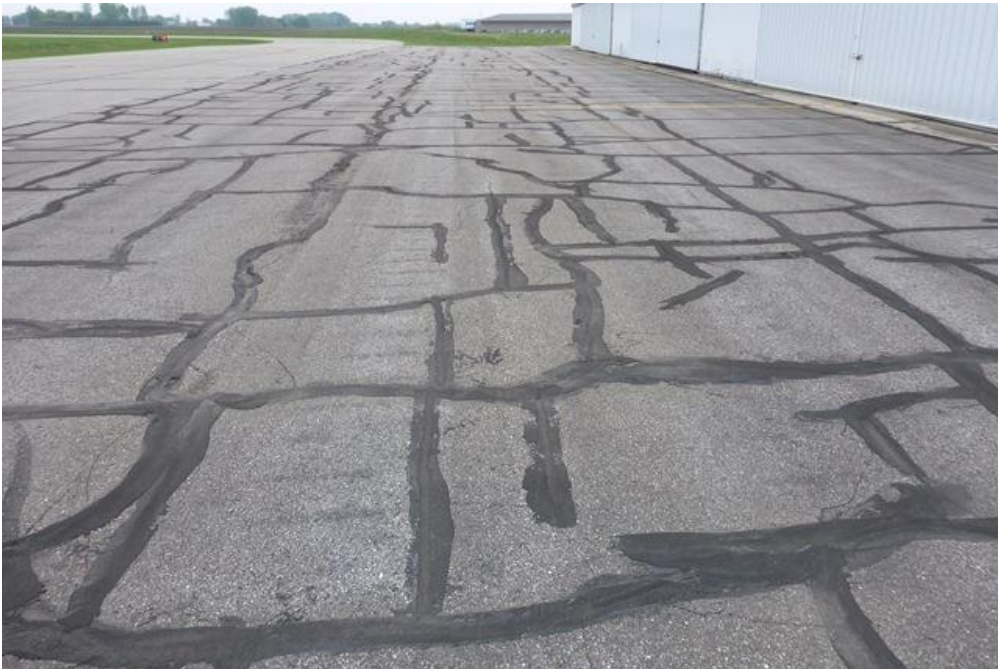
RWF APA 002 (PCI = 55)

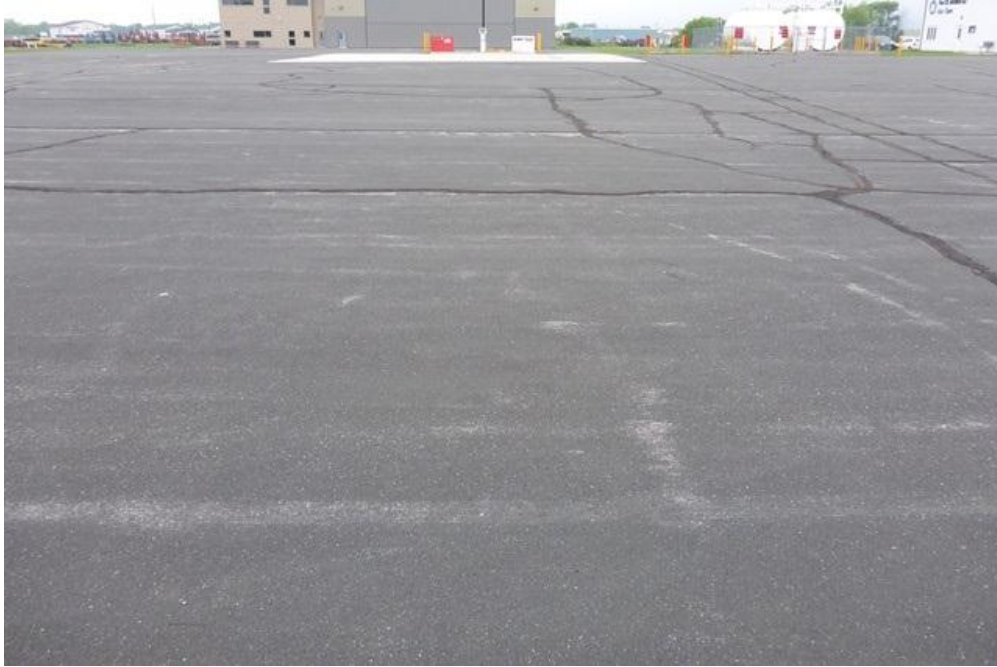
RWF APA 003 (PCI = 68)

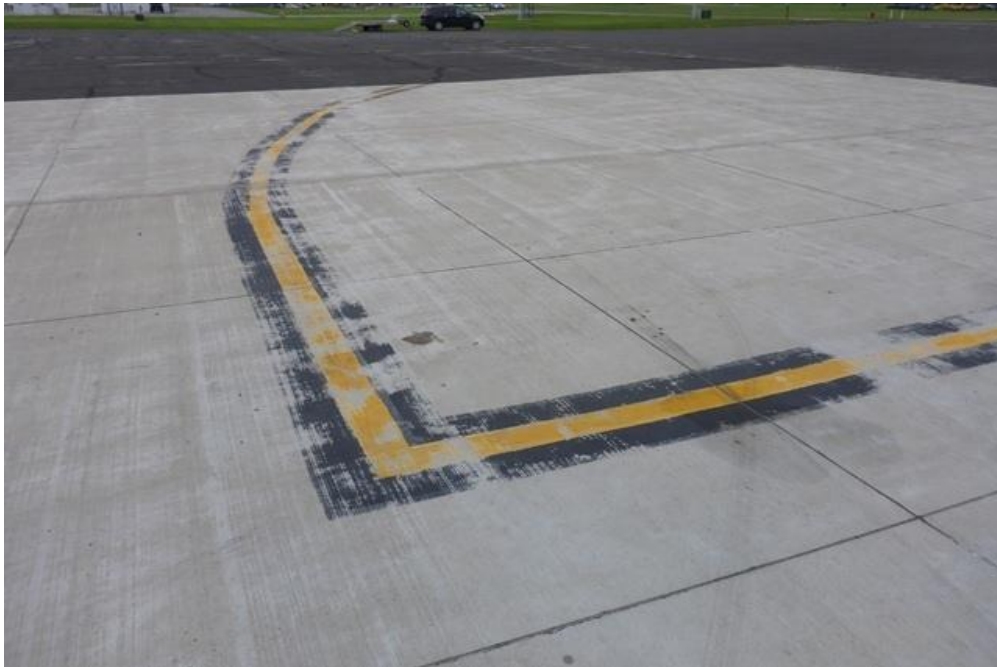
RWF APA 004 (PCI = 93)

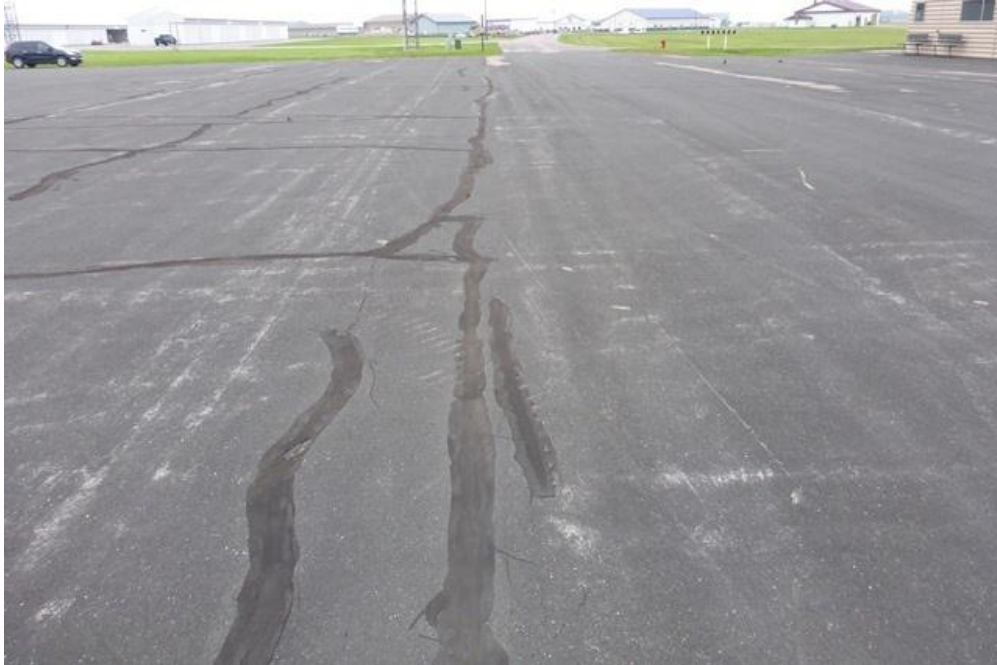
RWF APA 005 (PCI = 86)

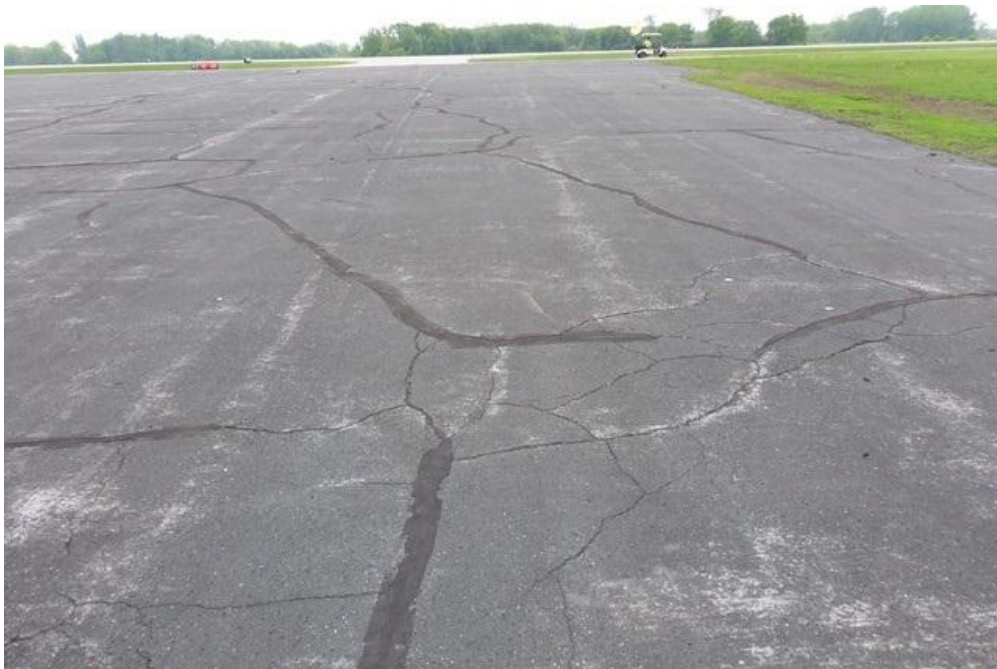
RWF APA 006 (PCI = 22)

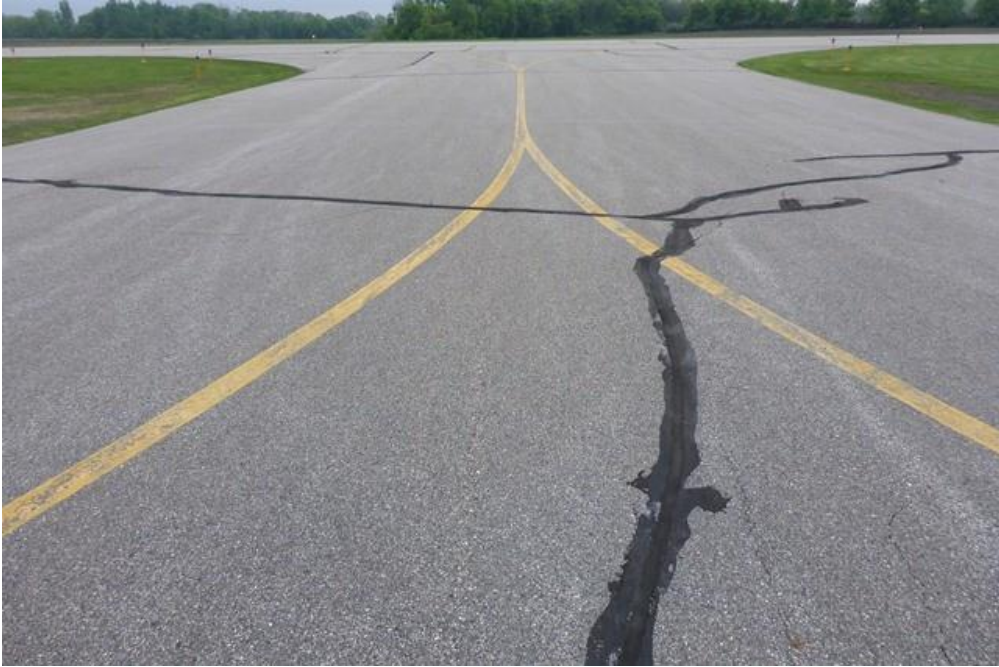
RWF CTA2 001 (PCI = 85)

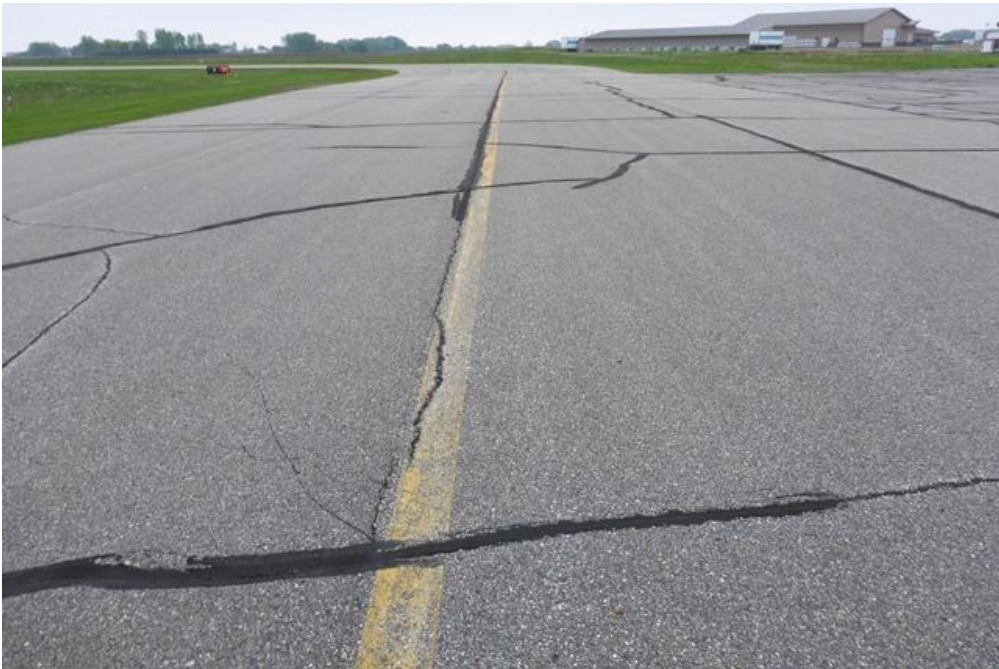
RWF PPTA 001 (PCI = 76)

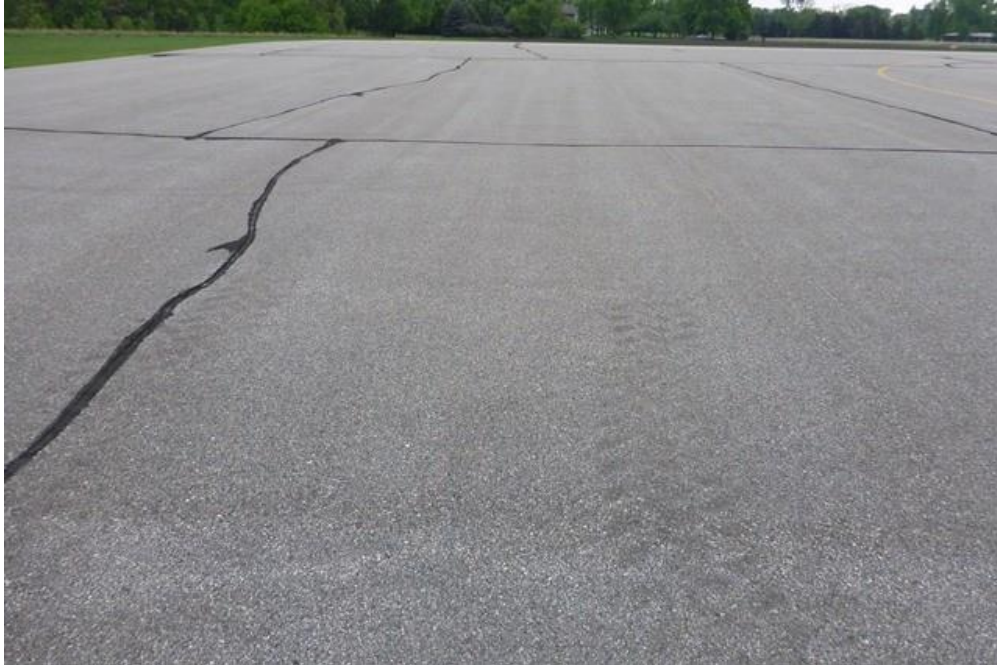
RWF RTA 001 (PCI = 90)

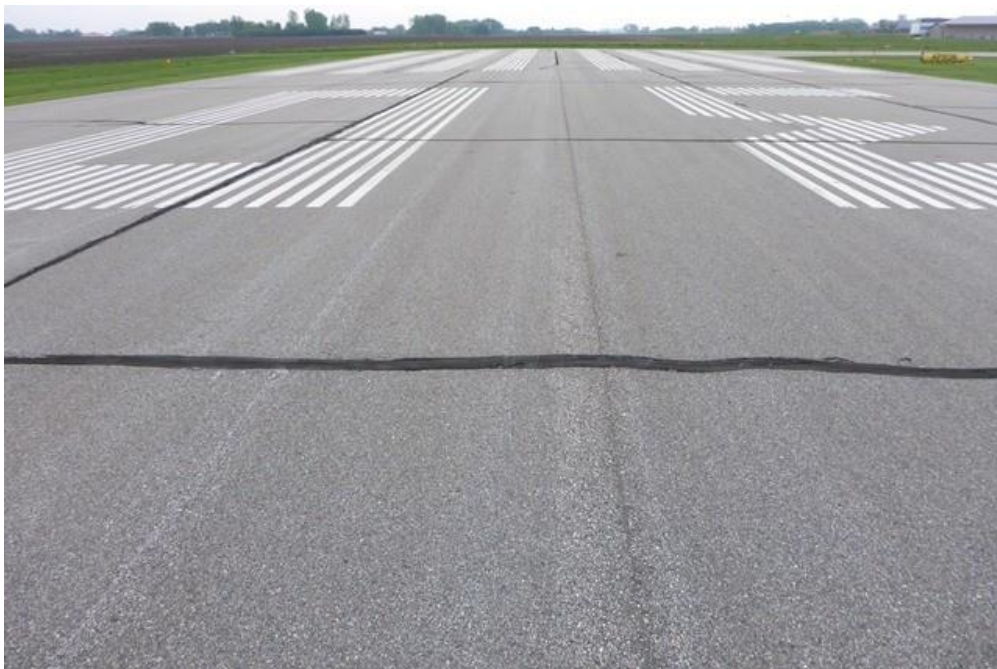
RWF RY1230 001 (PCI =83)

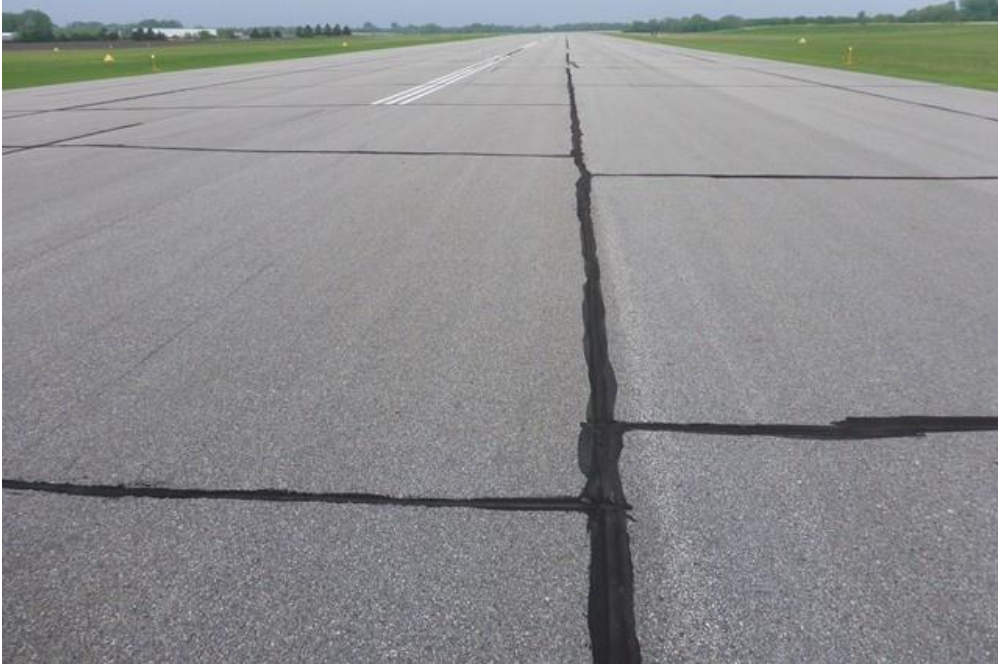
RWF RY1230 002 (PCI =81)

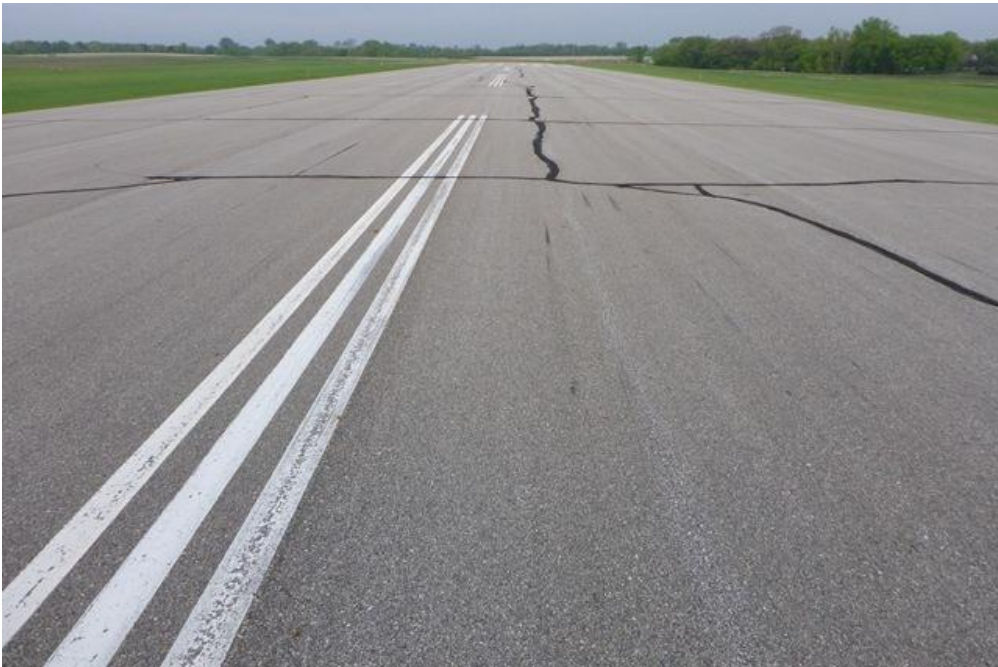
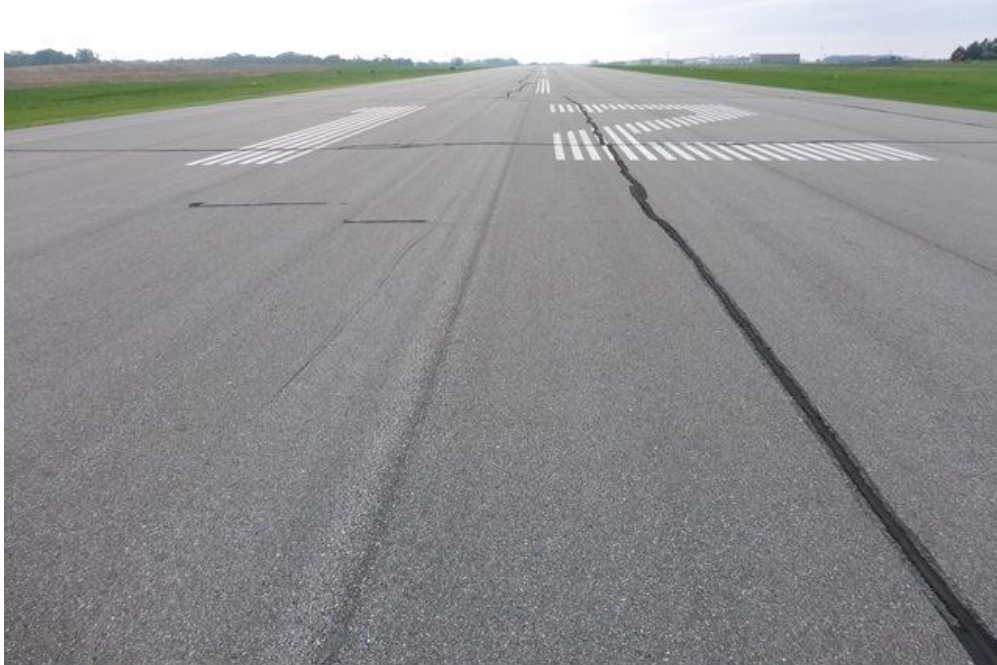
RWF RY1230 003 (PCI =80)

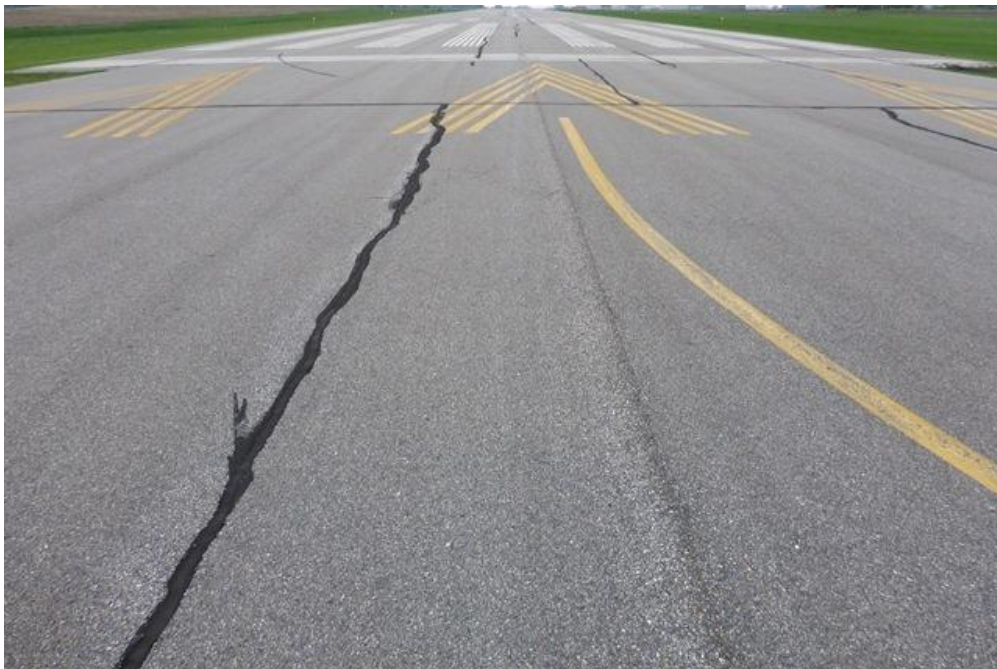
RWF RY1230 004 (PCI =82)

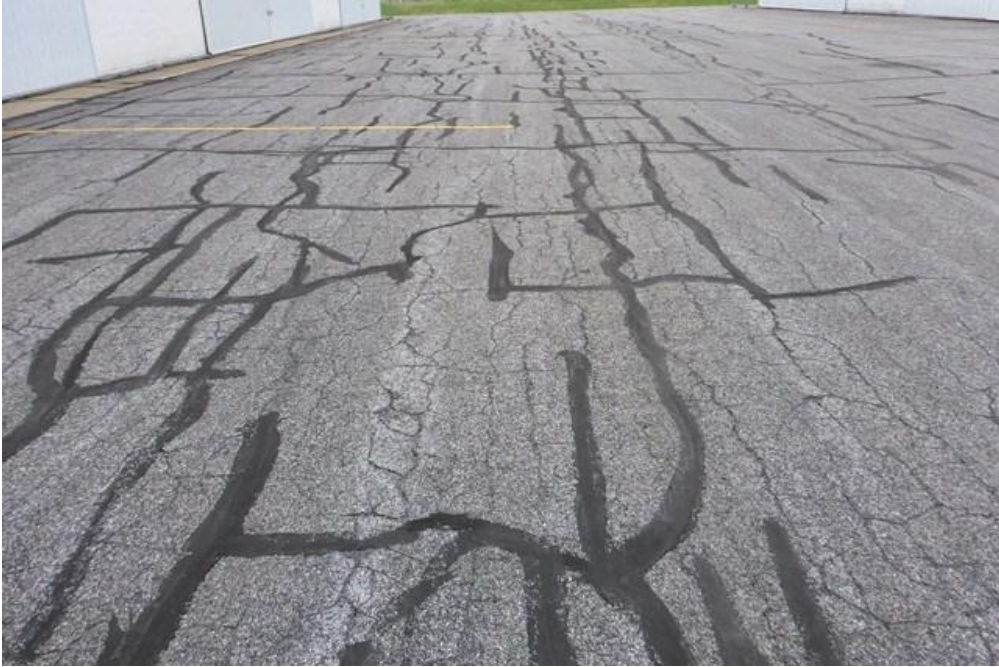
RWF TLA 001 (PCI = 42)
